SUBJECT: PUBLIC MEETING SUMMARY– REGULATORY CONFERENCE FOR
BROWNS FERRY NUCLEAR PLANT, DOCKET NO. 50-259

**TENNESSEE VALLEY AUTHORITY
BROWNS FERRY NUCLEAR PLANT, UNIT 1**

**Low Pressure Coolant Injection Valve
1-FCV-74-66**

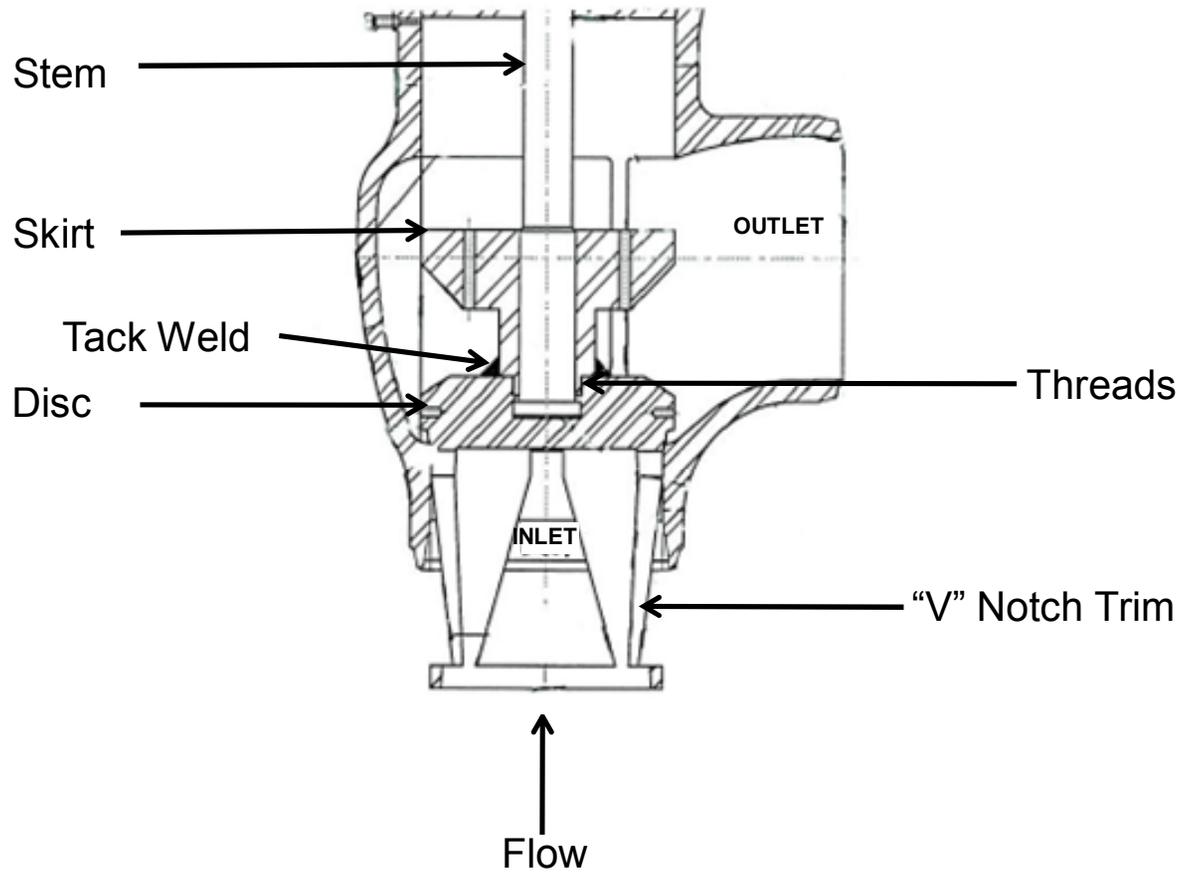
Root Cause – RHR Valve Cross Section

- The valve was purchased as an assembly that would not be taken apart to perform receipt inspections
 - Undersized skirt thread diameter caused the threaded connection between disc and skirt to be 38 percent of design strength

- Pressure on skirt/stem side of disc due to downstream check valve leakage and surveillance testing configuration
 - Tack welds designed to prevent rotational, not axial separation

- Root cause of separation was clearly the undersized disc to skirt threads
 - This was a manufacturing deficiency and has been reported under 10 CFR 21
 - No reasonable basis existed to examine threads and identify the undersized thread condition
 - No other root or contributing cause was identified
 - There was no licensee performance deficiency
- The disc would have released and provided proper flow within seven minutes, fully supporting the limiting Appendix R fire event
 - Industry experts performed extensive analysis and laboratory testing
 - *“As a result, PII has **very high** confidence in the credibility of its findings.”¹*
 - This confidence is supported by the conclusion that valve was functional in March 2009, even though the disc was separated from the stem

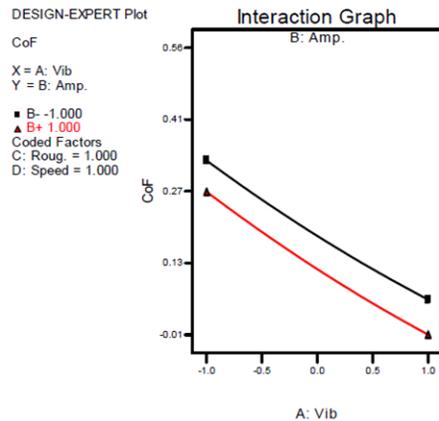
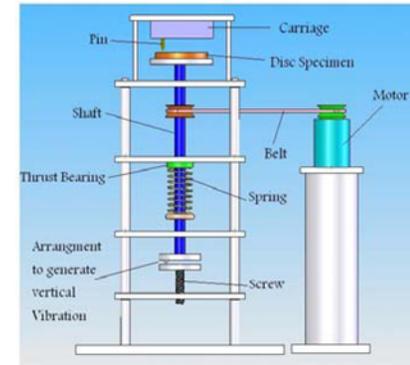
- A very similar experiment conducted by researchers concludes that vibrations greatly reduce the coefficient of friction.
- The coefficient of friction is most reduced by vibration frequency and amplitude, surface roughness, speed, and quadratic terms of the surface roughness and speed.

Steel C1020 with a surface roughness and speed of 2.5 μm and 1.2 m/s; respectively

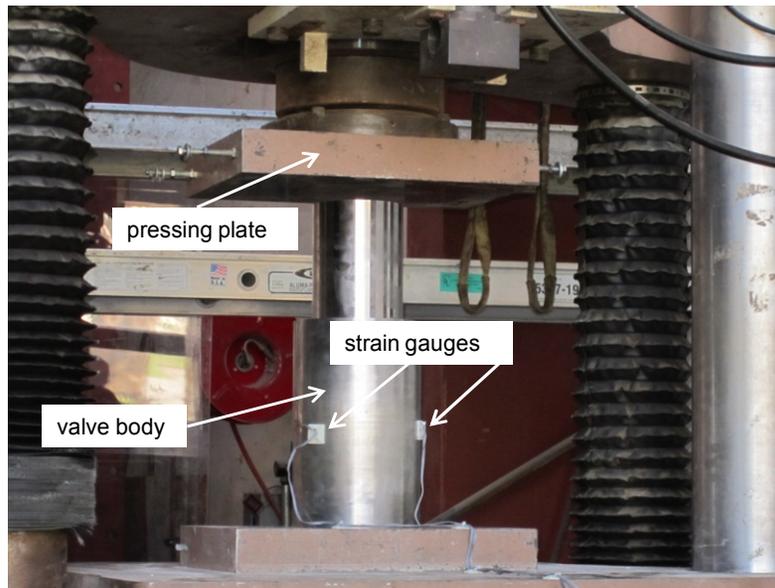
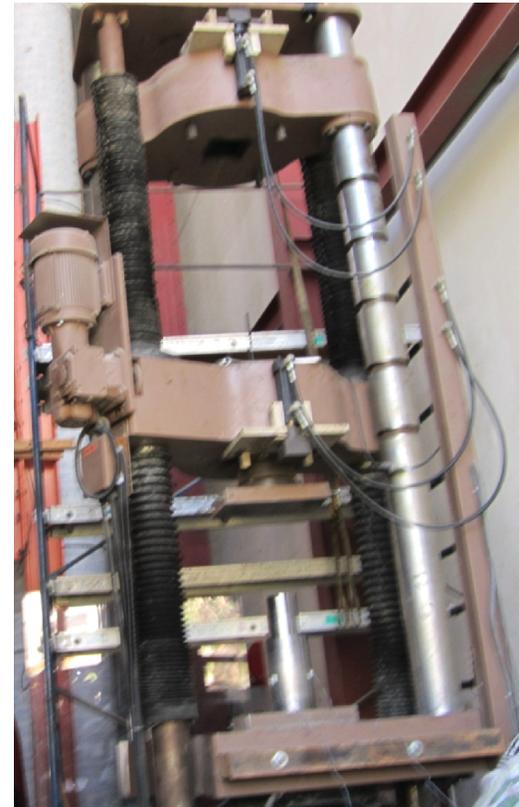
Vibration Effect on Coefficient of Friction Testing

- The valve disc was compressed into the valve body by a hydraulic press.
- Strain gauges were positioned on the outside of the valve body.
- Vibrations were applied to the disc modeled on the plant configuration.

- Multiple laboratory mockup tests concluded:
 - During multiple valve stroke surveillances, the free end of the stem “hammered” the disc into the seat
 - Disc loosens promptly with seats in clean unoxidized condition
 - Disc loosens within seven minutes with seating surfaces in roughened condition
 - System differential pressure would lift the disc, allowing proper flow as required by Safe Shutdown Analysis (SSA) for Appendix R fire (highest risk event)

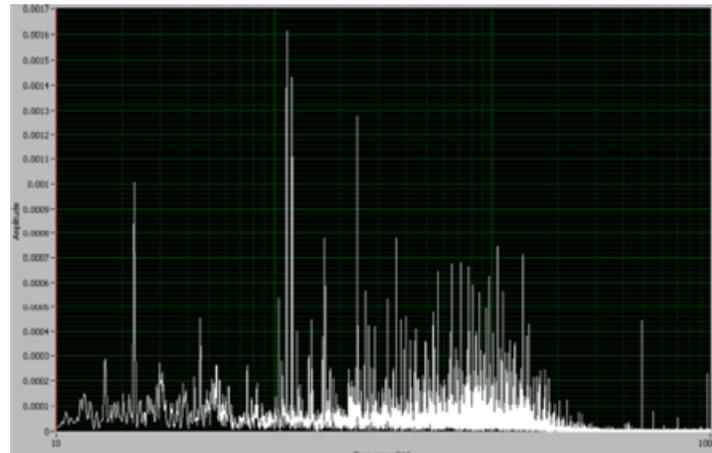
- Pressure amplitude and frequency data were measured at Browns Ferry Nuclear Plant using a high-speed recorder with the RHR pump running
- Fast-Fourier Transform was performed and utilized in laboratory mockup testing
