Subject: 10CFR21 Reporting of Defects and Non-Compliance -  
Engine Systems, Inc. Report No. 10CFR21-0100, Rev. 1

EMD Water Pump, P/N 8324589

**Report No. 10CFR21-0100**

COMPONENT: EMD water pumps

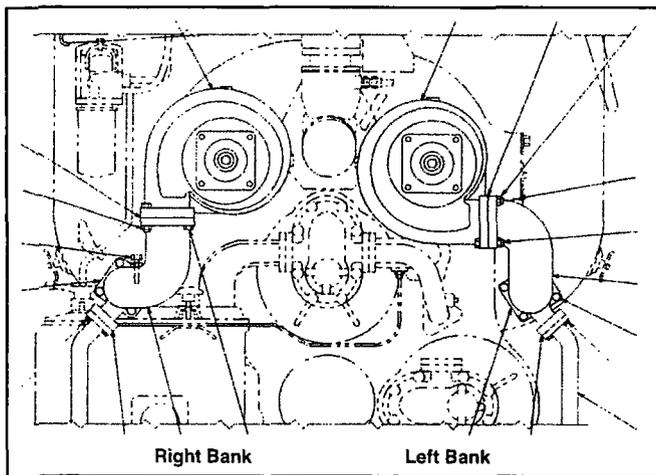
**Figure 1**

EMD diesel engines utilized for emergency diesel generator sets use two engine jacket water centrifugal pumps (one for each bank) to circulate fluid throughout the engine for cooling. Each pump is mounted on the front of the engine and rotates in the opposite direction of the engine crankshaft. For single engine generator set applications (i.e. left hand rotation engine, viewed from the rear of the engine), the pumps used on each bank contain identical components; the only difference is the position of the impeller housing in relation to the pump shaft housing. When viewed from the front of the engine, these water pumps rotate counterclockwise (see Figure 1 below).

**Water Pumps for LH Rotation Engine**

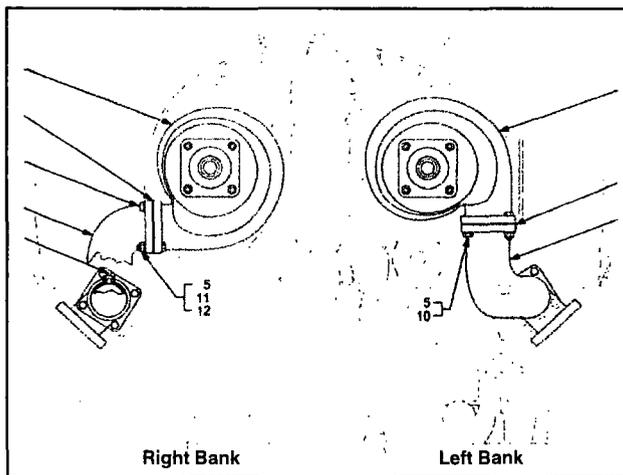
**Figure 2**

For tandem generator set applications, one engine is left hand rotation and the other is right hand rotation. For each engine, the pumps used on each bank contain identical components and the only difference is the position of the impeller housing in relation to the pump shaft housing. However, for a right hand rotation engine the water pumps rotate clockwise when viewed from the front of the engine (see Figure 2 below).

**Water Pumps for RH Rotation Engine**
