PVP2011-58001

Road Tunnels and Fires: Implications for the Transport of Used Nuclear Fuel

E. Easton,¹ C. Bajwa,¹ T. Mintz,² J. Huczek,³ K. Das,² K. Axler²

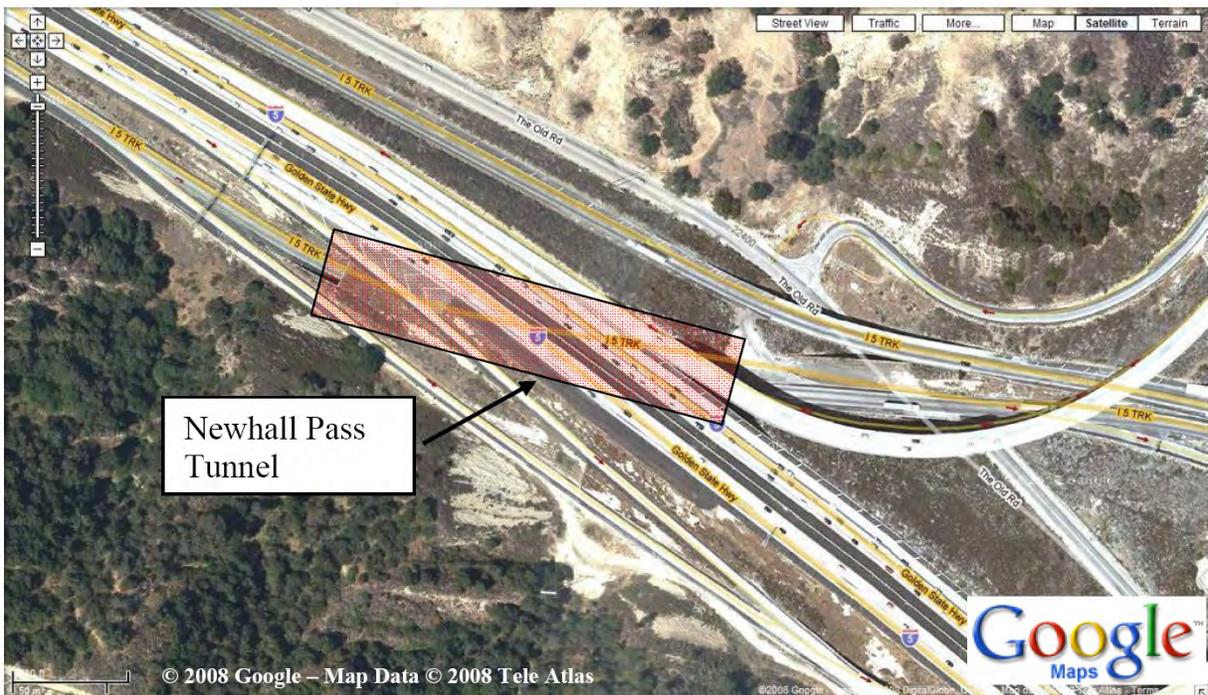
Figure 2. Aerial Photograph of Interstate 5 and Highway 14 Interchange

The Newhall Pass tunnel fire occurred on October 12, 2007, at approximately 10:40 p.m., near Santa Clarita, California. The Newhall Pass tunnel is part of the Interstate 5 southbound truck lane as it passes below Interstate 5 main lanes. The tunnel is a 165.8-m [544-ft] long reinforced concrete boxed girder, which was built in 1971. (See Figures 1 and 2)

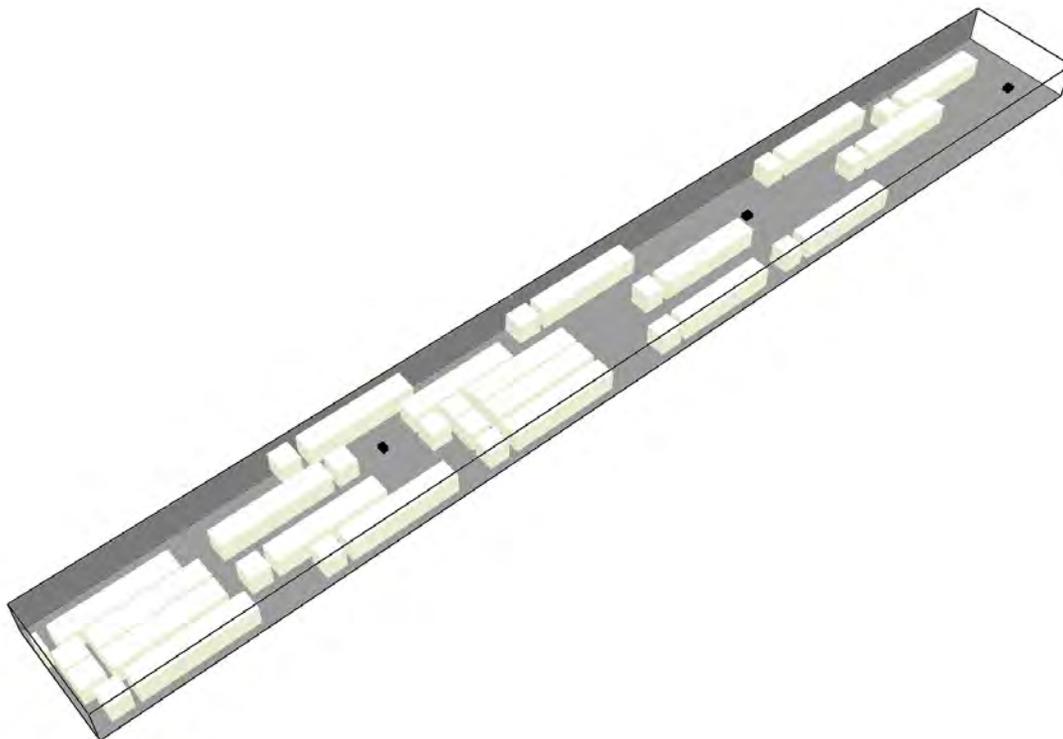
materials exposed to the tunnel fire and by developing a computational model of the fire. Materials analyses were conducted on samples collected from 5 of the 25 vehicles involved in the fire. The objective of the materials analyses work was to evaluate the characteristics of the sampled components exposed to this tunnel fire and estimate an approximate range of temperatures to which these components were exposed. This tunnel fire was also modeled [See Figure 3(b)] using the computational

fluid dynamics code FDS (Version 5)[2][3], developed by NIST, to calculate the gas and wall temperatures in the tunnel as the fire progressed. The geometry of the tunnel, amount of combustible materials, and weather conditions were considered in the modeling effort. The information from the materials analyses will be used as a consistency check with the fire model results and to provide additional support for temperature range estimates of the Newhall Pass tunnel fire.

Figure 3. Newhall pass tunnel geometry (a) provided by multidisciplinary accident investigation team (courtesy of CHP) and (b) fire dynamics simulator (FDS) model approximation
