Docket No. 50-305

SUMMARY REPORT
FEEDWATER LINE CRACKING
KEWAUNEE NUCLEAR POWER PLANT

July 13, 1979

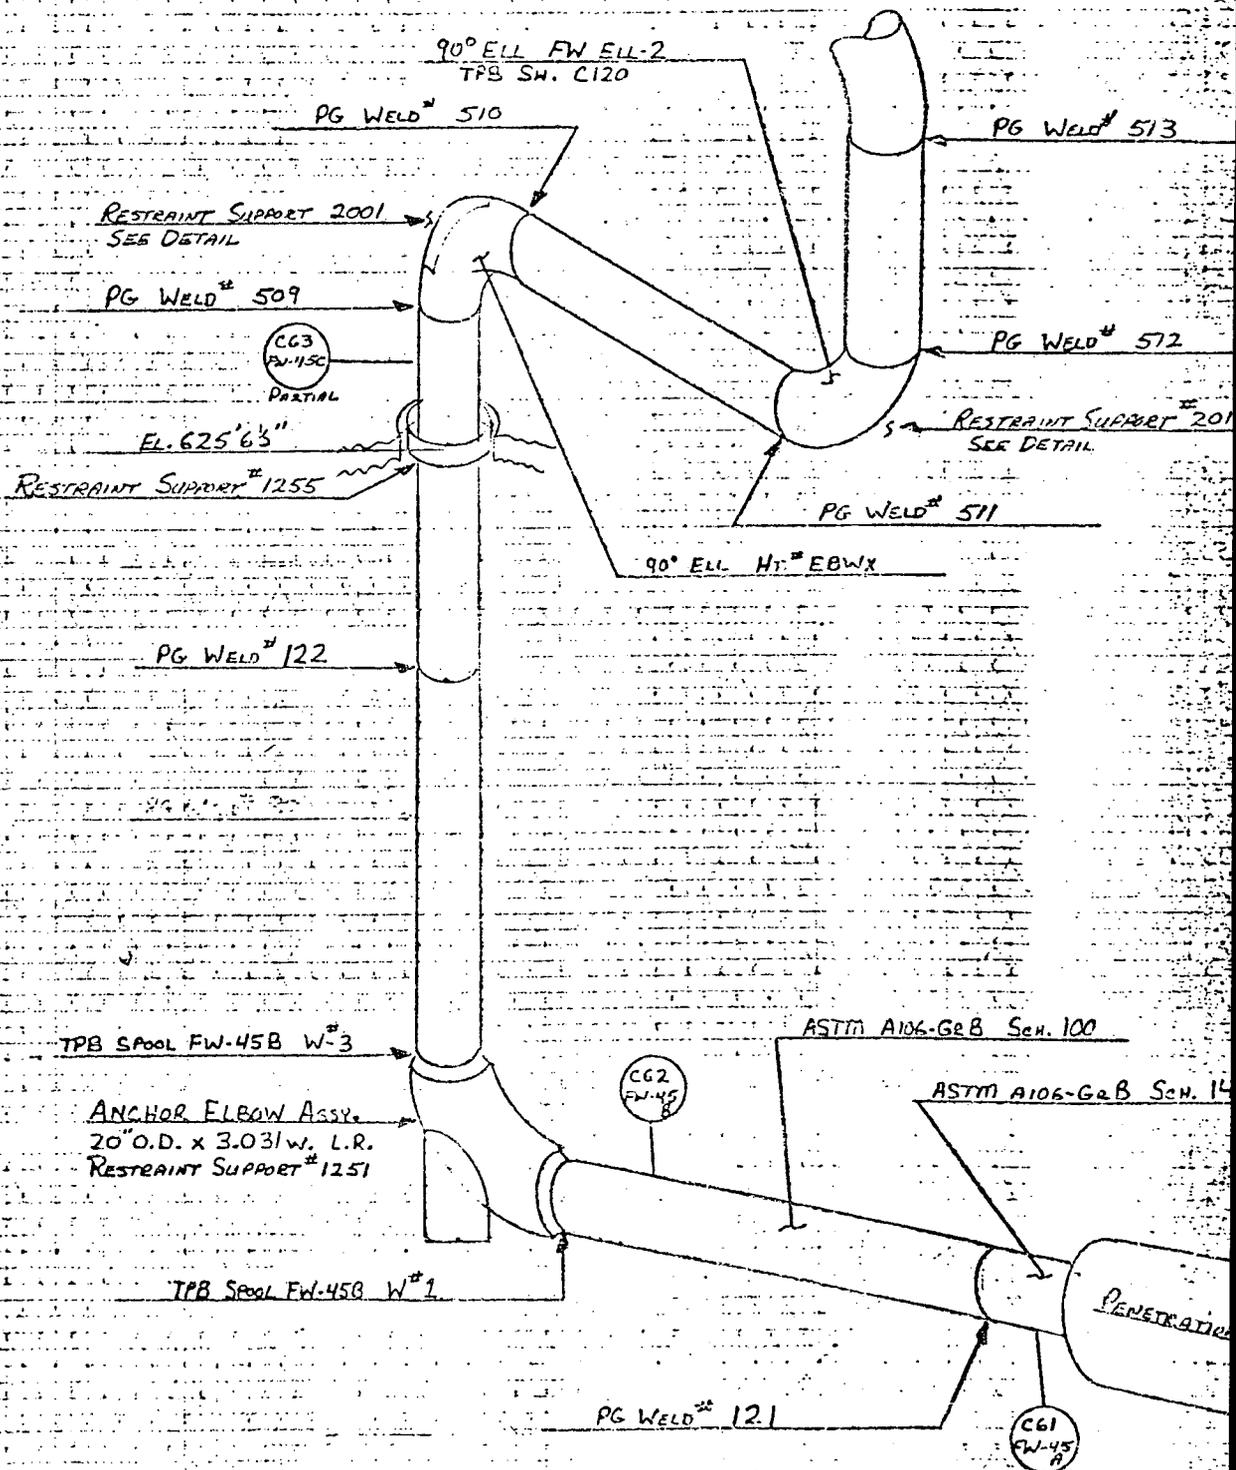
Figure 2.1-1
Loop A FW Piping (Upper)

When the sections of pipe were removed, about an 8 inch section on loop B and a 12 inch section on loop A, see figures 2.1-1 and 2.1-3, circumferential cracks were identified on the inside surface of pipe in the weld area and in pipe base metal near the weld. Several shallow surface cracks were also noticed on the nozzle side of the weld remaining attached to the S/G. These shallow cracks were removed by cutting away an additional 1/8 to 1/4 inch section of the nozzle on S/G A and by grinding and polishing loop B. The pipe sections were then flown to Westinghouse's metallurgical laboratory for detailed examination.
