Report of Japanese Government  
to the IAEA Ministerial Conference on Nuclear Safety  
- The Accident at TEPCO's Fukushima Nuclear Power Stations -

June 2011

Nuclear Emergency Response Headquarters  
Government of Japan

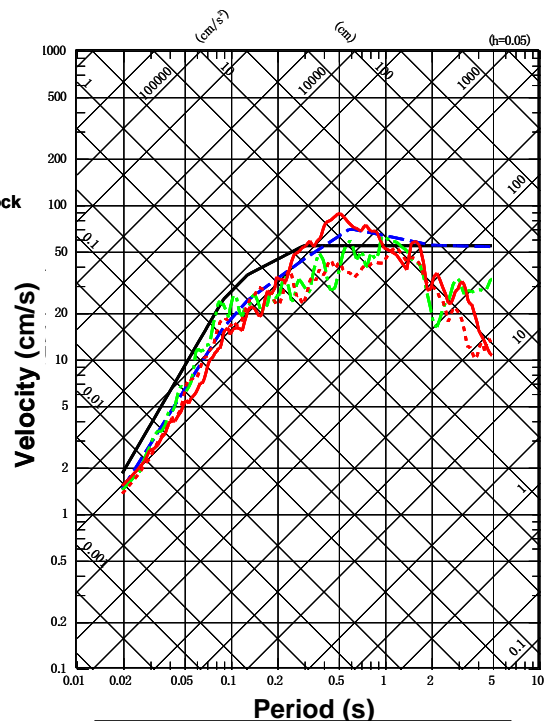
Fig. III-3-1 Deployment of seismometers and comparison of observed response spectra with the DBGM Ss on a free surface (equivalent to the base stratum) at Onagawa NPS.

Figure III-3-1 shows a comparison between response spectra of the observed seismic ground motions at the upper part of the bedrock on the site and response spectra for the standard seismic ground motion Ss. Response spectra of the observed seismic ground motions exceed response spectra for the standard seismic ground motion Ss in the periodic band between 0.2 and 1.0 sec.

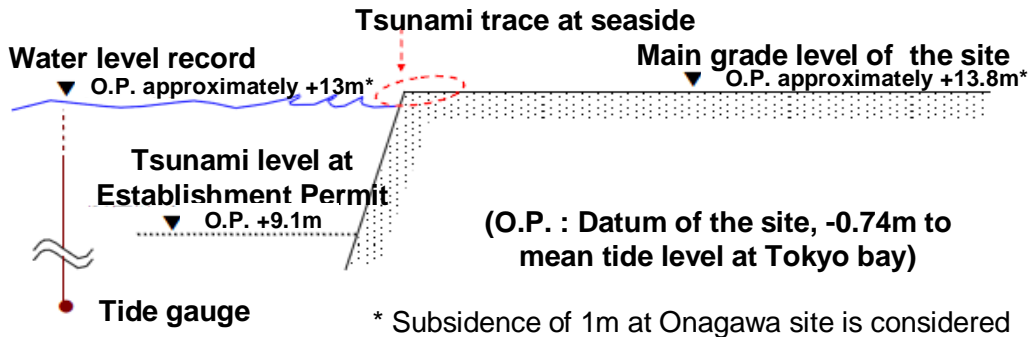
Fig. III-3-4 Outline of tsunami arrival at Onagawa NPS.

Figure III-3-3 shows the tsunami time history recorded by the tide gauge. From the record, it can be seen that the first big wave arrived at about 15:29 (43 min after the main shock). The observed tsunami height was about 13 m relative to O.P. (O. P.: the reference surface for construction of Onagawa NPS), which did not exceed the height of the site, i.e. 13.8 m relative to O.P. (the real height of the site is 14.8 m, adjusted to sinking by about 1 m due to crustal deformation, according to the Geographical Survey Institute QE, see Figure III-3-4). Although seawater was found to have entered the sea-facing side of the site, it did not reach the major buildings.

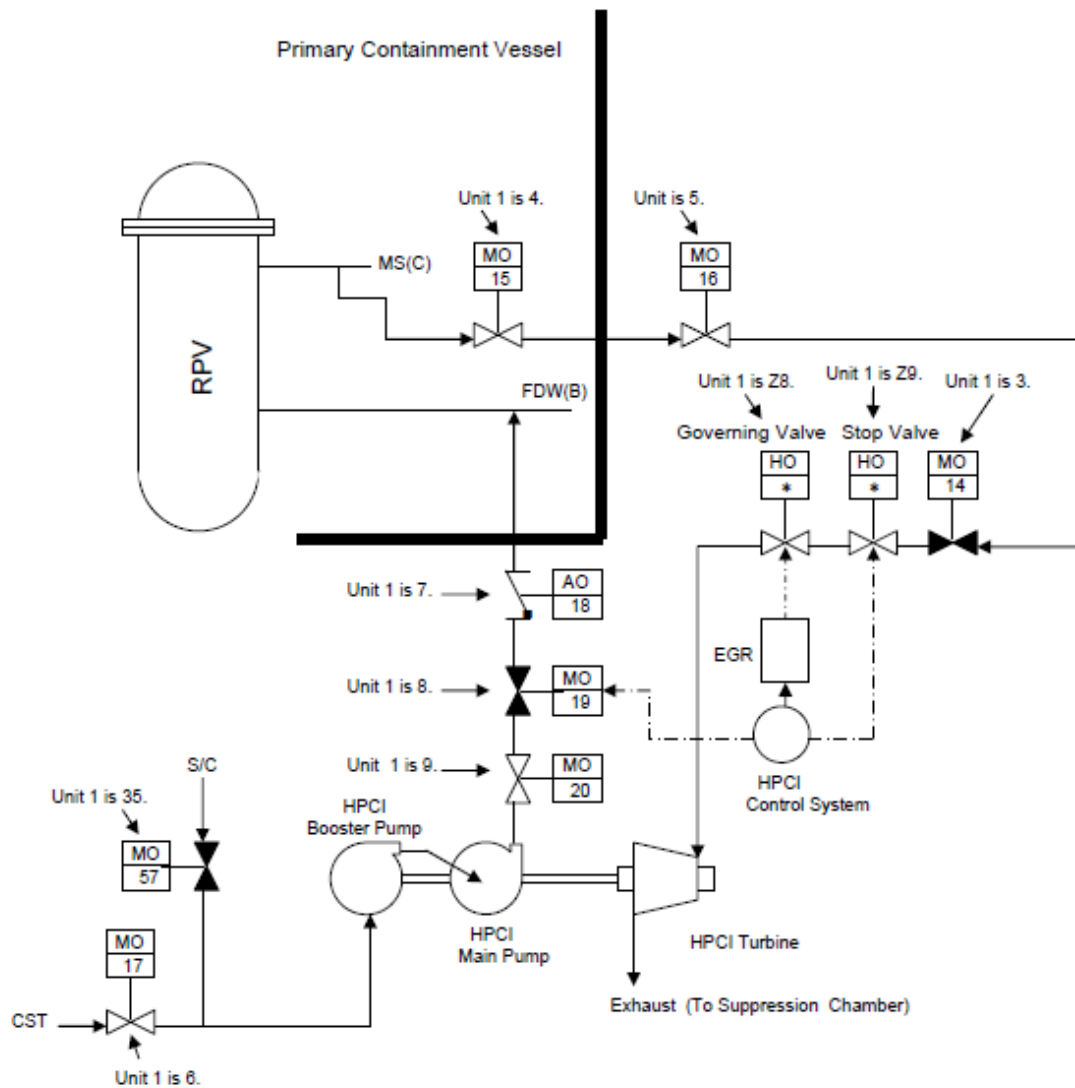
Fig. IV-2-3 System Structure Diagram of High Pressure Coolant Injection System  
(Units 1 to 3)

- \*1: During normal operation, MO-15, 16, 17, 20 and HO valves are "open" and MO-14 and 19 valves are "close".  
At startup, 14 and 19 valves are "open".
- \*2: MO-15 valve is inoperative due to AC power loss. (as-is)
- \*3: MO-14, 16, 17, 19 and 20 valves are inoperative due to DC power loss (the separate power source from isolation logic circuits). (as-is)
- \*4: During DC power loss, isolation (close) logic circuits are operative.  
At that time, if the drive power of each valve (written in \*2 and \*3) is activated, each valve is closed. If the drive power of each valve is already lost, the circuits are inoperative. (as-is)

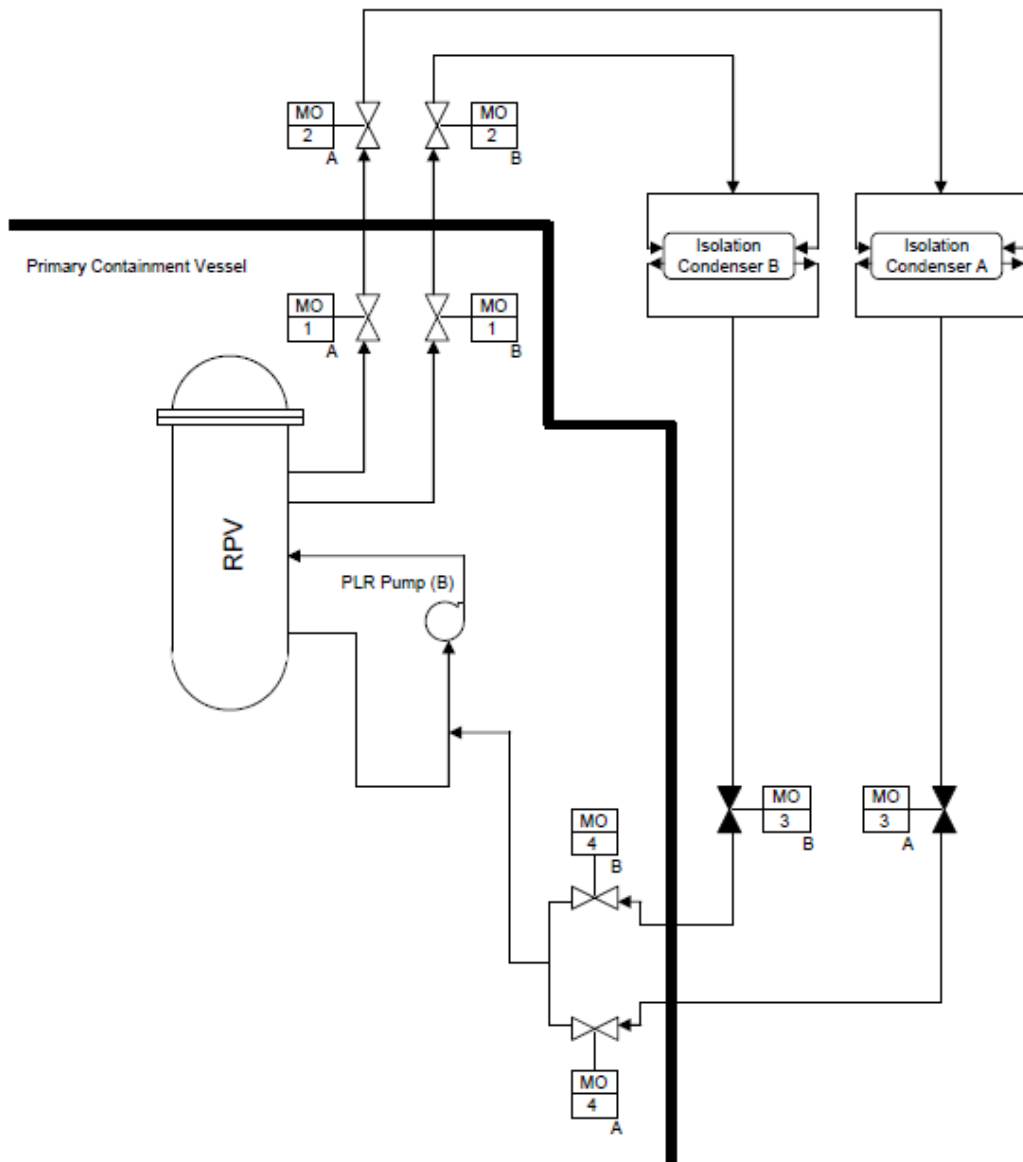
Fig. IV-2-4 System Structure Diagram of Isolation Condenser (Unit 1)

- \*1: During normal operation (in a standby condition), MO-1, 2 and 4 valves are "open" and MO-3 valve is "close". At startup, MO-3 valve is "open".
- \*2: MO-1 and 4 valves are inoperative due to AC power loss. (as-is)
- \*3: MO-2 and 3 valves are inoperative due to DC power loss (the same power source as isolation logic circuits). (as-is)
- \*4: During DC power loss, isolation (close) logic circuits are operative.  
At that time, if the drive power of each valve (written in \*2 and \*3) is activated, each valve is closed. If the drive power of each valve is lost, the valves are inoperative. (as-is)

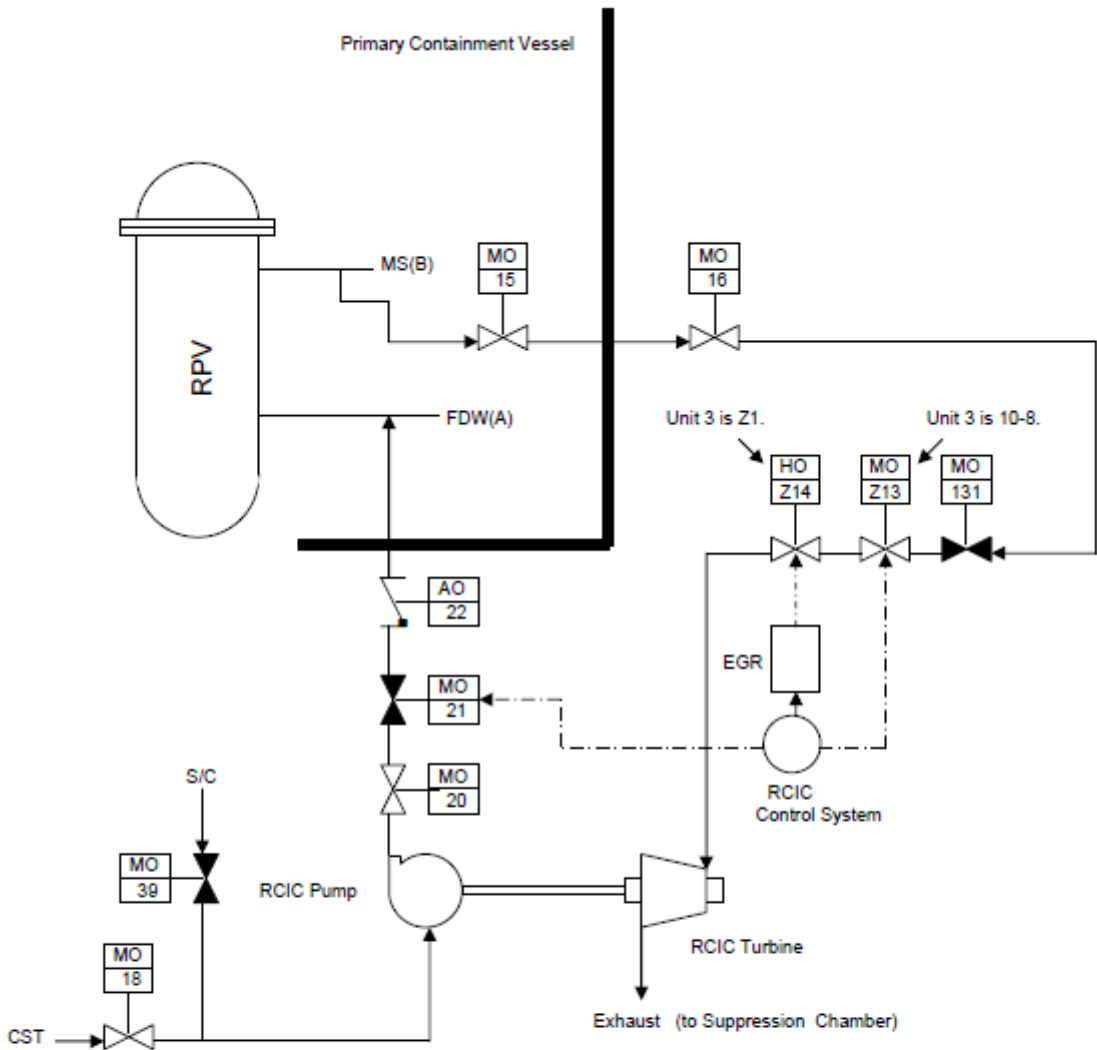
Fig. IV-2-5 System Structure Diagram of Reactor Core Isolation Cooling System (Units 2 and 3)

\*2: MO-15 valve is inoperative due to AC power loss. (as-is)

\*4: During DC power loss, isolation (close) logic circuits are operative.  
At that time, the drive power of each valve (written in \*2 and \*3) is activated, each valve is closed. If the drive power of each valve is already lost, the valves are inoperative. (as-is)

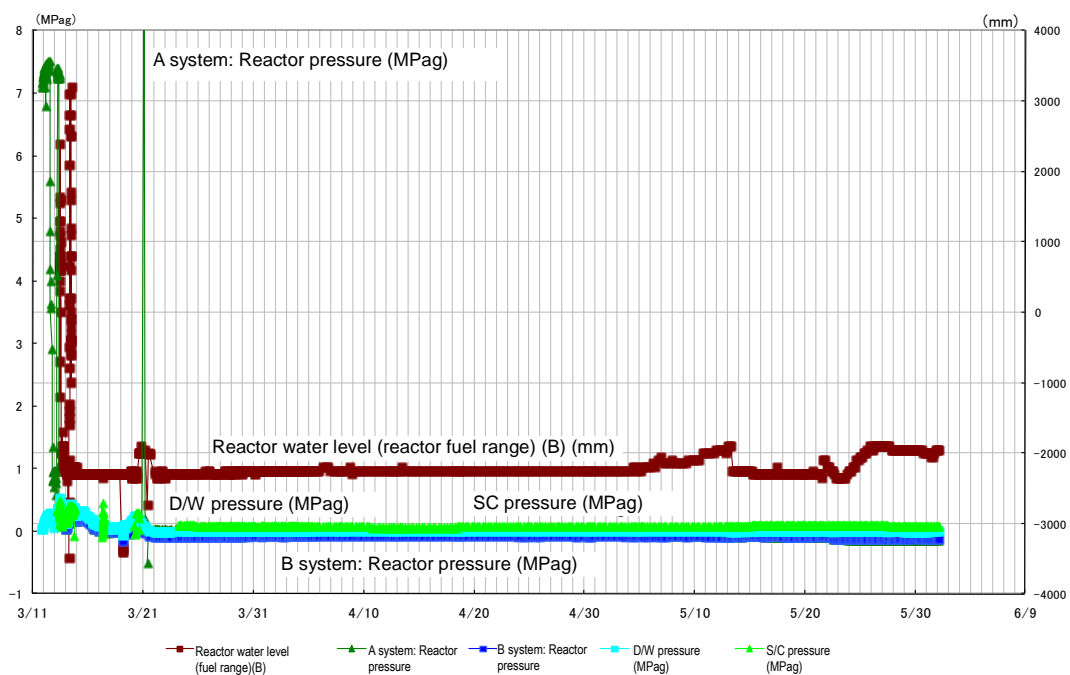
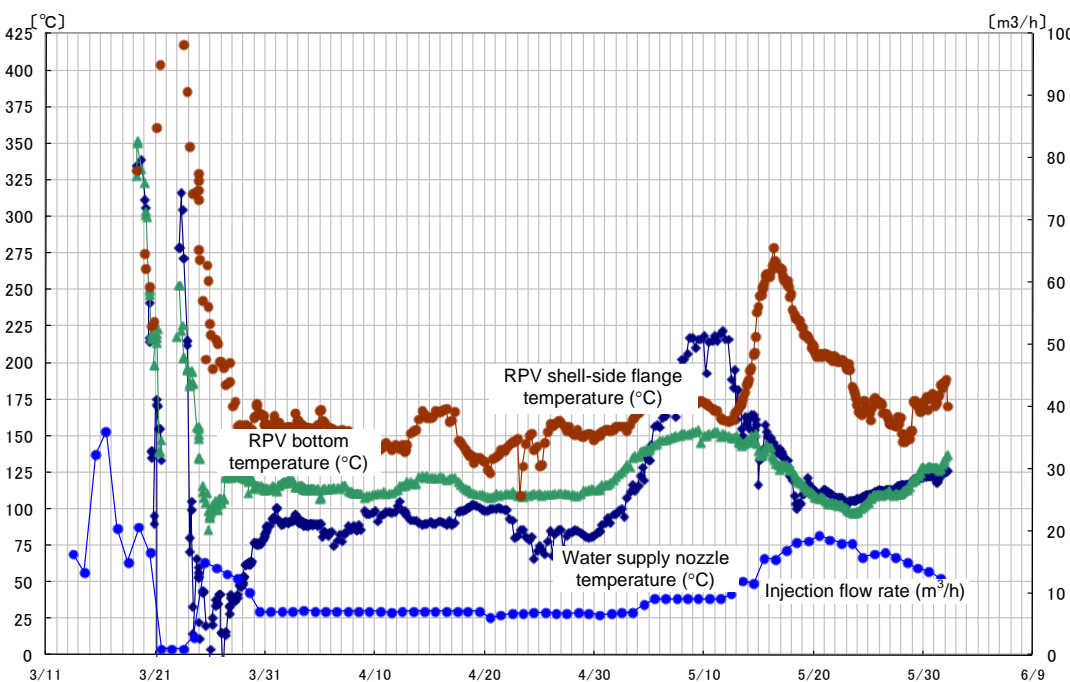
Figure IV-5-7 Changes of Main Parameters (1F-3) (March 11 to May 31)

Some RPV temperatures exceeded the measurable range (higher than 400°C) due to the lower injection flow rate caused by the increase of RPV pressure on March 20, but the temperature dropped through the securing of injection flow rate on March 24 and stayed around 100°C. Accordingly a considerable amount of reactor fuel may remain within the RPV. It cannot be denied at this moment that the bottom of the RPV might get

As the pressure of D/W and S/C exceeded the maximum operating pressure (0.427 MPag) of the PCV to reach about 0.5 MPag on March 13, it is assumed at this moment that the performance of the gaskets of flanges and the seals of penetrations deteriorated. The D/W pressure is maintained around the atmospheric pressure (0 MPag). Therefore, it is assumed at this moment that the vapor generated by decay heat may be released to the outside through D/W.

From the balance between the injected water volume and volume of steam produced, it is estimated that the water injected into the RPV is leaking.

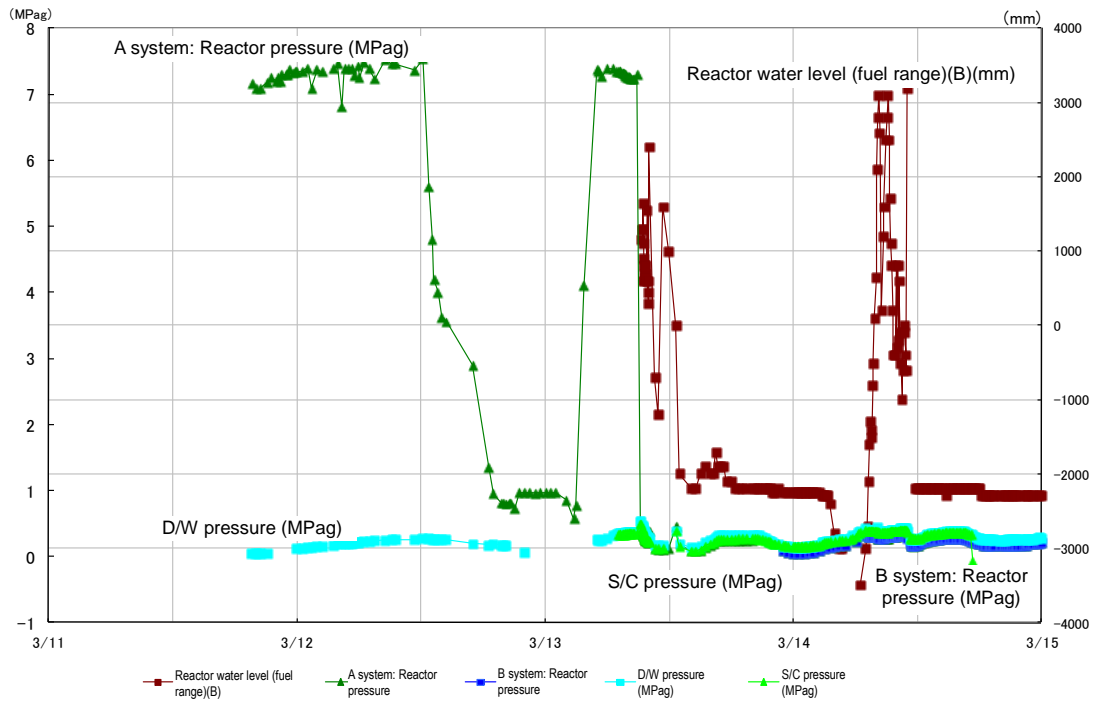
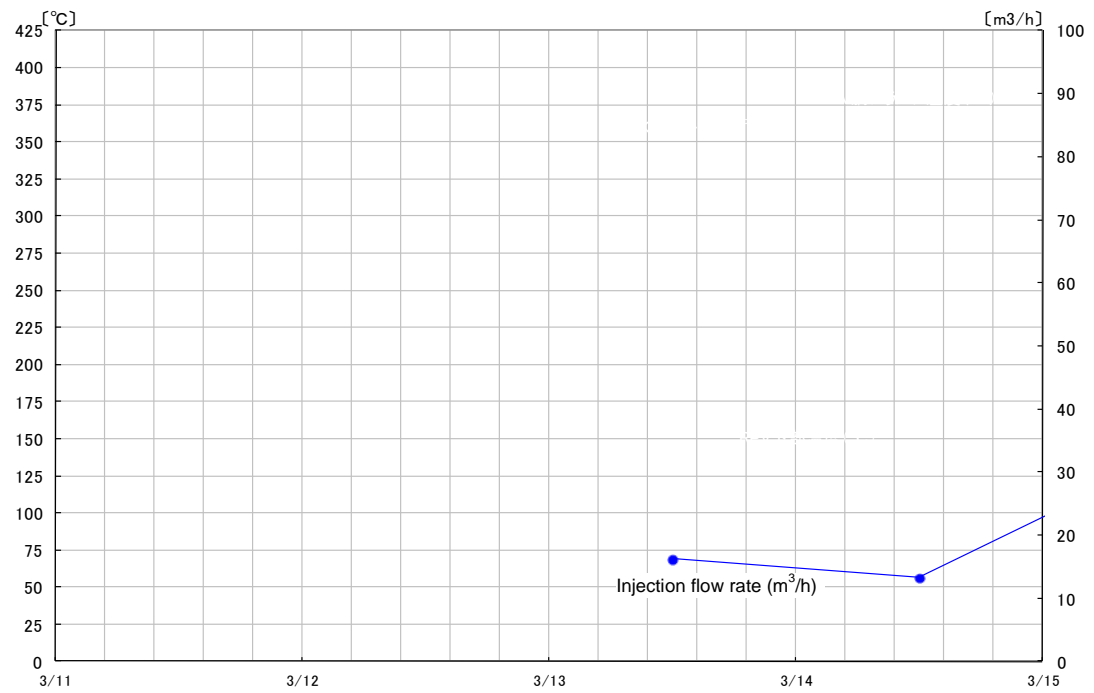
Figure IV-5-8 Changes of Main Parameters (1F-3) (March 11 to March 15)

Considering that the reactor pressure dropped for more than six hours from 12:30 on March 12, it is considered unlikely that a large-scale pressure leak occurred. Steam may have leaked from the HPCI, since the pressure began to drop at around the same time as the HPCI started and the reactor pressure began rising after the HPCI stopped.

TEPCO estimated that during this process the reactor fuel was exposed for about four hours from 2:42 on March 13, when the HCPI stopped (about forty hours after the earthquake hit), and two hours later, damage to the core began. Later, as the reactor water level was not able to be maintained around the fuel, flow volume for the alternative water injection was assumed. The decay heat began melting the core and the

melted fuel shifted to the lower plenum and then some 66 hours after the earthquake, it started to damage the RPV.

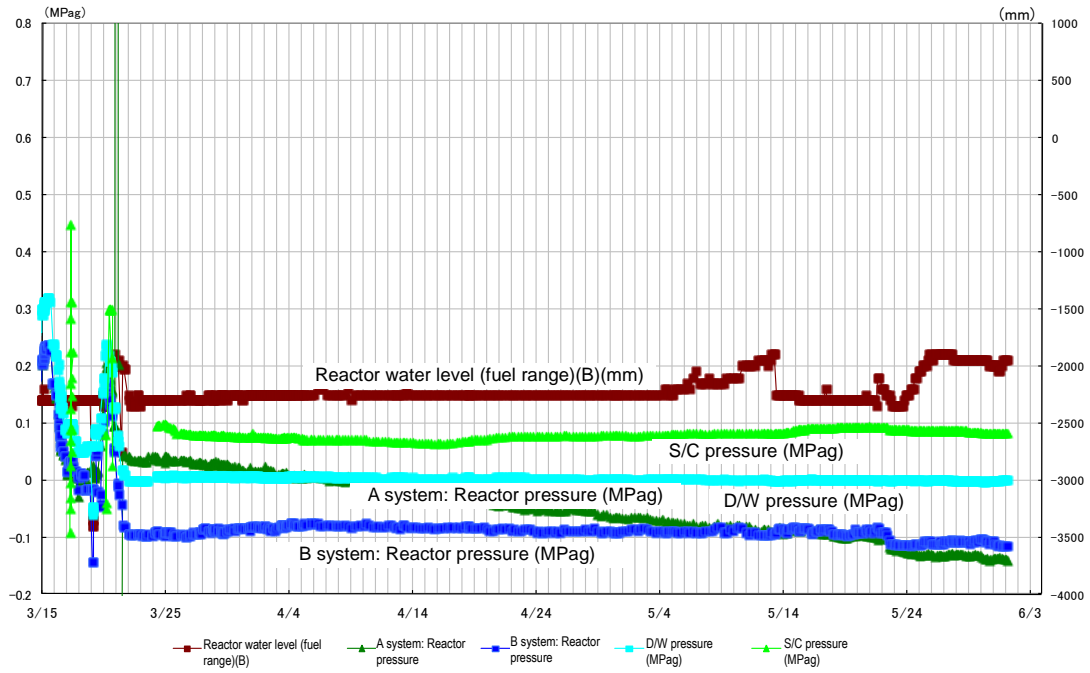
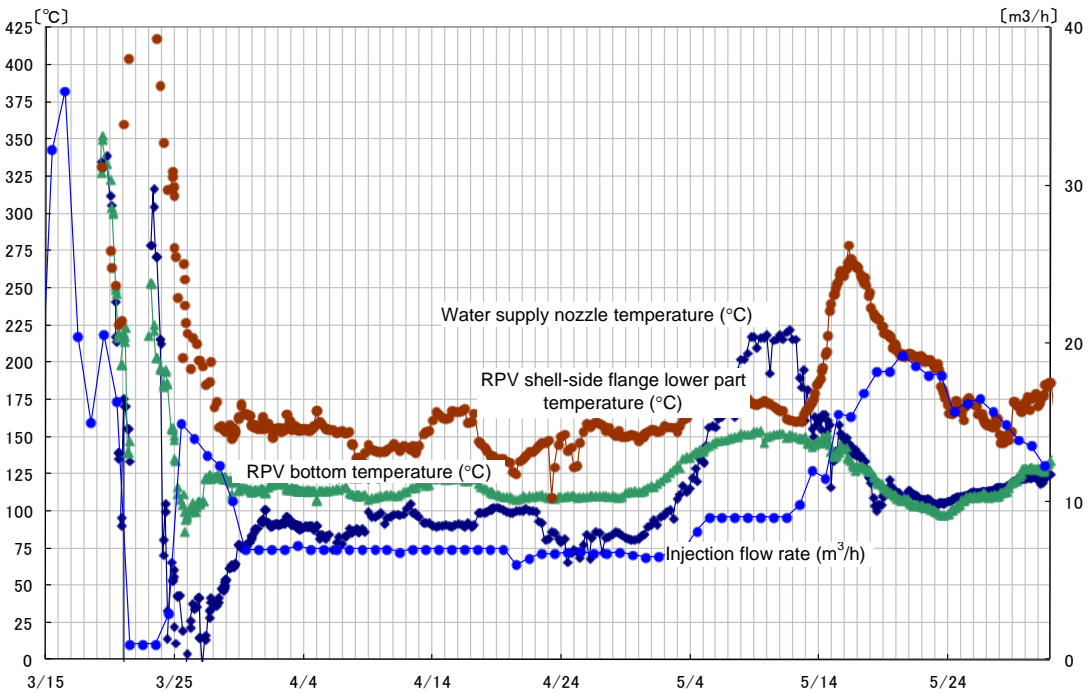
Figure IV-5-9 Changes of Main Parameters (1F-3) (March 15 to May 31)

The study was done on plant data obtained during the period from March 15 to May 31, when the plant was in a comparatively stable condition, and the plant data from this period was handled as shown below.

According to the information of the Tokyo Electric Power Co., Inc. (TEPCO), the total injection amount to RPV up to May 31 is considered to be about 20,700 tons. The total amount of vapor generated from the start of injection is about 8,300 tons when the decay heat is estimated on the outside in the decay heat evaluation formulation. If the pressure boundary is secured, a difference of about 12,400 tons at least may be kept there. As the capacity of RPV is 500 m<sup>3</sup> at most, the injected water may not only evaporate within RPV and leak as vapor, but also may leak as water. The injection to RPV was executed through the nozzles of recirculating water inlet and water supply equipment. The water injected through the nozzle of water supply equipment would gather once in the outside of shroud (from about 17:00 May 21 to about 23:00 May 28) and then would move to the bottom of RPV via the jet pump diffuser to cool the reactor fuel. The water is very likely to leak to outside at this portion.
