Subject: Draft Letter Report, Status and Results from Intermediate-Scale Grout Tests  
(Deliverable 14003.01.007.440)

**BONDING AND CRACKING BEHAVIOR AND RELATED  
PROPERTIES OF CEMENTITIOUS GROUT IN AN  
INTERMEDIATE-SCALE GROUT MONOLITH**

**U.S. Nuclear Regulatory Commission  
Contract NRC-02-07-006**

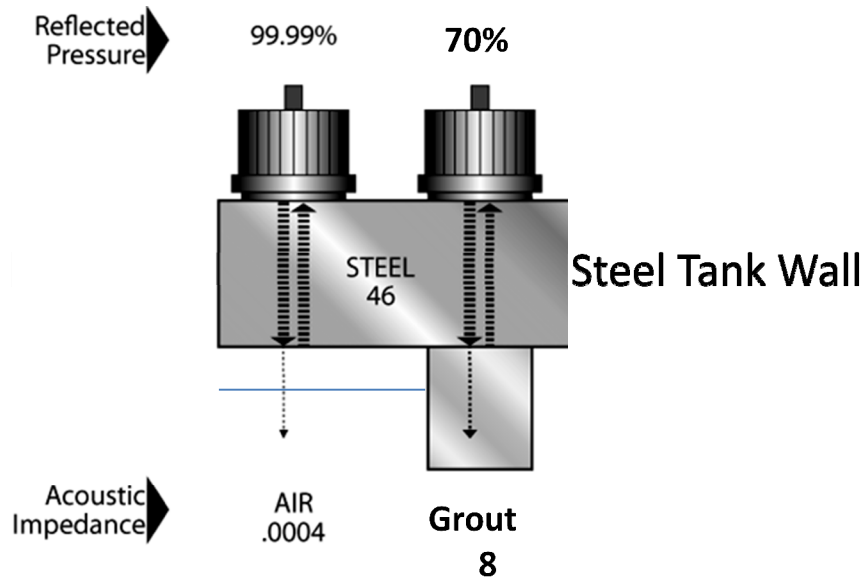
If there is an air gap behind the steel tank wall, then the ultrasonic pressure ( $R_p + T_p$ ) will be nearly 100 percent reflected at the steel–air interface and will reverberate in the tank wall with essentially no transmission into the grout (Figure 2-1). If there is no air gap, then approximately 30 percent of the ultrasonic pressure will be transmitted into the grout and 70 percent will be reflected at the interface (Figure 2-1). This represents a 3 decibel shift.

**Figure 2-1. Illustration of the Reflection of Ultrasonic Waves From a Steel–Air Interface and a Steel–Grout Interface**

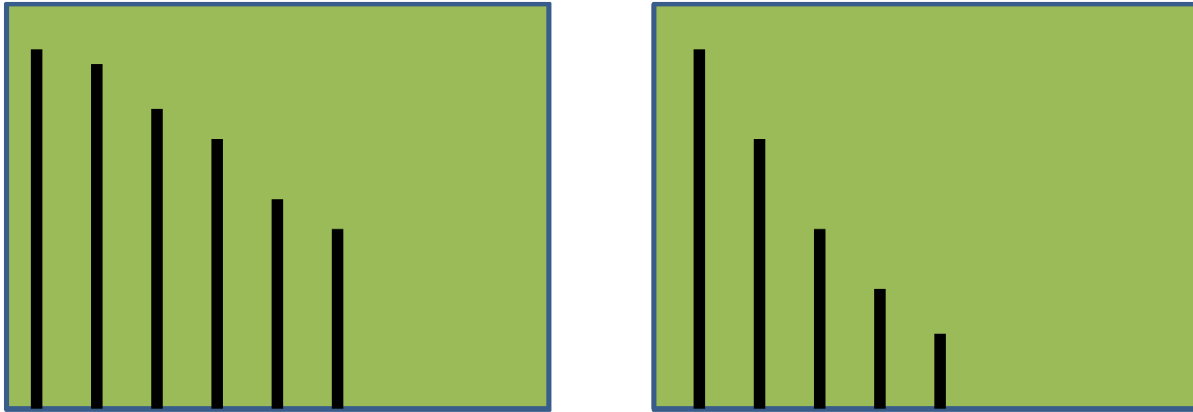
If a pulse echo ultrasonic technique is used, it is anticipated that where there is an air gap between the grout and tank wall, the ultrasonic signal would reverberate many times in the steel wall, which has low ultrasonic attenuation. For the case where there is no air gap, the energy would quickly dissipate into the grout. Schematically, this is illustrated in Figure 2-2.

Figure 2-2. Illustration of the Expected Ultrasonic (UT) Signal Amplitude Data Obtained from a Pulse-Echo Transducer Placed on the Steel Wall with a Steel–Air Interface (Left) and a Steel–Grout Interface (Right)

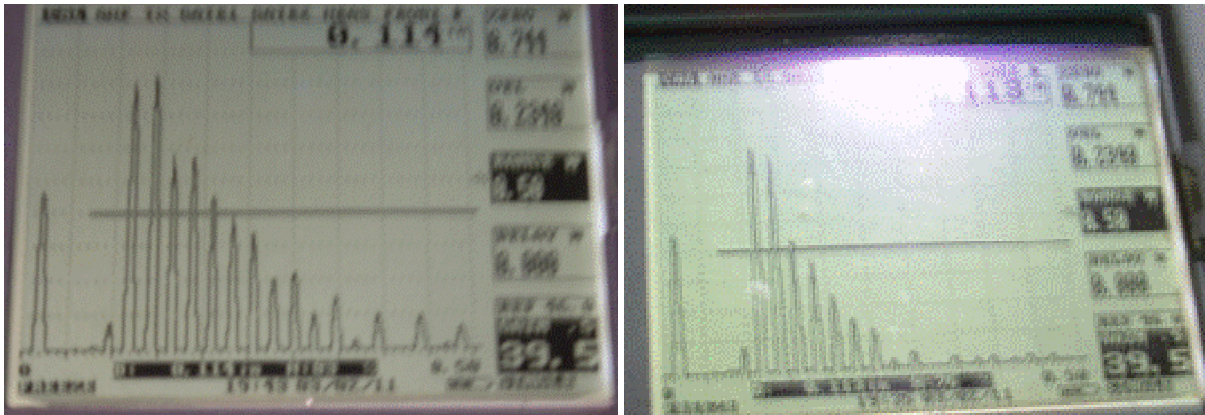
Ultrasonic test results were obtained from several of the drum grout specimens within the upper, middle, and lower lifts. Results are presented as the number of multiple reflections above the midscreen level of the oscilloscope (Figures 2-3). Examples of ultrasonic data collected are shown in Figure 2-4 for inferred no-air-gap (Tank T7 middle lift) and air-gap (T6 upper lift) cases. These data look very similar to illustrations shown in Figure 2-2.

**Figure 2-4. Ultrasonic Signal Amplitude Data Collected From Drum Grout Specimens With an Air Gap (Left) and Without (Right) an Air Gap (Compare With Schematic Illustration of Figure 2-2)**

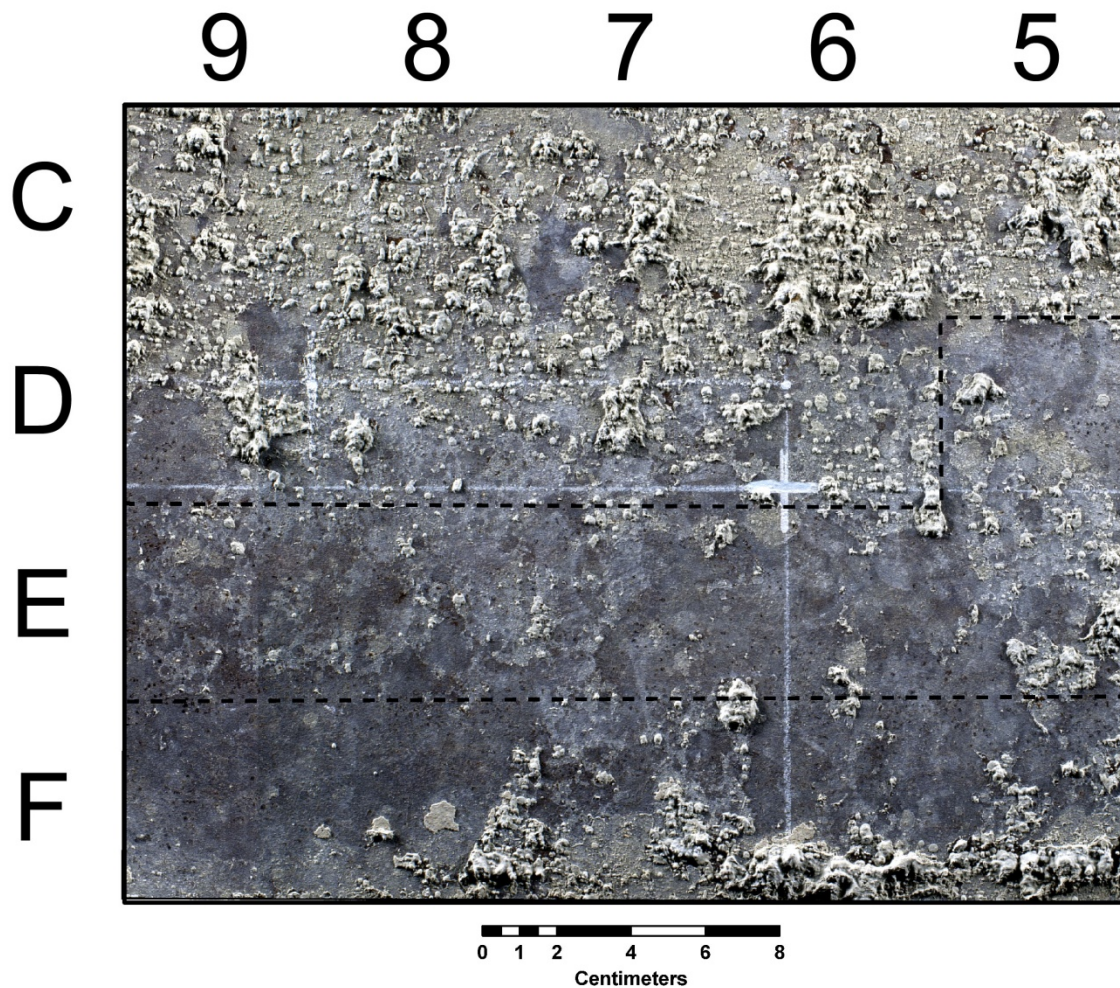
Surface roughness of the interior tank wall is produced by the relative thickness of the adhering grout material. Thickness of the adhering grout material generally ranges from a few millimeters to less than 0.1 mm [0.004 in] (Figure 2-17). Surface roughness varies with location and sometimes appears to reflect grout stratigraphy (Figures 2-17 and 2-19), although not uniformly so [Figure 2-17(a), rows D, E, and F; Figure 2-18(a), rows C, D, E, and F]. Where tank wall sections have been removed, smooth surfaces are often observed along the lower portion of a lift.

**Figure 2-17(b). Digital Photograph of the Mirror Image Area Shown in Figure 2-11 and the Area Shown in Figure 2-17(a). Area Bounded by Dashed Lines Is as In Figure 2-17a. Surface Roughness Illustrated in Figure 2-17(a) Appears as Thin Coatings of Grout  $\sim \leq 2$  mm [0.078 in] Thick That Remain Bonded to the Steel Tank Wall. Smooth Areas Appear as Grey Mottling With a Dark Red Undertone. The Grey Mottling Is Interpreted To Be a Thin Film of Grout Particles; the Dark Red Undertone Is Interpreted as the Original Antirust Red Coating of the Tank Wall and as Oxidation of the Tank Wall. Maximum Relief of the Mottled Areas Is Approximately 0.1 mm [0.039 in] Relative to the Surface of the Steel Plate.**

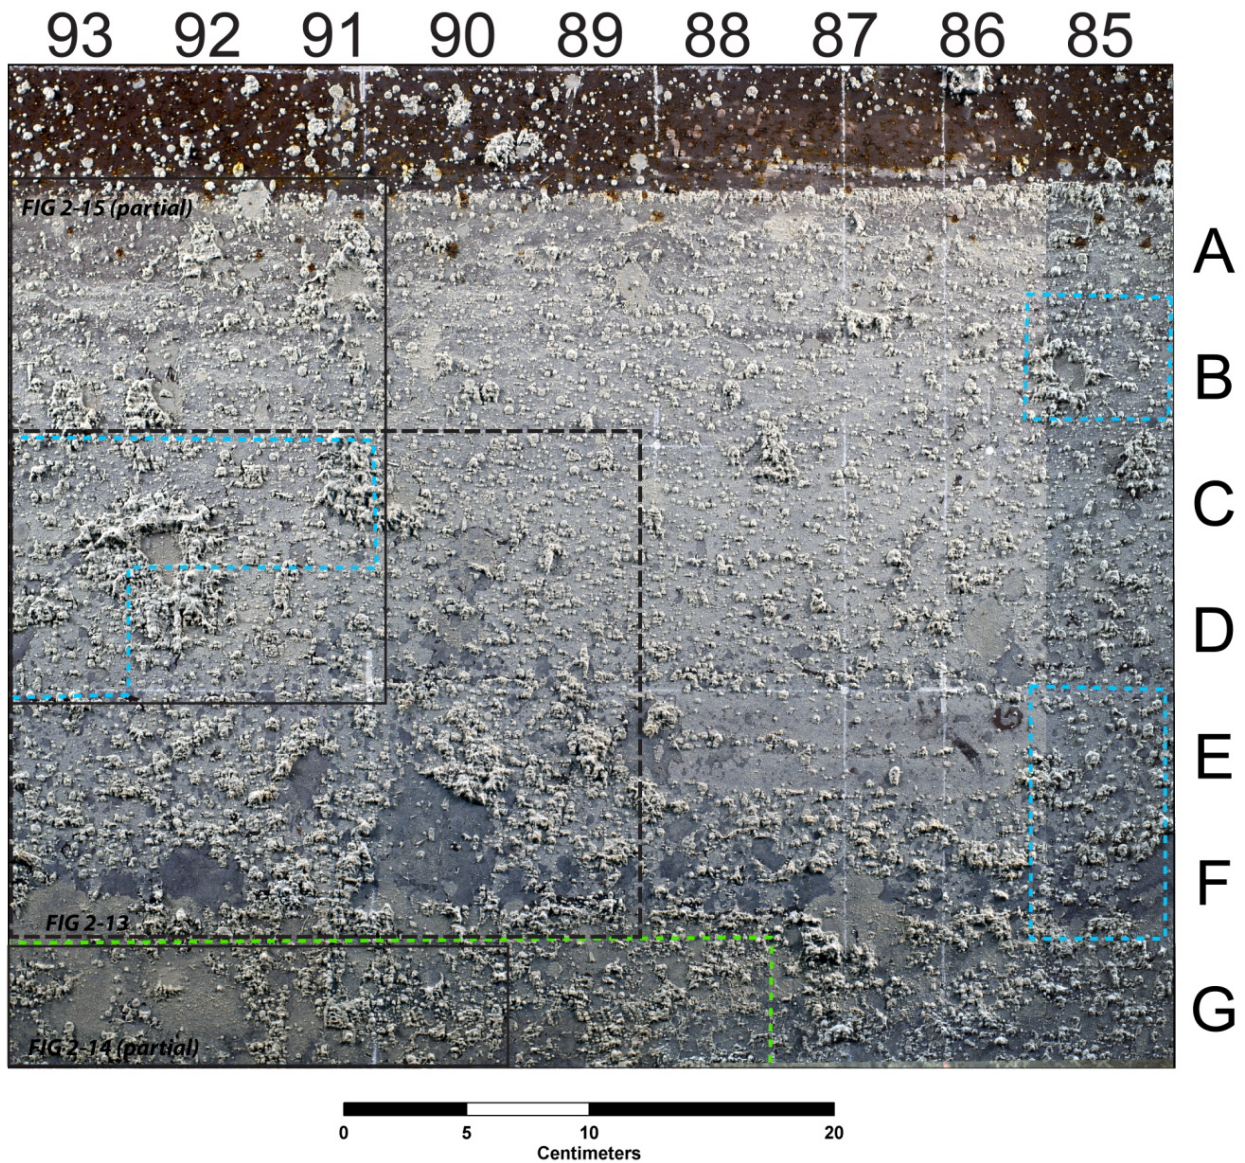
Grout appears to have variably bonded to the tank wall during curing, as indicated by observations of the interior surface of the metal tank wall, which shows that grout variably adheres to the wall. Figure 2-18(b) shows two adherence patterns corresponding to grout spatters and bulk grout pours. In the lower or subgrout portions of the interior tank wall, it appears that early grout spatters were covered during successive pours, and that in at least some cases, the spatter adheres better than the grout pour that covers it [Figure 2-19(b)]. When compared with spatters adhering to the exposed tank wall [Figure 2-18(b)], the morphology, outline, and pattern of the covered spatters are closely similar. It appears that early forming and subsequently covered grout spatter appreciably adheres to the tank wall, whereas the successive pours do not adhere as well to the tank wall or to the spatters. This may be interpreted that even where grout adheres to the tank wall, it is possible that a nonbonded contact exists within a few millimeters and parallel with the tank wall, and that this contact may intersect the grout-to-wall interface. This contact can act and appear as a crack, even though the surface or contact did not form in response to mechanical strain.

Figure 2-18(b). Digital Photomosaic of Area Shown in Figure 2-18(a). Topographic Relief and Color Pattern Is Similar to Those Described in Figure 2-17.

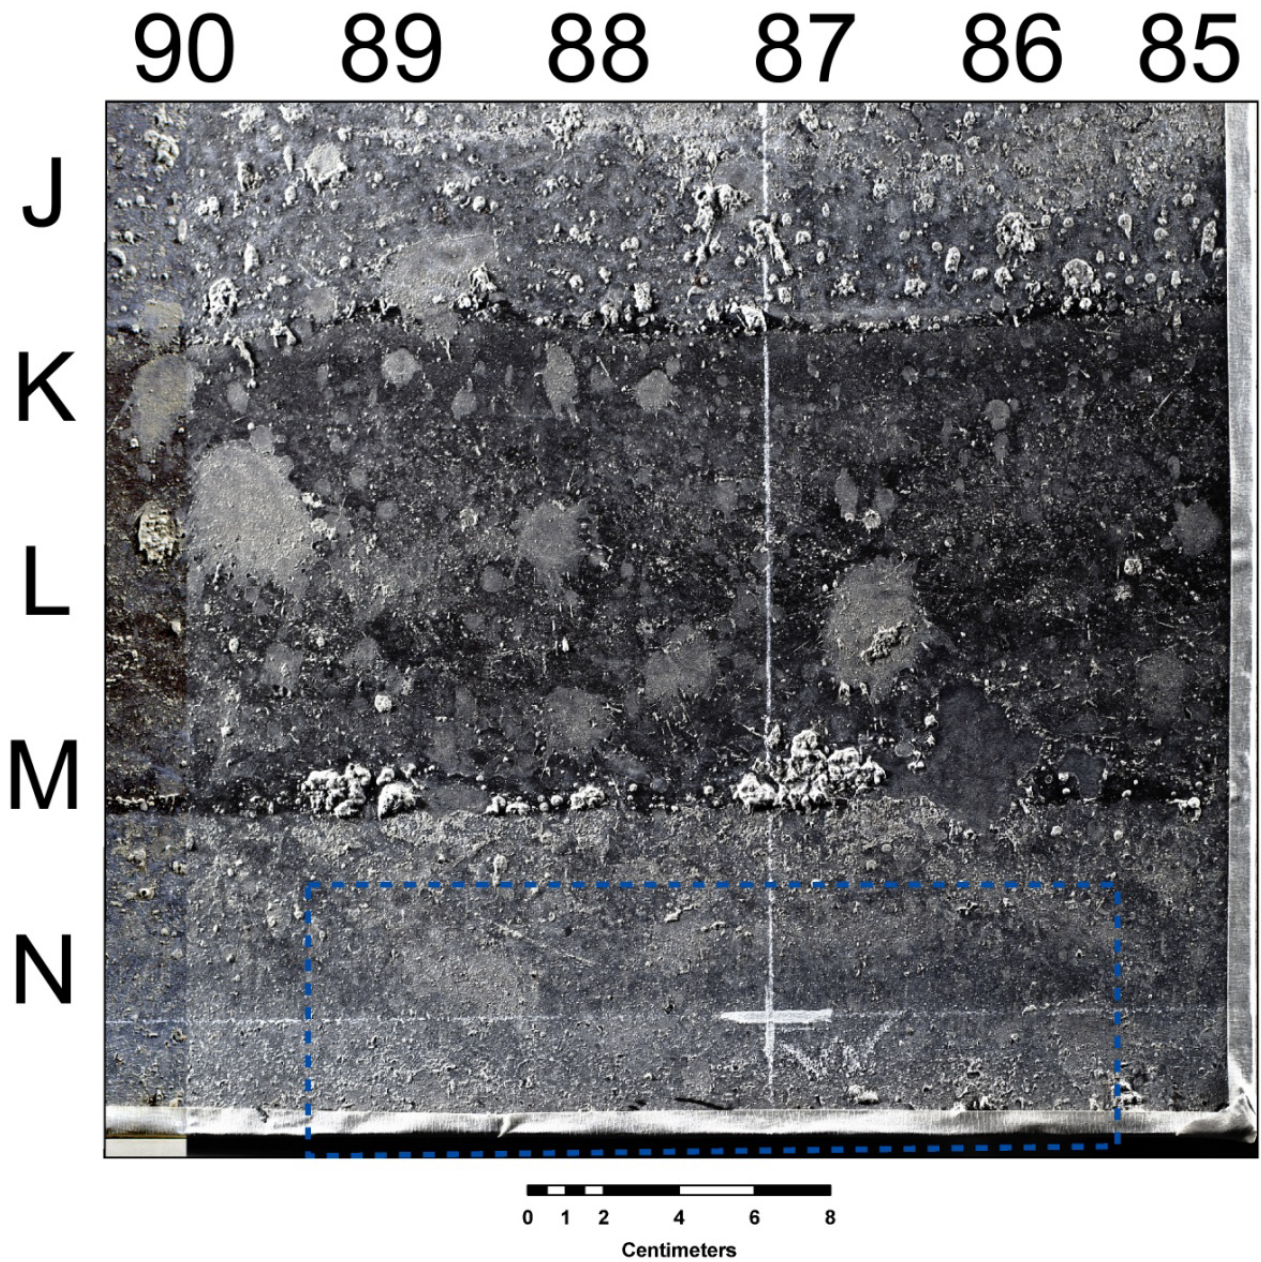
**Figure 2-19(b). Digital Photomosaic of Area Shown in Figure 2-19a. Topographic Relief and Color Pattern Is Similar to That Described in Figure 2-17. At Least Some Light-Colored Mottling Appear To Be Remnant Spatter Marks, Particularly in Rows J–M. Soapstone-Inscribed Guidelines, as Described In Figure 2-17 Are Clearly Visible.**
