**SUBJECT: NRC SPECIAL INSPECTION REPORT NO. 70-1113/2011-006 AND NOTICE
OF VIOLATION**

Special Inspection Team Charter
Global Nuclear Fuel - Americas
Failure to Maintain Mass Control in HEPA Filter Housing

The purpose of the special inspection was to inspect and assess the facts surrounding the failure to maintain mass control within the uranium dioxide (UO₂) sinter test grinding station high efficiency particulate air (HEPA) filter enclosure. The objectives of the inspection were to: 1) review the facts surrounding the failure to maintain mass control within the UO₂ sinter test grinding station HEPA filter enclosure; 2) assess Global Nuclear Fuel – Americas (GNF-A)'s response to the higher than anticipated UO₂ mass in the HEPA enclosure; and 3) evaluate GNF-A's immediate and long term corrective actions to prevent recurrence.

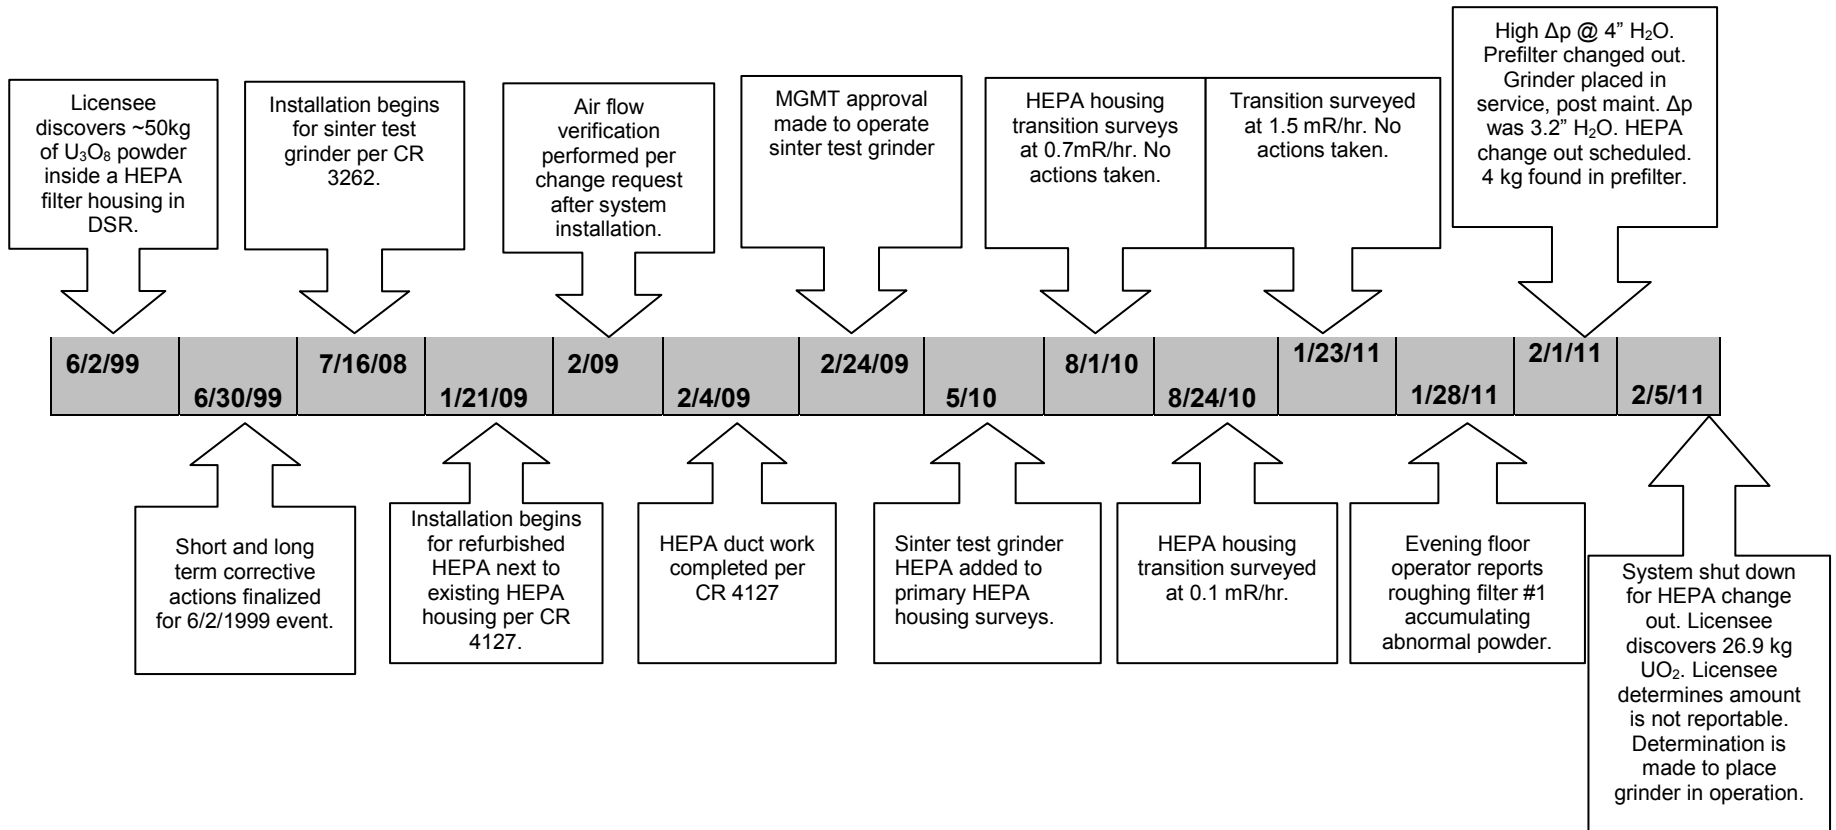
Through interviews of licensee personnel and review of licensee records, the team developed a timeline associated with the event surrounding the loss of mass control in the sinter test grinder HEPA enclosure. The timeline is shown in Figure 2-a and 2-b.

Figure 2-a: Timeline of events leading up to the loss of mass control in the sinter test grinder and subsequent responses

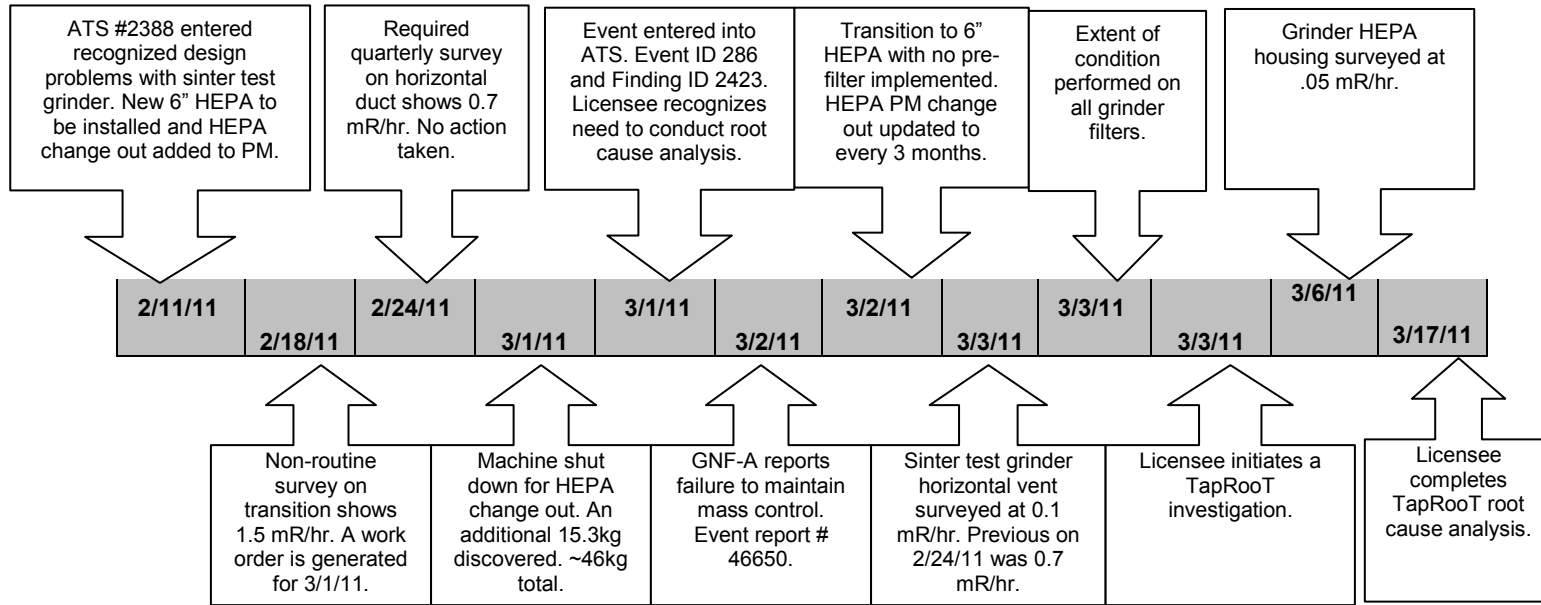
Figure 2-b: Timeline of events leading up to the loss of mass control in the sinter test grinder and subsequent responses
