SUBJECT: Submits relief request RR2-1 to allow continued plant operation w/two pin hole leaks in 3/4 inch ASME Code Class 2 chemical injection weldment.

KEWAUNEE

RELIEF REQUEST NO. RR2-1 TO ALLOW CONTINUED
PLANT OPERATION

Relief Request RR2-1

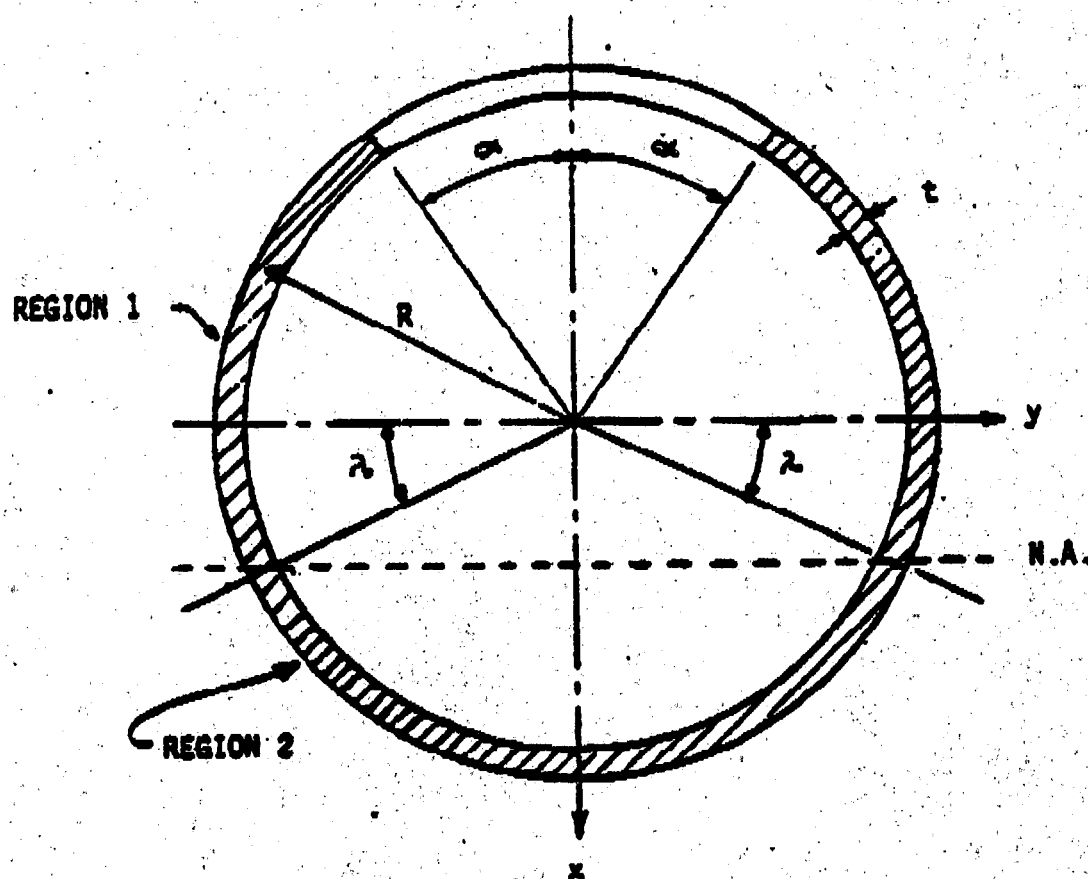
A thin walled pipe of mean radius R and wall thickness t , contains a through-wall circumferential crack of total angular length 2α (Figure A-1). The cracked cross-section of the pipe is subject to a bending moment M (about the y -axis), and axial load N , an internal pressure p , and a torsional moment T . The bending moment is assumed to be acting about the y -axis and the cross section is analytically divided into region 1 and 2 (Figure A-1). The stress state of the cracked cross-section consists of the hoop stress, axial stress, and shear stress. The hoop stress (σ_θ) and shear stress ($\tau_{r\theta}$) are constant on the uncracked portion of the circumference. The axial stress is uniform tension (σ_{zT}) in region 1 and uniform compression (σ_{zC}) in region 2. Region 1 is above the neutral axis (N.A.) of the cross section and region 2 is below the neutral axis. The position of the neutral axis is geometrically defined by the angle Θ_0 .

Figure A-1. Cross Section Of Pipe With A Through-Wall Circumferential Crack of Length 2α .
