Examination of Kewaunee Cold Leg Steam Generator Tube R15C28

P. Kuchirka*, A. Madeyski, and M. Blaszkiewicz

May 8, 1997

The first and second tube support plate crevice regions of cold leg Tube R15C28 from Steam Generator B of Kewaunee were examined by nondestructive and destructive examination techniques. Shallow, but extensively distributed, OD-origin intergranular corrosion was found contained in the tube support plate crevice regions of the mill annealed Alloy 600 tubing.

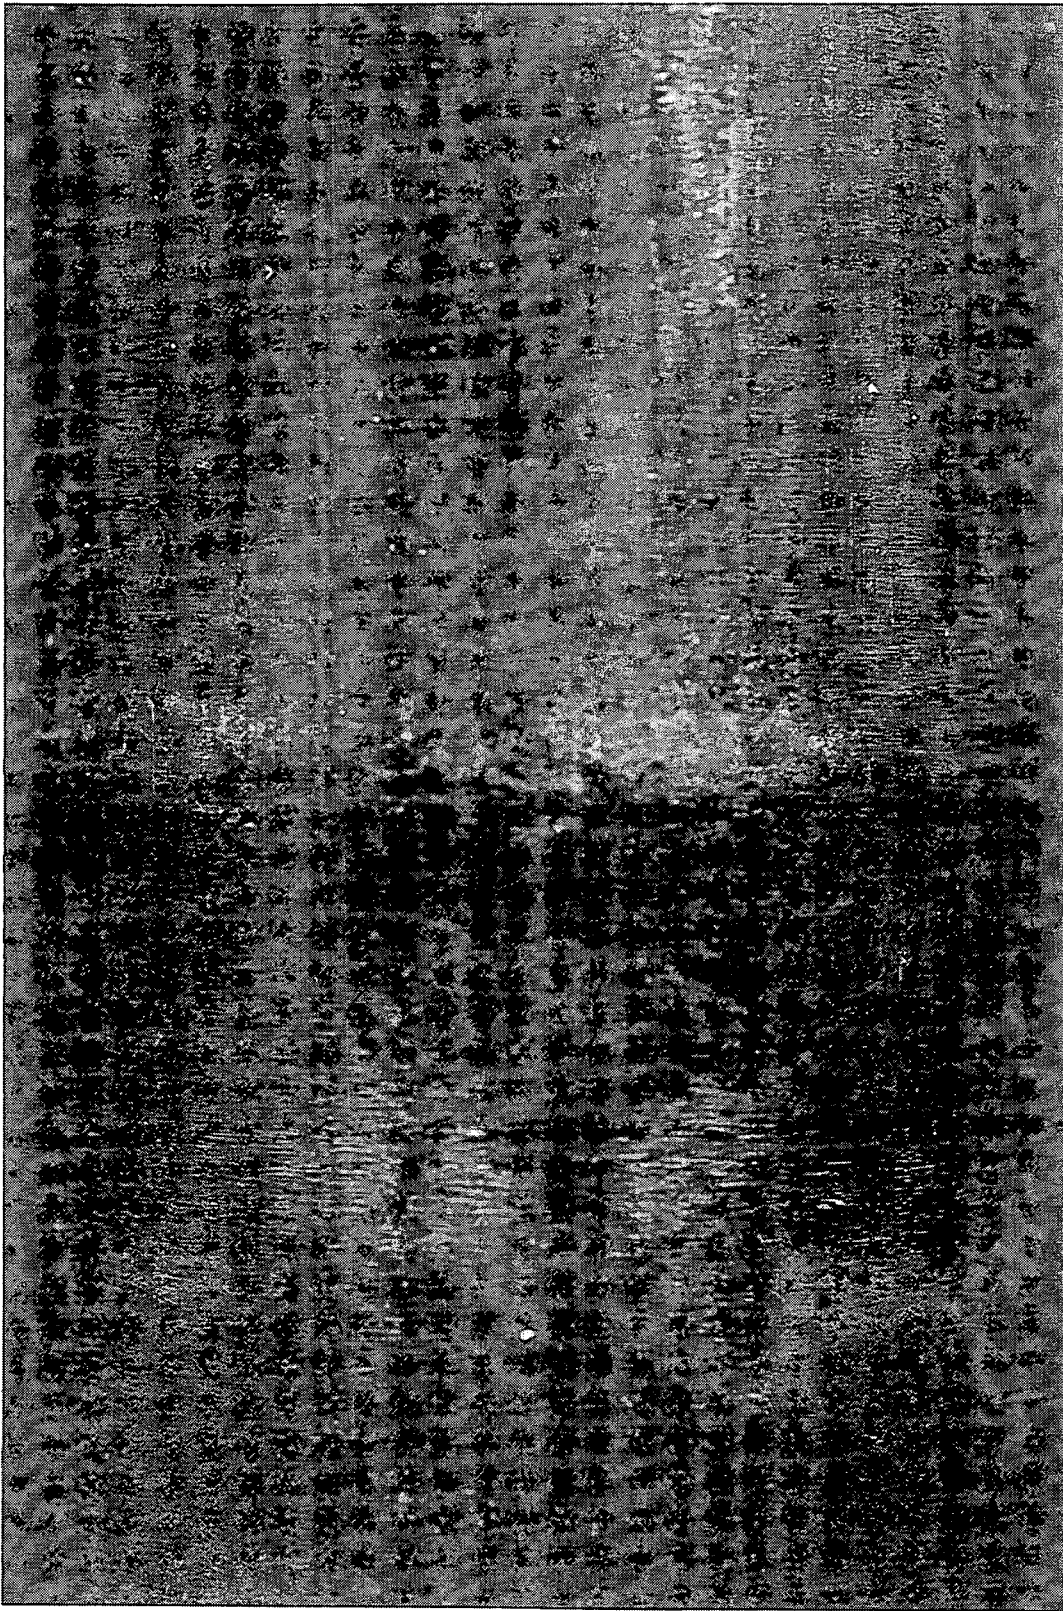
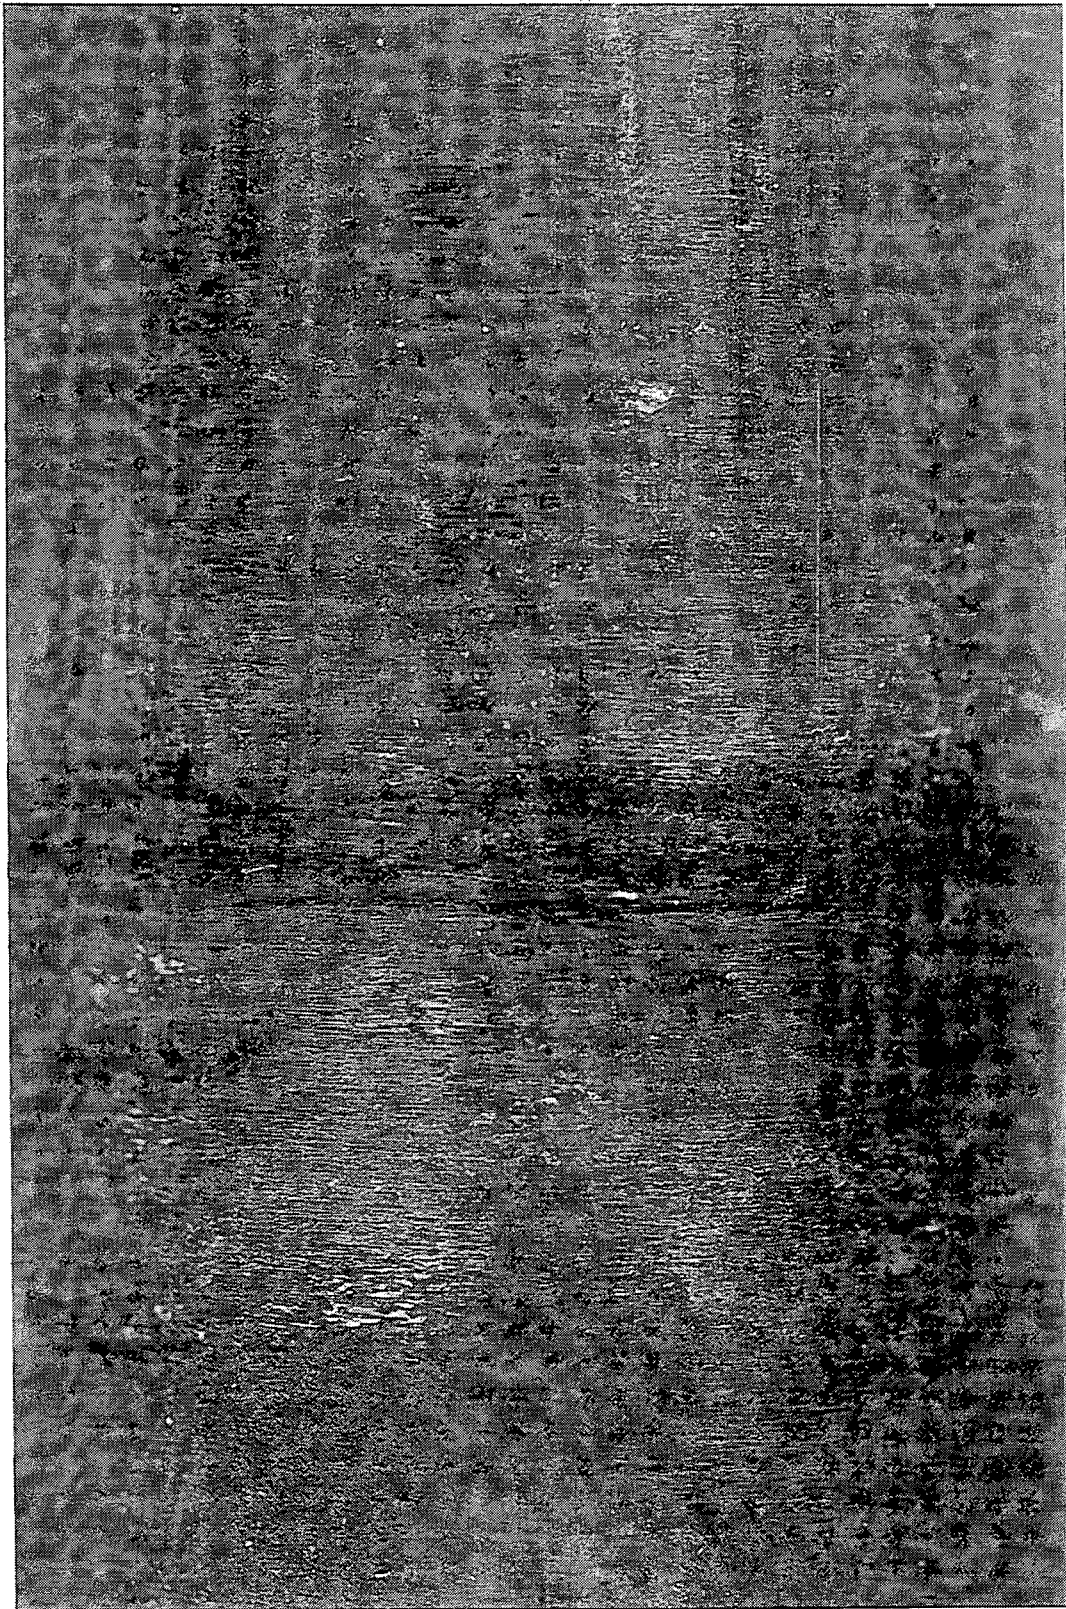
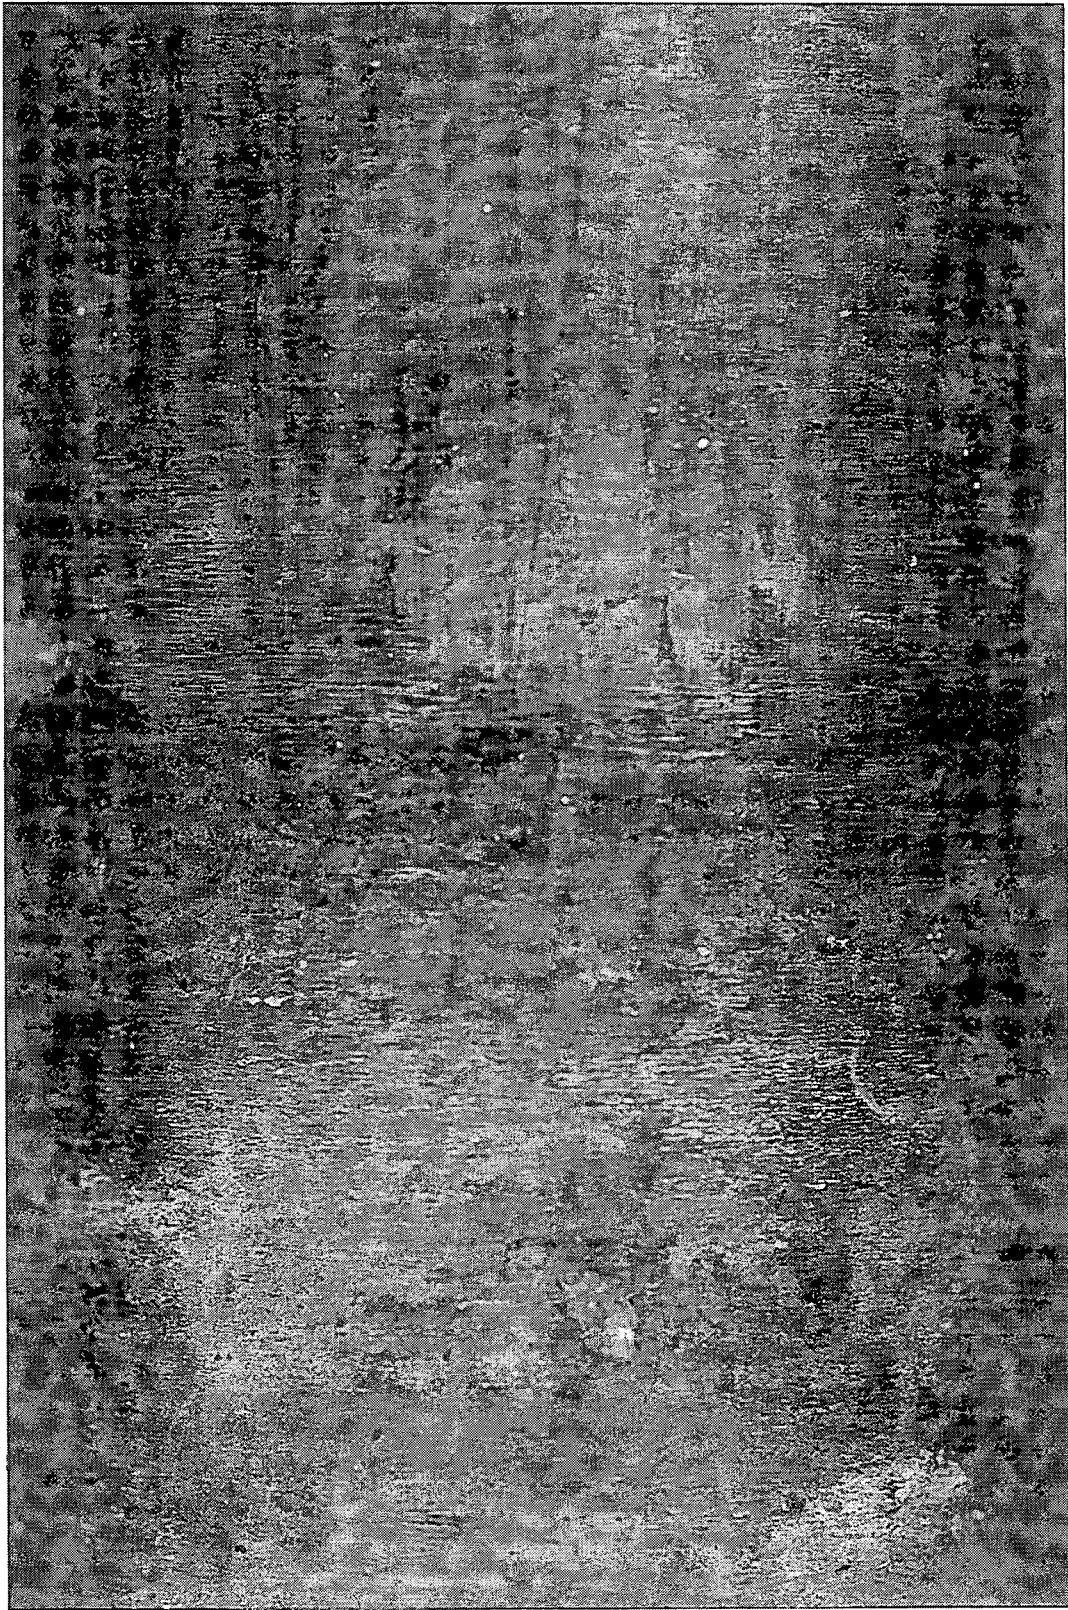
Figure 2-1 Photograph of the tubesheet top region of Tube R15C28, 0° face. Specimen 2B. Mag. 6.3X.

Figure 2-2 Photograph of the tubesheet top region of Tube R15C28, 90° face. Specimen 2B. Mag. 6.3X.

Figure 2-3 Photograph of the tubesheet top region of Tube R15C28, 180° face. Specimen 2B. Mag. 6.3X.

Figure 2-4 Photograph of the tubesheet top region of Tube R15C28, 270° face. Specimen 2B. Mag. 6.3X.

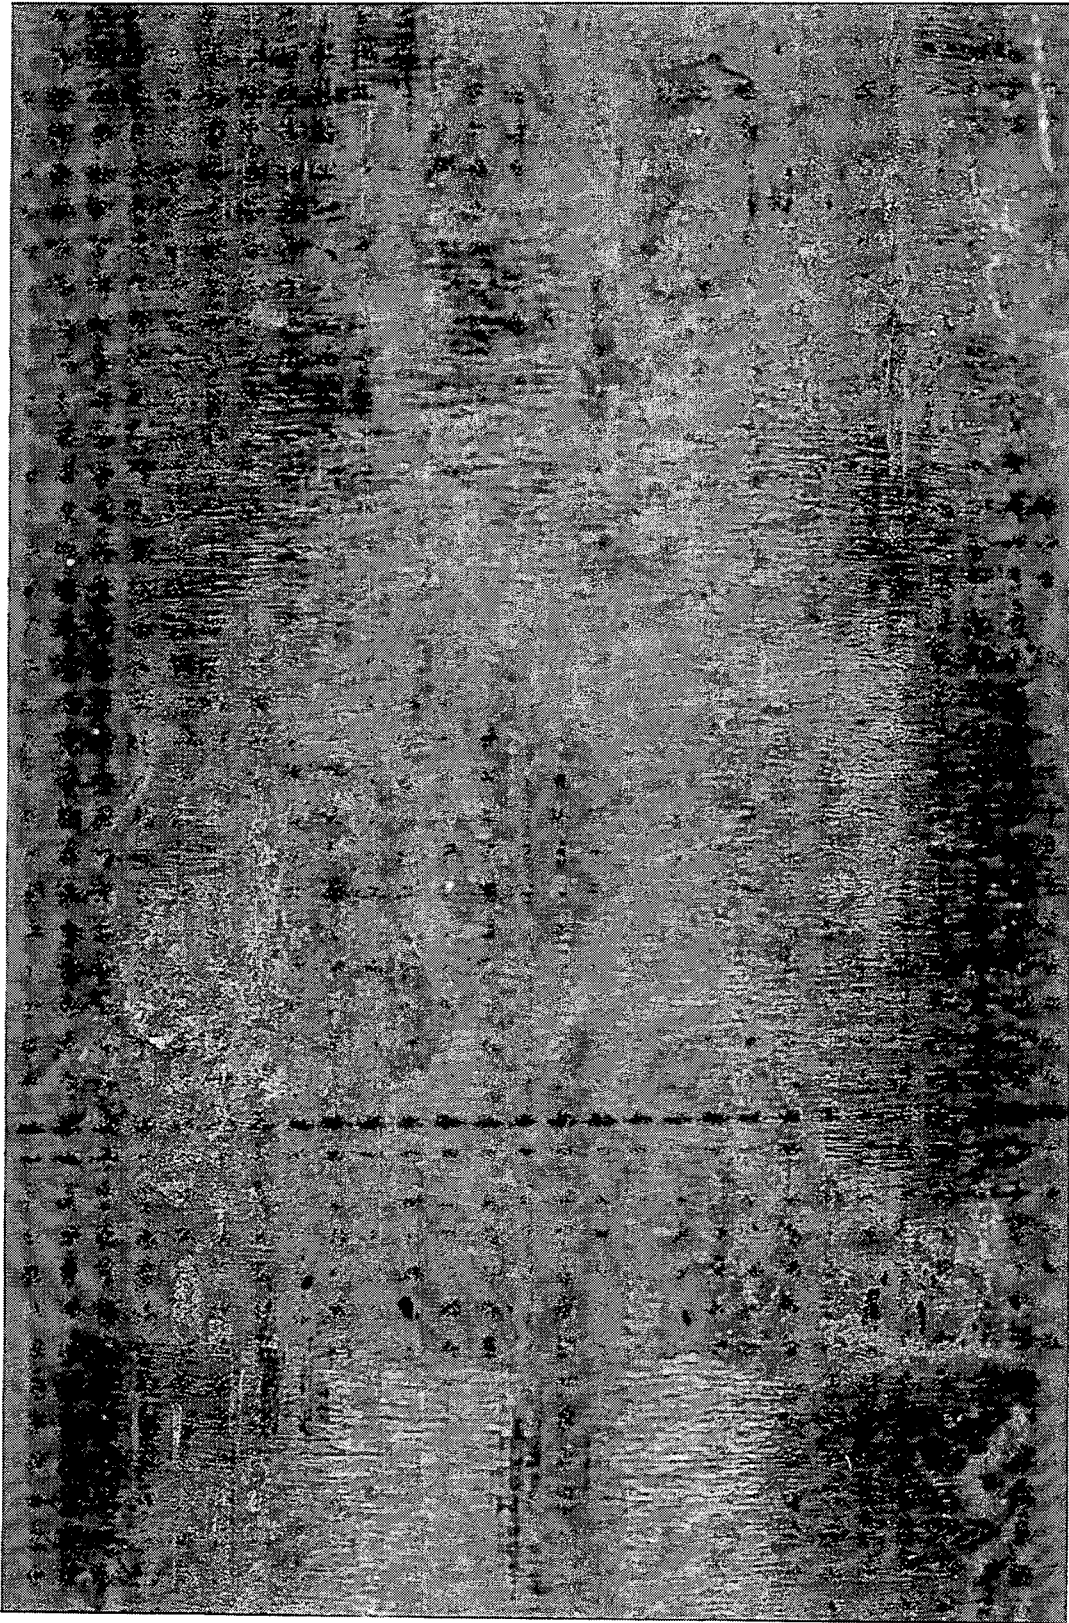
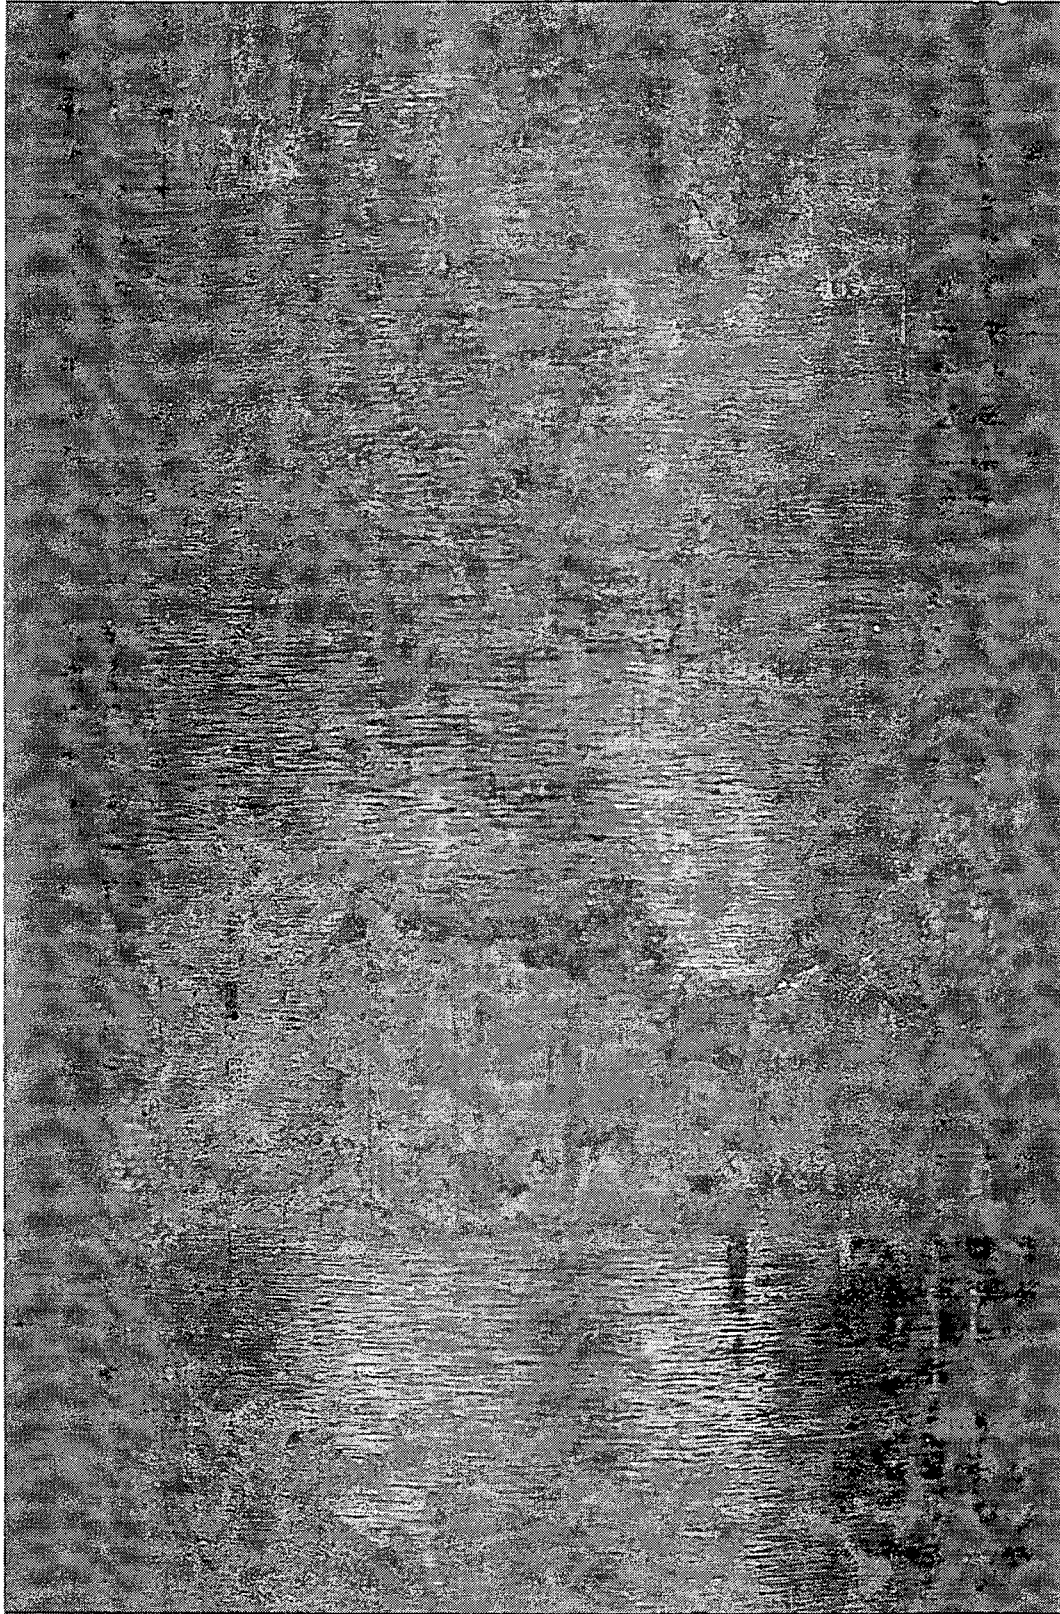
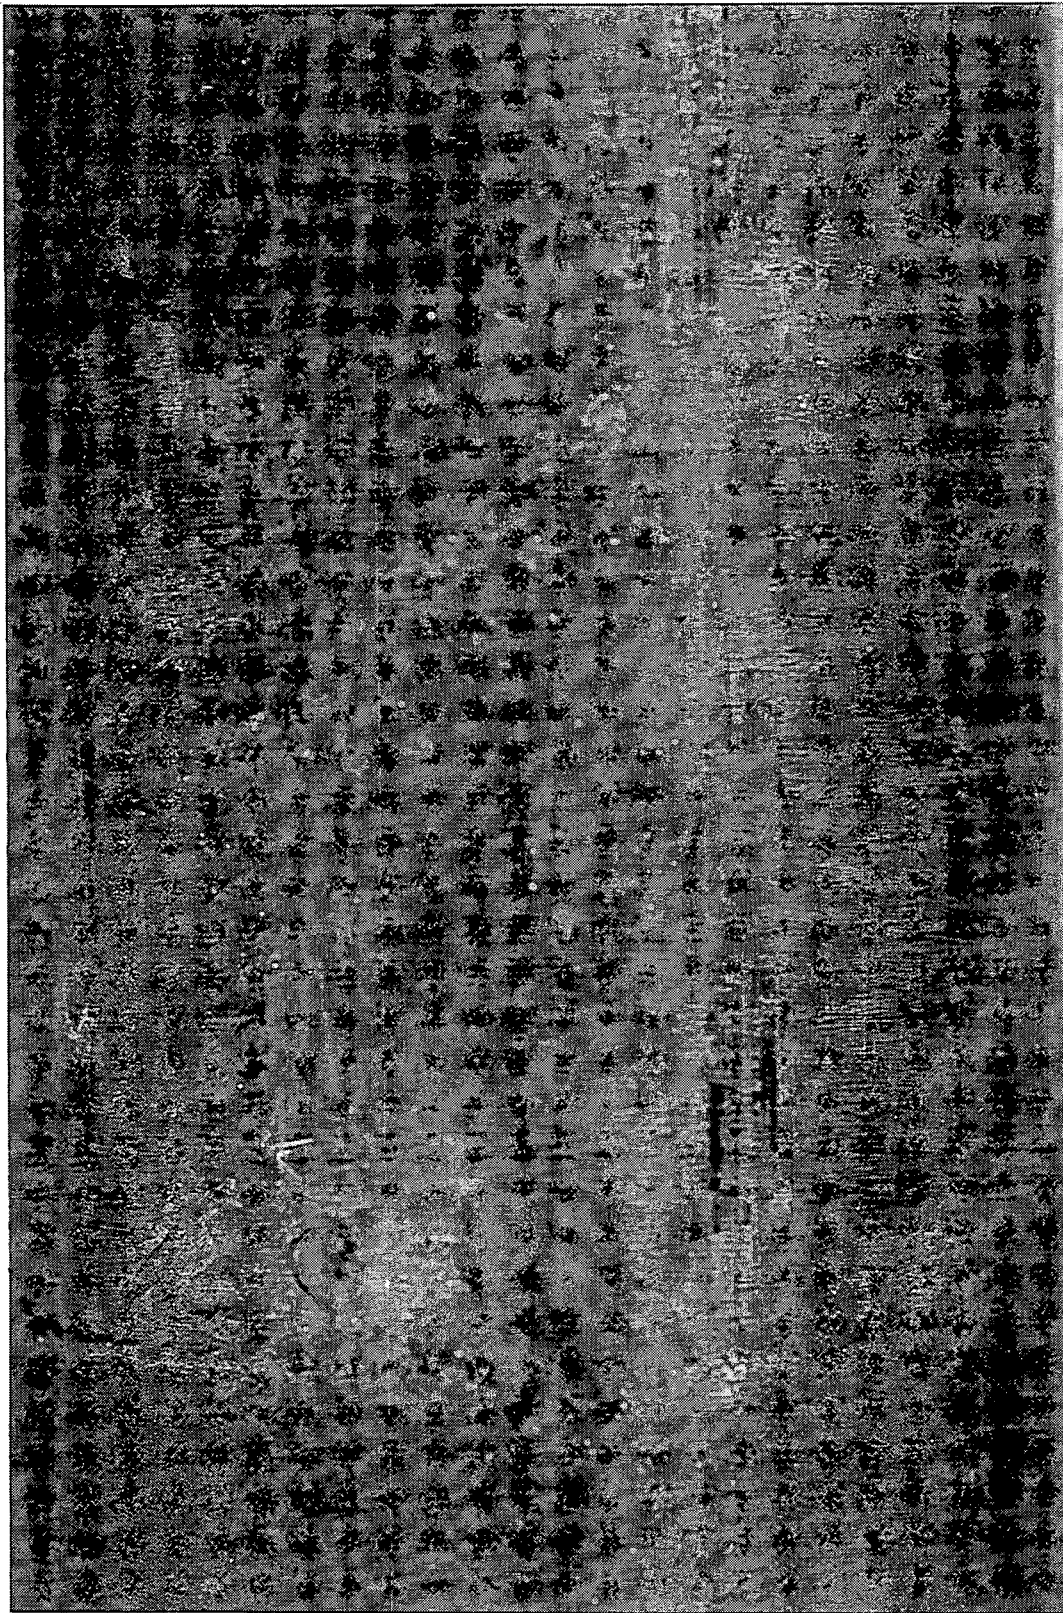
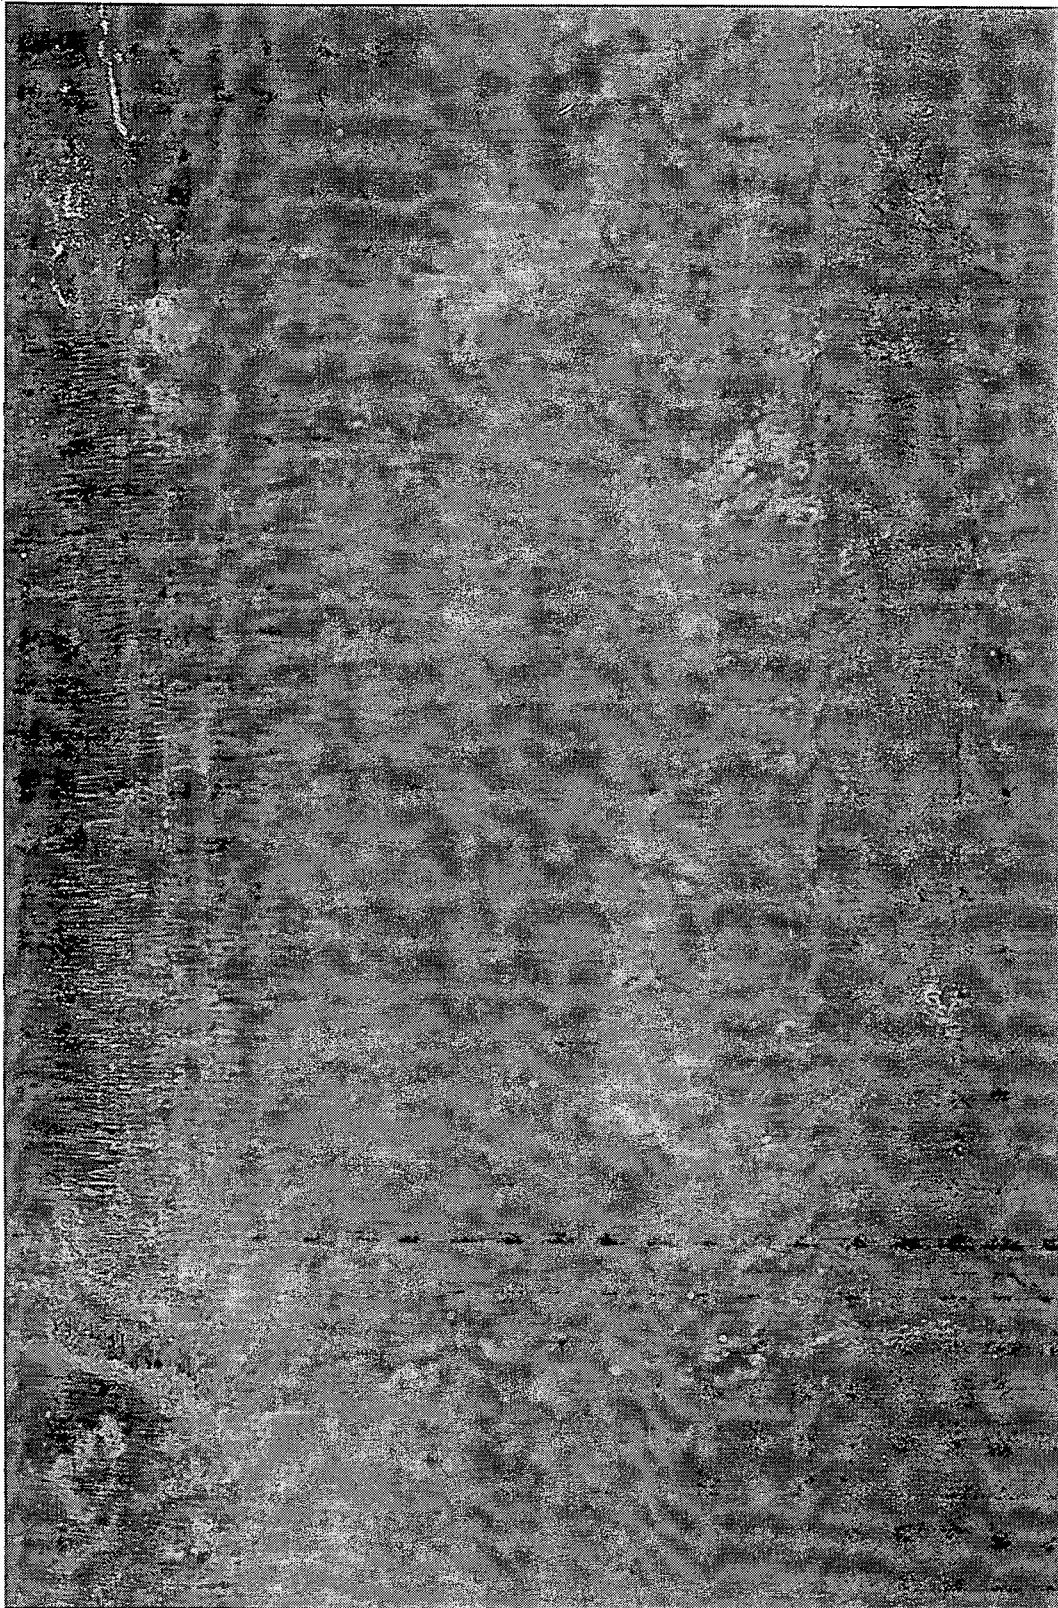
The first tube support plate crevice region of Tube R15C28 is illustrated in Figures 2-5 through 2-8. The location of the TSP1 is reasonably well delineated by a mostly thin, grayish-brown, deposit, showing evidence of abrasion and smearing in the tube pulling process. The tube polishing marks are visible in many areas. However, in other areas the deposit is thicker and heavily spalled, revealing relatively clean tube surface underneath (e.g., Figures 2-5 and 2-6, 0° and 90° faces, respectively). The OD surface areas outside the TSP1 crevice show occasional scratches from the tube pulling (e.g., Figure 2-5, 0° face). Some of the scratches may be also seen within the TSP1 ring (e.g., Figure 2-7, 180° face).

Figure 2-5 Photograph of the first support plate crevice region of Tube R15C28, 0° face.
Specimen 4B. Mag. 6.3X.

Figure 2-6 Photograph of the first support plate crevice region of Tube R15C28, 90° face. Specimen 4B. Mag. 6.3X.

Figure 2-7 Photograph of the first support plate crevice region of Tube R15C28, 180° face. Specimen 4B. Mag. 6.3X.

Figure 2-8 Photograph of the first support plate crevice region of Tube R15C28, 270° face. Specimen 4B. Mag. 6.3X.

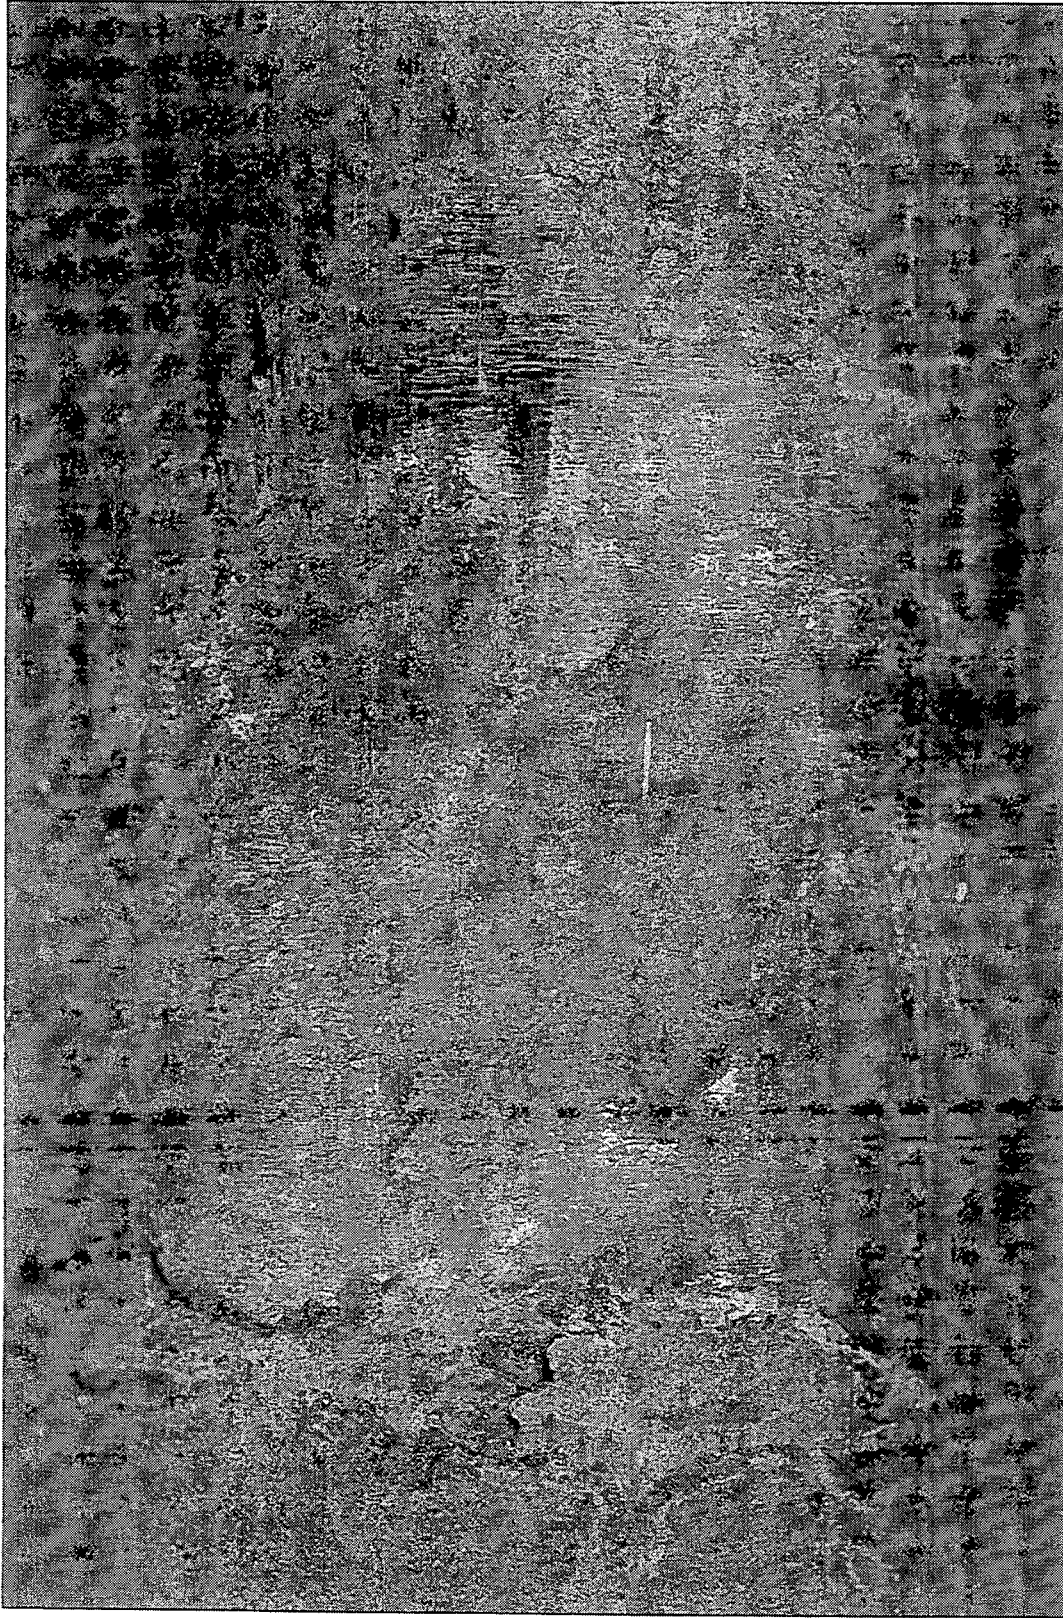
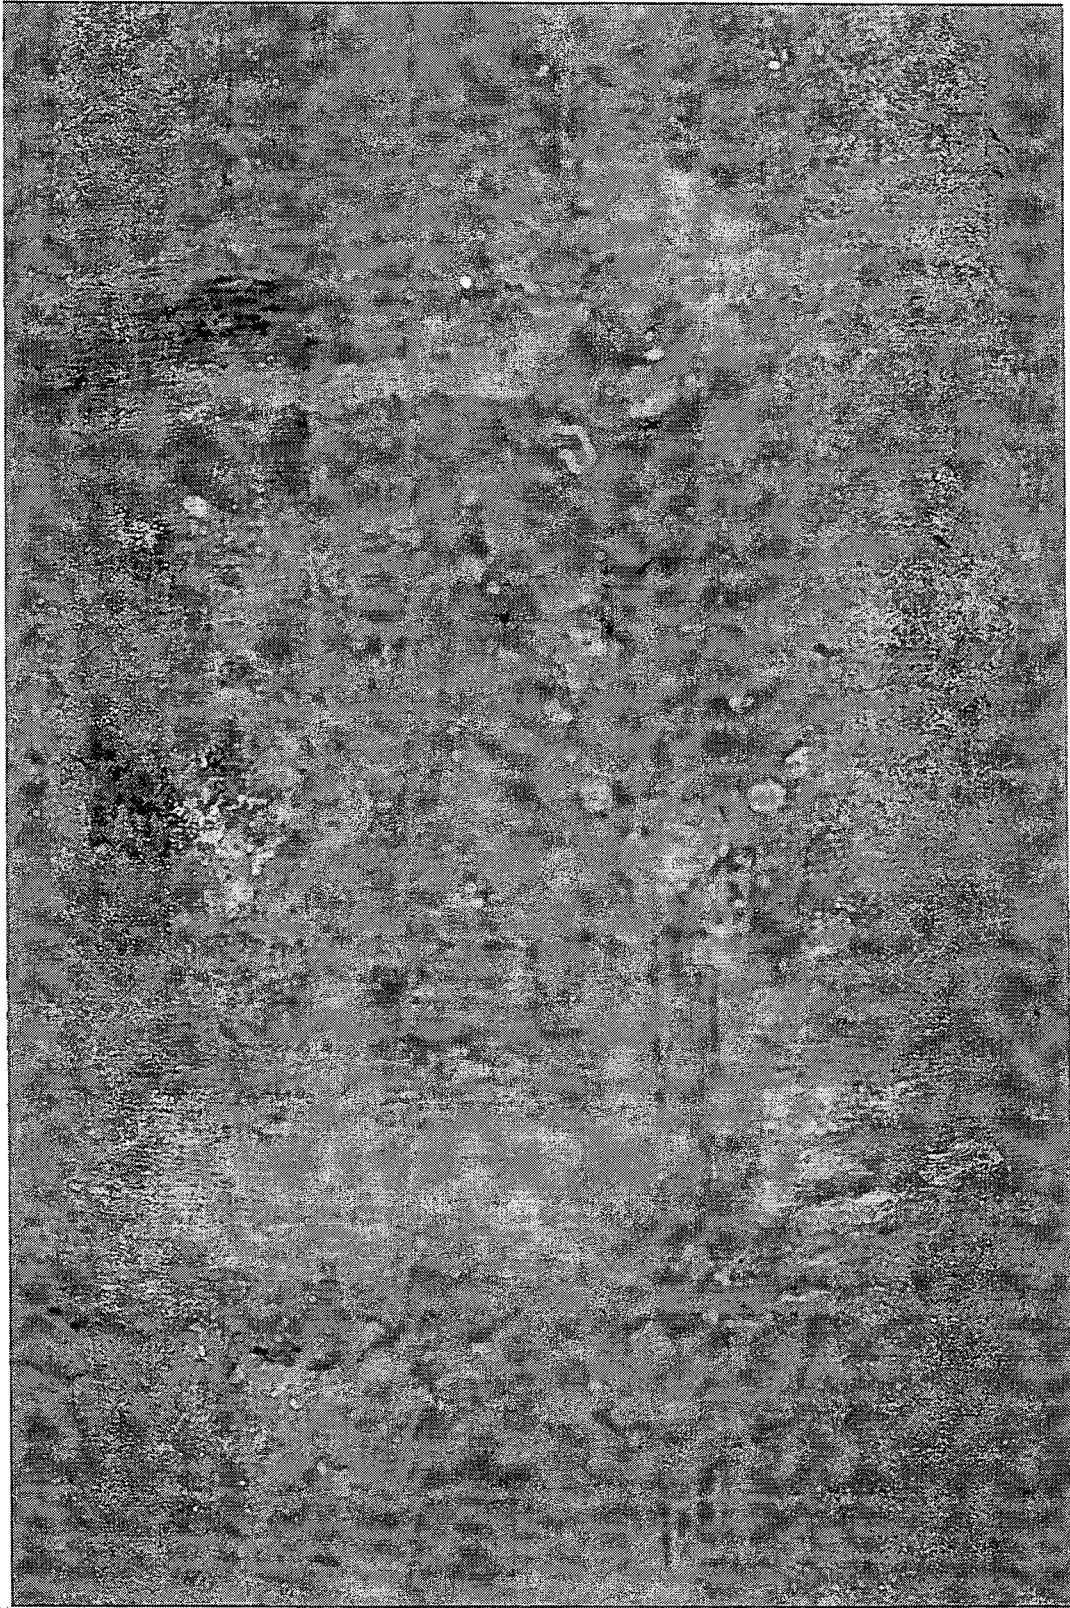
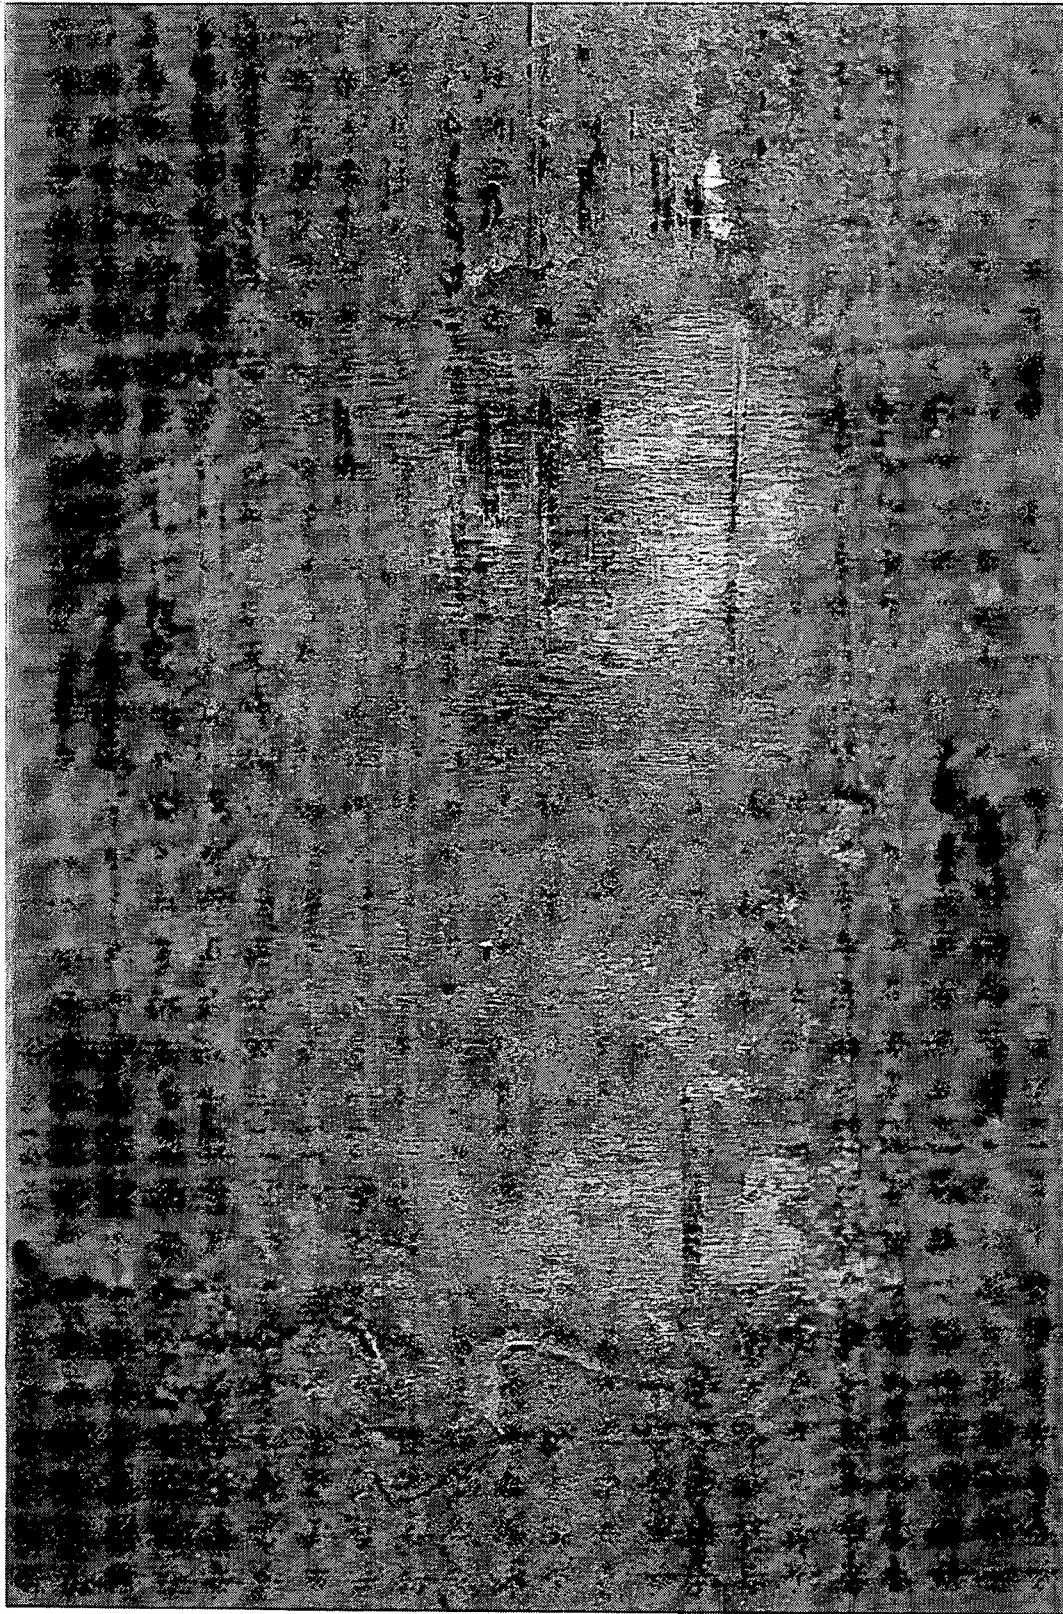
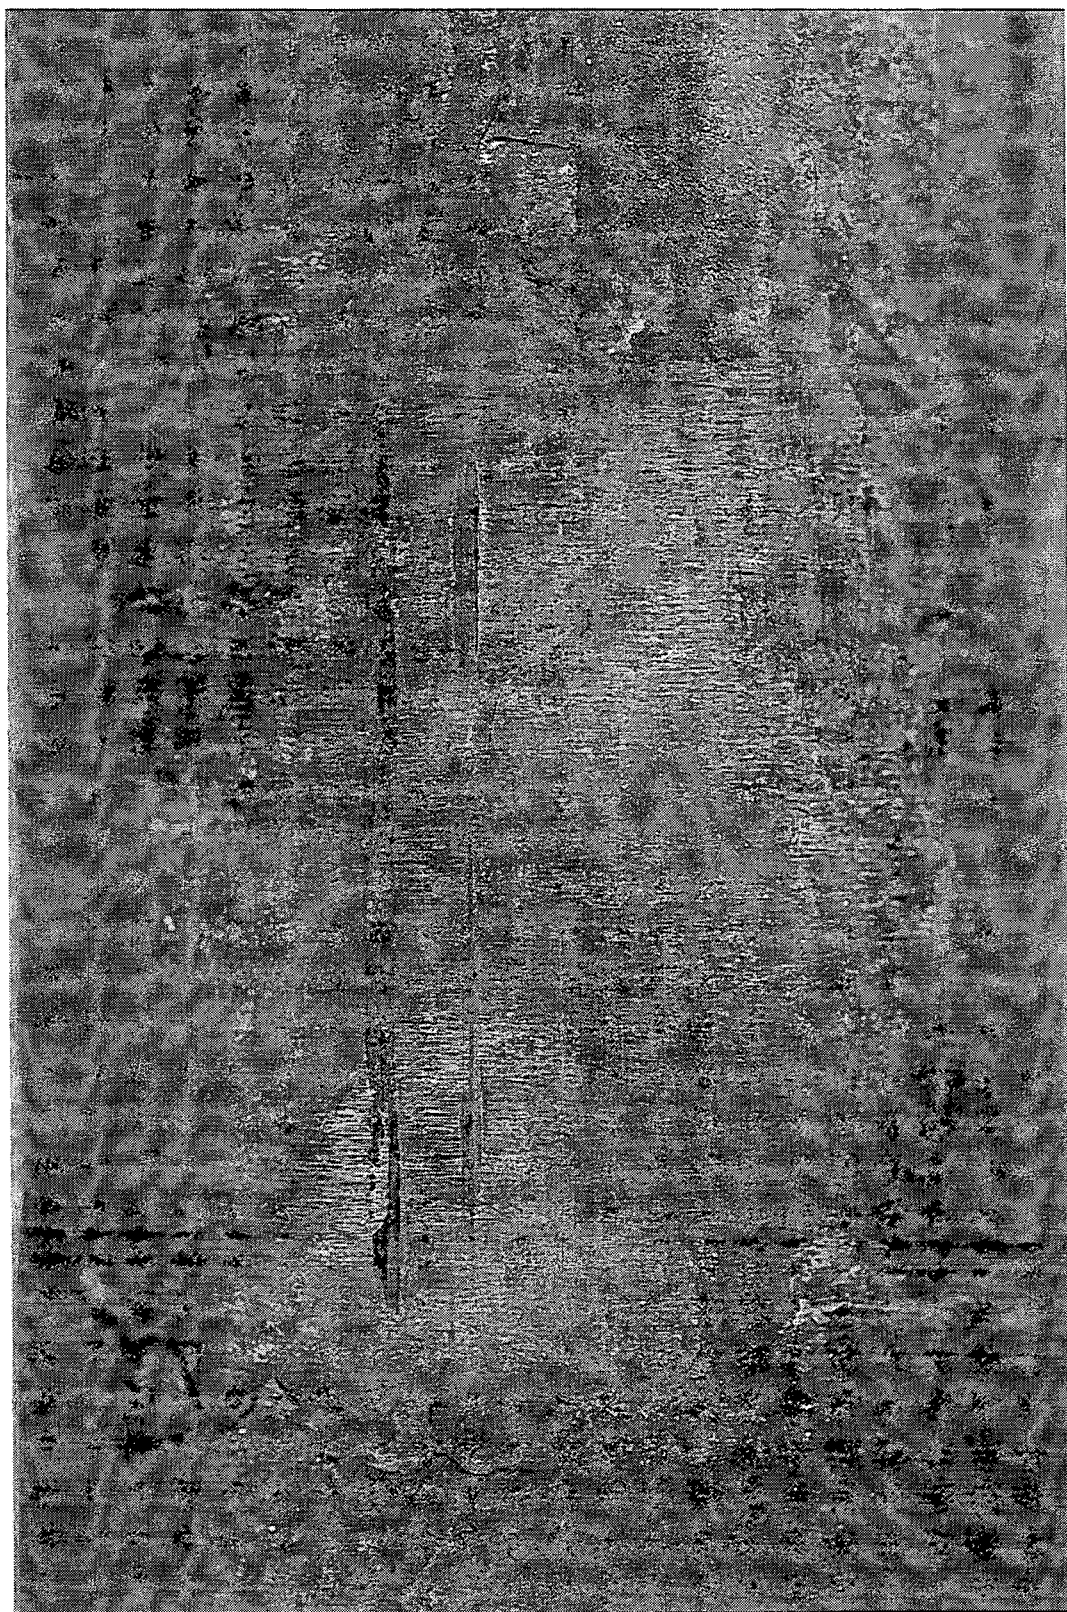
The second tube support plate crevice region of Tube R15C28 may be seen in Figures 2-9 through 2-12. Again, the location of the crevice ring on the tube surface is reasonably well defined. The grayish-brown deposit at TSP2 is similar to slightly thicker than at TSP1. There are fewer areas showing the tube polishing marks. Some areas have occasional white spots (e.g., Figure 2-10, 90° face). Long scratches are visible on the 270° face, Figure 2-12. The areas outside the TSP2 crevice appear to have relatively thick deposits.

Figure 2-9 Photograph of the second support plate crevice region of Tube R15C28, 0° face. Specimen 6B. Mag. 6.3X.

Figure 2-10 Photograph of the second support plate crevice region of Tube R15C28, 90° face. Specimen 6B. Mag. 6.3X.

Figure 2-11 Photograph of the second support plate crevice region of Tube R15C28, 180° face. Specimen 6B. Mag. 6.3X.

Figure 2-12 Photograph of the second support plate crevice region of Tube R15C28, 270° face. Specimen 6B. Mag. 6.3X.

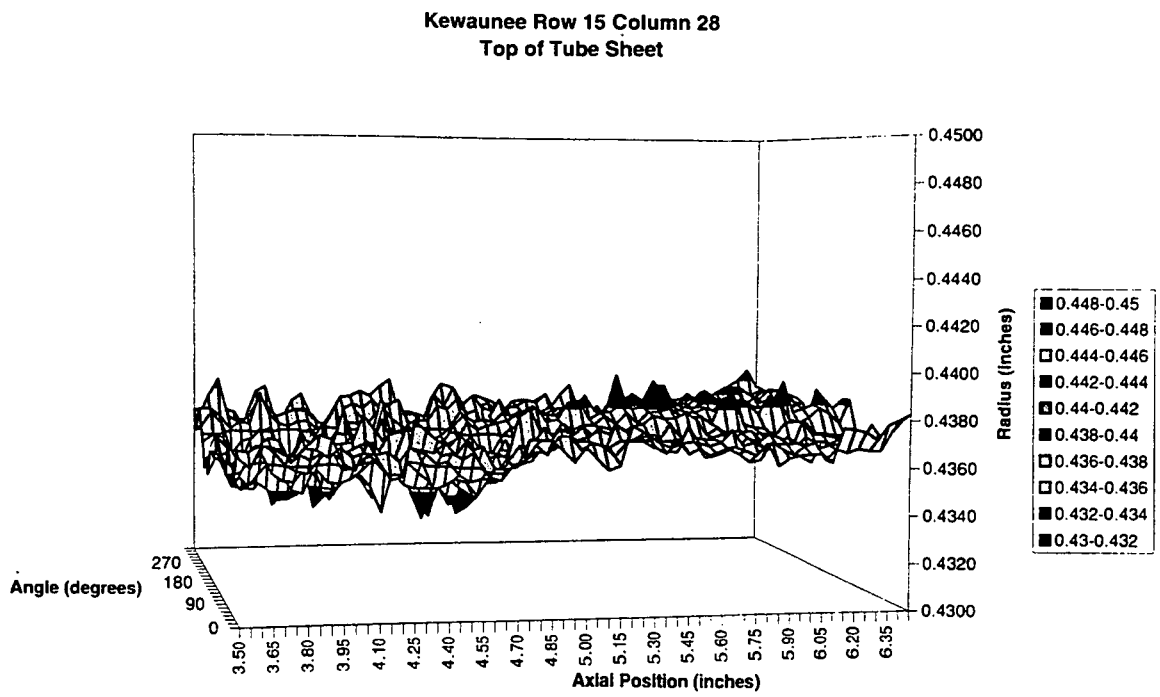
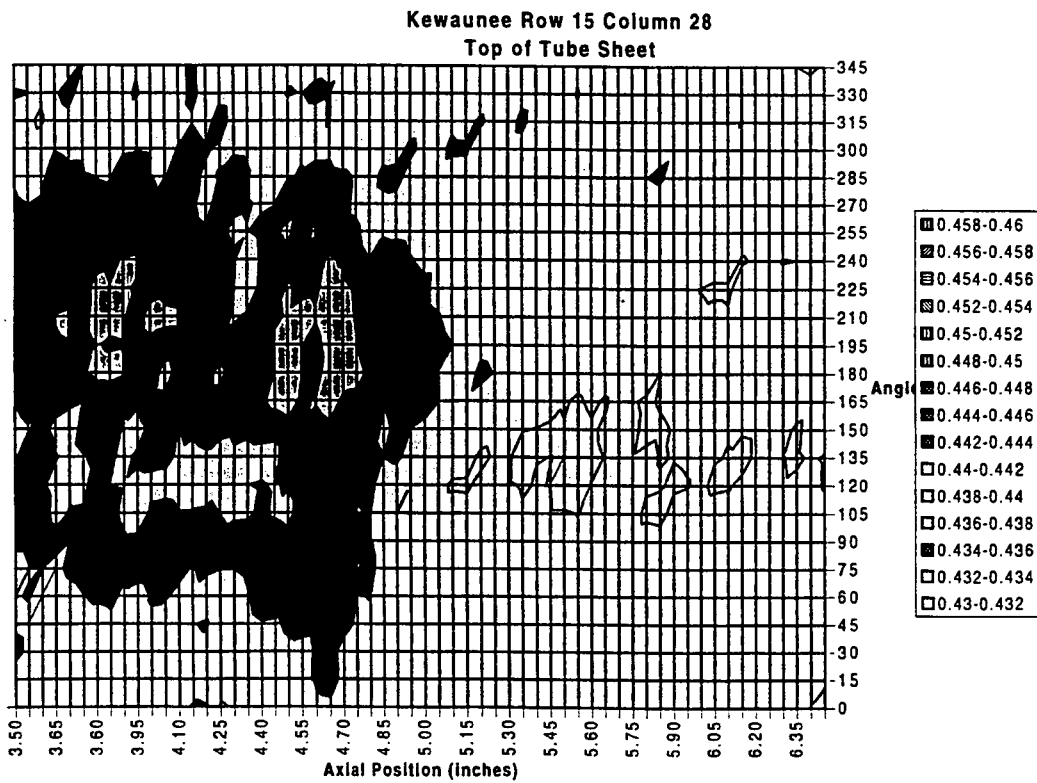
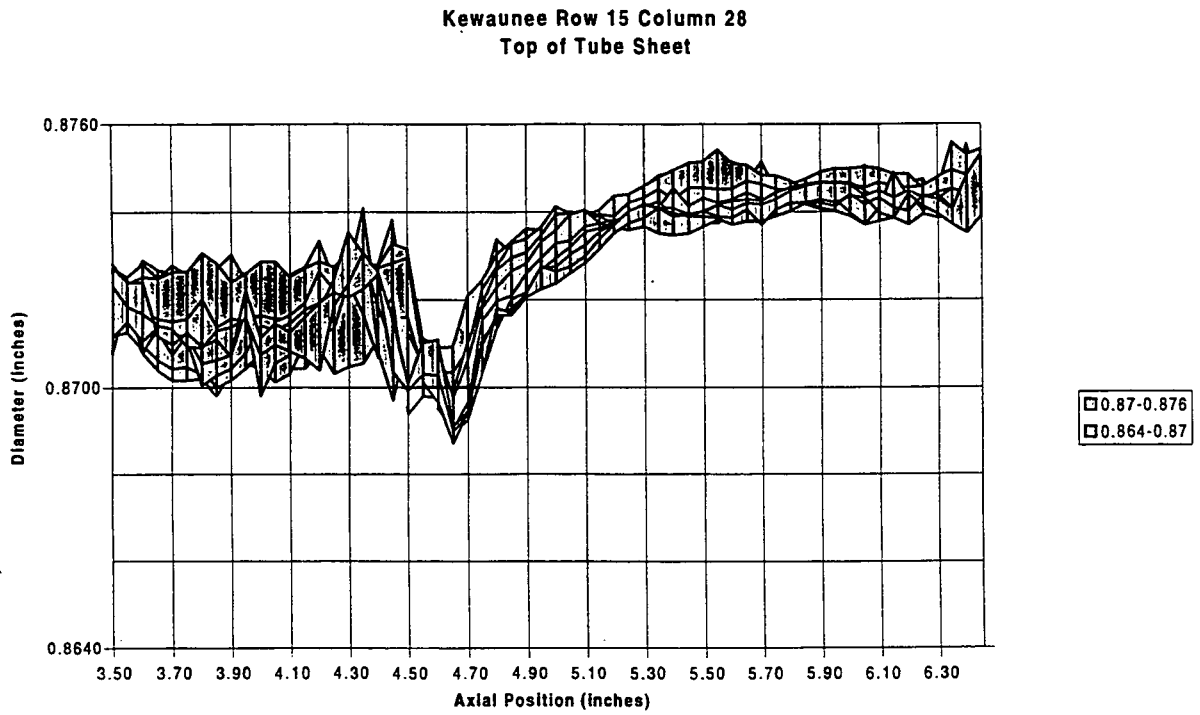
Figures 2-13 through 2-15 present the radial laser profilometry data for the tubesheet top region of Tube R15C28.

Figure 2-13 OD dimensional data obtained by laser micrometry of the tubesheet top region of Tube R15C28, showing radial data as a function of axial and circumferential position.

Figure 2-14 OD dimensional data obtained by laser micrometry of the tubesheet top region of Tube R15C28, showing radial data as a function of axial and circumferential position, in form of a contour map.

Figure 2-15 OD dimensional data obtained by laser micrometry of the tubesheet top region of Tube R15C28, showing diametrical data as a function of axial position, with circumferential information compressed.
