Examination of Kewaunee Cold Leg Steam Generator Tube R15C28

P. Kuchirka*, A. Madeyski, and M. Blaszkiewicz

May 8, 1997

The first and second tube support plate crevice regions of cold leg Tube R15C28 from Steam Generator B of Kewaunee were examined by nondestructive and destructive examination techniques. Shallow, but extensively distributed, OD-origin intergranular corrosion was found contained in the tube support plate crevice regions of the mill annealed Alloy 600 tubing.

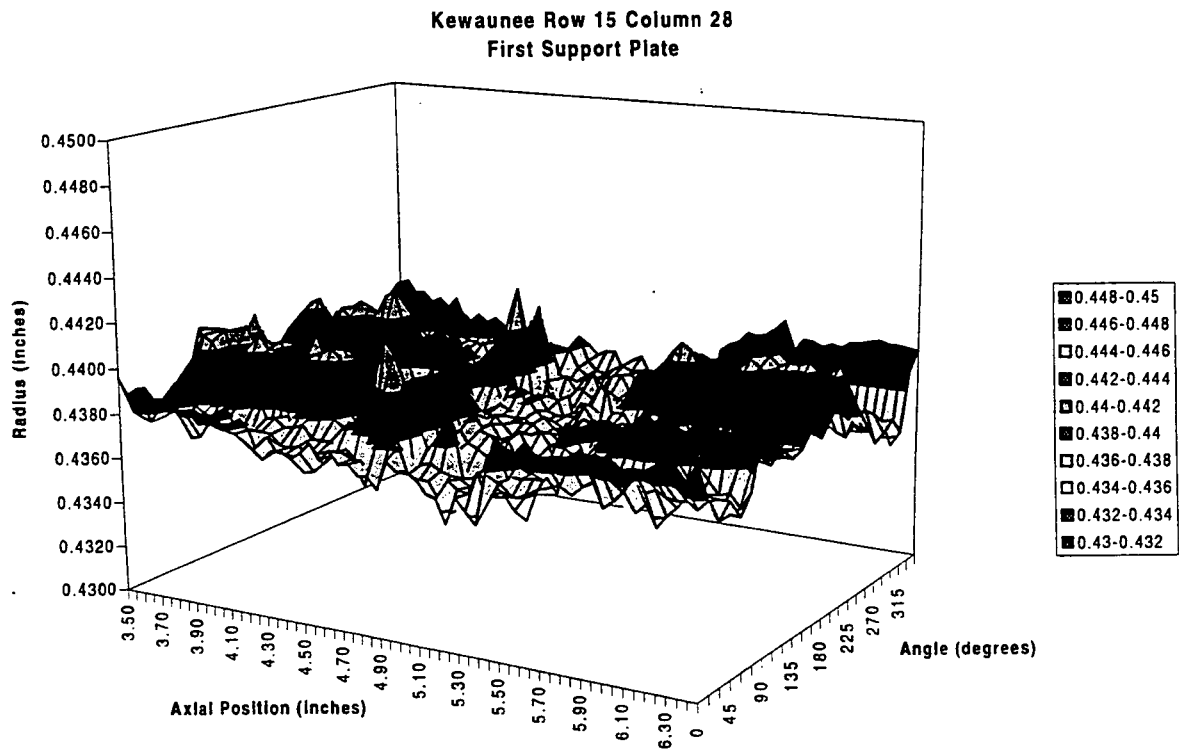
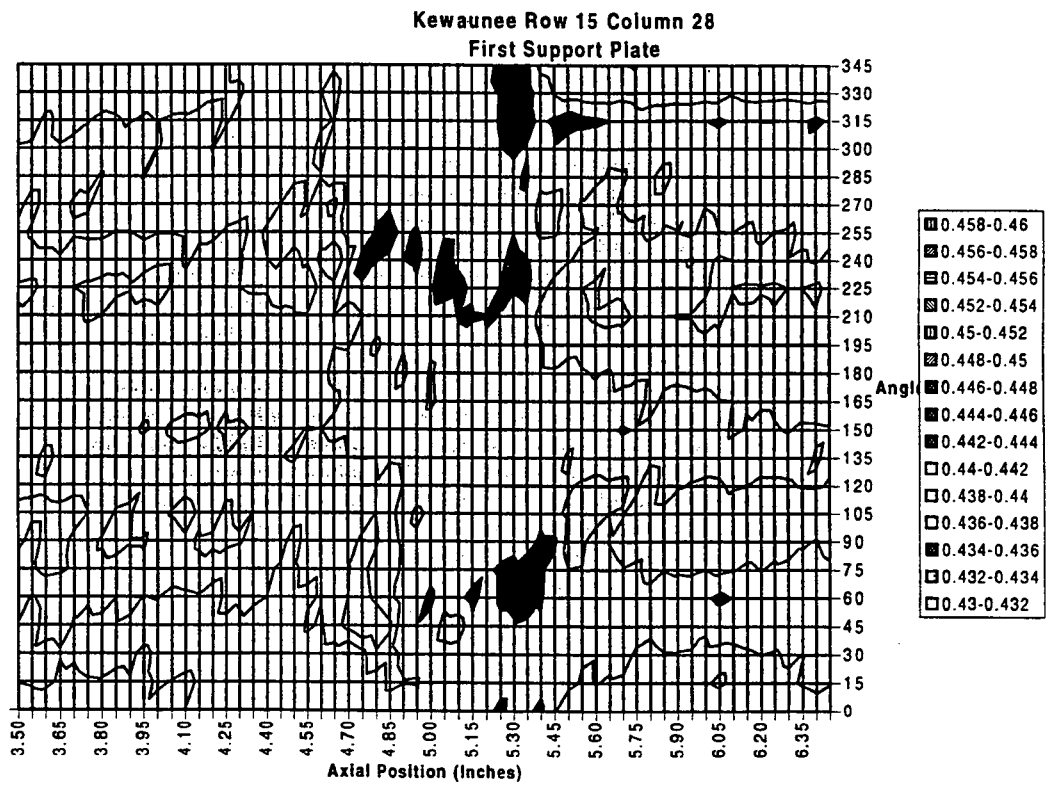
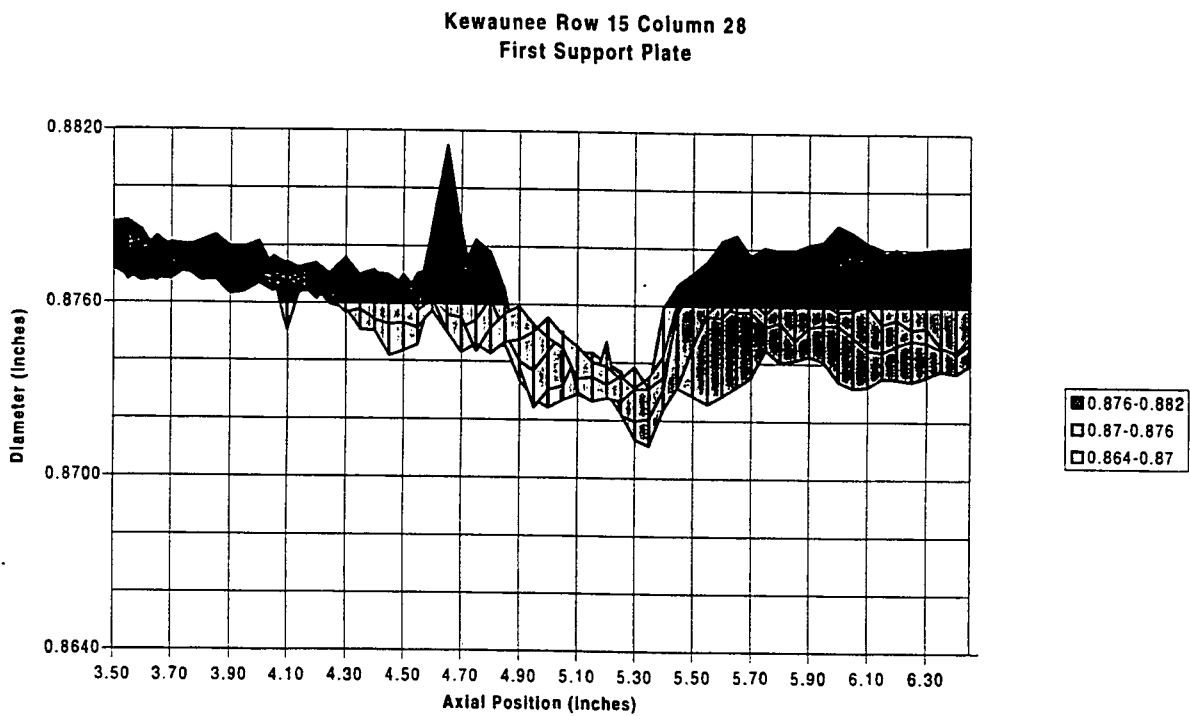
Figures 2-16 through 2-18 present the radial laser profilometry data for the first tube support plate region of Tube R15C28.

Figure 2-16 OD dimensional data obtained by laser micrometry of the first tube support plate region of Tube R15C28, showing radial data as a function of axial and circumferential position.

Figure 2-17 OD dimensional data obtained by laser micrometry of the first tube support plate region of Tube R15C28, showing radial data as a function of axial and circumferential position, in form of a contour map.

Figure 2-18 OD dimensional data obtained by laser micrometry of the first tube support plate region of Tube R15C28, showing diametrical data as a function of axial position, with circumferential information compressed.

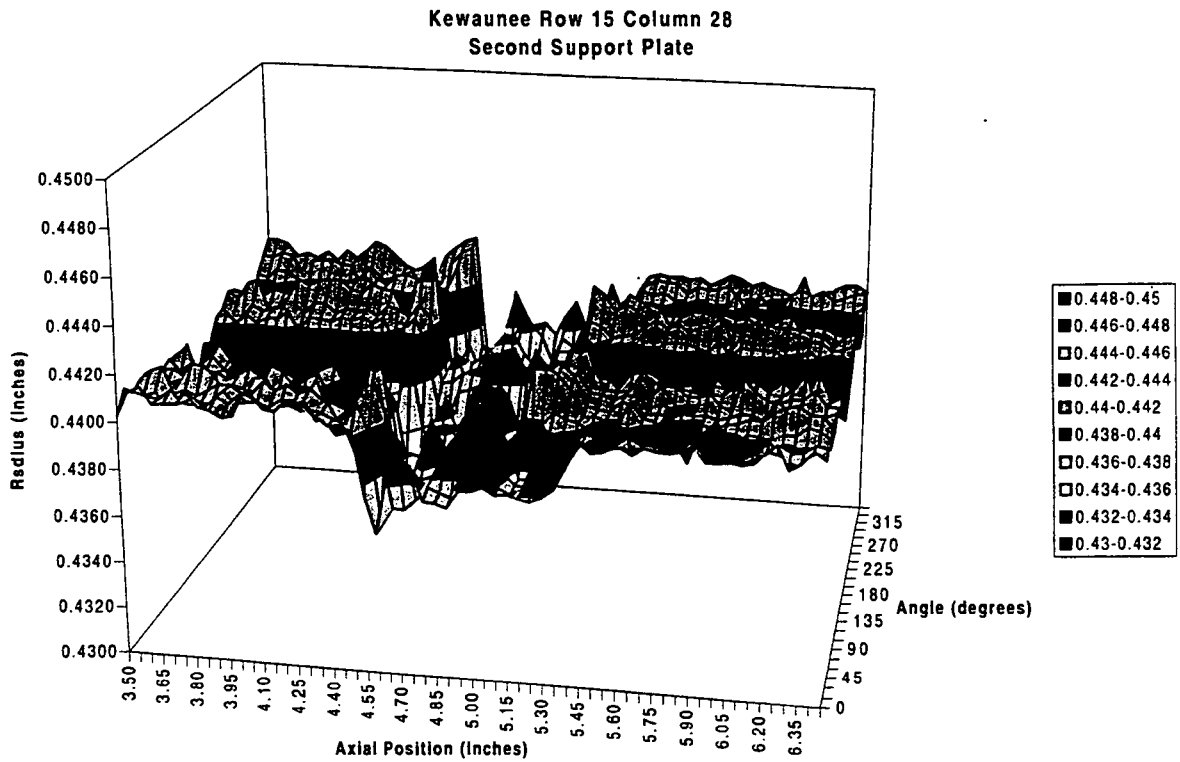
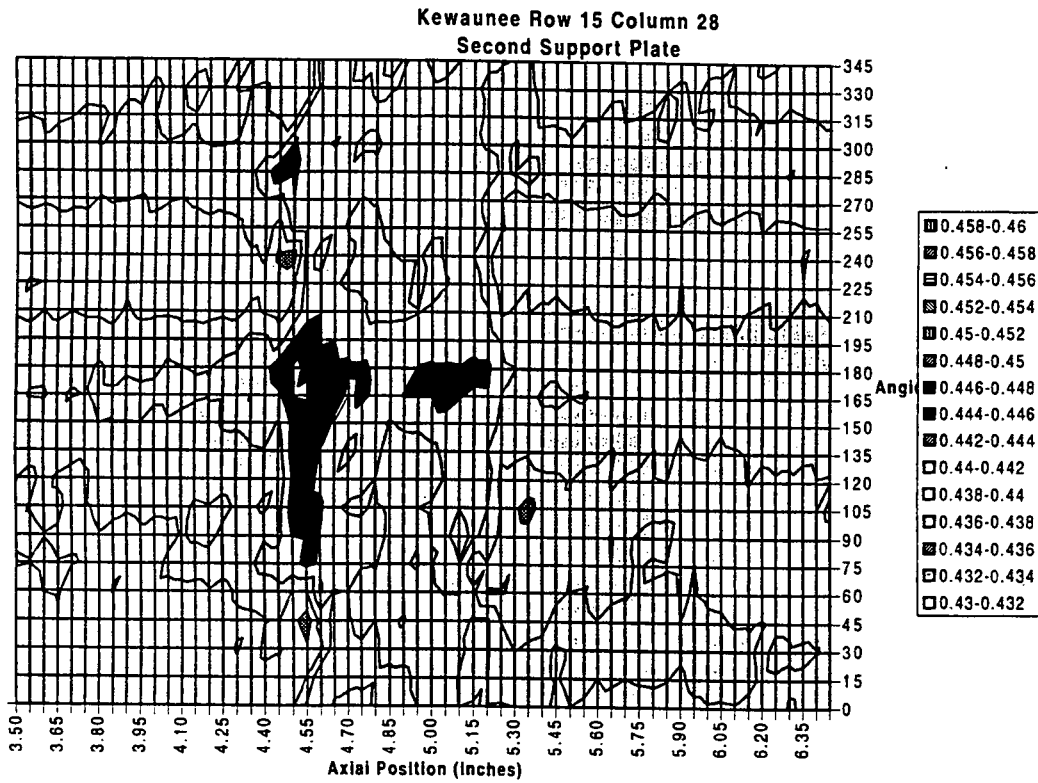
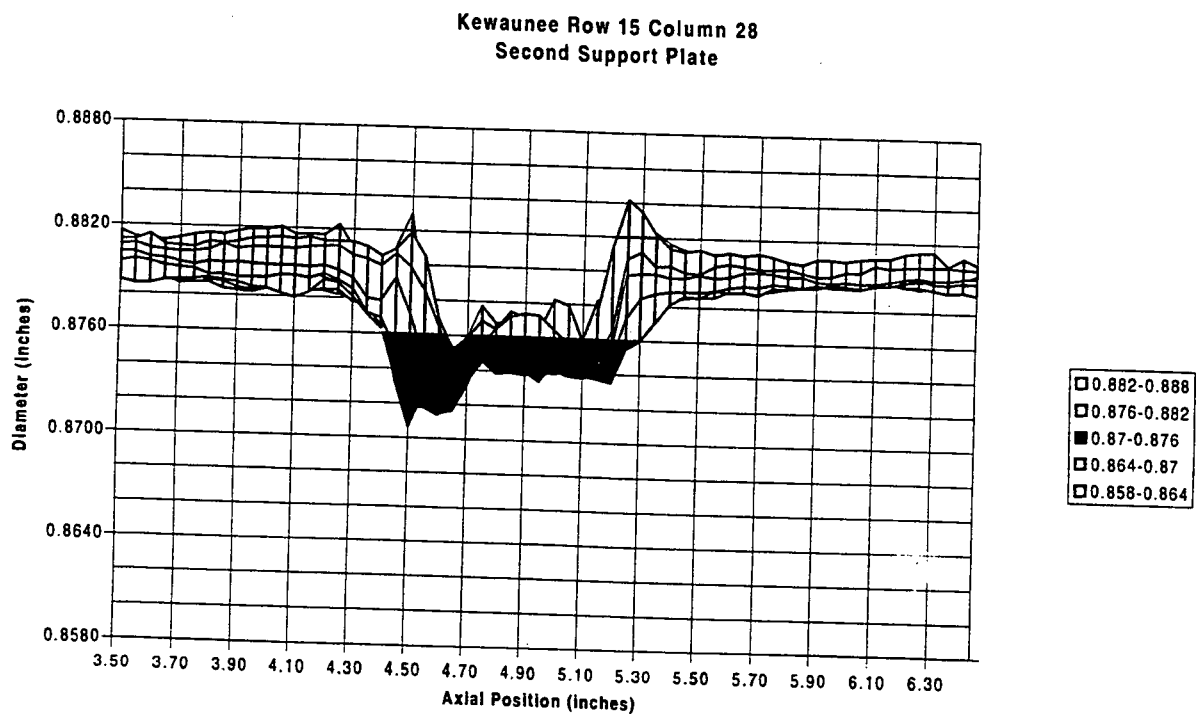
Figures 2-19 through 2-21 present the radial laser profilometry data for the second tube support plate region of Tube R15C28.

Figure 2-19 OD dimensional data obtained by laser micrometry of the second tube support plate region of Tube R15C28, showing radial data as a function of axial and circumferential position.

Figure 2-20 OD dimensional data obtained by laser micrometry of the second tube support plate region of Tube R15C28, showing radial data as a function of axial and circumferential position, in form of a contour map.

Figure 2-21 OD dimensional data obtained by laser micrometry of the second tube support plate region of Tube R15C28, showing diametrical data as a function of axial position, with circumferential information compressed.

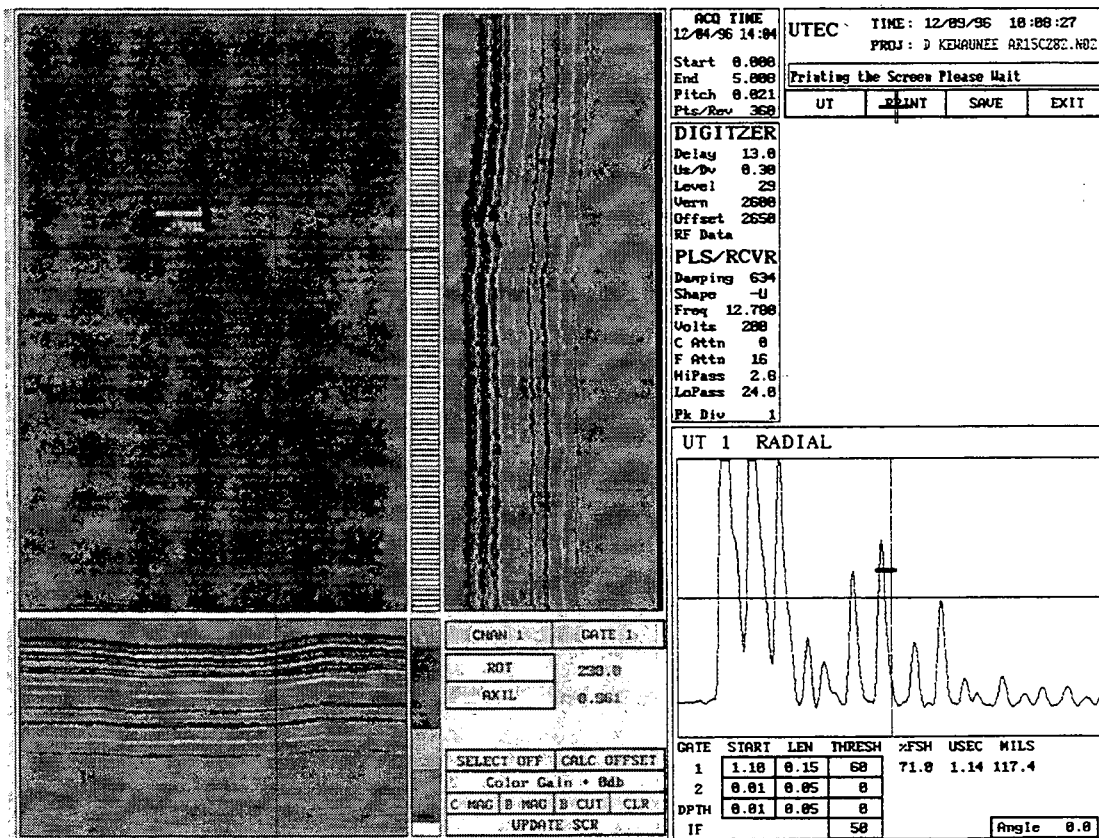
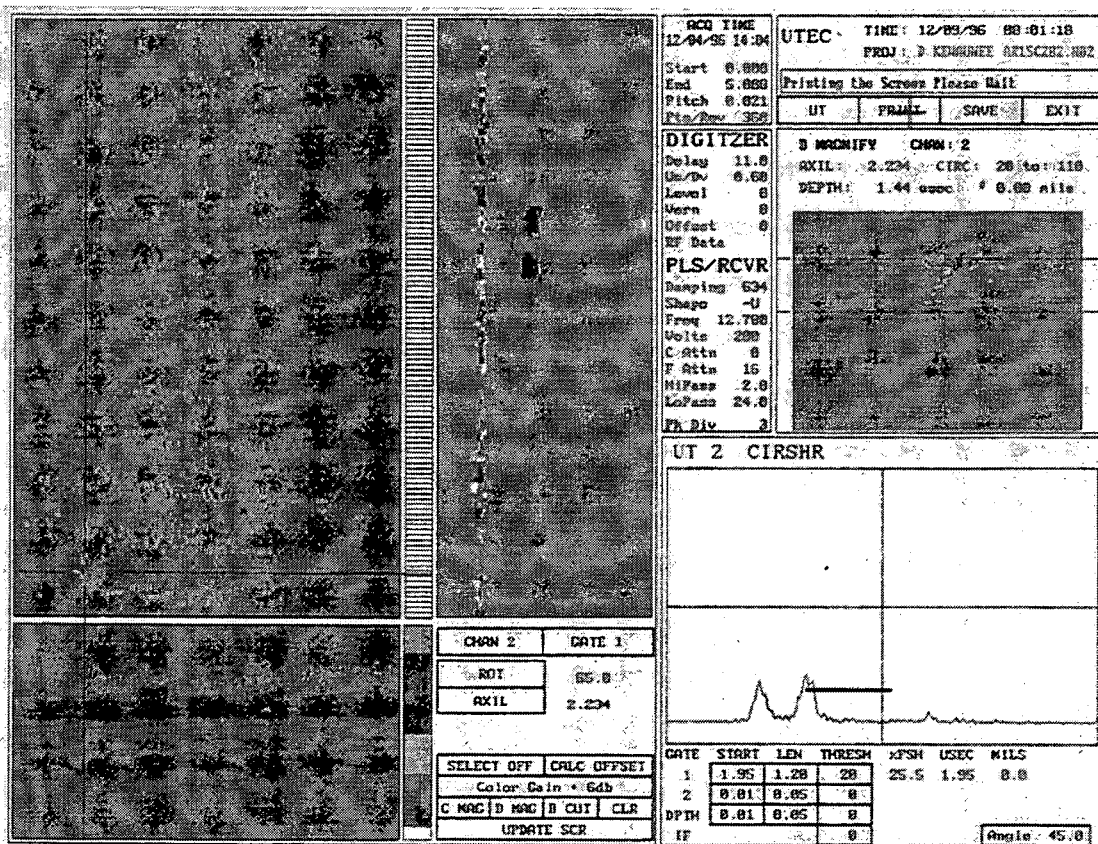
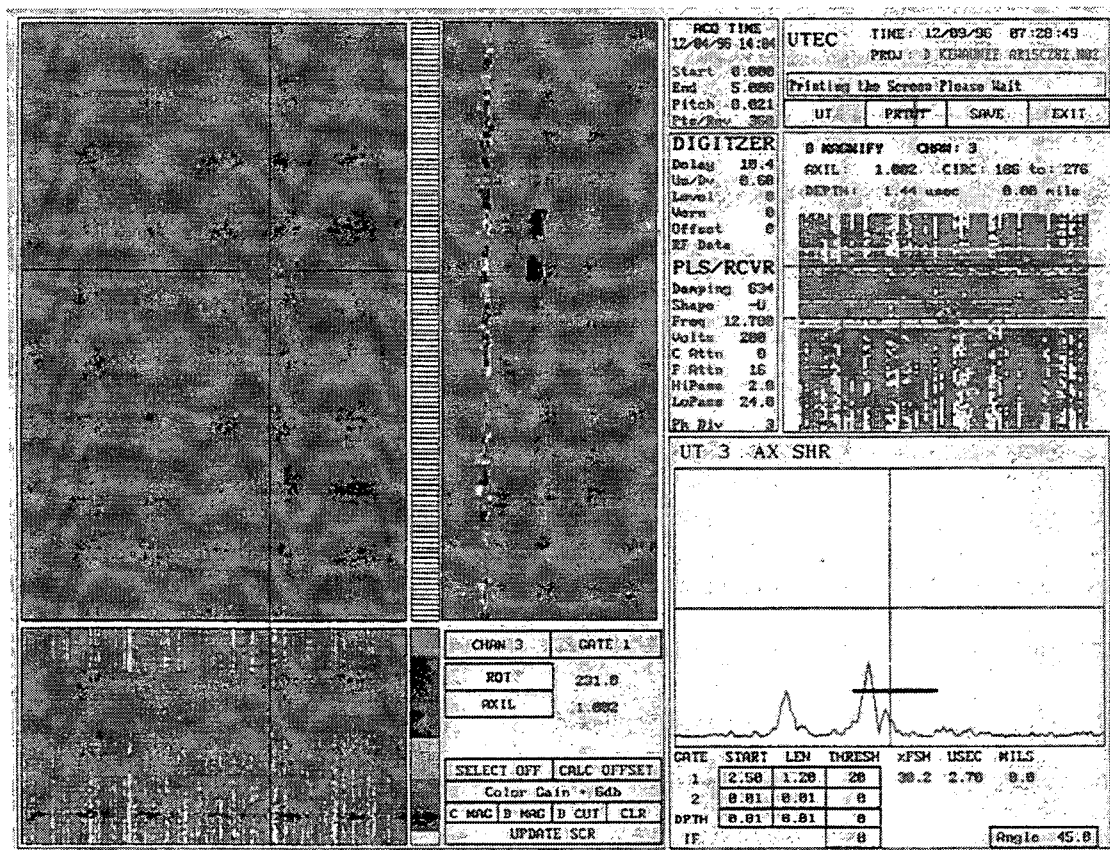
The radial aim data, Figure 2-26, showed only some helical markings and axial scratches on the tube. The circumferential and axial aim data, Figures 2-27 and 2-28, respectively, did not show any detectable degradation, either.

Figure 2-26 Ultrasonic test UTEC display of the radial aim data obtained on the tubesheet top region of Tube R15C28.

Figure 2-27 Ultrasonic test UTEC display of the circumferential aim data obtained on the tubesheet top region of Tube R15C28.

Figure 2-28 Ultrasonic test UTEC display of the axial aim data obtained on the tubesheet top region of Tube R15C28.

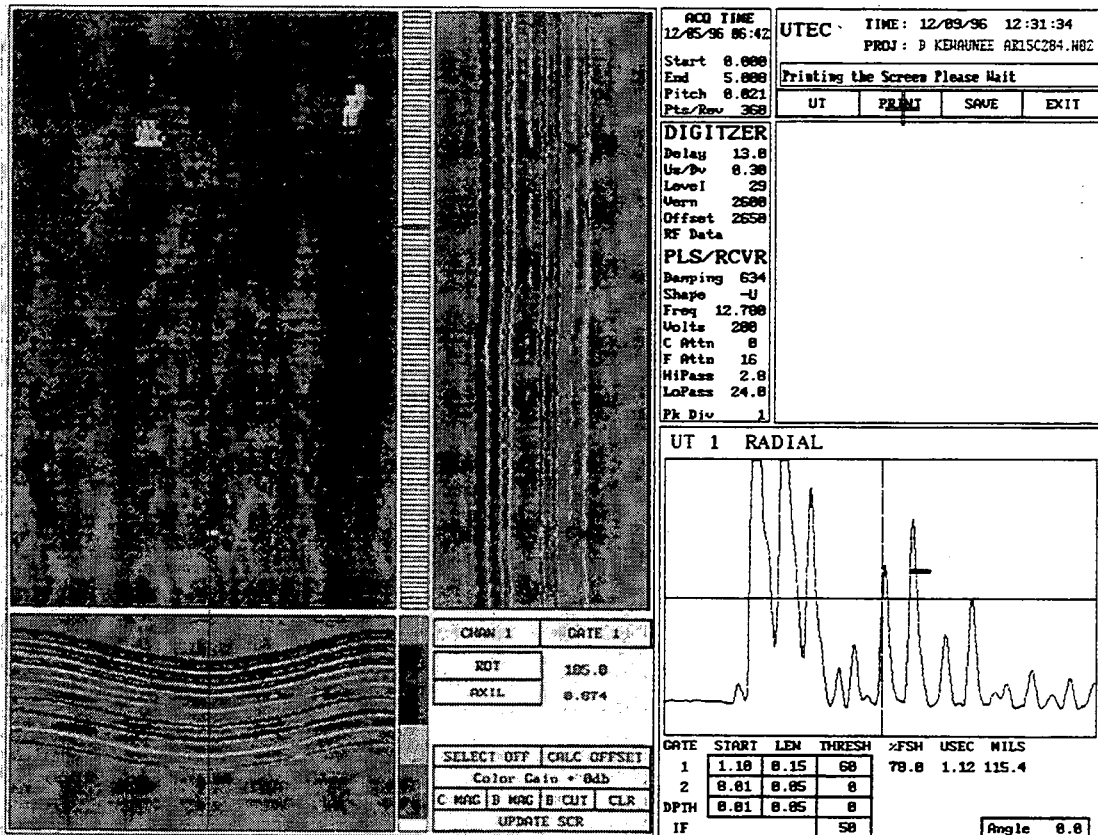
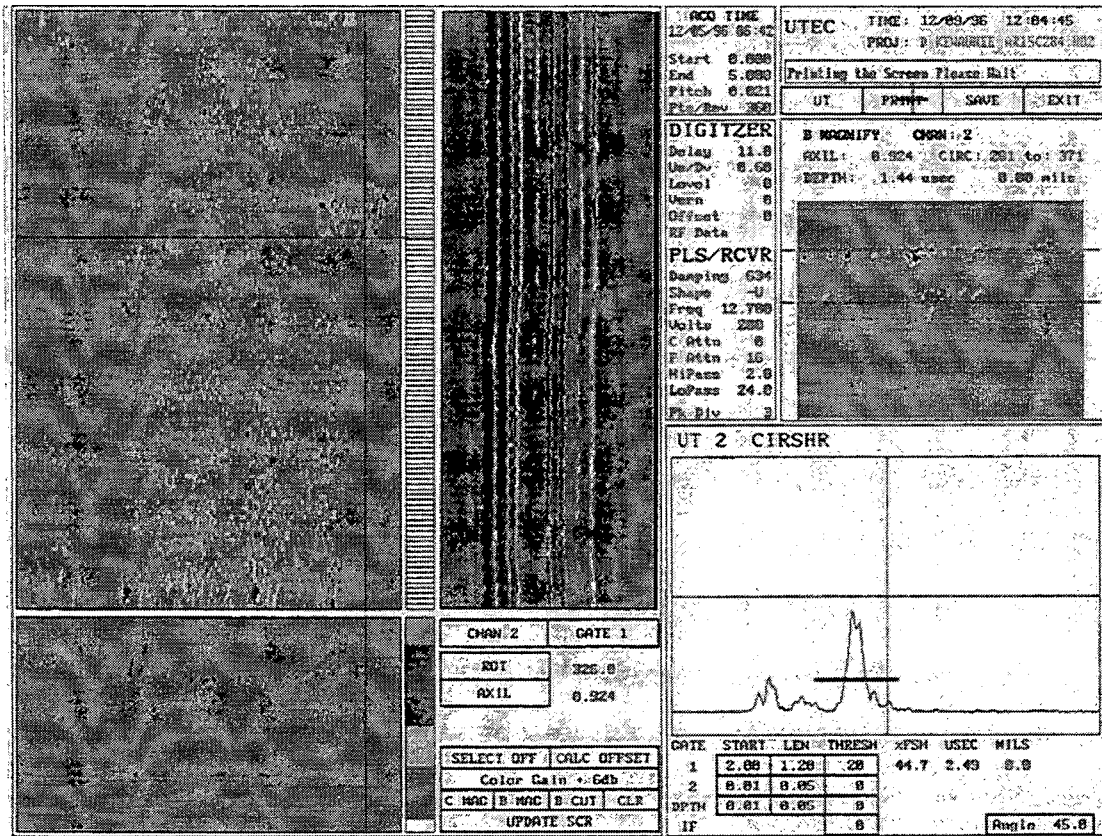
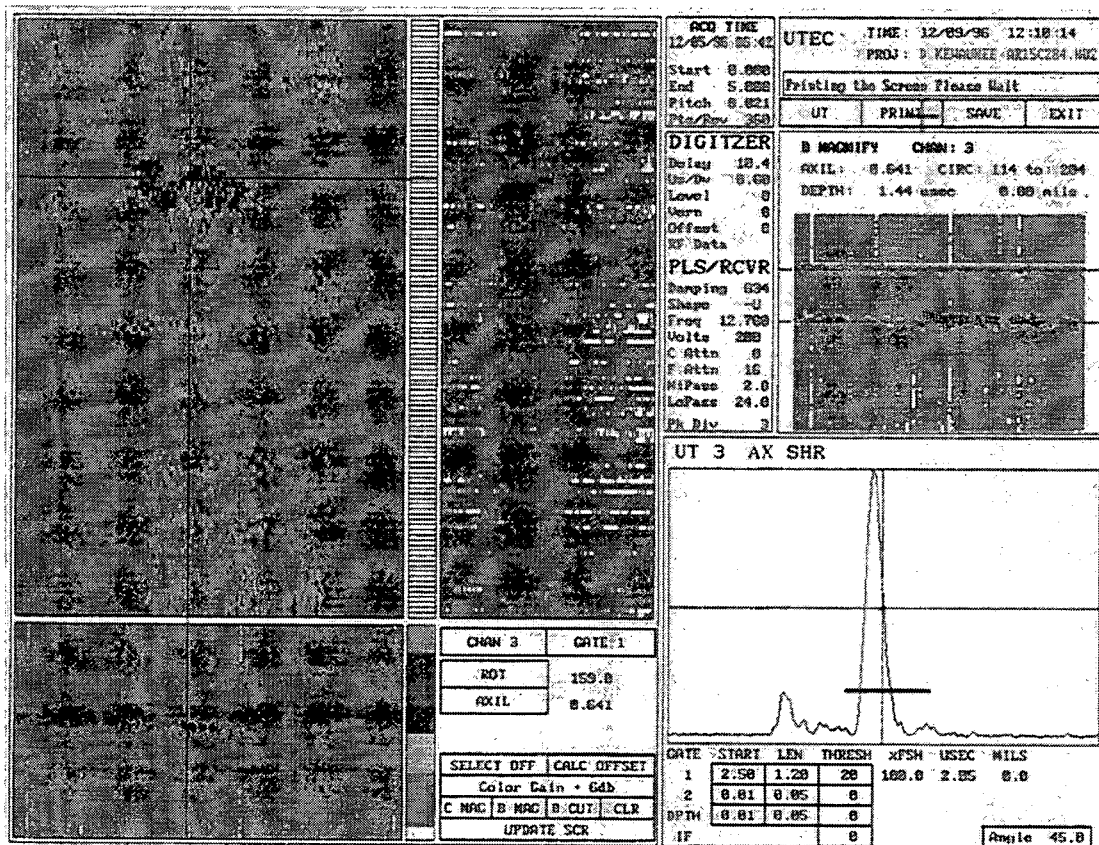
The radial aim data, Figure 2-29, showed possible indications around 150° and 320°. The circumferential and axial aim data, Figures 2-30 and 2-31, confirmed the presence of numerous, short, shallow ($\leq 20\%$ deep), indications at the OD, located mostly in two patches: one centered near 320°, and the other near 150° (with an axial extent of about 0.2 inch). Also, some axial scratches were shown by the circumferential aim data, Figure 2-30.

Figure 2-29 Ultrasonic test UTEC display of the radial aim data obtained on the first support plate crevice region of Tube R15C28.

Figure 2-30 Ultrasonic test UTEC display of the circumferential aim data obtained on the first support plate crevice region of Tube R15C28.

Figure 2-31 Ultrasonic test UTEC display of the axial aim data obtained on the first support plate crevice region of Tube R15C28.

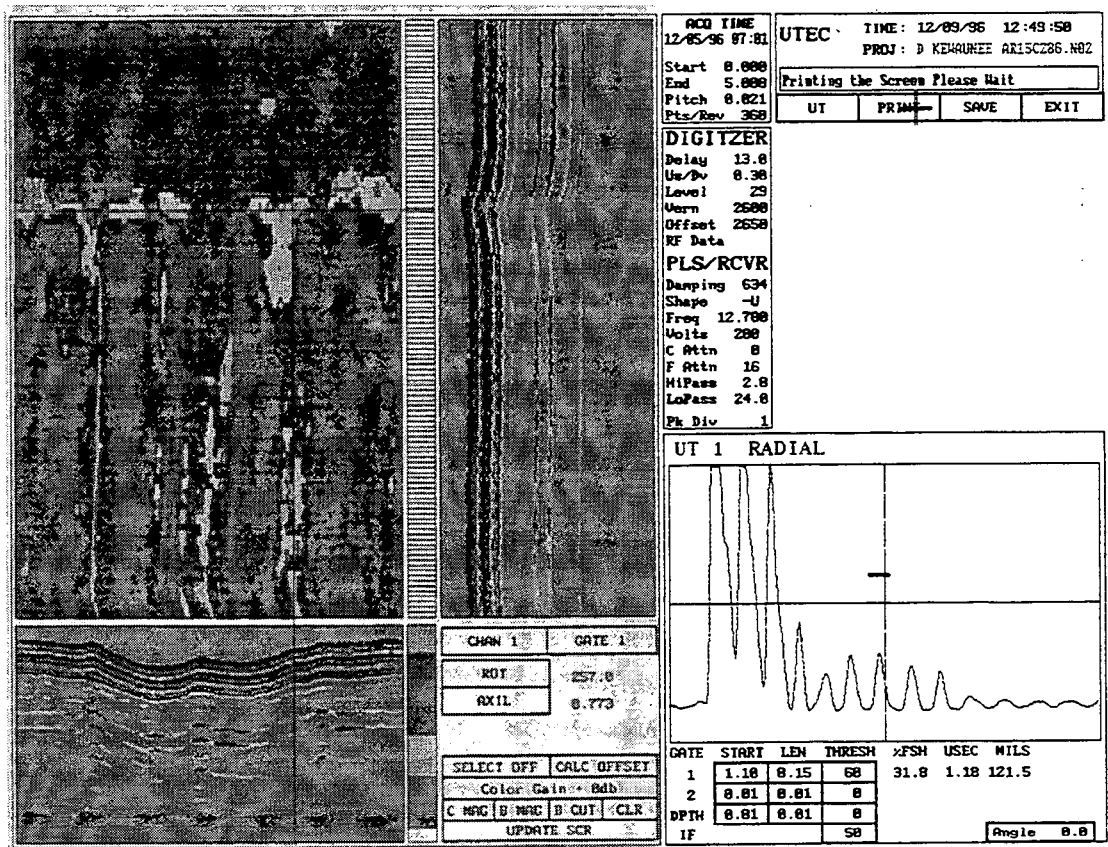
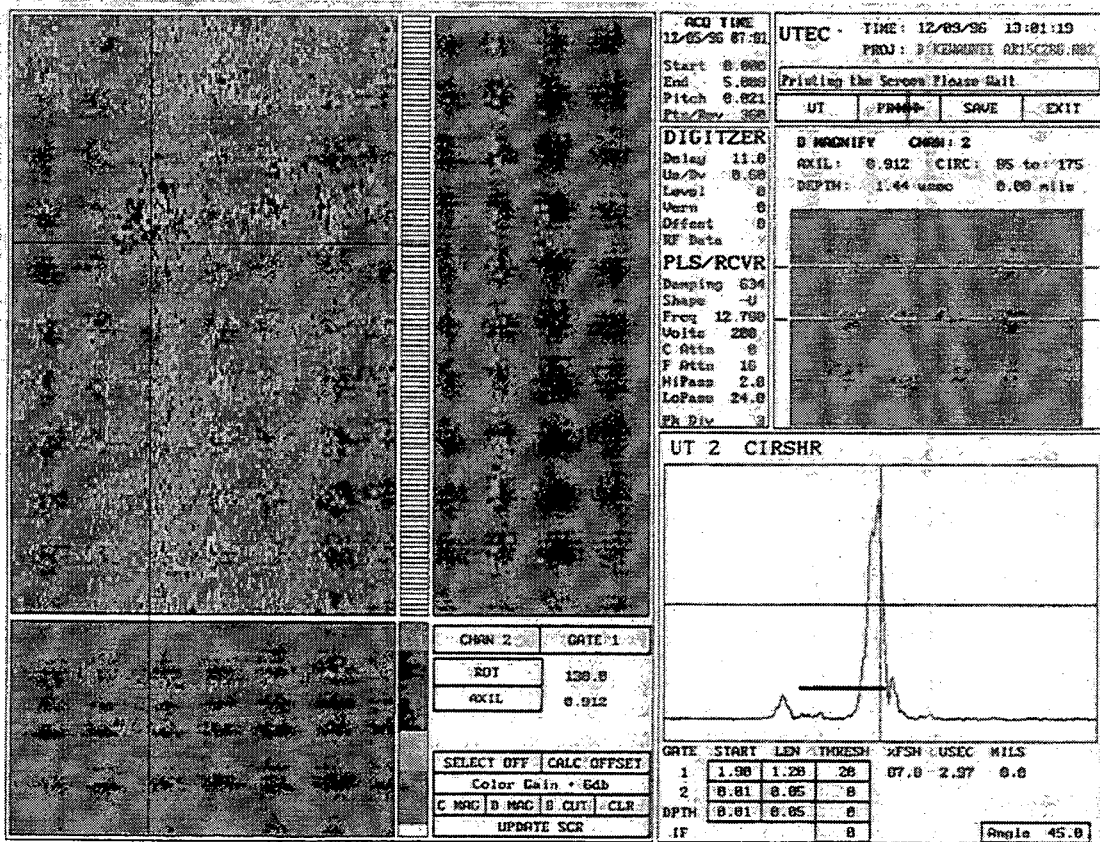
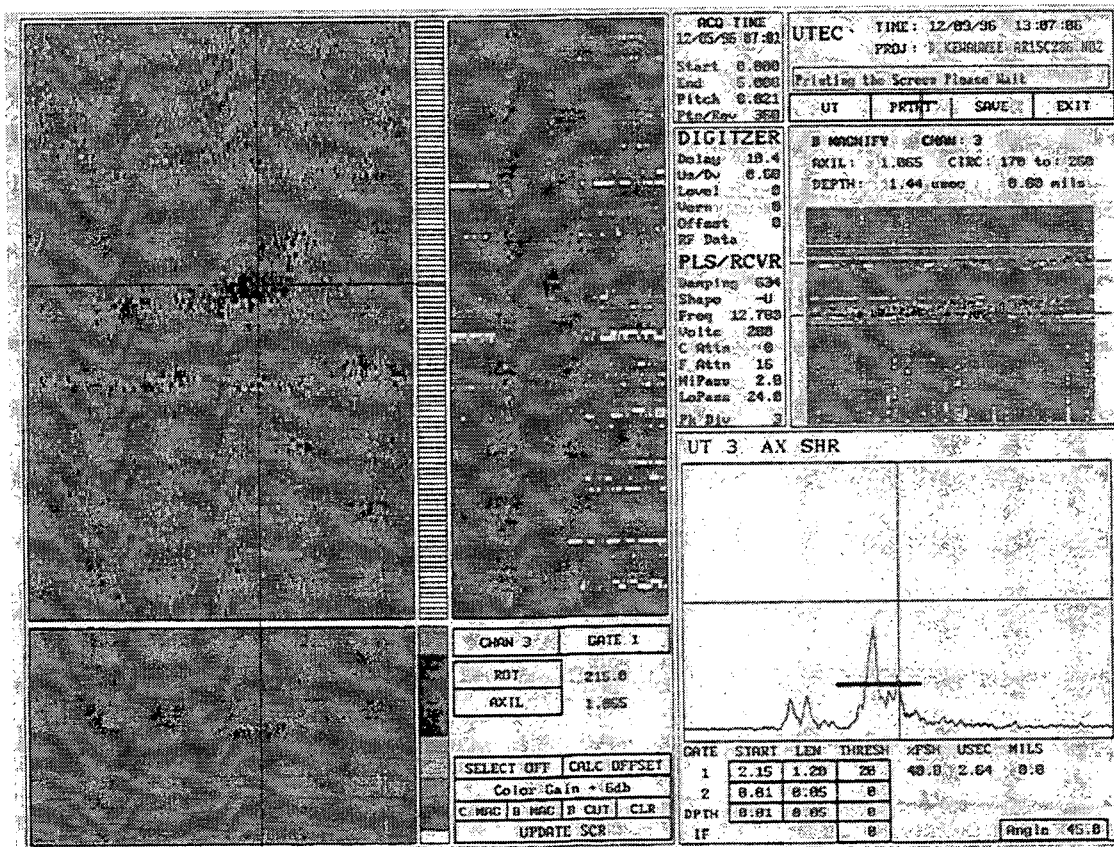
In the assessment of these data it has been concluded that, basically, in the TSP2 crevice region there were multiple, short, shallow ($\leq 30\%$ deep), indications shown by both the circumferential and the axial aim scans, and that most of them were located in two patches: one centered near 120°, and the other near 290°. The indications were suggestive of either two dimensional intergranular cellular corrosion (ICC) or a three dimensional intergranular attack (IGA).

Figure 2-32 Ultrasonic test UTEC display of the radial aim data obtained on the second support plate crevice region of Tube R15C28.

Figure 2-33 Ultrasonic test UTEC display of the circumferential aim data obtained on the second support plate crevice region of Tube R15C28.

Figure 2-34 Ultrasonic test UTEC display of the axial aim data obtained on the second support plate crevice region of Tube R15C28.

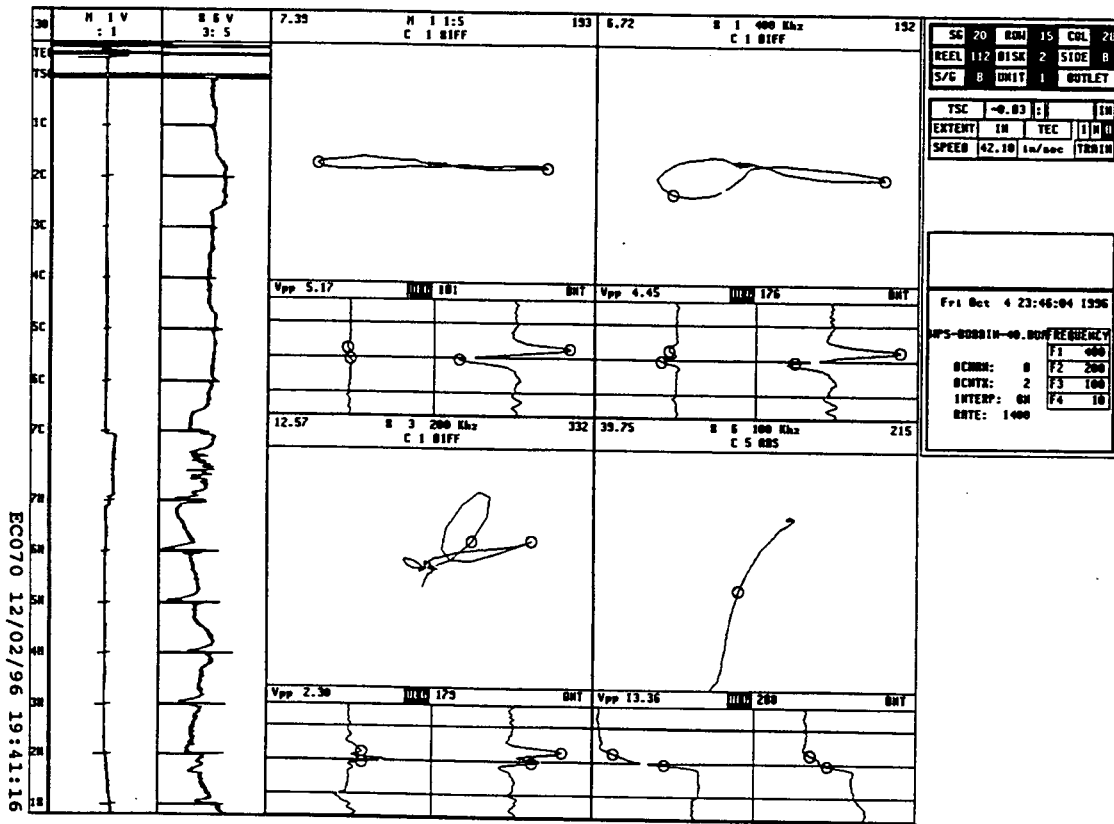
The field EC test data for the tubesheet top region of Tube R15C28 are shown in Figure 2-35¹. The data were obtained with a bobbin probe, which showed a 5.17 Vpp (Volts peak-to-peak) dent indication. The 3-coil probe data, not displayed, showed no detectable degradation (NDD) of the tube in this region.

Figure 2-35 TST (tubesheet top) region of Tube R15C28. Field bobbin probe eddy current test data.

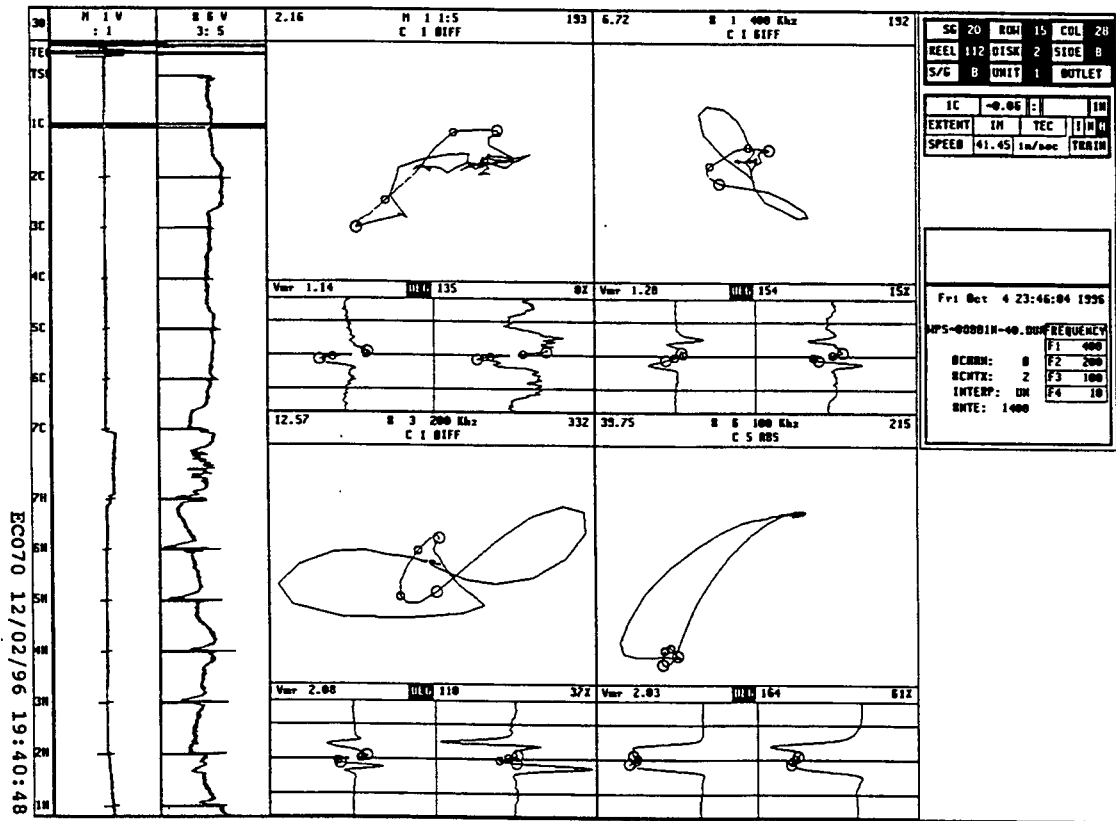
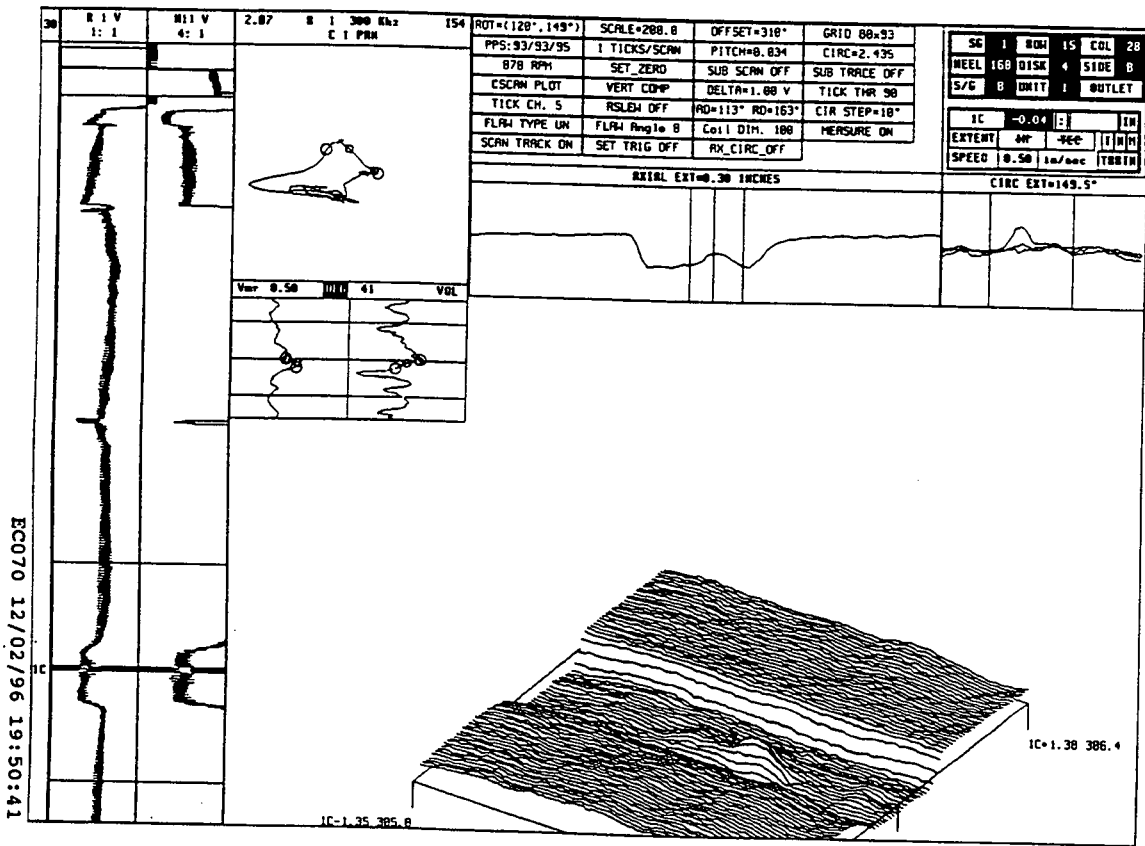
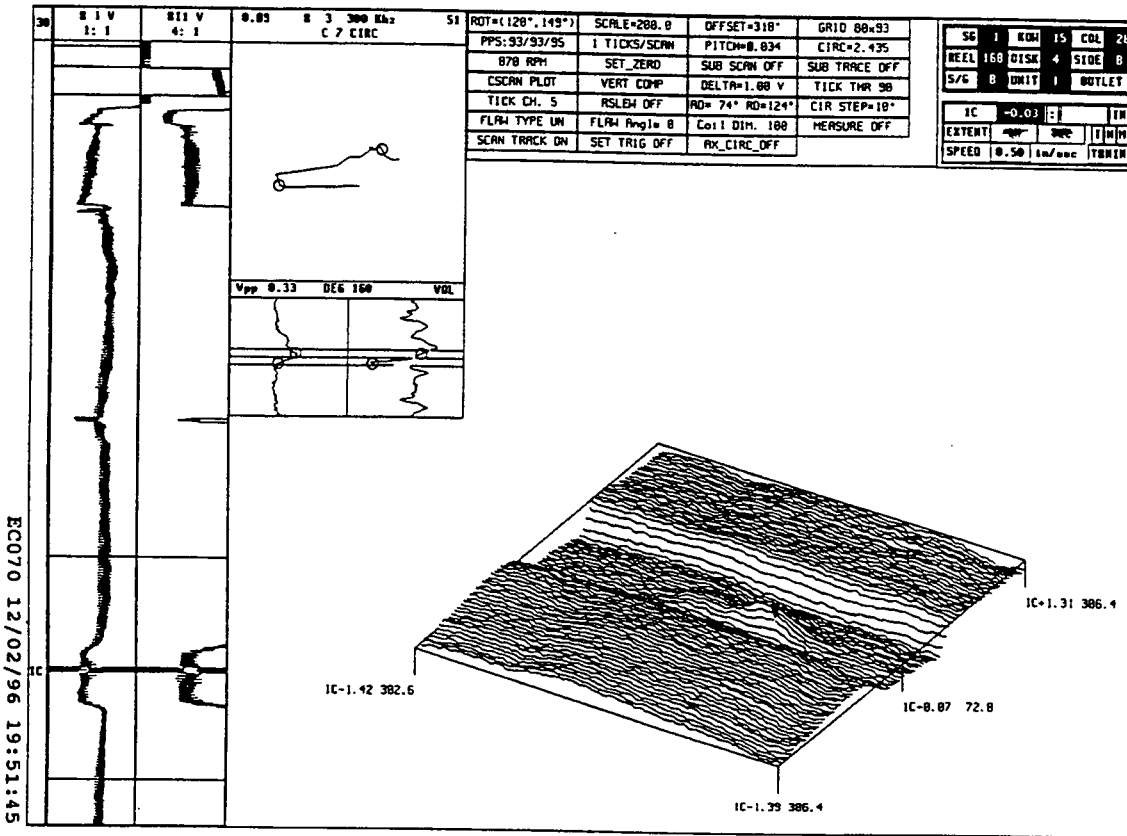
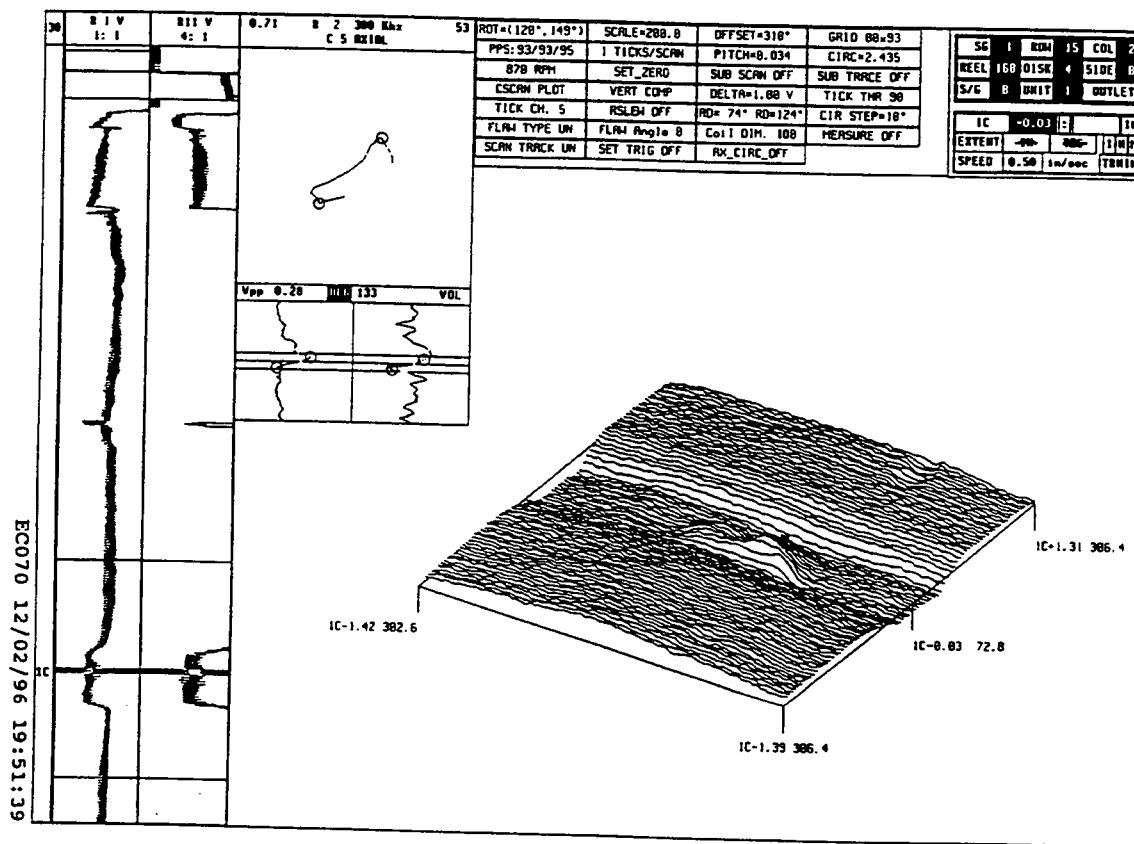
The field EC test data for the first tube support plate crevice region of Tube R15C28 are shown in Figures 2-36 through 2-39. They were obtained using the bobbin, as well as the pancake coil, the circumferentially sensitive coil, and the axially sensitive coil of the 3-coil probe. The bobbin probe showed a 1.14 Vpp indication, less than 20% deep. The 3-coil probe revealed a 0.50 Vpp volumetric indication, extending over a distance of 0.30 inch axially and 150° circumferentially. The responses of the axially sensitive and circumferentially sensitive coils were approximately equal, shallow, and non-quantifiable.

Figure 2-36 TSP1 (first tube support plate) crevice region of Tube R15C28. Field bobbin probe eddy current test data.

Figure 2-37 TSP1 crevice region of Tube R15C28. Field 3-coil MRPC probe pancake coil eddy current test data.

Figure 2-38 TSP1 crevice region of Tube R15C28. Field 3-coil MRPC probe circumferentially sensitive coil eddy current test data.

Figure 2-39 TSP1 crevice region of Tube R15C28. Field 3-coil MRPC probe axially sensitive coil eddy current test data.

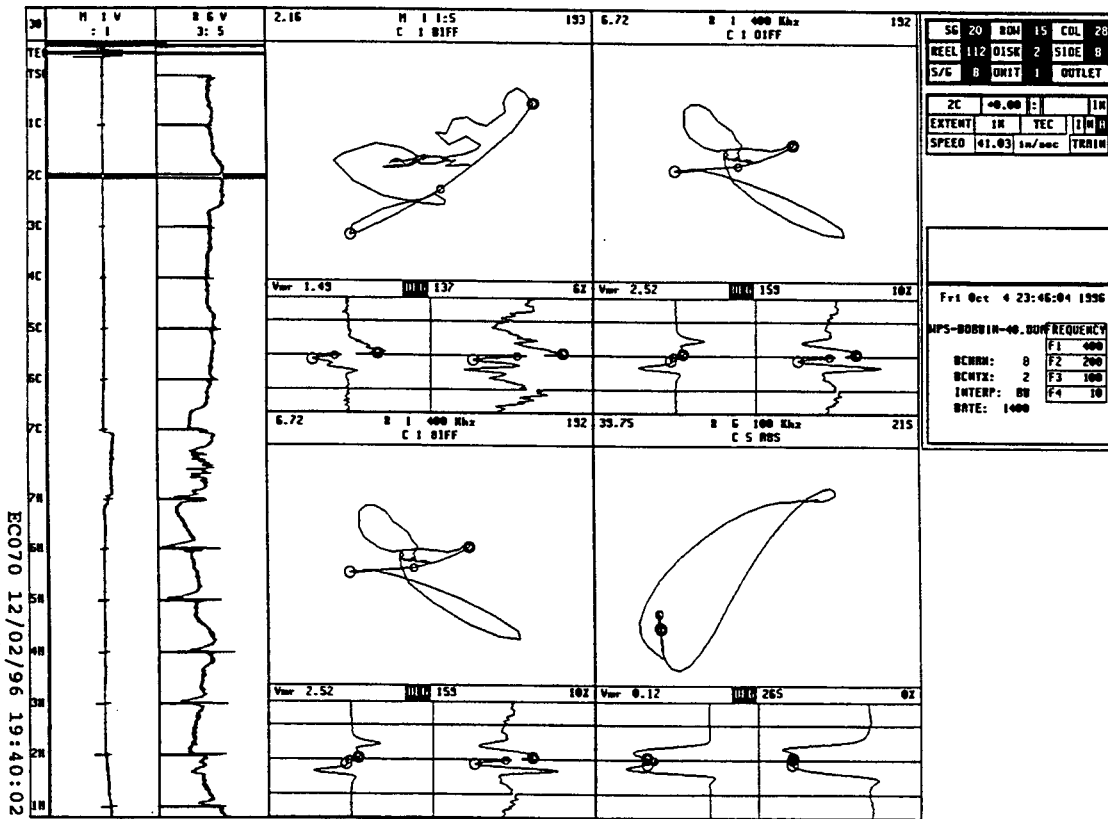
Figures 2-40 through 2-43 show the field EC test data for the second tube support plate crevice region of Tube R15C28. The bobbin probe showed a 1.49 Vpp indication, less than 20% deep. The 3-coil probe revealed a 0.11 Vpp volumetric indication, extending over a distance of 0.30 inch axially and 193° circumferentially. Again, the responses of the axially sensitive and circumferentially sensitive coils were approximately equal, shallow, and non-quantifiable.

Figure 2-40 TSP2 (second tube support plate) crevice region of Tube R15C28. Field bobbin probe eddy current test data.

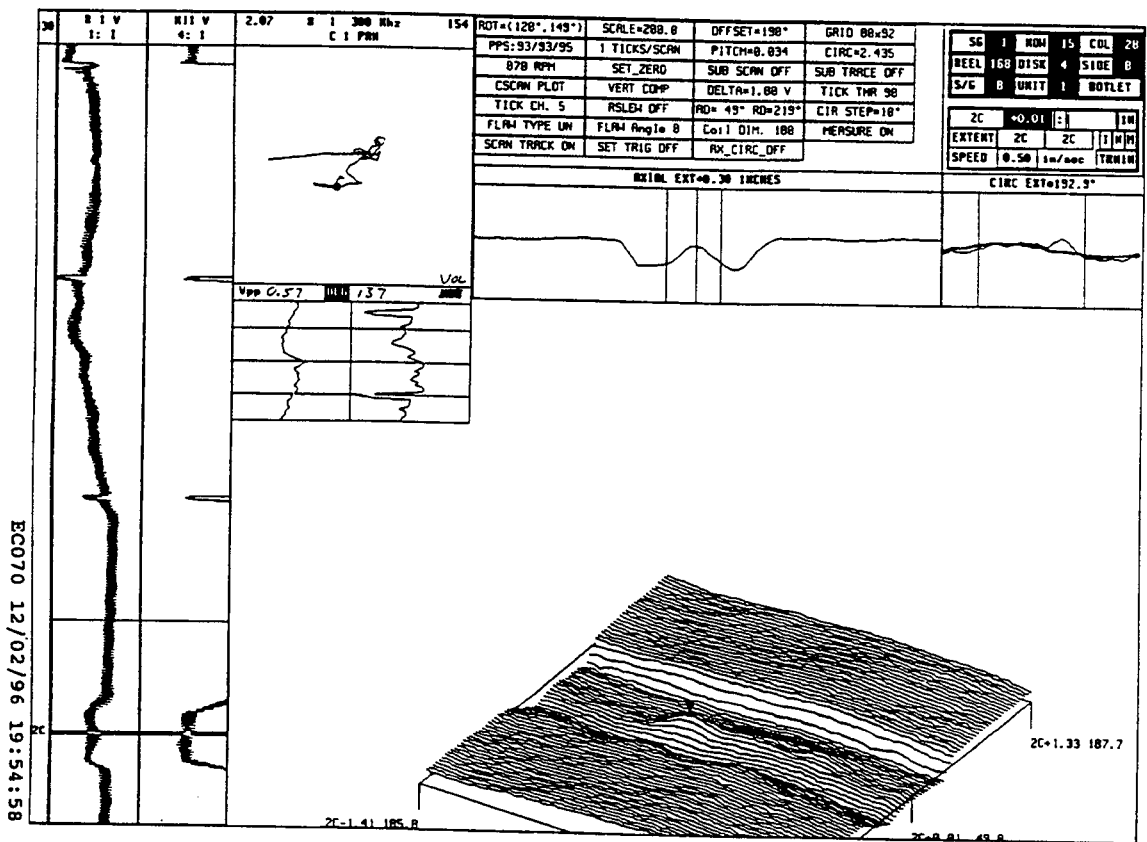
Figure 2-41 TSP2 crevice region of Tube R15C28. Field 3-coil MRPC probe pancake coil eddy current test data.

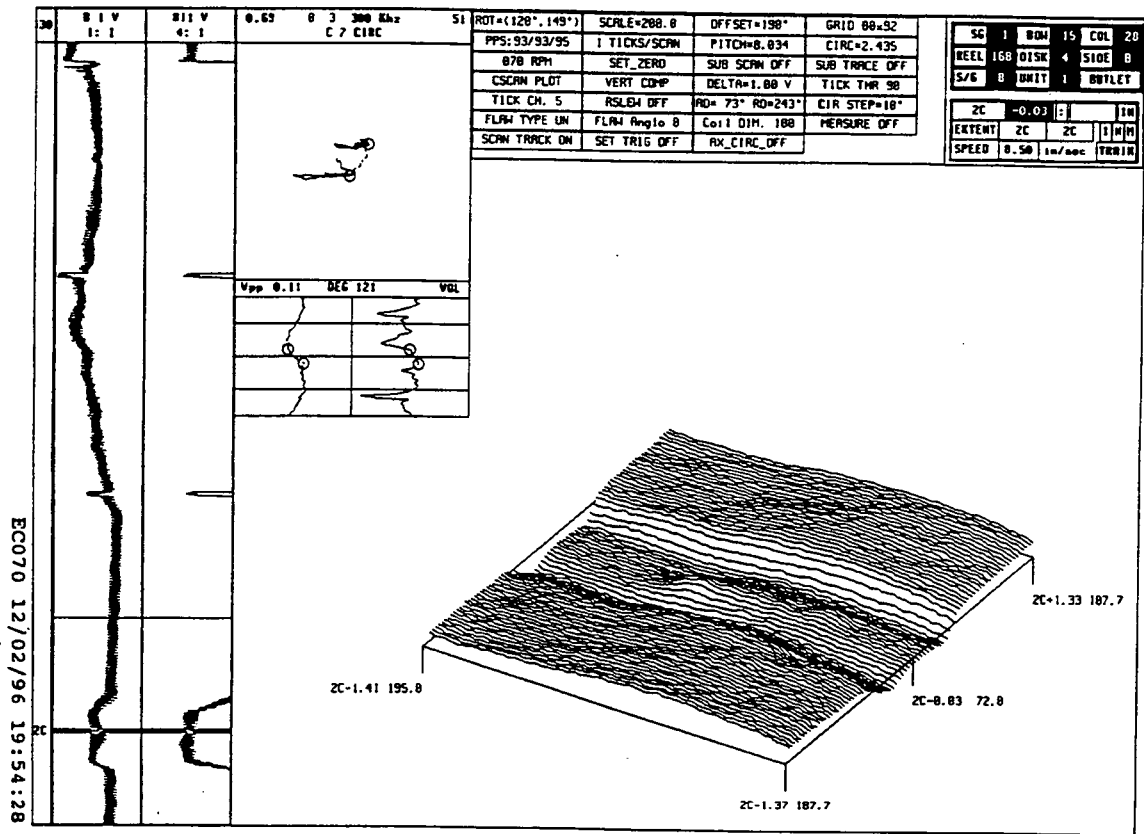
Figure 2-42 TSP2 crevice region of Tube R15C28. Field 3-coil MRPC probe circumferentially sensitive coil eddy current test data.
