Examination of Kewaunee Cold Leg Steam Generator Tube R15C28

P. Kuchirka*, A. Madeyski, and M. Blaszkiewicz

May 8, 1997

The first and second tube support plate crevice regions of cold leg Tube R15C28 from Steam Generator B of Kewaunee were examined by nondestructive and destructive examination techniques. Shallow, but extensively distributed, OD-origin intergranular corrosion was found contained in the tube support plate crevice regions of the mill annealed Alloy 600 tubing.

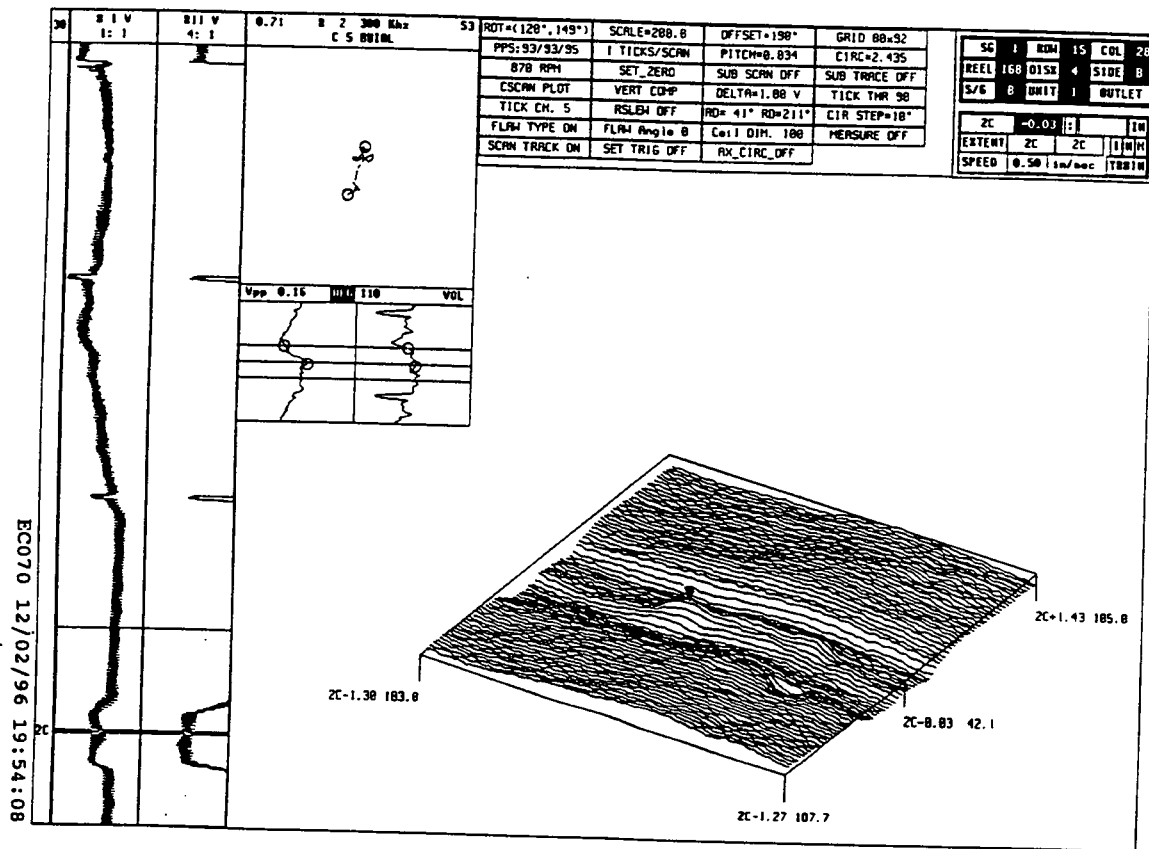
Figures 2-40 through 2-43 show the field EC test data for the second tube support plate crevice region of Tube R15C28. The bobbin probe showed a 1.49 Vpp indication, less than 20% deep. The 3-coil probe revealed a 0.11 Vpp volumetric indication, extending over a distance of 0.30 inch axially and 193° circumferentially. Again, the responses of the axially sensitive and circumferentially sensitive coils were approximately equal, shallow, and non-quantifiable.

Figure 2-43 TSP2 crevice region of Tube R15C28. Field 3-coil MRPC probe axially sensitive coil eddy current test data.

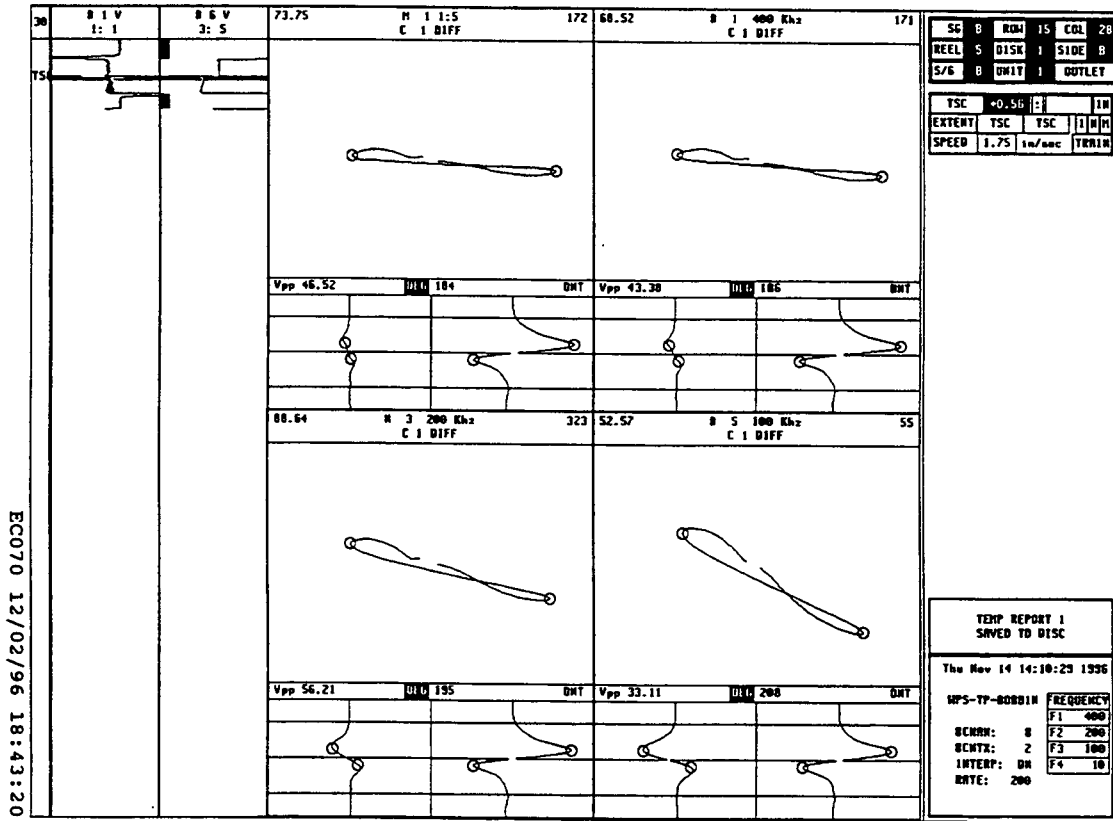
The laboratory EC test data for the tubesheet top region of Tube R15C28 are shown in Figures 2-44 through 2-47. The data were obtained with a bobbin probe, 3-coil probe pancake coil, + Point probe, and Cecco 5 probe. The bobbin probe indicated a 46.52

Figure 2-44 TST (tubesheet top) region of Tube R15C28. Laboratory bobbin probe eddy current test data.

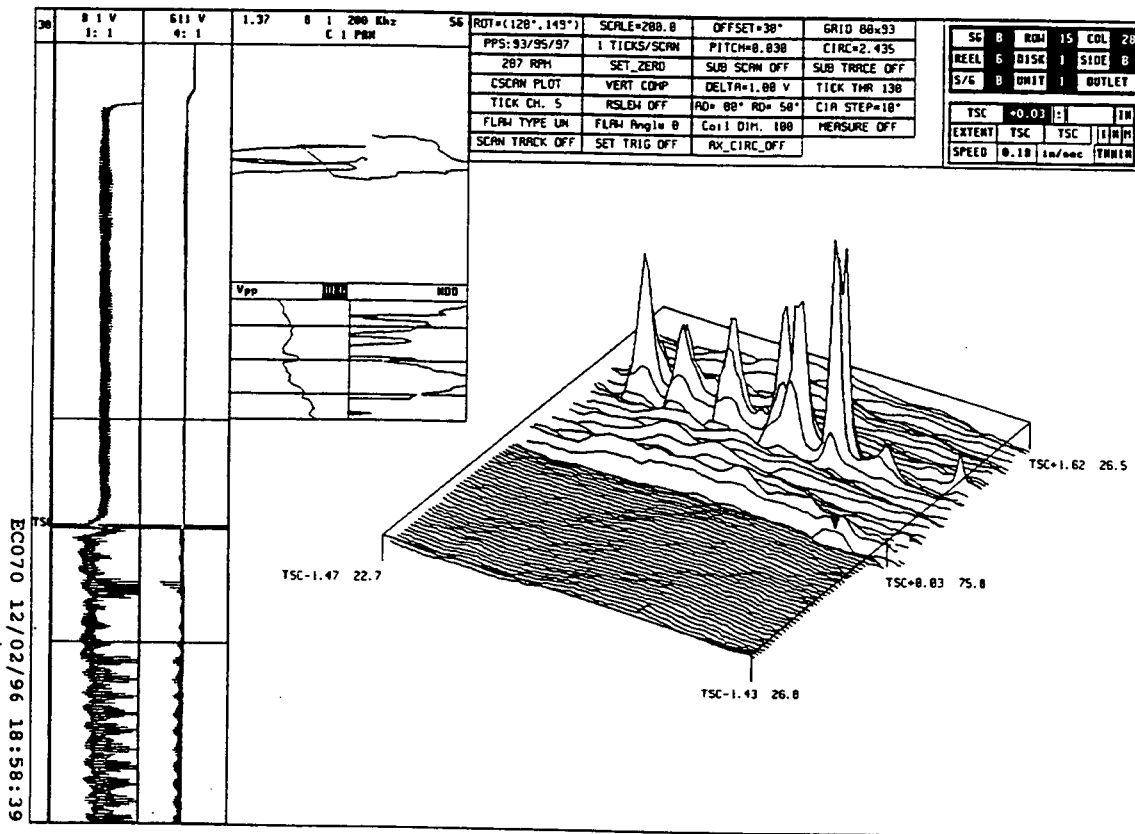
Figure 2-45 TST region of Tube R15C28. Laboratory 3-coil MRPC probe pancake coil eddy current test data, showing only numerous lift-off signals.

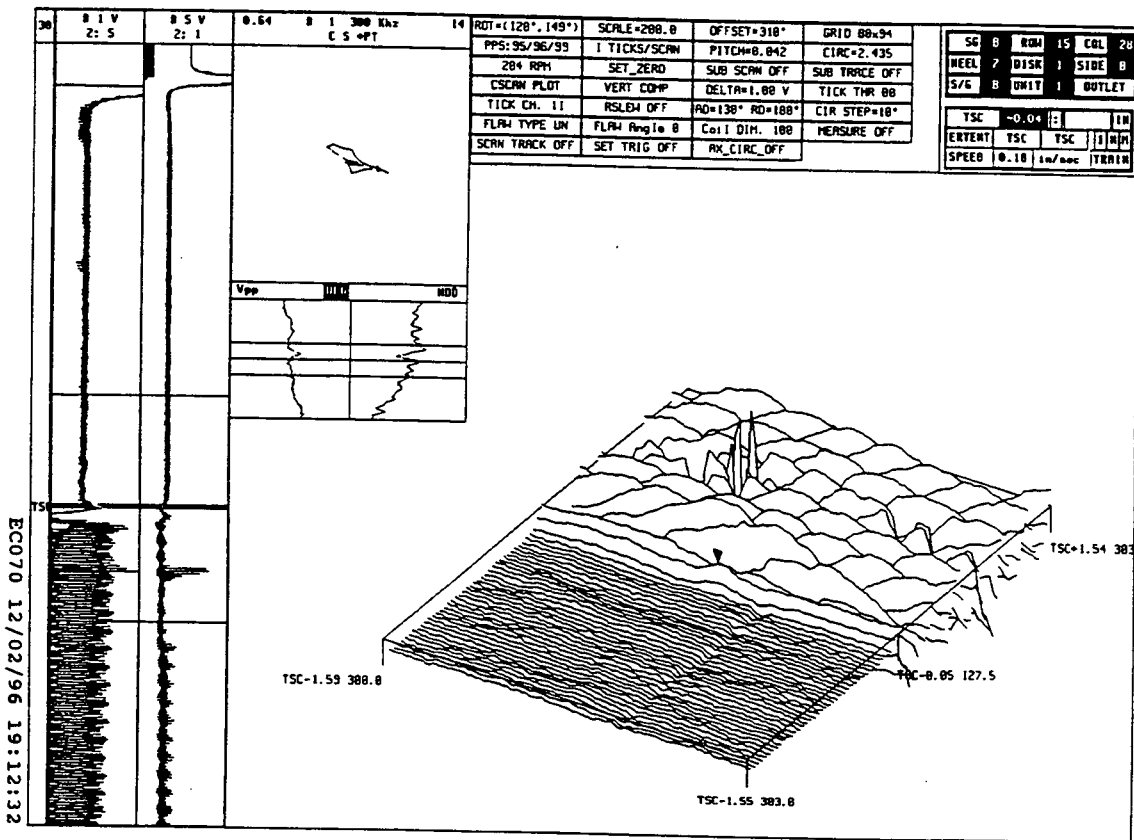
Figure 2-46 TST region of Tube R15C28. Laboratory +Point probe eddy current test data, showing only a few lift-off signals.

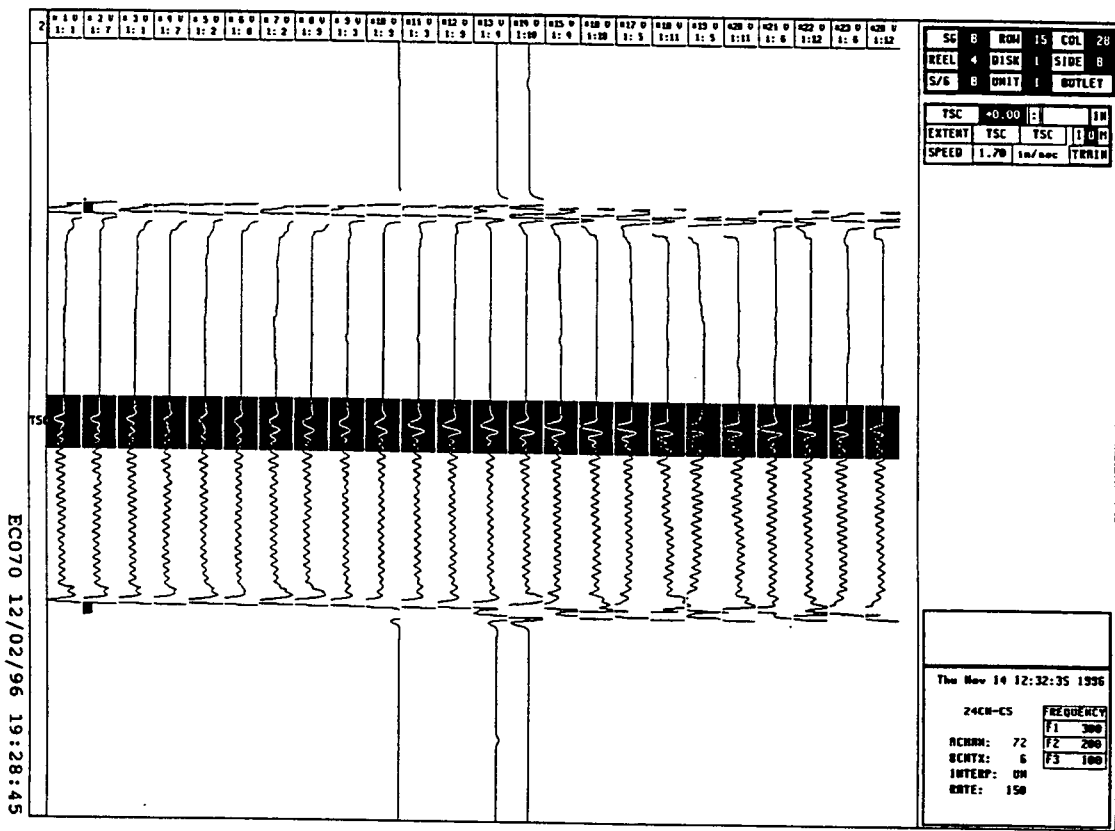
Figure 2-47 TST region of Tube R15C28. Laboratory Cecco 5 probe eddy current test data strip chart.

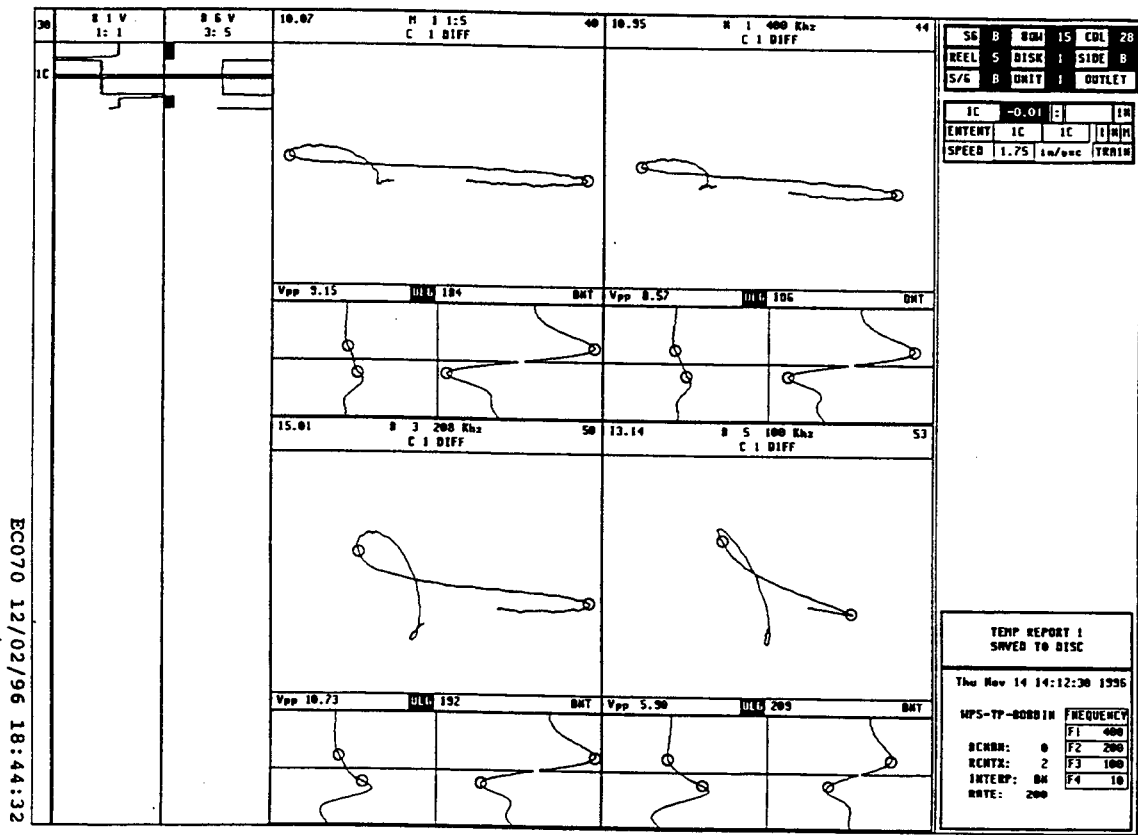
Figures 2-48 through 2-55 show the laboratory EC test data for the first tube support plate crevice region of Tube R15C28. The bobbin test results, illustrated in Figures 2-48 and 2-49, showed a 2.14 Vpp distorted indication in a 9.15 Vpp dent. The 3-coil test data revealed a 0.56 Vpp volumetric indication, extending over a distance of 0.57 inch axially and 140° circumferentially. Two relatively large, localized dent signals (not present in the field) are clearly visible in Figures 2-50, and 2-51. There was an approximately equal response on the axially and circumferentially sensitive coils of the 3-coil probe. The + Point probe data, Figure 2-53, showed one region of nominally axial indication, 0.15 Vpp, spanning about 100°. The signal did not have a distinctive volumetric character, and was shallow. The Cecco 5 test data, presented as Lissajous patterns in Figure 2-54, and a strip chart in Figure 2-55, showed possible indications over about 105° of tube circumference, with an estimated depth of less than 20% of the wall.

Figure 2-48 TSP1 (first tube support plate) crevice region of Tube R15C28. Laboratory bobbin probe eddy current test data, showing a dent signal.

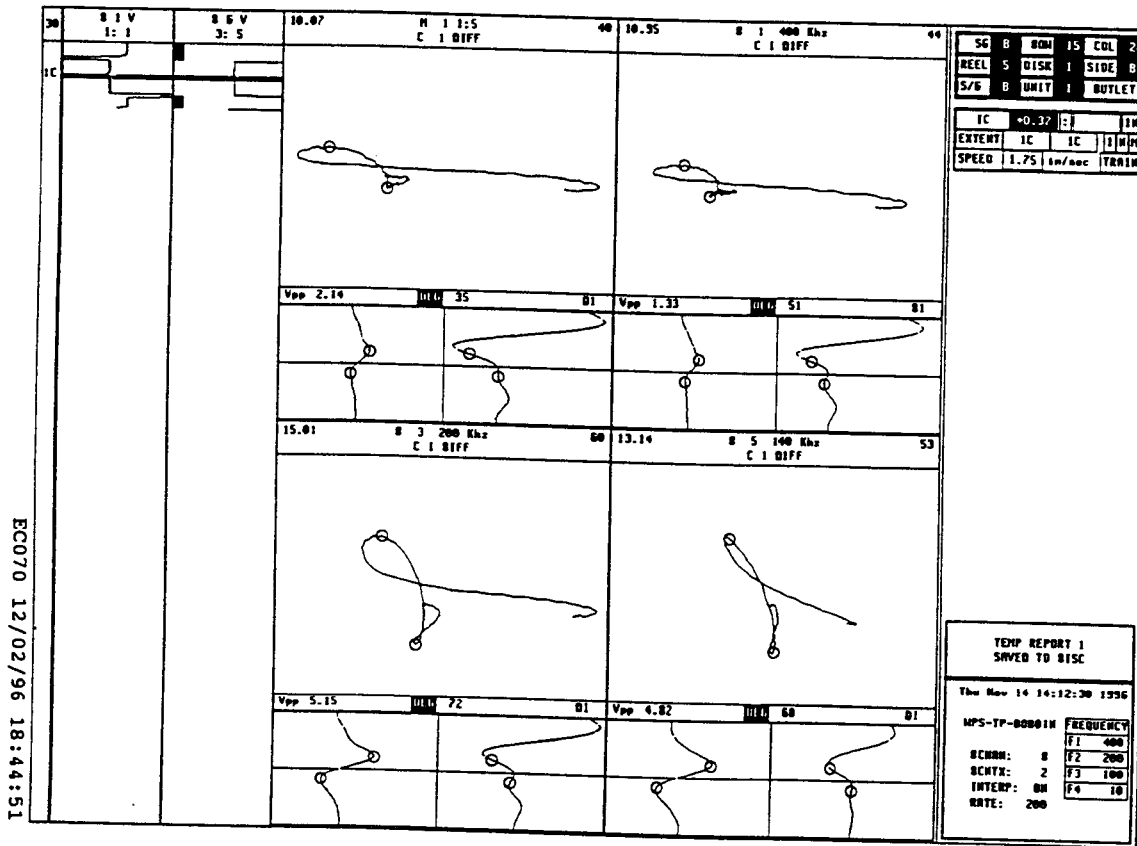
Figure 2-49 TSP1 crevice region of Tube R15C28. Laboratory bobbin probe eddy current test data, showing a distorted indication in the previous dent signal.

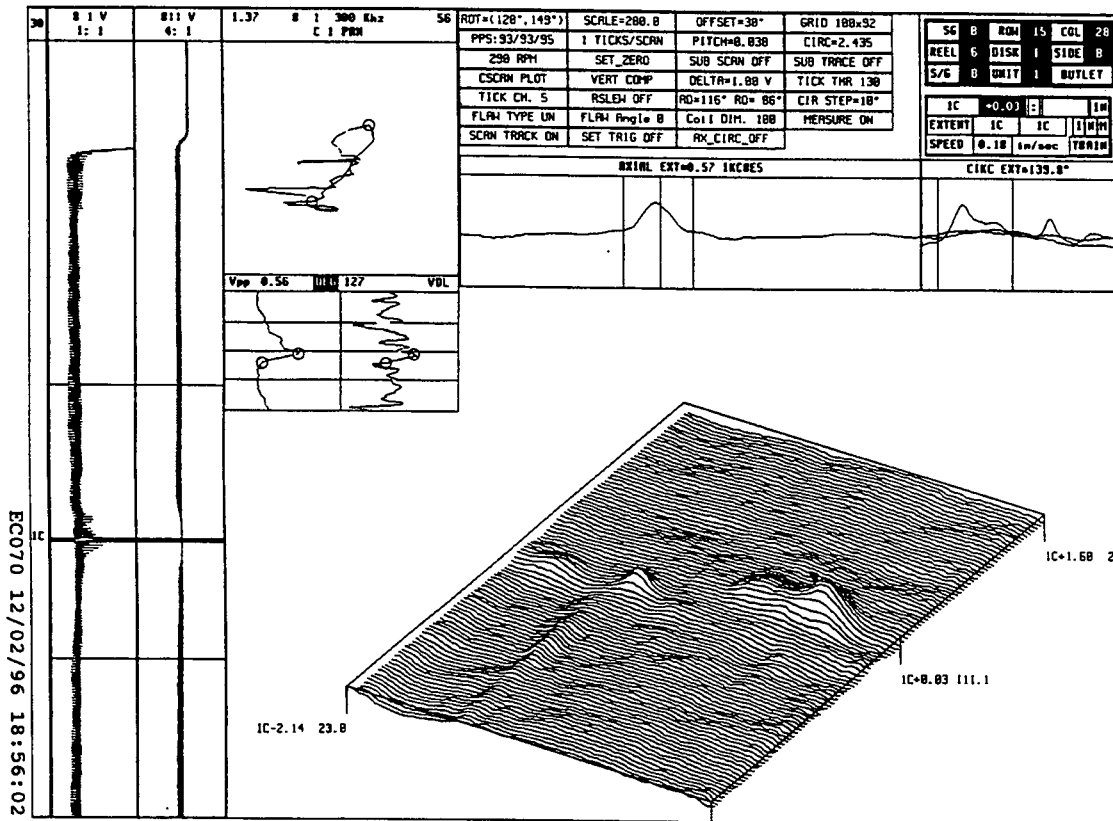
Figure 2-50 TSP1 crevice region of Tube R15C28. Laboratory 3-coil probe pancake coil eddy current test data.

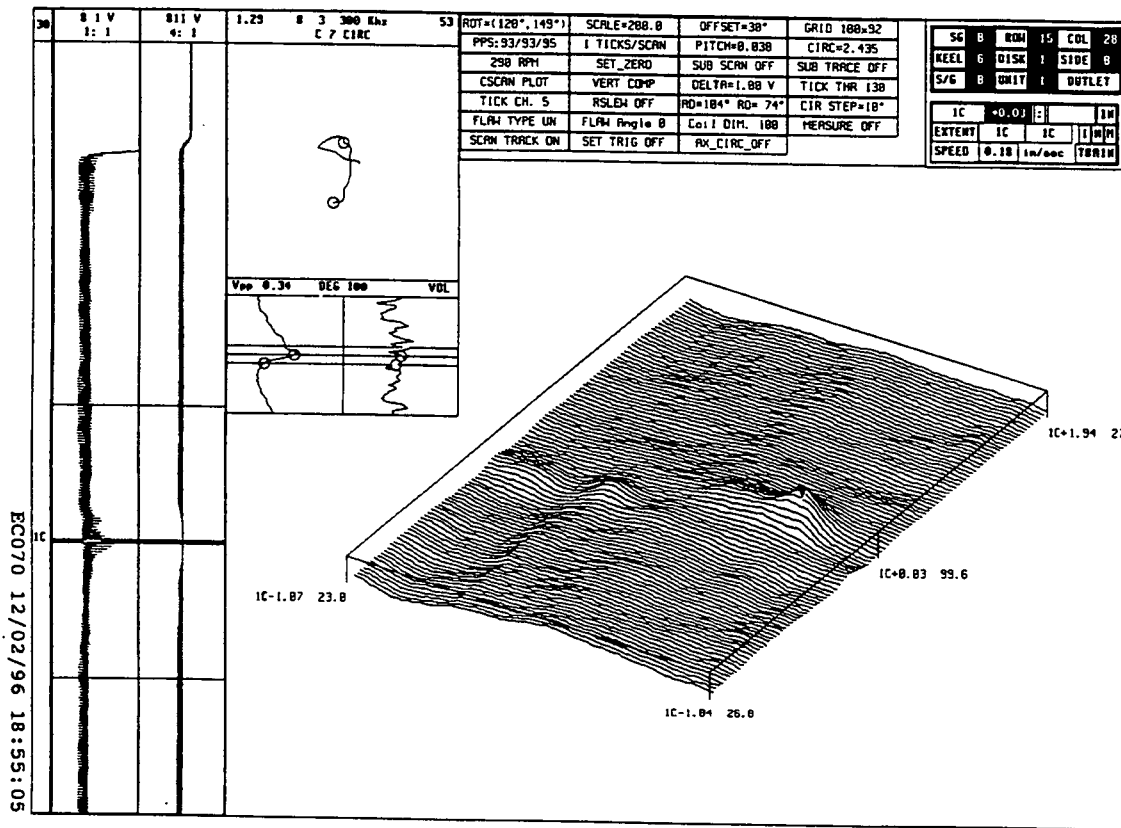
Figure 2-51 TSP1 crevice region of Tube R15C28. Laboratory 3-coil probe circumferentially sensitive coil eddy current test data.

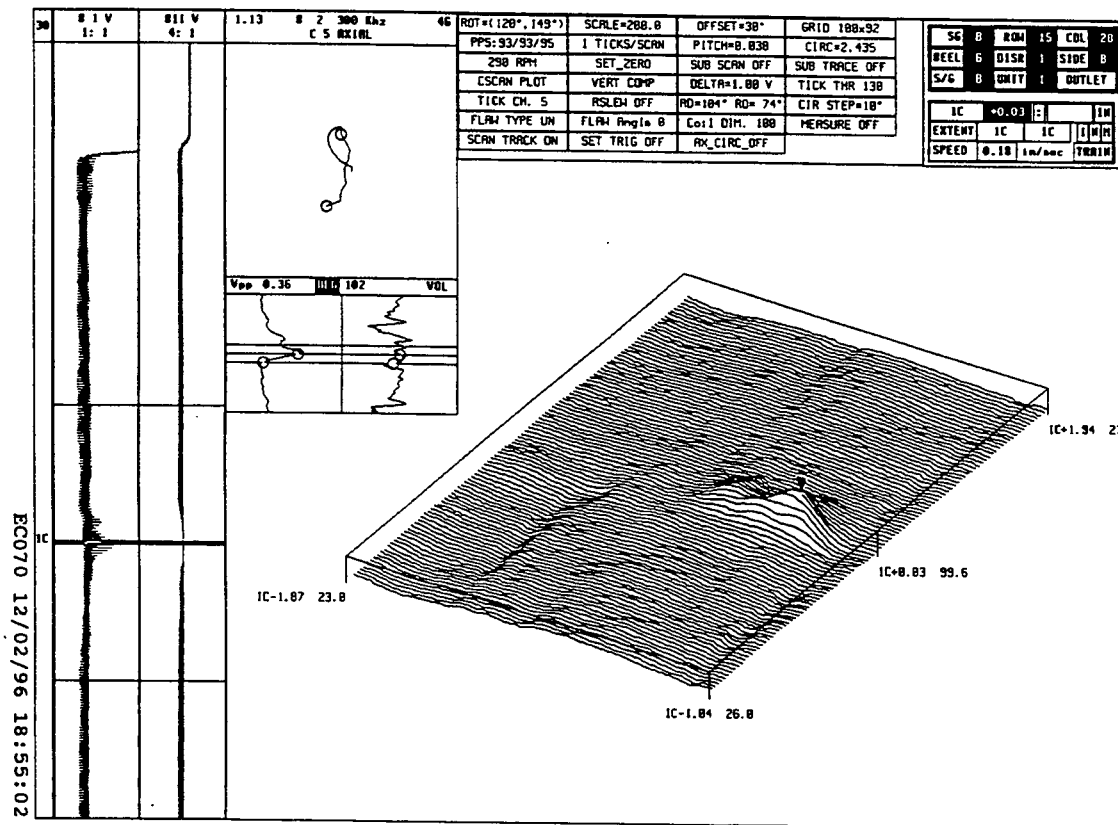
Figure 2-52 TSP1 crevice region of Tube R15C28. Laboratory 3-coil probe axially sensitive coil eddy current test data.

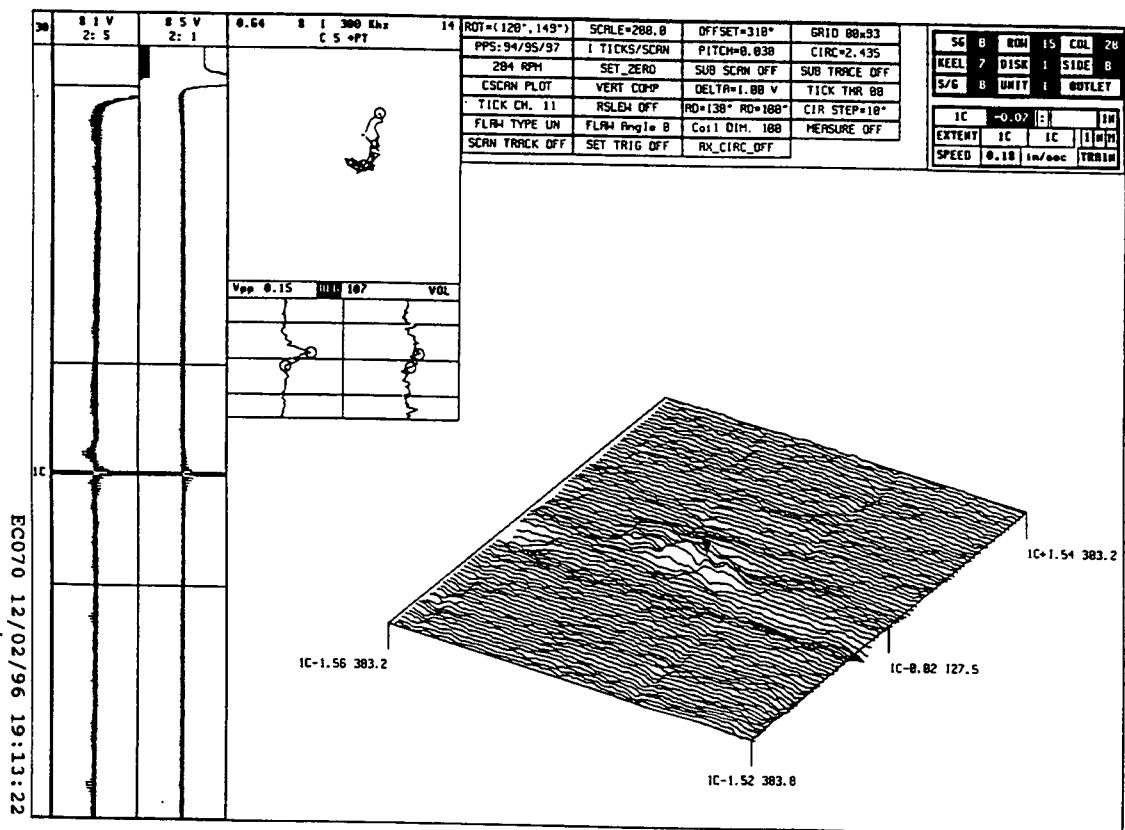
Figure 2-53 TSP1 crevice region of Tube R15C28. Laboratory +Point probe eddy current test data.

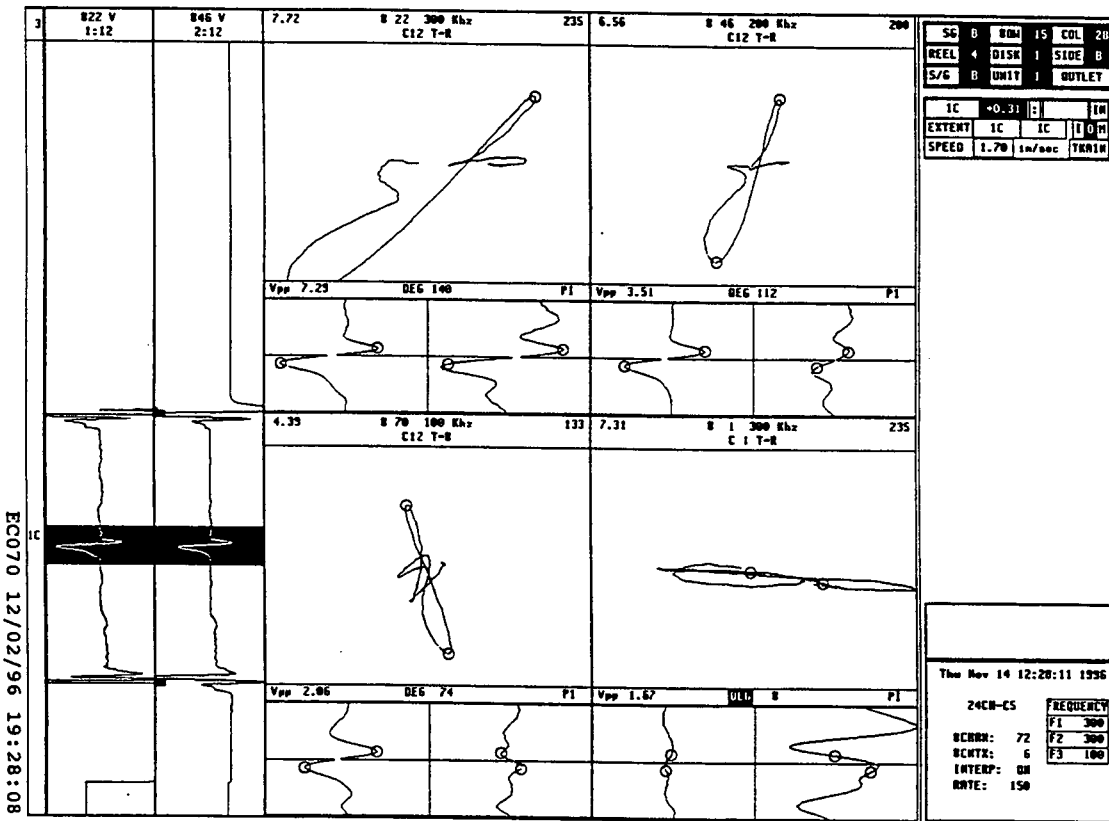
Figure 2-54 TSP1 crevice region of Tube R15C28. Laboratory Cecco 5 probe eddy current test data Lissajous patterns.

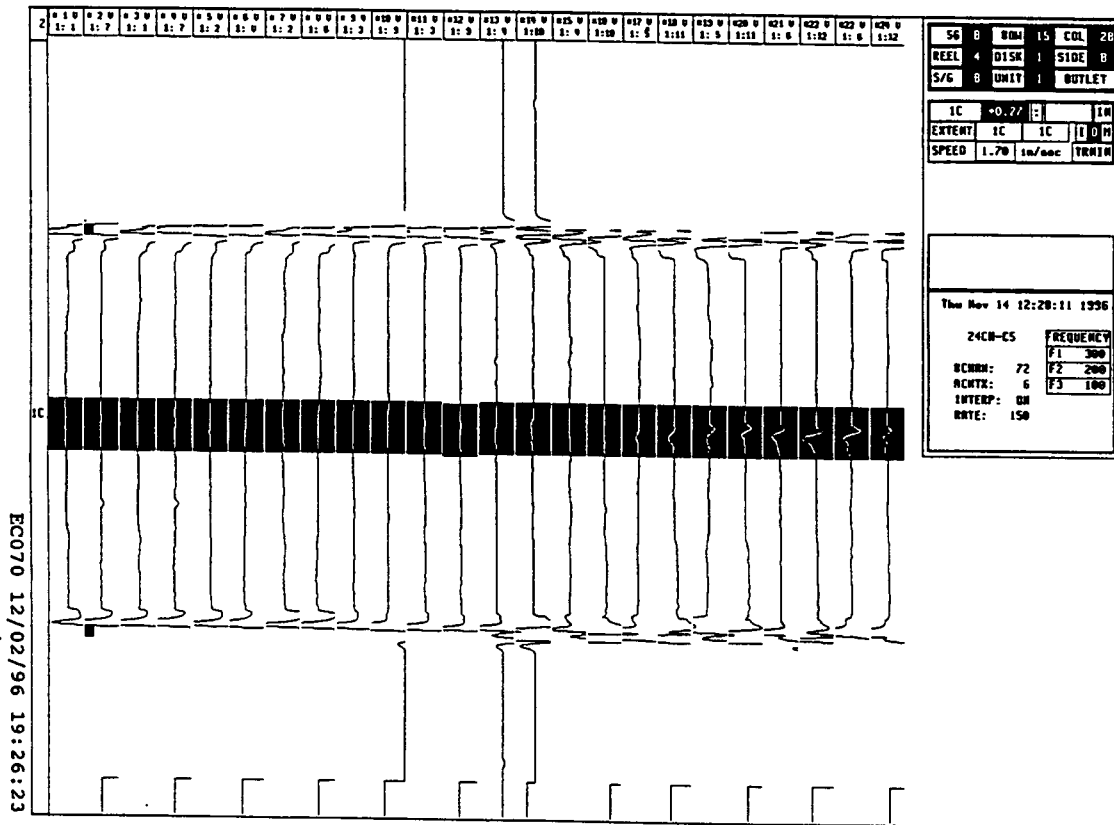
Figure 2-55 TSP1 crevice region of Tube R15C28. Laboratory Cecco 5 probe eddy current test data strip chart.

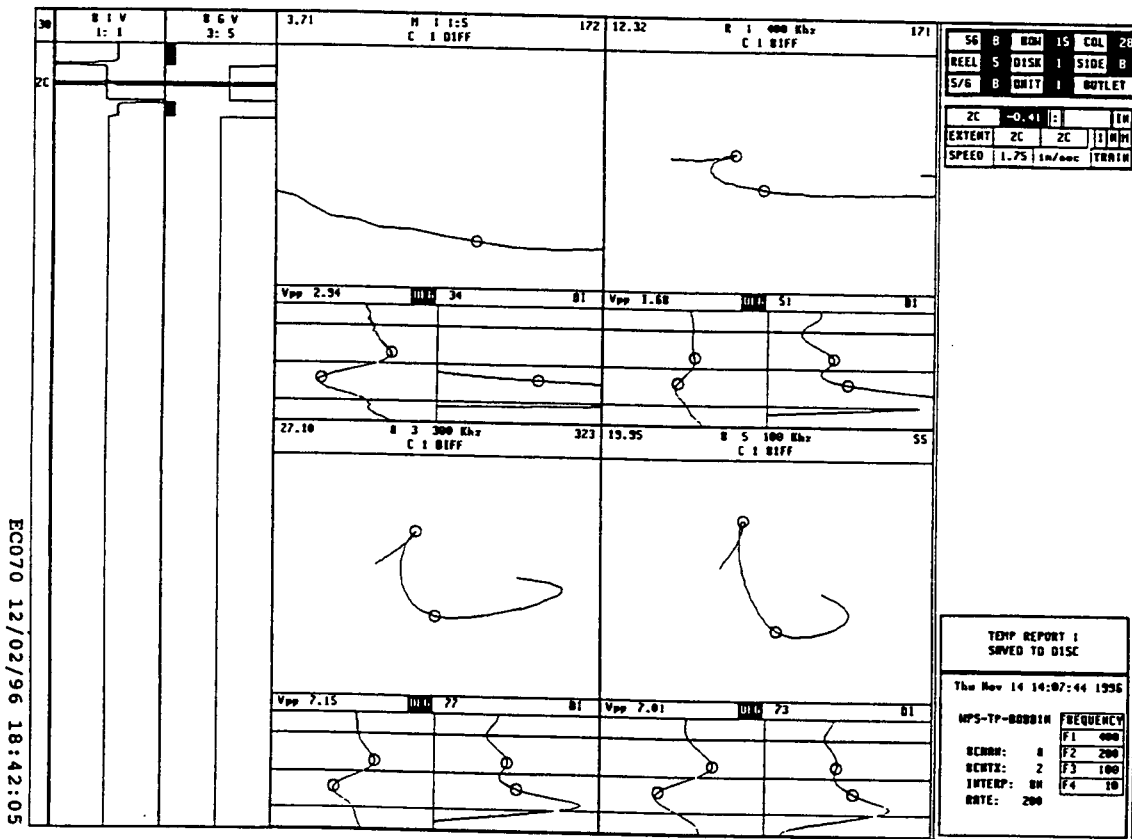
The laboratory EC test data for the second tube support plate crevice region of Tube R15C28 are shown in Figures 2-56 through 2-64. The bobbin probe, Figures 2-56 and 2-57, showed a 2.94 Vpp indication distorted by a 23.37 Vpp dent. The 3-coil probe data, obtained by the pancake coil, (Figure 2-58), circumferentially sensitive coil (Figure 2-59), and axially sensitive coil (Figure 2-60), showed a 0.45 Vpp volumetric indication, with a 0.45 inch x 240° extent. Four relatively large dent indications (not present in the field) are clearly visible in the above figures. There was approximately equal response on the circumferentially and axially sensitive coils (shallow indications). The + Point probe, Figures 2-61 and 2-62, revealed two regions of nominally axial indications, 0.13 Vpp and 0.12 Vpp, spanning about 240°, but shallow, with no distinctive volumetric character. Figures 2-63 and 2-64 present the Cecco 5 probe data, which showed two regions of possible indications over about 90° and 45° of circumference, with a 30° region without indications in between. The estimated depth was 30%.

Figure 2-57 TSP2 crevice region of Tube R15C28. Laboratory bobbin probe eddy current test data, showing a distorted indication in the previous dent signal.

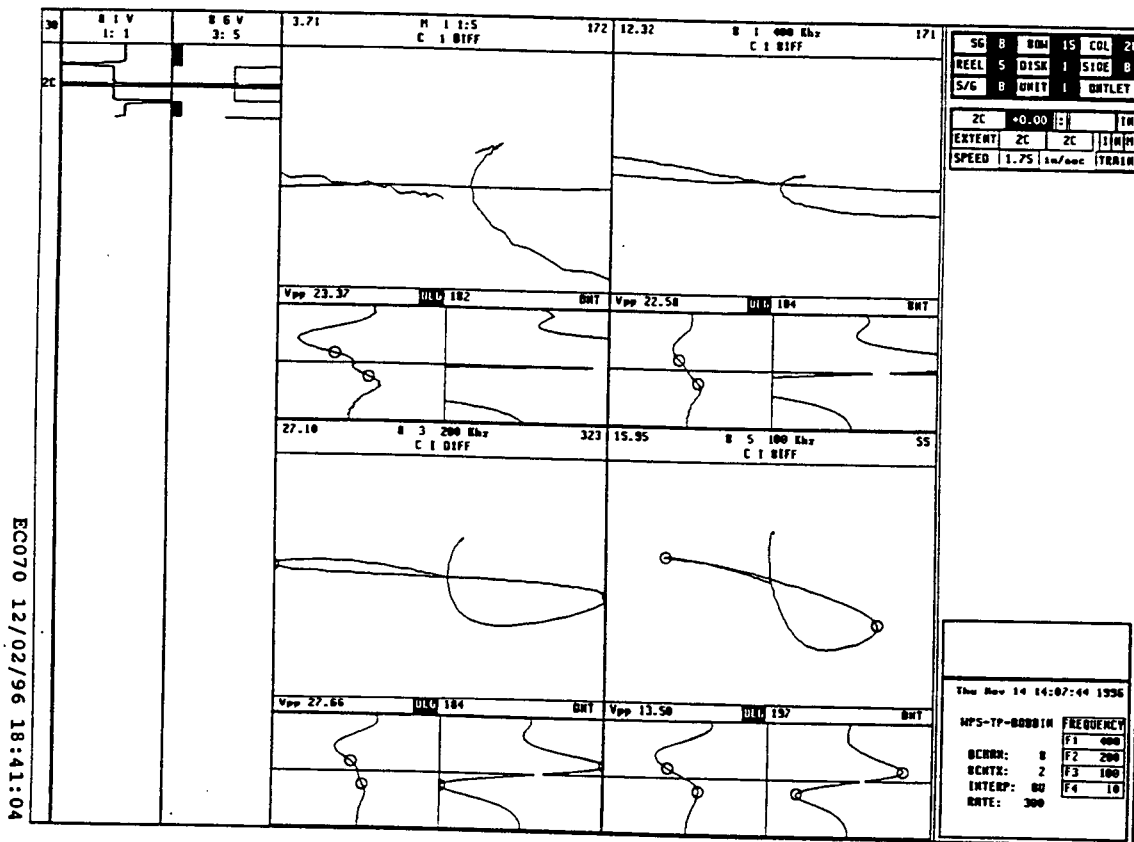
Figure 2-56 TSP2 (second tube support plate) crevice region of Tube R15C28. Laboratory bobbin probe eddy current test data, showing a dent signal.

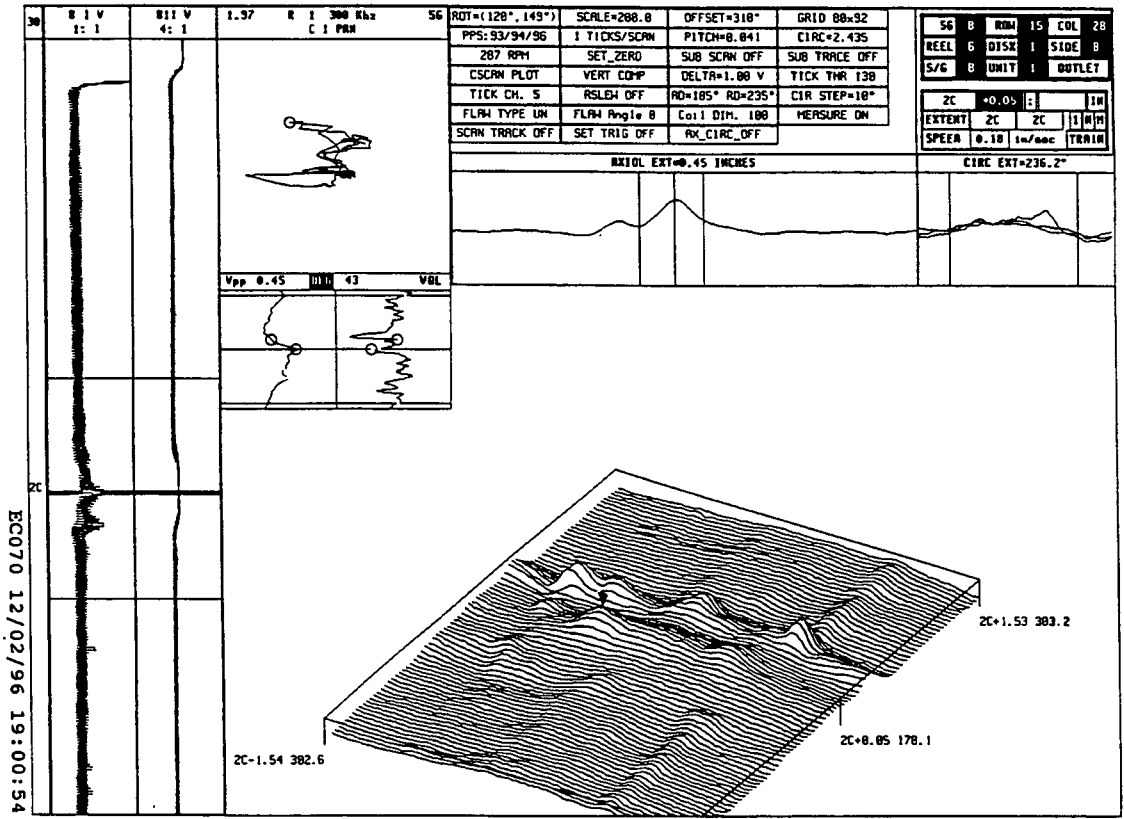
Figure 2-58 TSP2 crevice region of Tube R15C28. Laboratory 3-coil probe pancake coil eddy current test data.

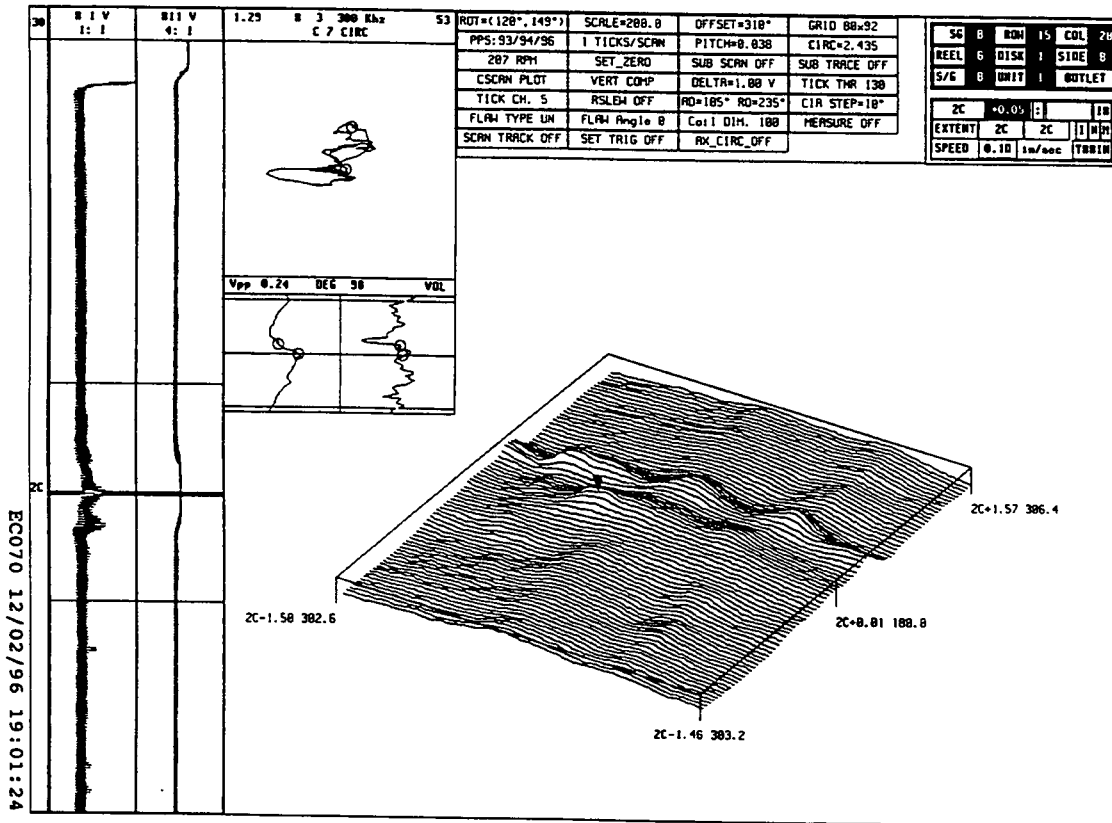
Figure 2-59 TSP2 crevice region of Tube R15C28. Laboratory 3-coil probe circumferentially sensitive coil eddy current test data.

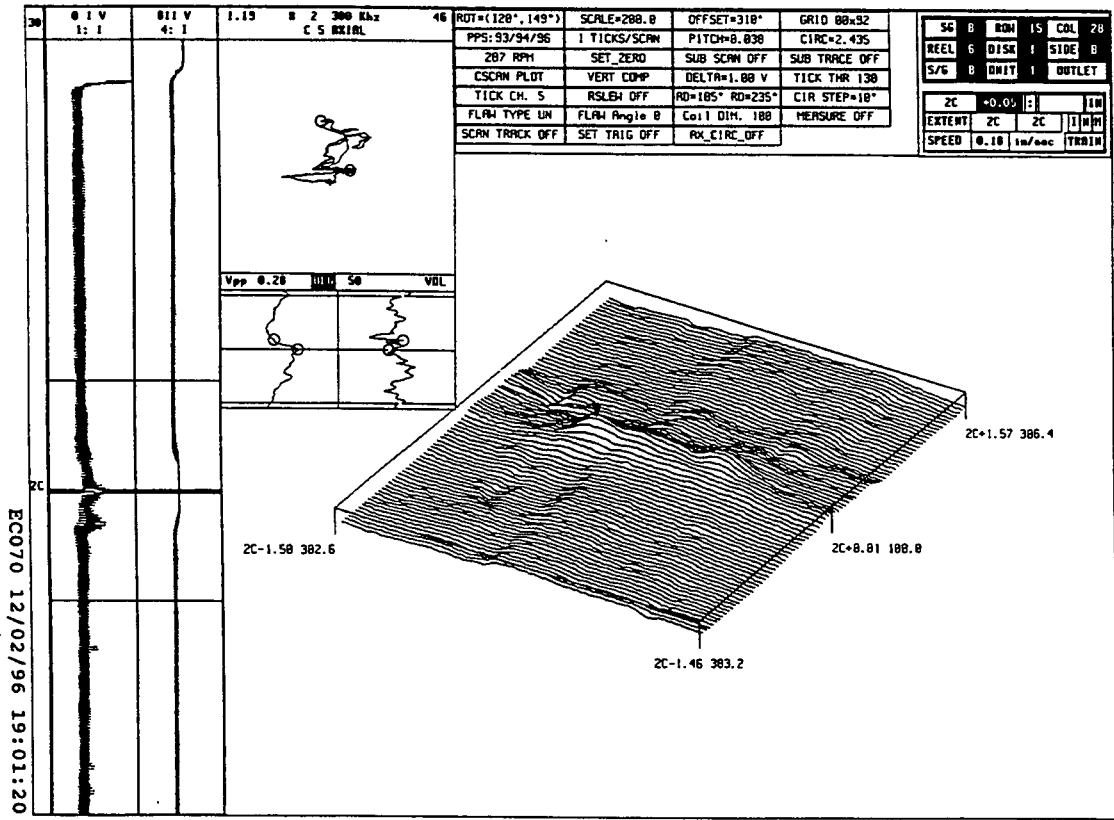
Figure 2-60 TSP2 crevice region of Tube R15C28. Laboratory 3-coil probe axially sensitive coil eddy current test data.

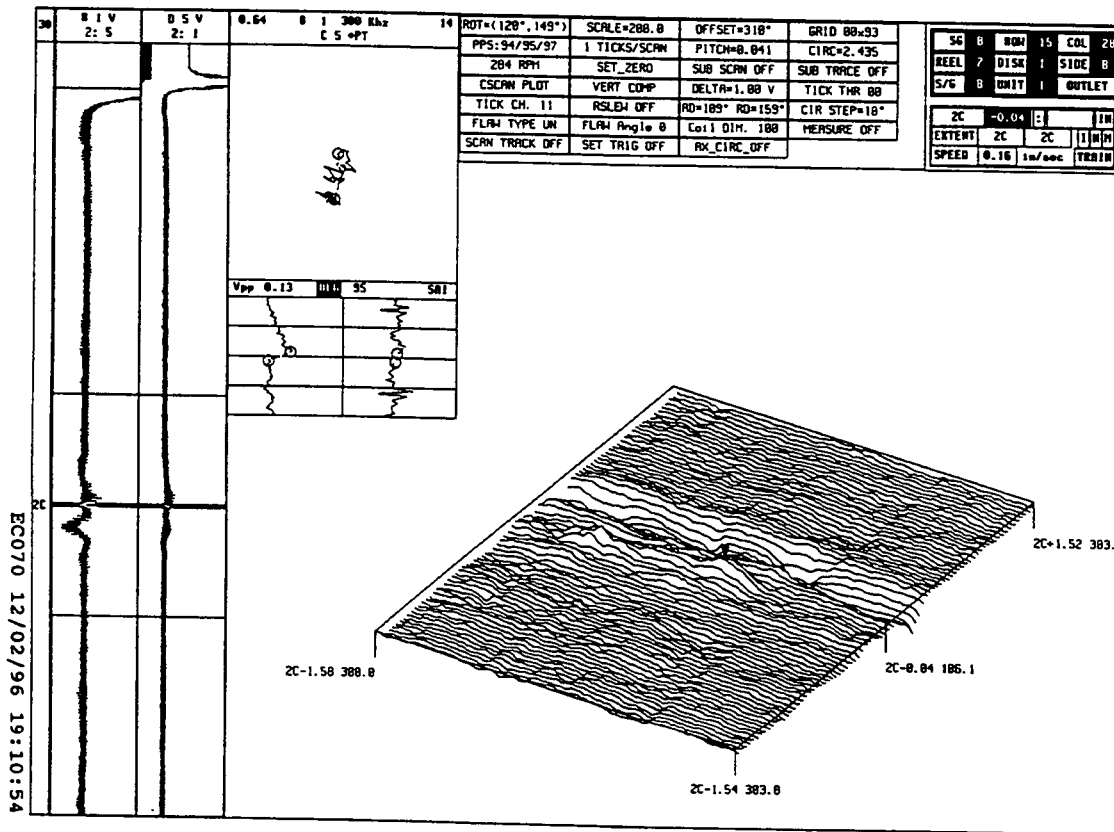
Figure 2-61 TSP2 crevice region of Tube R15C28. Laboratory +Point probe eddy current test data.

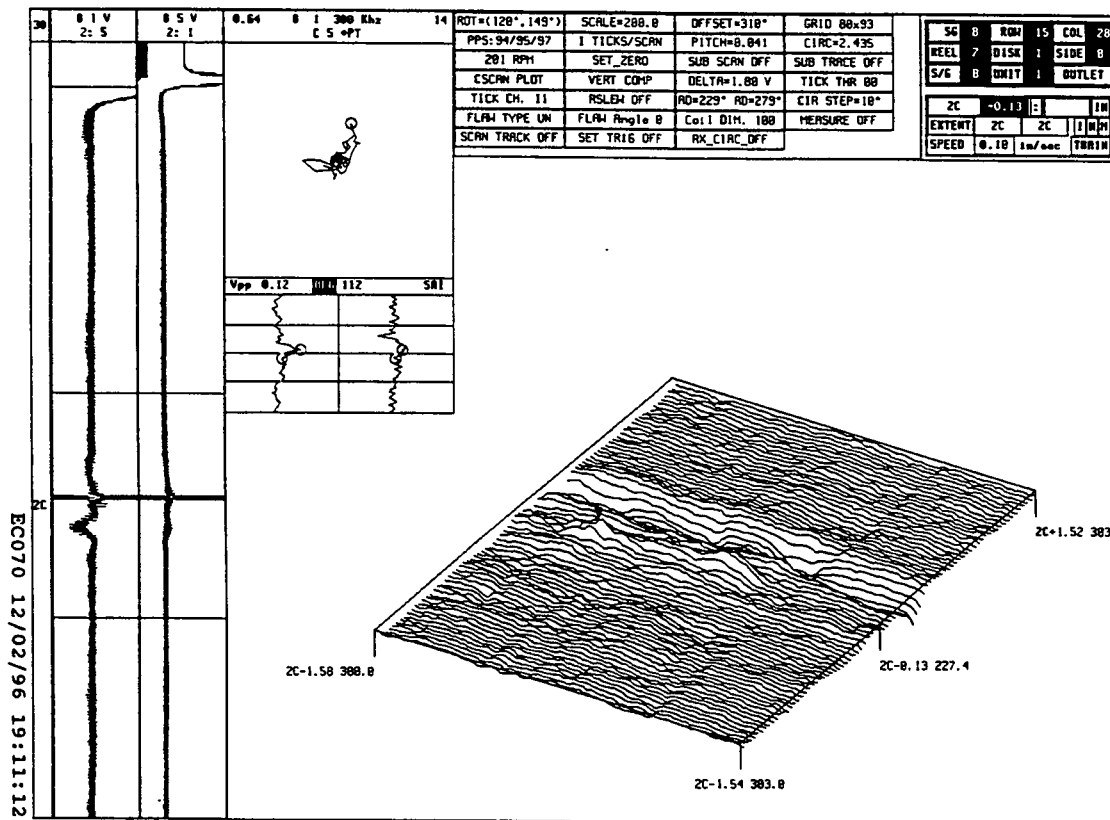
Figure 2-62 TSP2 crevice region of Tube R15C28. Laboratory +Point probe eddy current test data.

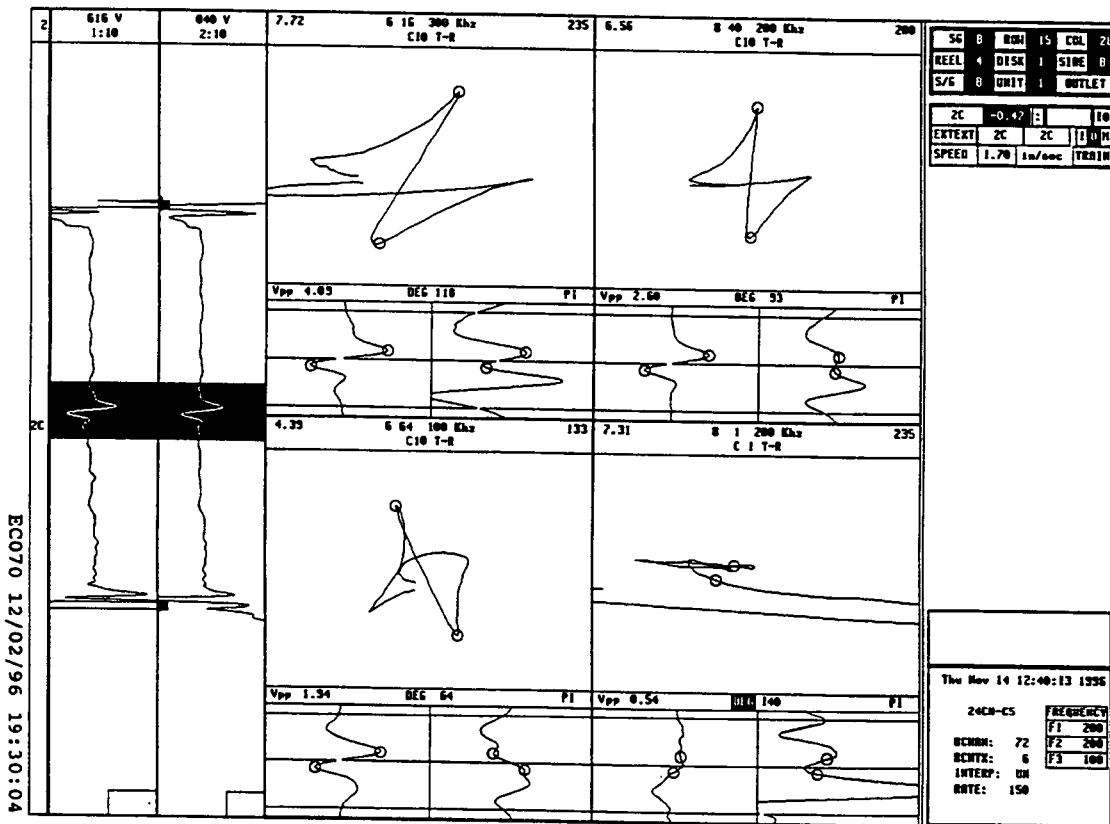
Figure 2-63 TSP2 crevice region of Tube R15C28. Laboratory Cecco 5 probe eddy current test data Lissajous patterns.

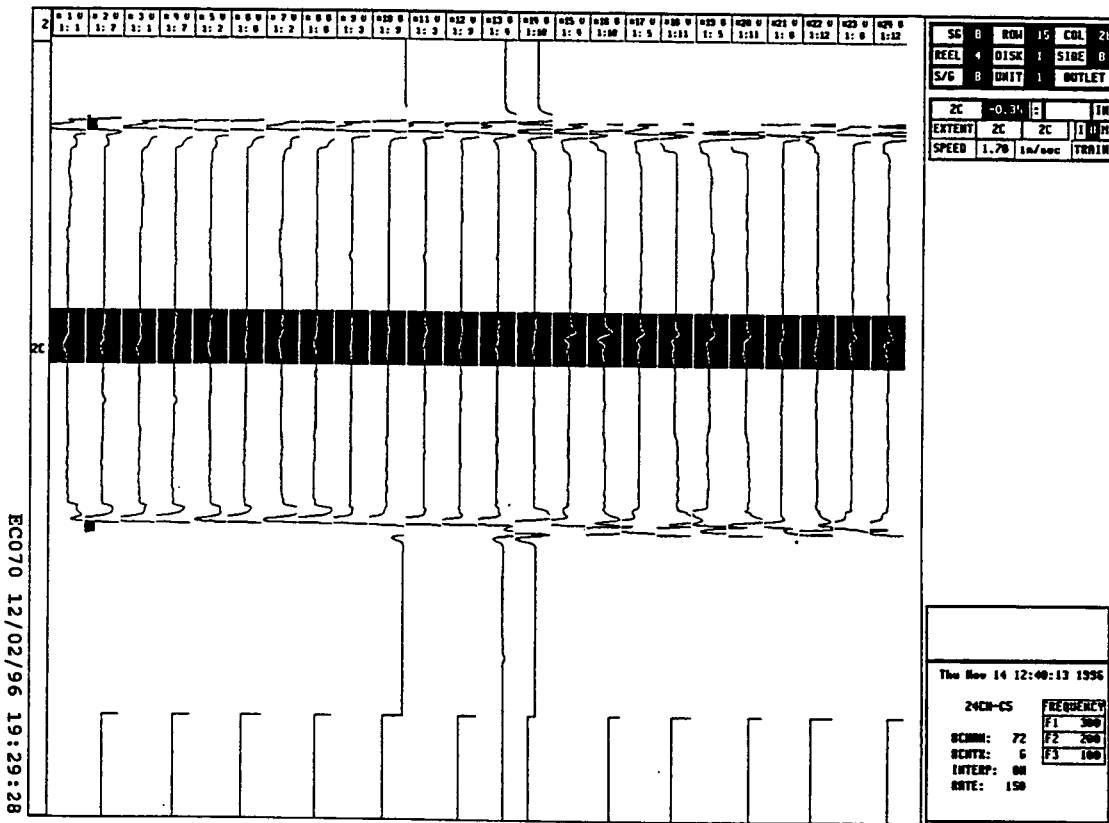
Figure 2-64 TSP2 crevice region of Tube R15C28. Laboratory Cecco 5 probe eddy current test data strip chart.

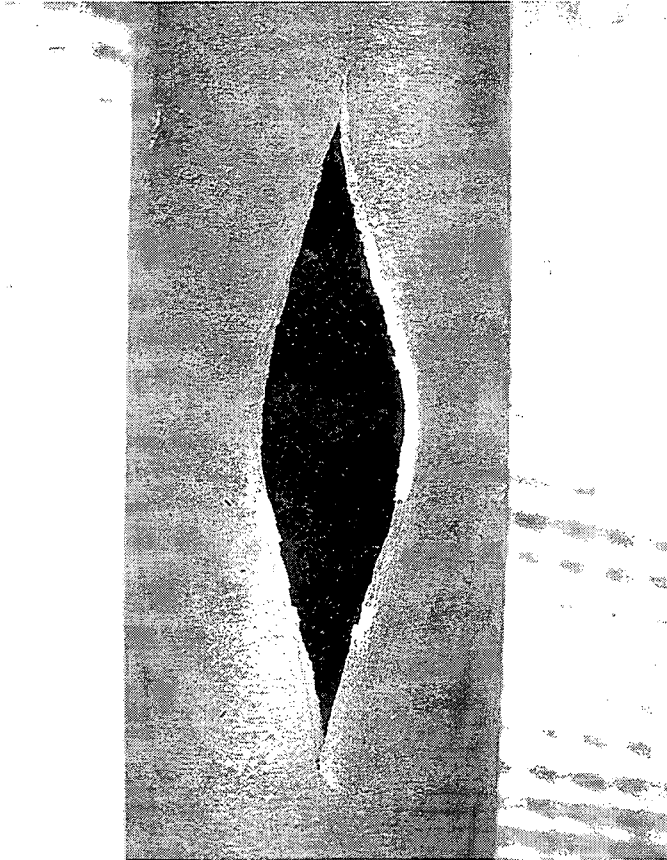
The appearance of the burst openings of specimens 5B (FS), 4B (TSP1), and 6B (TSP2) is shown in Figures 3-1 through 3-9. Visual inspection of the fractures at 30X after the burst tests showed that no corrosion was present in the FS specimen, confirming that it was not degraded, and therefore it was valid as a control specimen. Axial corrosion, with intergranular cellular corrosion (ICC) characteristics, was found on approximately half of the central crevice region of TSP1 and on most of the central crevice region locations of TSP2. All corrosion was confined to the crevice regions. More detailed observations of the corrosion morphology, using a scanning electron microscope (SEM) at higher magnifications, are covered in the Destructive Examination section of this report.

Figure 3-1 FS (control) Specimen 5B of Tube R15C28. Appearance of the 345° face after the burst test. Mag. 2X.
