Examination of Kewaunee Cold Leg Steam Generator Tube R15C28

P. Kuchirka*, A. Madeyski, and M. Blaszkiewicz

May 8, 1997

The first and second tube support plate crevice regions of cold leg Tube R15C28 from Steam Generator B of Kewaunee were examined by nondestructive and destructive examination techniques. Shallow, but extensively distributed, OD-origin intergranular corrosion was found contained in the tube support plate crevice regions of the mill annealed Alloy 600 tubing.

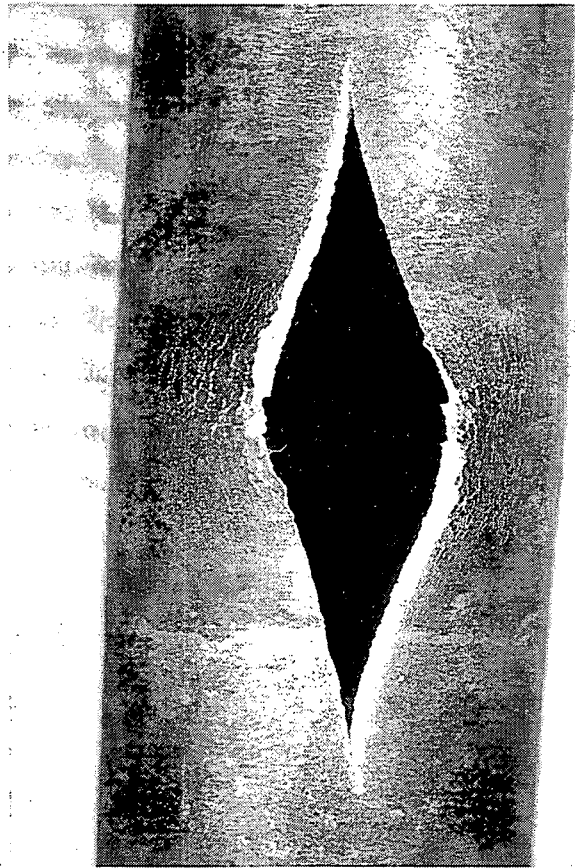
The appearance of the burst openings of specimens 5B (FS), 4B (TSP1), and 6B (TSP2) is shown in Figures 3-1 through 3-9. Visual inspection of the fractures at 30X after the burst tests showed that no corrosion was present in the FS specimen, confirming that it was not degraded, and therefore it was valid as a control specimen. Axial corrosion, with intergranular cellular corrosion (ICC) characteristics, was found on approximately half of the central crevice region of TSP1 and on most of the central crevice region locations of TSP2. All corrosion was confined to the crevice regions. More detailed observations of the corrosion morphology, using a scanning electron microscope (SEM) at higher magnifications, are covered in the Destructive Examination section of this report.

Figure 3-2 TSP1 (first tube support plate) crevice region Specimen 4B of Tube R15C28.
Appearance of the 225° face after the burst test. Mag. 2.5X.

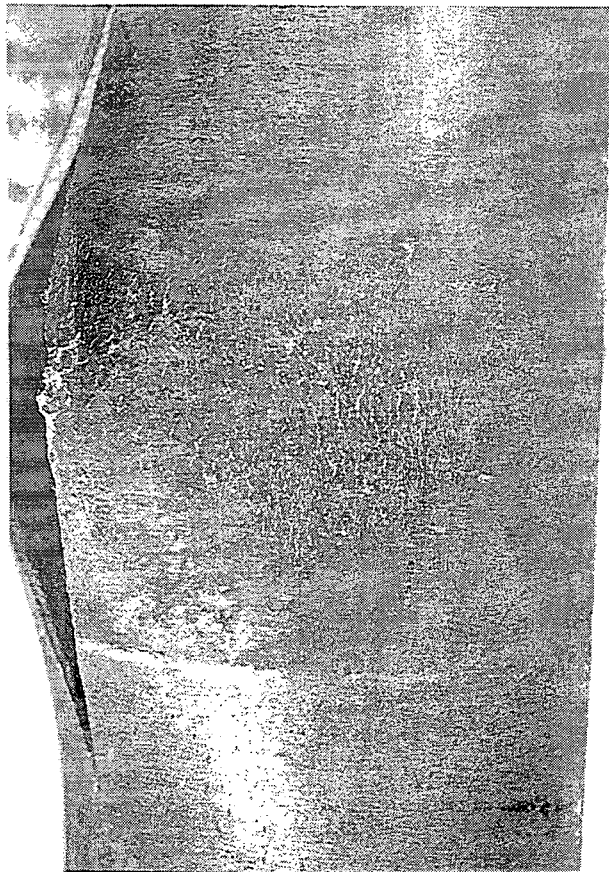
Figure 3-3 TSP1 crevice region Specimen 4B of Tube R15C28. Appearance of the 180° face after the burst test. Mag. 3X.

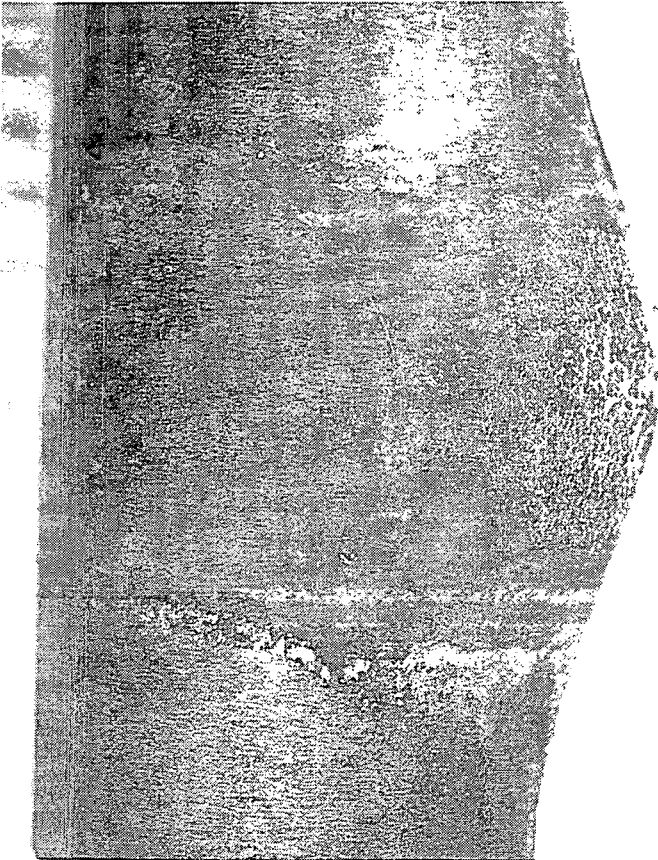
Figure 3-4 TSP1 crevice region Specimen 4B of Tube R15C28. Appearance of the 315° face after the burst test. Mag. 3X.

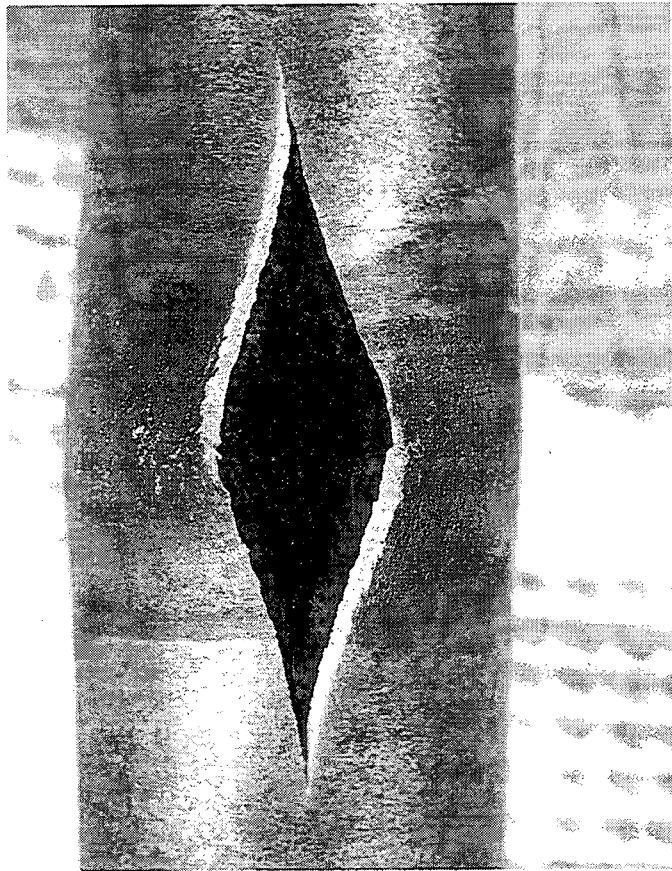
Figure 3-5 TSP2 crevice region Specimen 6B of Tube R15C28. Appearance of the 135° face after the burst test. Mag. 2.5X.

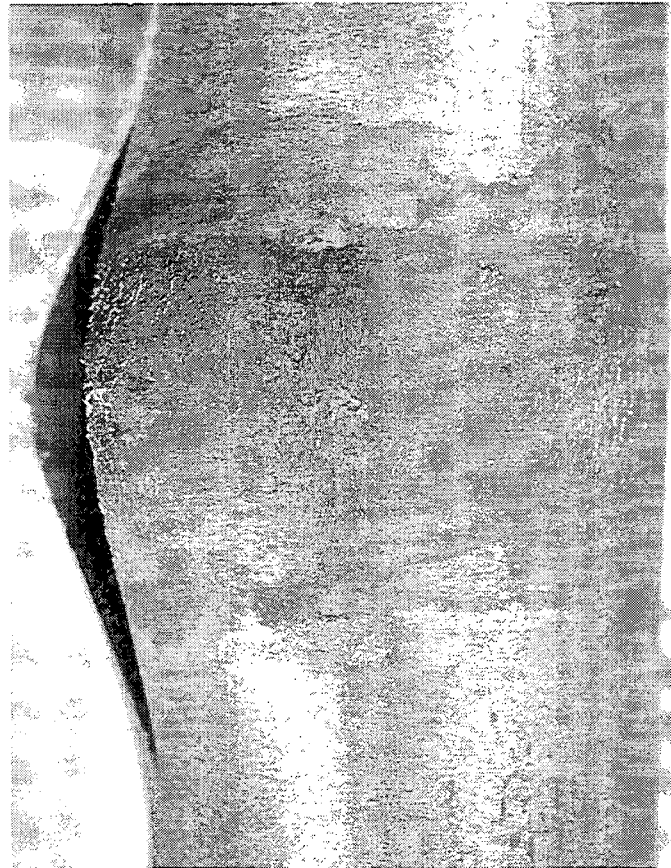
Figure 3-6 TSP2 crevice region Specimen 6B of Tube R15C28. Appearance of the 70° face after the burst test. Mag. 3X.

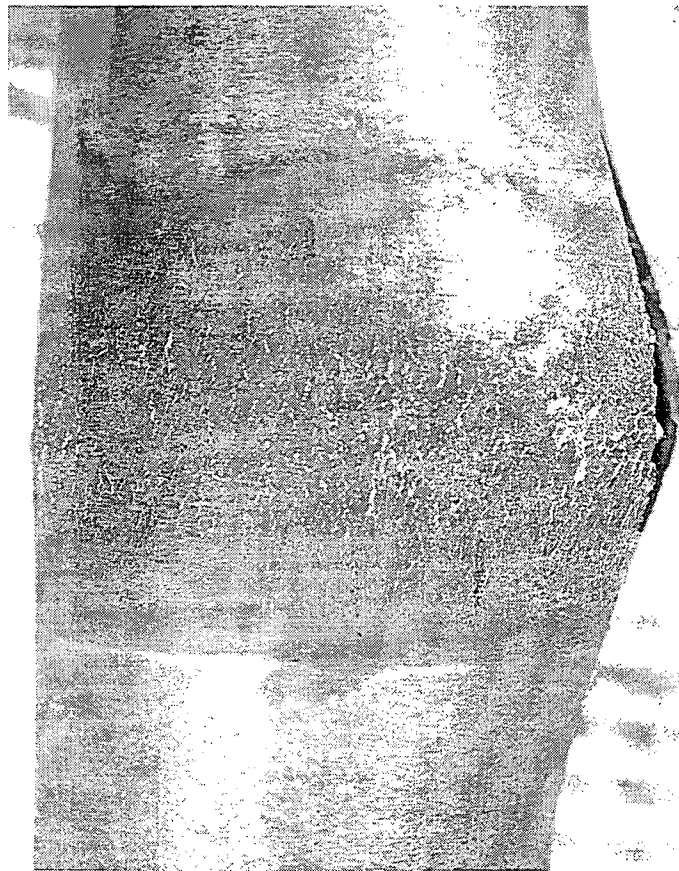
Figure 3-7 TSP2 crevice region Specimen 6B of Tube R15C28. Appearance of the 200° face after the burst test. Mag. 3X.

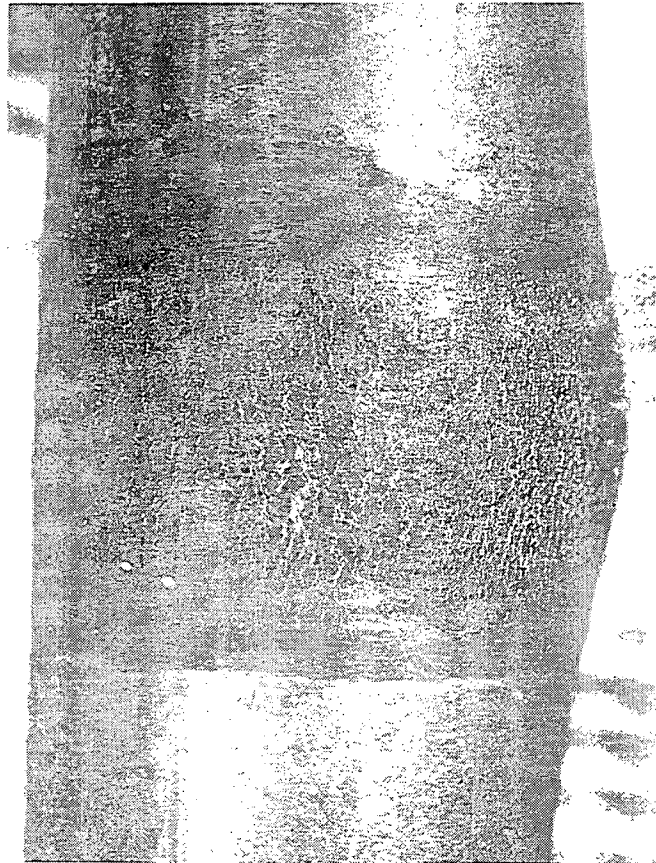
Figure 3-8 TSP2 crevice region Specimen 6B of Tube R15C28. Appearance of the 270° face after the burst test. Mag. 3X.

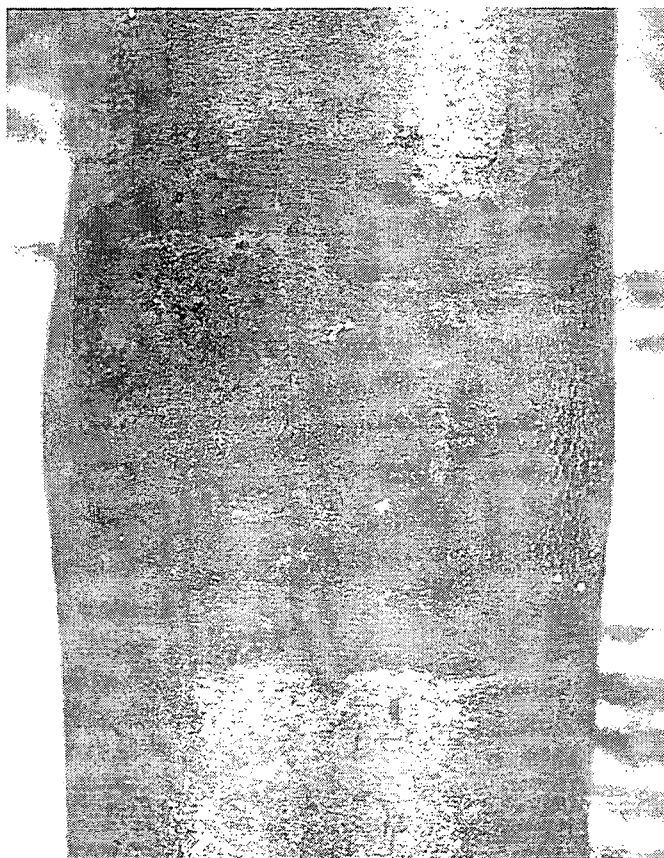
Figure 3-9 TSP2 crevice region Specimen 6B of Tube R15C28. Appearance of the 340° face after the burst test. Mag. 3X.

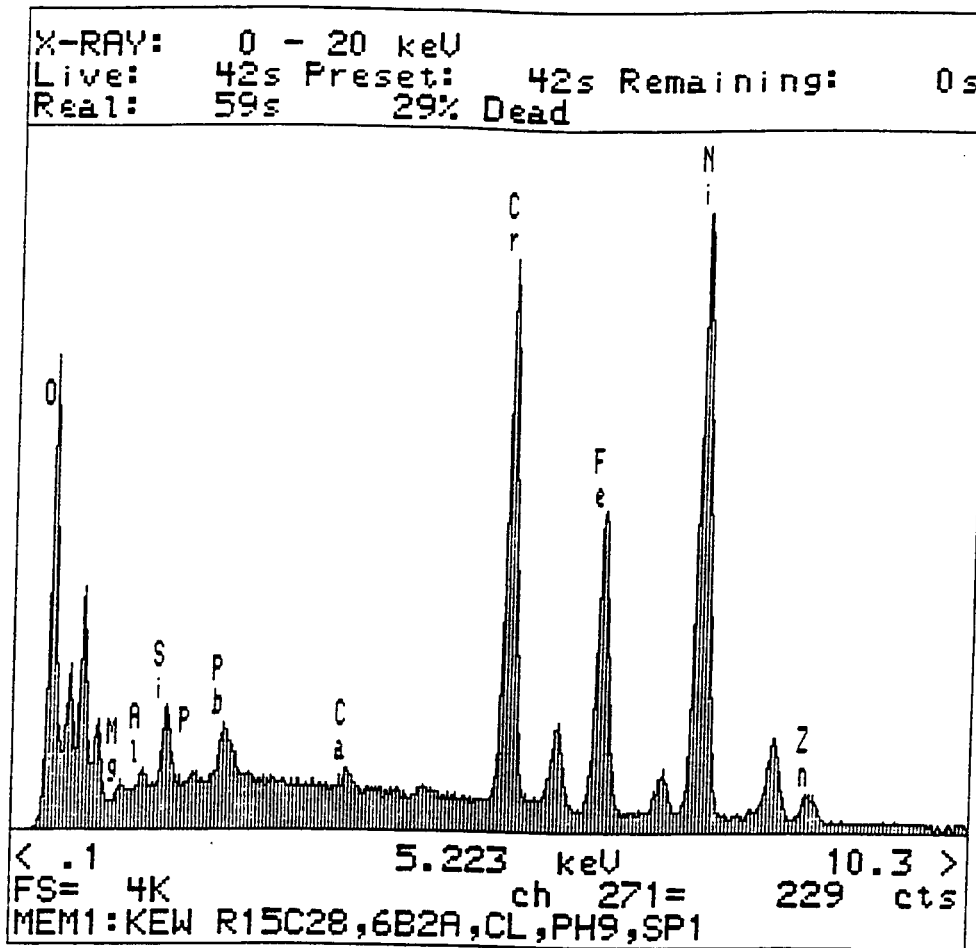
Three spots on the OD surface in Areas 7 and 9, and their vicinity, were analyzed using the energy dispersive X-ray spectroscopy (EDS) technique. The locations of the analyzed spots, marked 1, 2 and 3, are shown in Figure 4-41. It may be seen that Spot 1 was in Area 9. Spot 2 had a thicker deposit than Spot 1. This deposit appears to be the same as in Area 7. In the backscattered electron image Spot 3 was a bright particle in Area 7, suggesting the presence of a different element than in the rest of the deposit in this area. The results of the EDS analyses are presented in Figures 4-42 through 4-44, both as spectra and as numerical tables. The second column in each table lists the weight percent of every element, while the last column shows the equivalent atomic percent. The estimated weight percent error range values are shown in the third column of each table.

Figure 4-42 TSP2 crevice region Specimen 6B-2A of Tube R15C28. Results of the EDS analysis of Spot 1, Figure 4-41, on the OD surface at Area 9 from Figure 4-37.

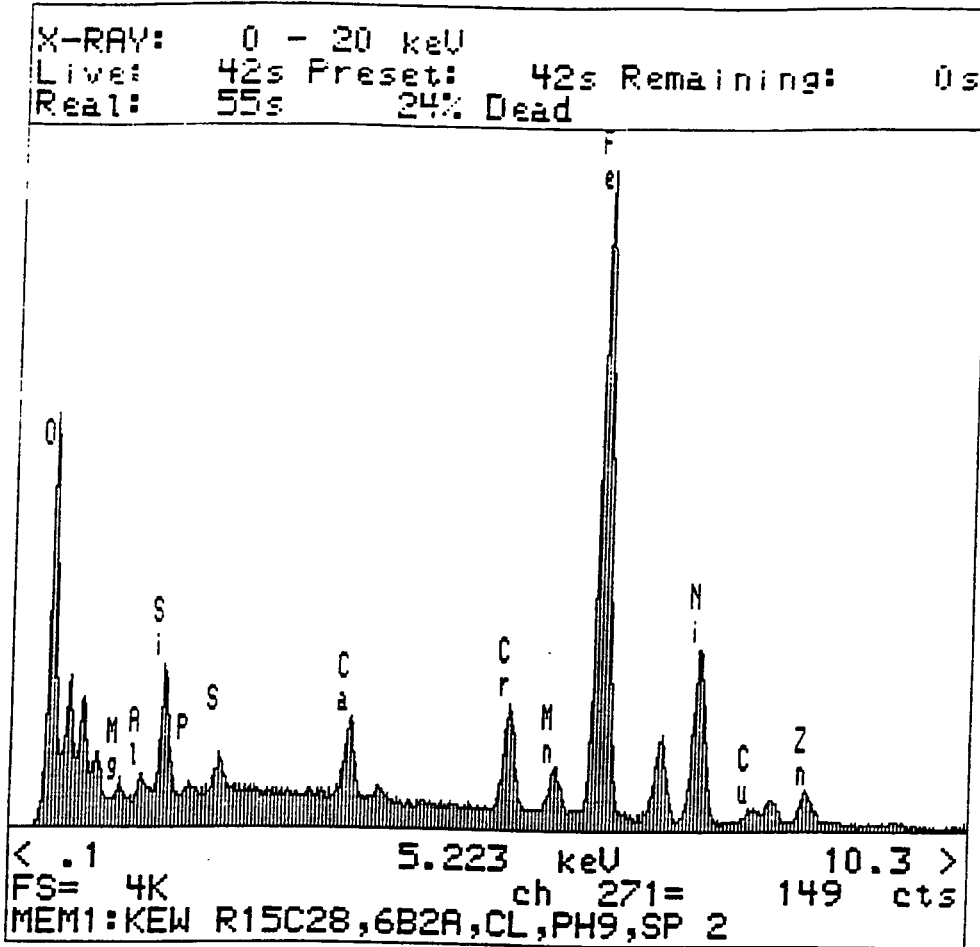
Figure 4-43 TSP2 crevice region Specimen 6B-2A of Tube R15C28. Results of the EDS analysis of Spot 2, Figure 4-41, on the OD surface next to Area 9 from Figure 4-37.

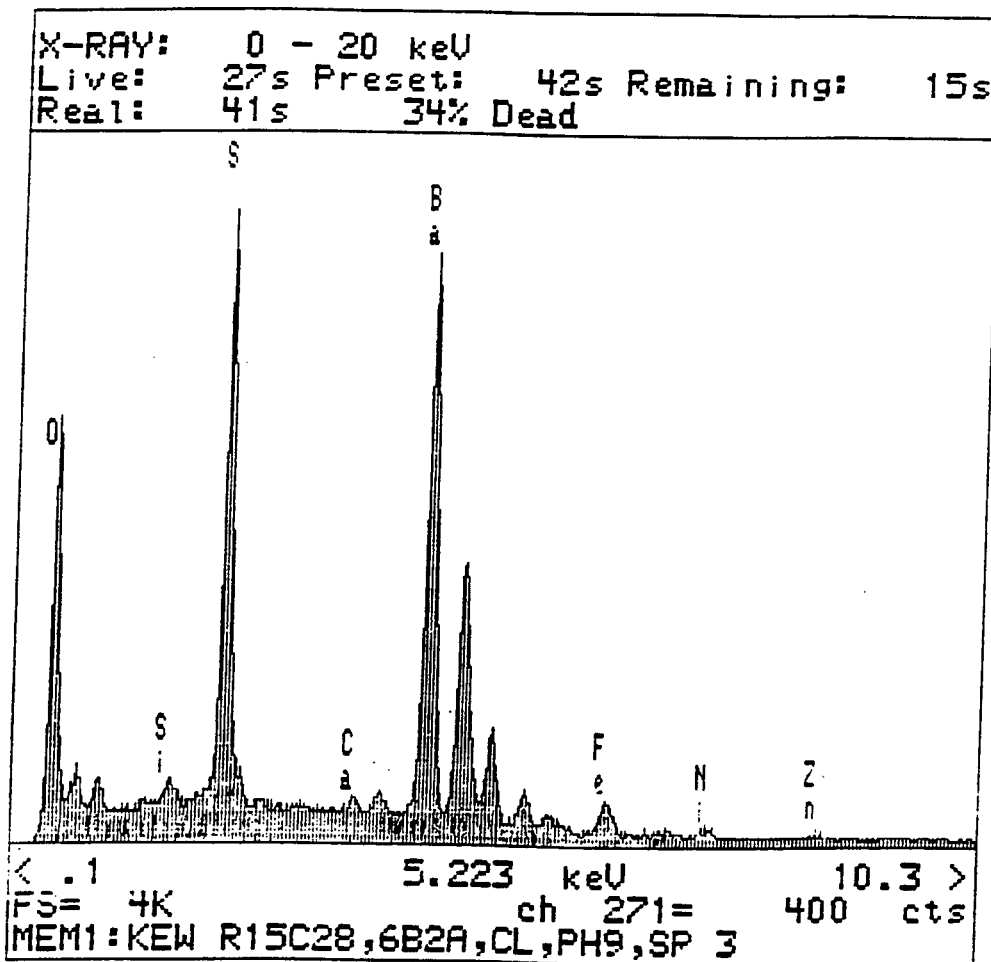
Figure 4-44 TSP2 crevice region Specimen 6B-2A of Tube R15C28. Results of the EDS analysis of Spot 3, Figure 4-41, on the OD surface at Area 7 from Figure 4-37.

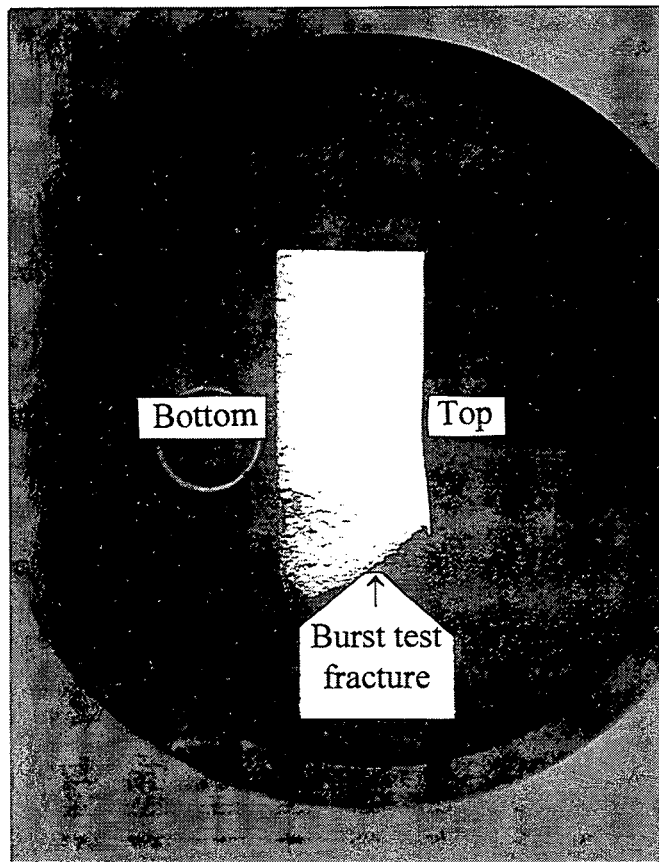
The radial metallography Specimen 6B-2D was first polished to a depth of 0.001 inch below the OD surface. Figures 4-45 and 4-46 show the specimen at this stage. These two figures are reversed left to right with respect to each other because of the different optics of the corresponding cameras. A large number of corrosion cracks may be seen near the burst fracture. Typical cracks visible at this level are shown at a higher magnification in Figures 4-47, 4-48, and 4-49. Both axial IGSCC and cellular ICC crack

Figure 4-45 TSP2 crevice region Specimen 6B-2D of Tube R15C28. Radial metallographic sample after flattening and polishing to a depth of 0.001 inch below the OD surface. Mount M2163. Mag. 3.25X.

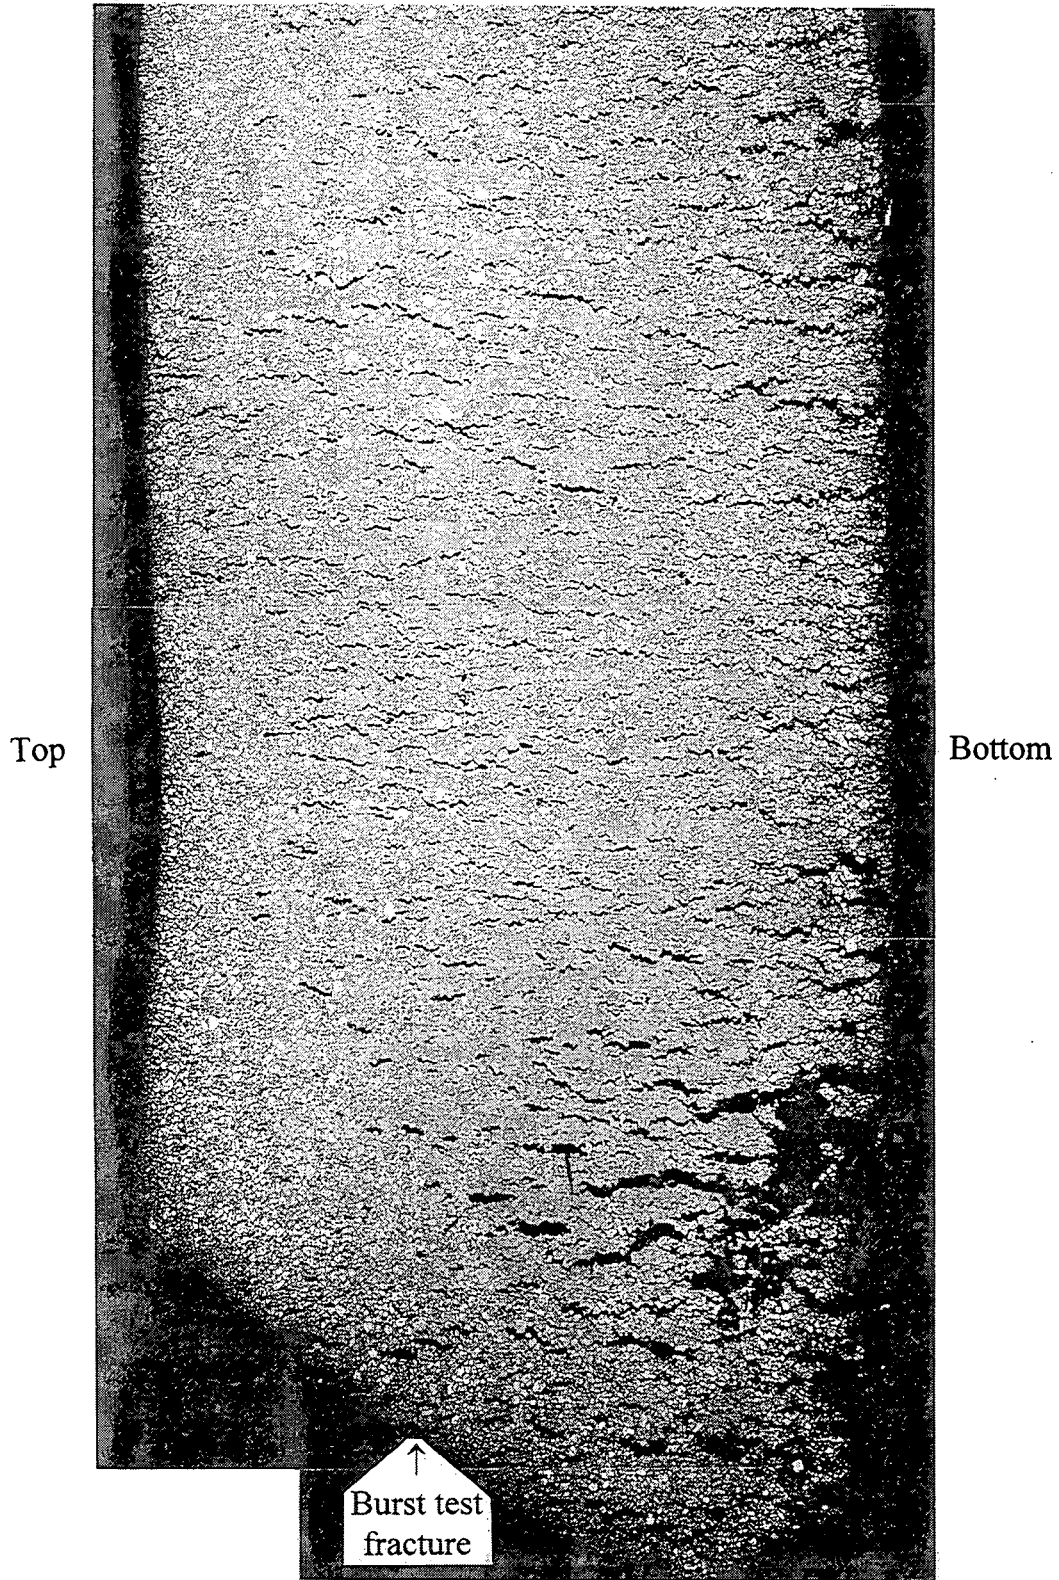
Figure 4-46 TSP2 crevice region Specimen 6B-2D of Tube R15C28. Radial metallographic sample after flattening and polishing to a depth of 0.001 inch below the OD surface. This montage is a higher magnification mirror image of Figure 4-45 because of the reversed optics of the two cameras. Mount M2163. Mag. 16X.

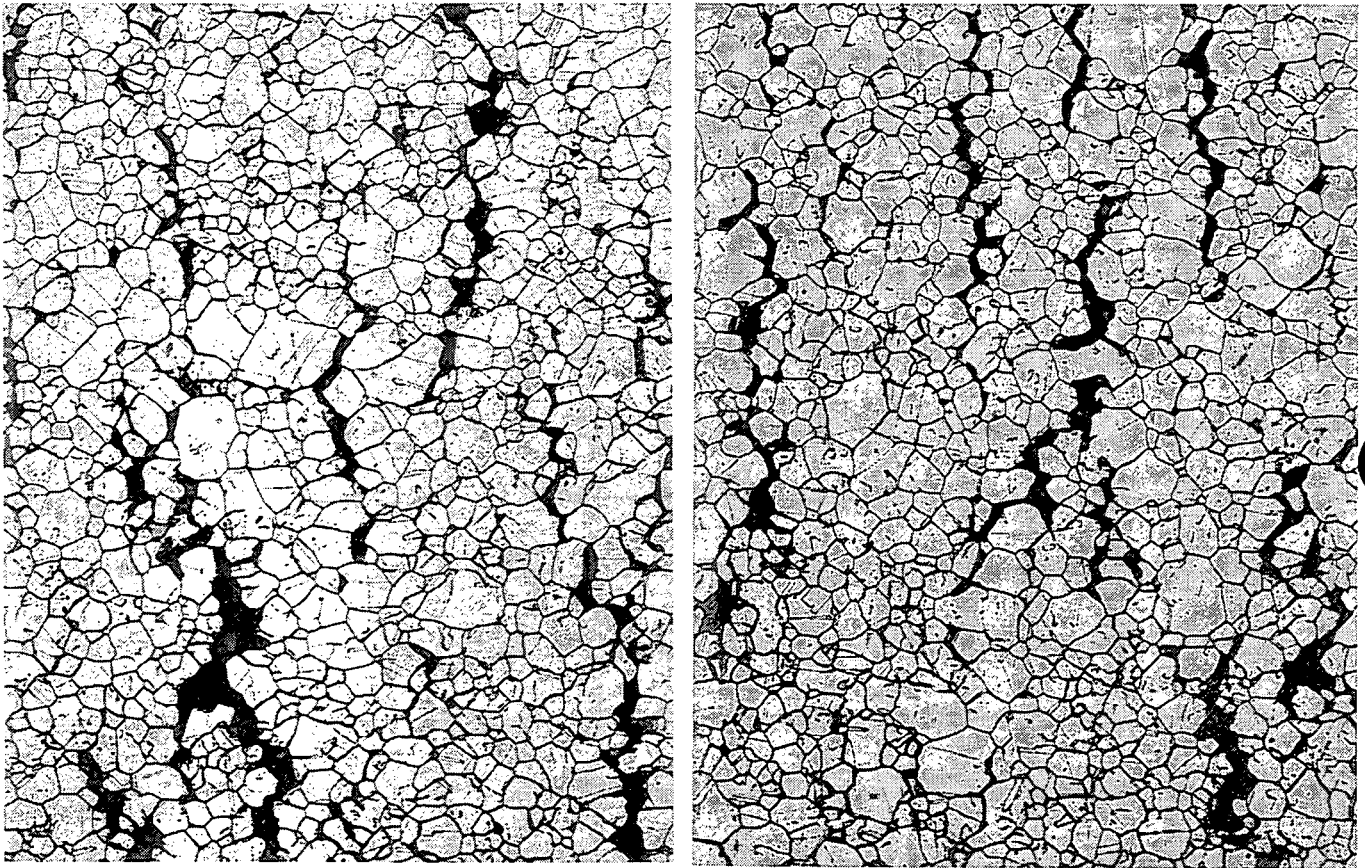
Figure 4-47 TSP2 crevice region Specimen 6B-2D of Tube R15C28. Radial metallographic sample after flattening and polishing to a depth of 0.001 inch below the OD surface. Examples of the corrosion crack pattern at this level of grinding and polishing. Mount M2163. Mag. 100X.

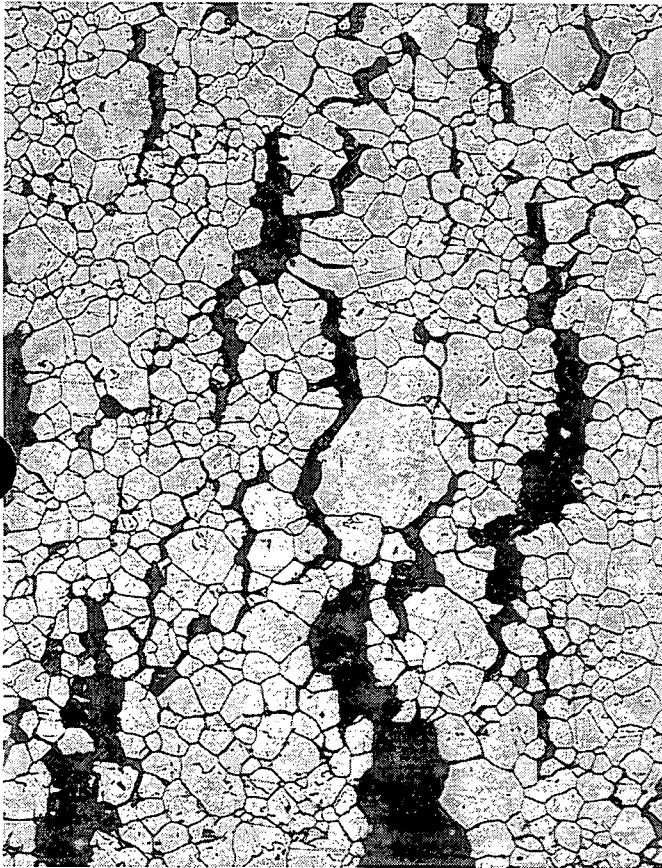
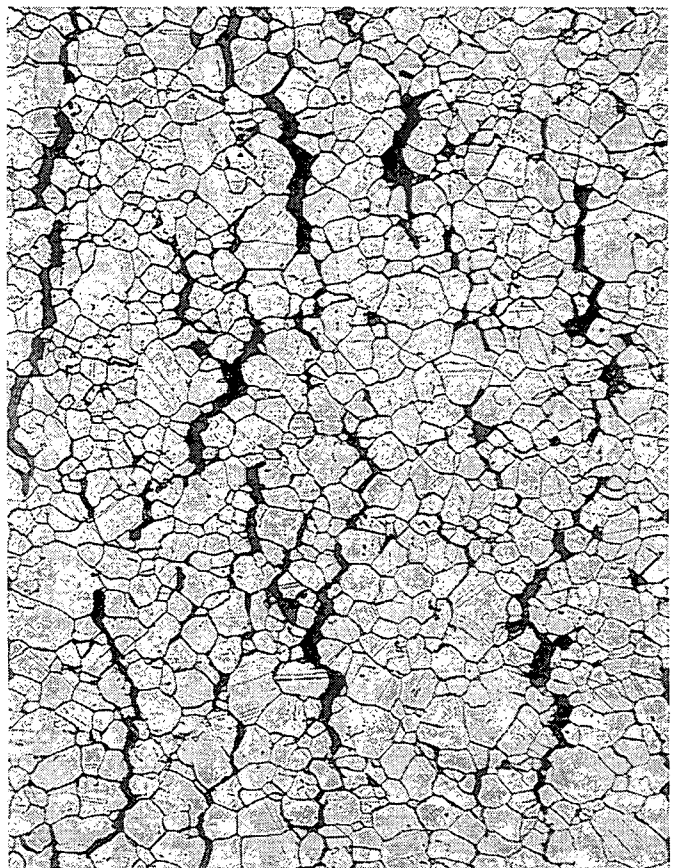
Figure 4-48 TSP2 crevice region Specimen 6B-2D of Tube R15C28. Radial metallographic sample after flattening and polishing to a depth of 0.001 inch below the OD surface. Examples of the corrosion crack pattern at this level of grinding and polishing. Mount M2163. Mag. 100X.

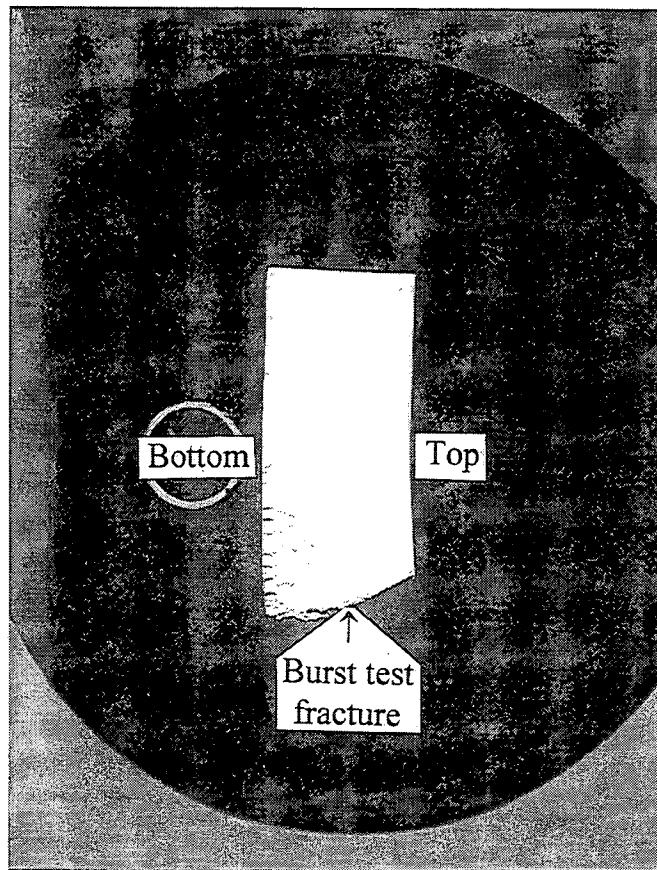
morphology is observed, although axially seems to predominate. The specimen was then polished an additional 0.004 inch to a total depth of 0.005 inch below the OD surface (Figures 4-50 and 4-51). At this stage the cracks were less numerous and their morphology appears to be even more axial, although some cellular character was still retained, as may be seen in Figures 4-52 and 4-53. The third polishing, of 0.005 inch, brought the total depth of the examined plane of the specimen to 0.010 inch below the OD surface. This last polishing removed the rest of the cracks, as may be seen in Figure 4-54.

Figure 4-50 TSP2 crevice region Specimen 6B-2D of Tube R15C28. Radial metallographic sample after flattening and polishing to a depth of 0.005 inch below the OD surface. Mount M2163. Mag. 3.25X.

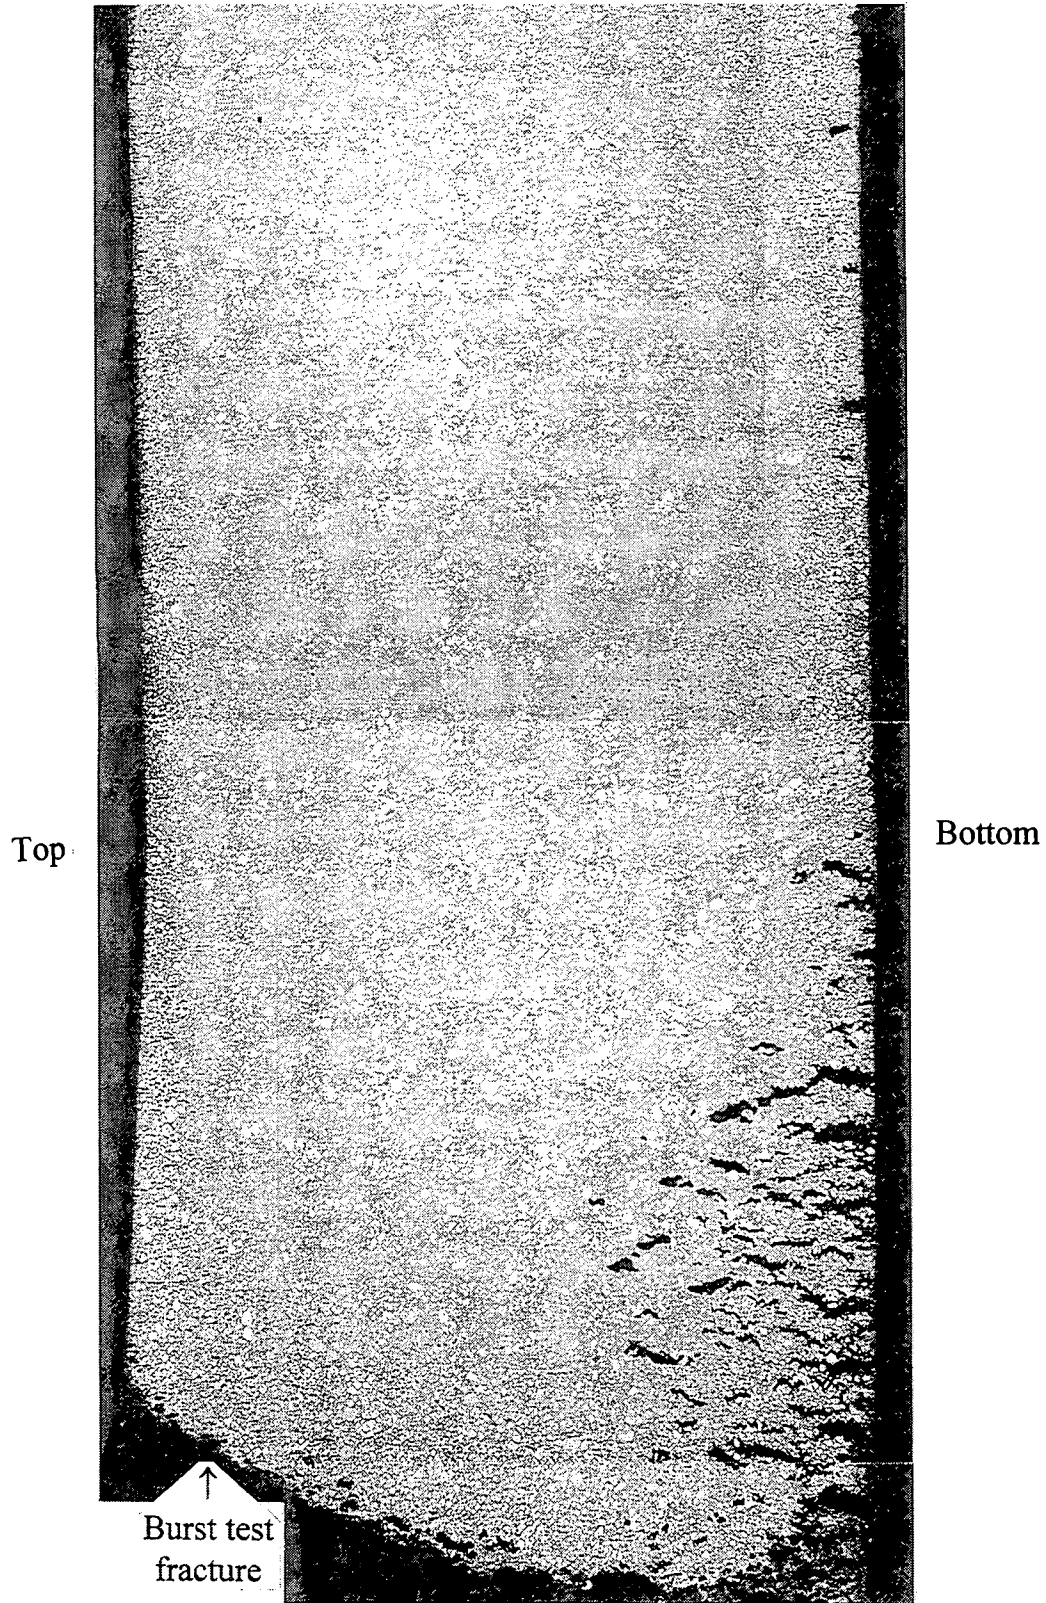
Figure 4-51 TSP2 crevice region Specimen 6B-2D of Tube R15C28. Radial metallographic sample after flattening and polishing to a depth of 0.005 inch below the OD surface. This montage is a higher magnification mirror image of Figure 4-50 because of the reversed optics of the two cameras. Mount M2163. Mag. 16X.

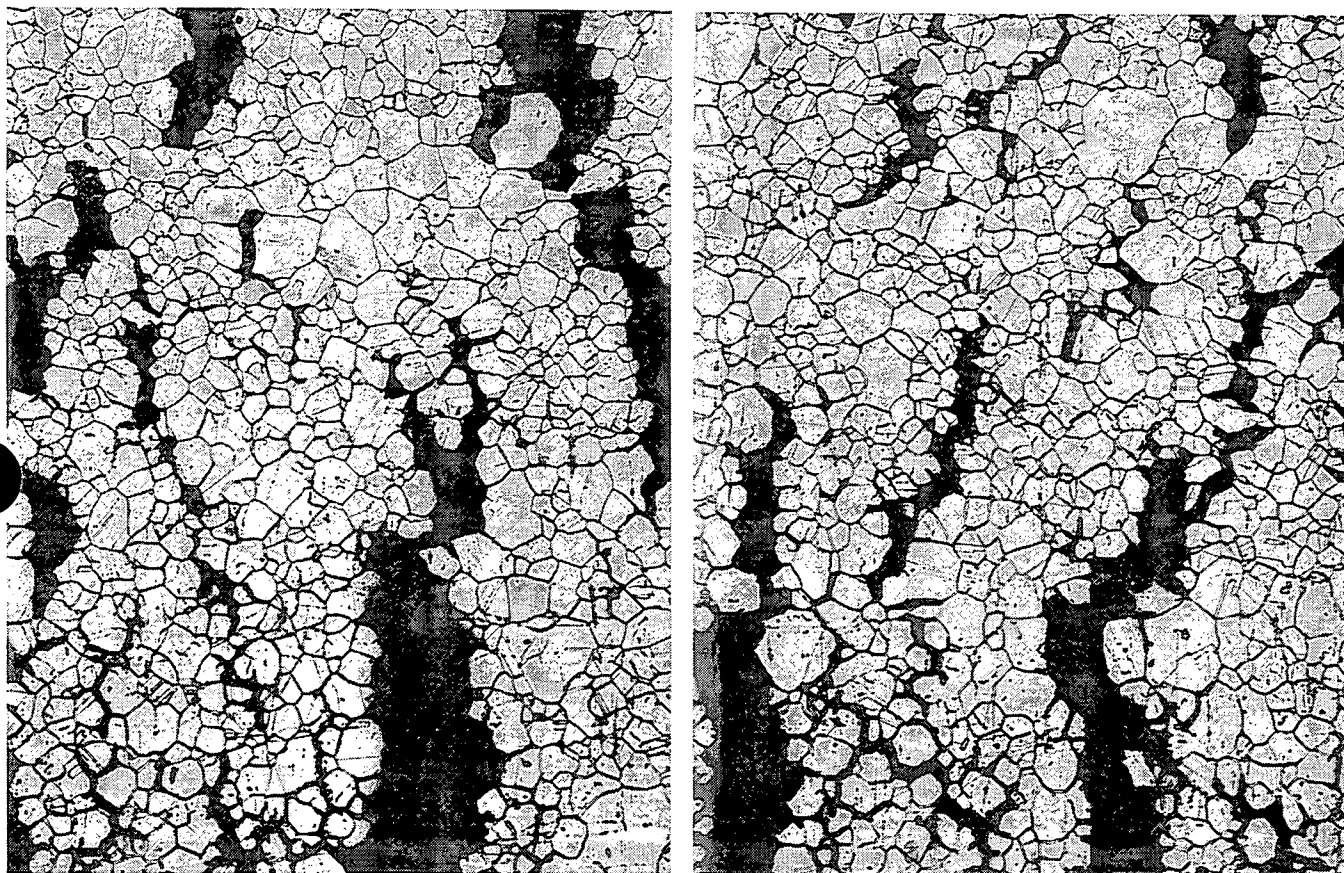
Figure 4-52 TSP2 crevice region Specimen 6B-2D of Tube R15C28. Radial metallographic sample after flattening and polishing to a depth of 0.005 inch below the OD surface. Examples of the corrosion crack pattern at this level of grinding and polishing. Mount M2163. Mag. 100X.

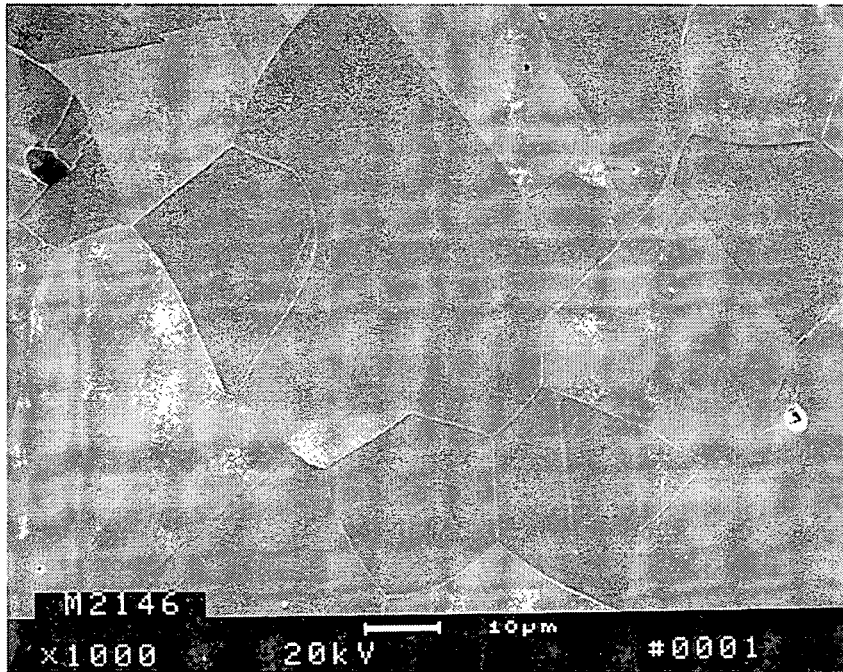
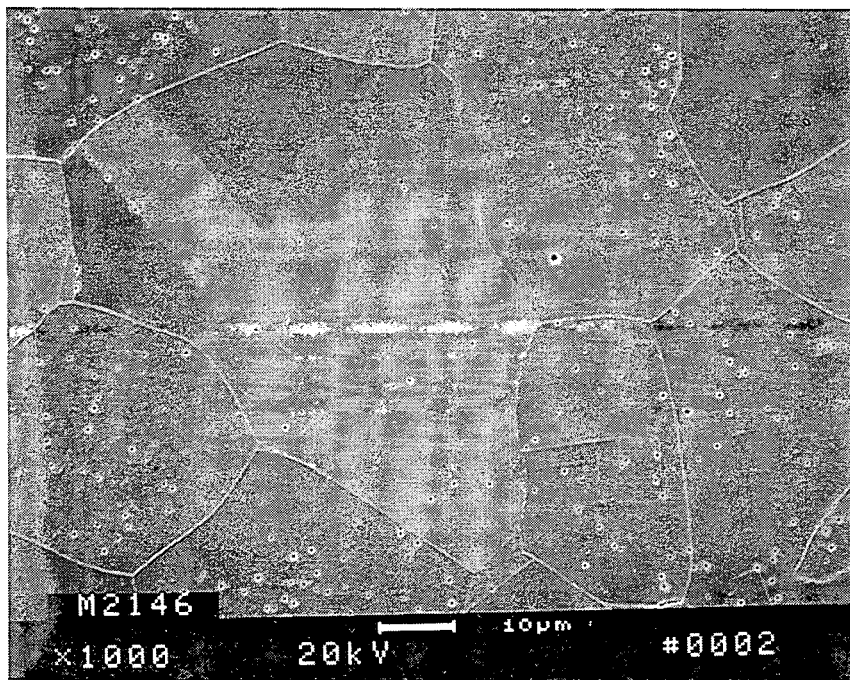
The carbide distribution in Tube R15C28 was determined by an SEM examination of a metallographic sample of the tube etched in bromine methanol. The results are shown in Figures 5-1, 5-2, and 5-3. The photomicrographs in these figures demonstrate that the microstructure of this tubing contained a small amount of spherical carbides randomly distributed throughout the microstructure, with practically none at the grain boundaries. As determined before, the average grain size of Tube R15C28 was approximately ASTM 7. This grain size is larger than normally found in Westinghouse steam generator tubing.

The stress corrosion behavior of Alloy 600 is known to vary with grain boundary carbide precipitation and heat treatment. The large grain size of Tube R15C28 suggests that the mill annealing temperature was high (above 1700°F). This would explain also why some of the grains grew to very large sizes, without carbides pinning down the grain boundaries. In general, high temperature heat treatment is beneficial to stress corrosion cracking (SCC) resistance, but in this case the absence of intergranular carbides suggests that the carbon content of the material was low, since little or no solid solution carbon was apparently available for precipitation along the grain boundaries. This type of microstructure is less corrosion resistant to primary and secondary water in

steam generators than a microstructure with semi-continuous or continuous grain boundary carbide precipitates.

Figure 5-1 SEM photomicrographs showing the microstructure and carbide distribution of Tube R15C28. Mount M2146. Mag. 1000X.

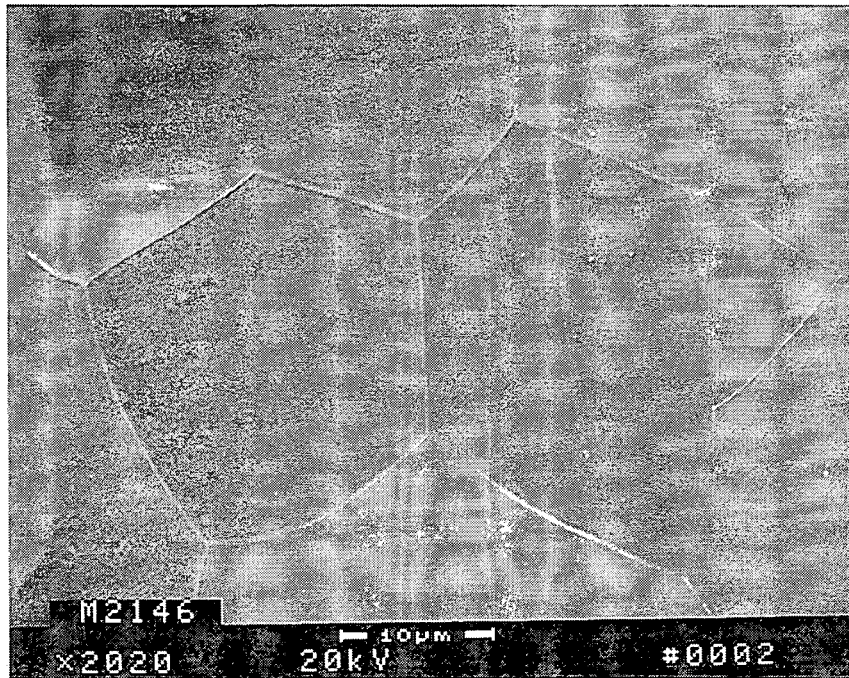
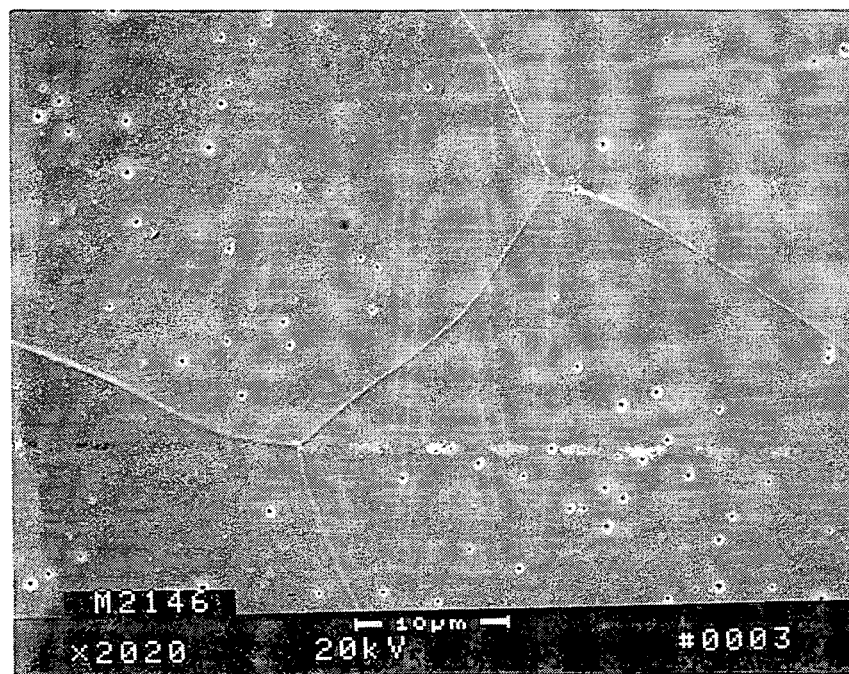
Figure 5-2 Higher magnification SEM photomicrographs showing the microstructure and carbide distribution of Tube R15C28. Mount M2146. Mag. 200X.

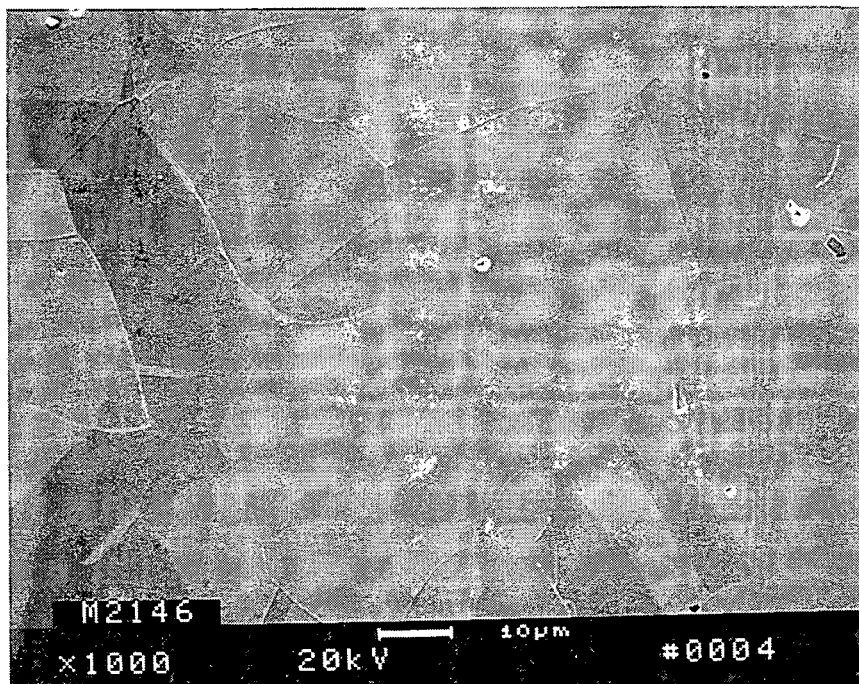
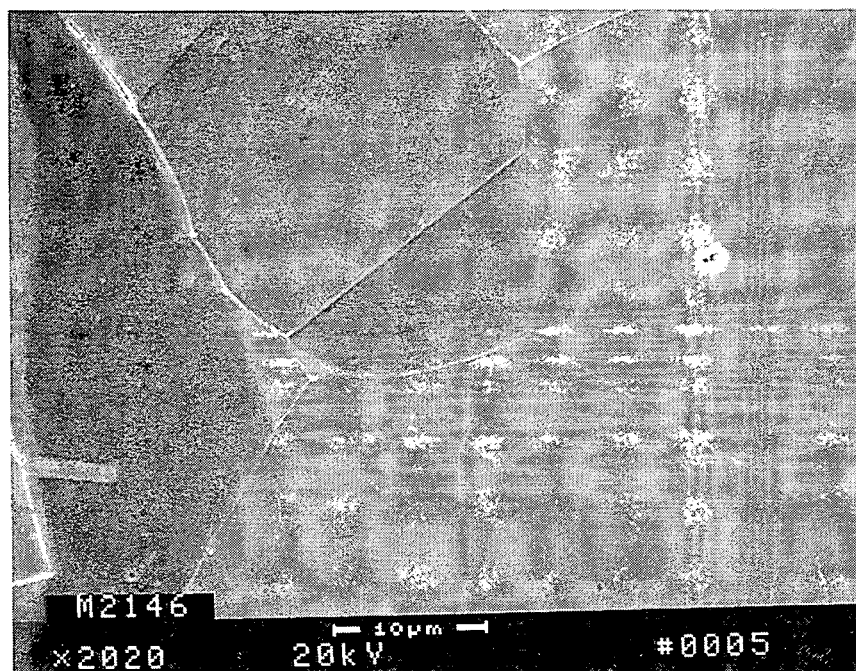
Figure 5-3 SEM photomicrographs showing the microstructure and carbide distribution of Tube R15C28. Mount M2146. Upper photomicrograph: Mag. 1000X. Lower photomicrograph: Mag. 2020X.

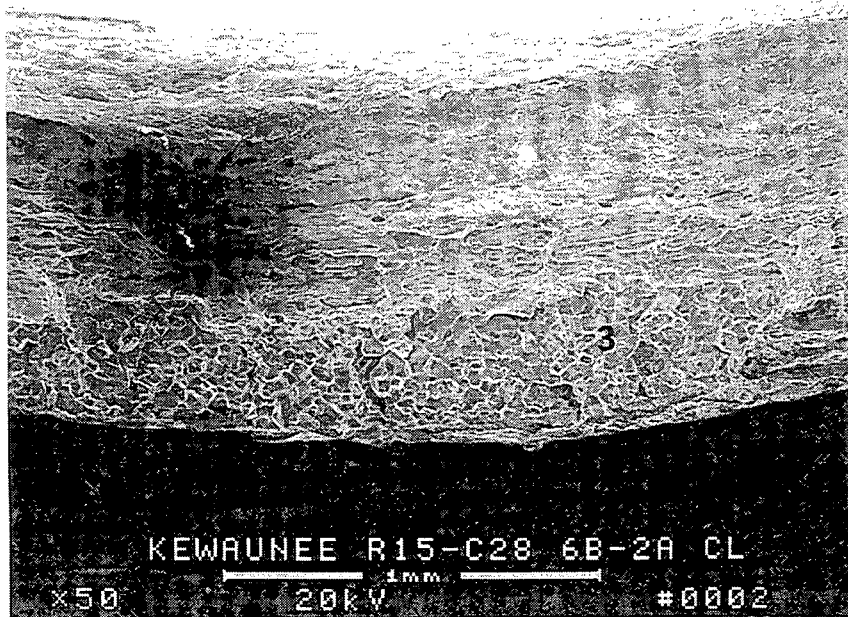
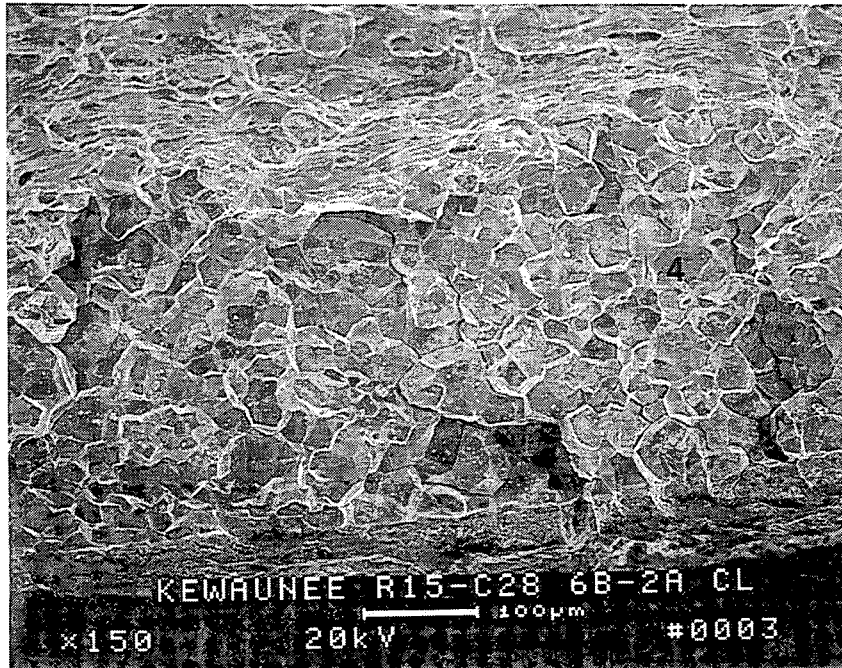
Figure 4-34 TSP2 crevice region Specimen 6B-2A of Tube R15C28. Areas 2 and 3 from Figure 4-33, showing the topography of the burst fracture at the location of the deepest corrosion penetration (31% throughwall).
