Examination of Kewaunee Cold Leg Steam Generator Tube R15C28

P. Kuchirka*, A. Madeyski, and M. Blaszkiewicz

May 8, 1997

The first and second tube support plate crevice regions of cold leg Tube R15C28 from Steam Generator B of Kewaunee were examined by nondestructive and destructive examination techniques. Shallow, but extensively distributed, OD-origin intergranular corrosion was found contained in the tube support plate crevice regions of the mill annealed Alloy 600 tubing.

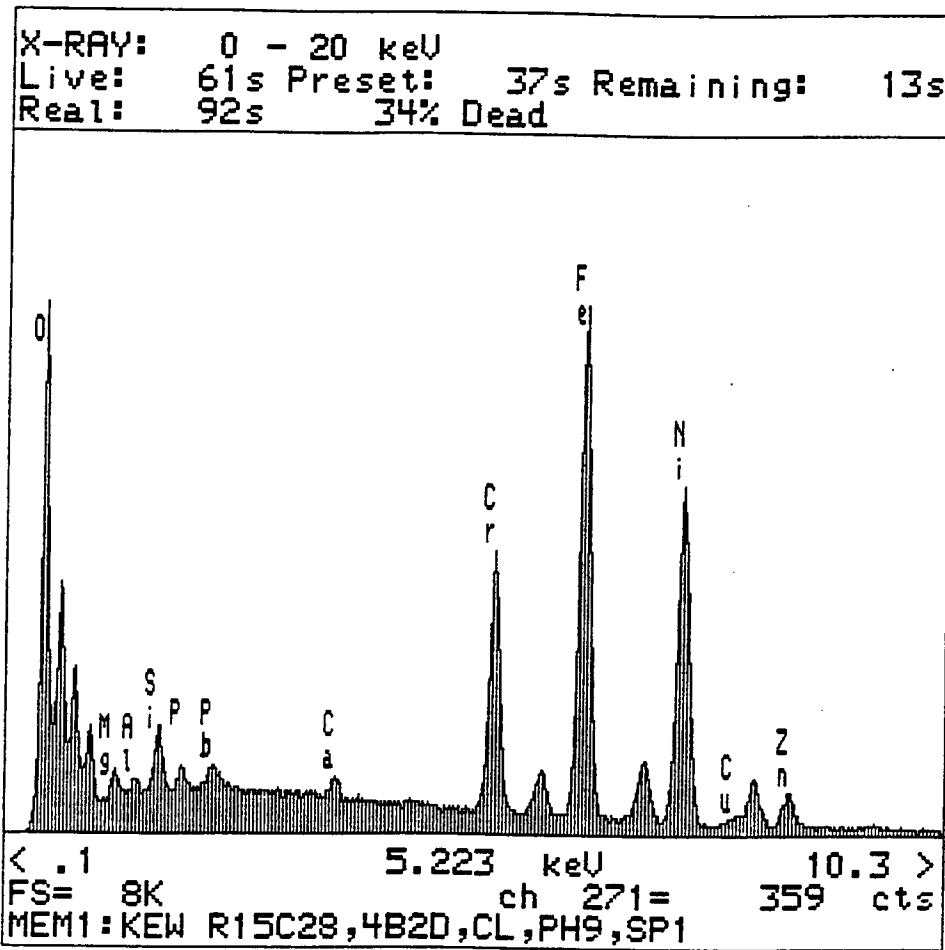
ELMT	%ELMT	+-	Error	ATOM. %
O K	26.882	+-	.300	55.770
MgK	1.171	+-	.146	1.598
P K	.466	+-	.059	.500
CaK	.374	+-	.037	.310
ZnK	3.240	+-	.197	1.645
PbM	1.277	+-	.162	.205
AlK	.211	+-	.061	.259
SiK	1.227	+-	.055	1.450
CrK	9.407	+-	.129	6.005
FeK	26.897	+-	.245	15.986
NiK	27.930	+-	.333	15.791
CuK	.920	+-	.189	.480
TOTAL	100.000			100.000

Figure 4-11 TSP1 crevice region Specimen 4B-2D of Tube R15C28. Results of the EDS analysis of Spot 1, Figure 4-10, on the OD surface at Area 7 from Figure 4-6.

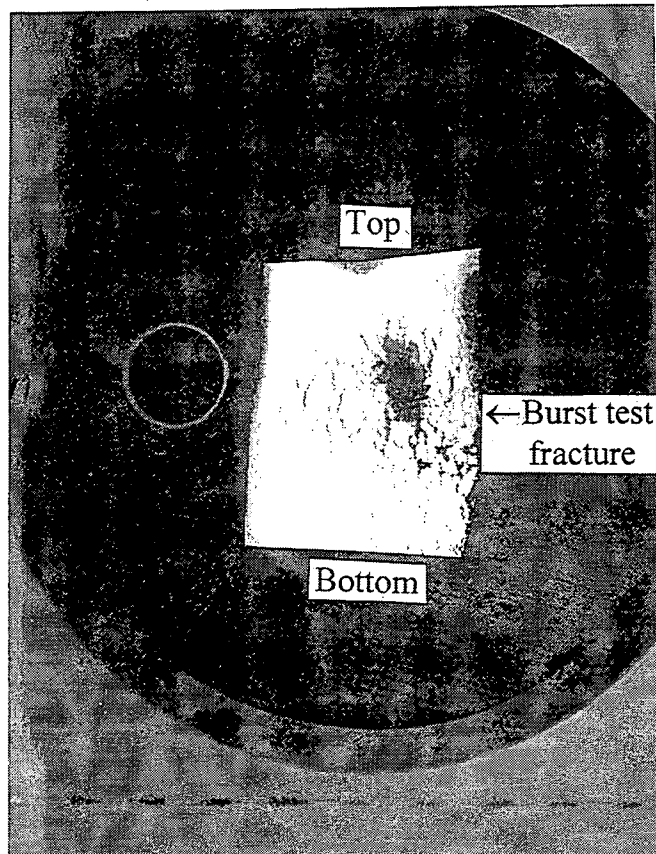
Figure 4-13 TSP1 crevice region Specimen 4B-2C of Tube R15C28. Radial metallographic sample after flattening and polishing to a depth of 0.001 inch below the OD surface. Mount M2161. Mag. 3.25X.

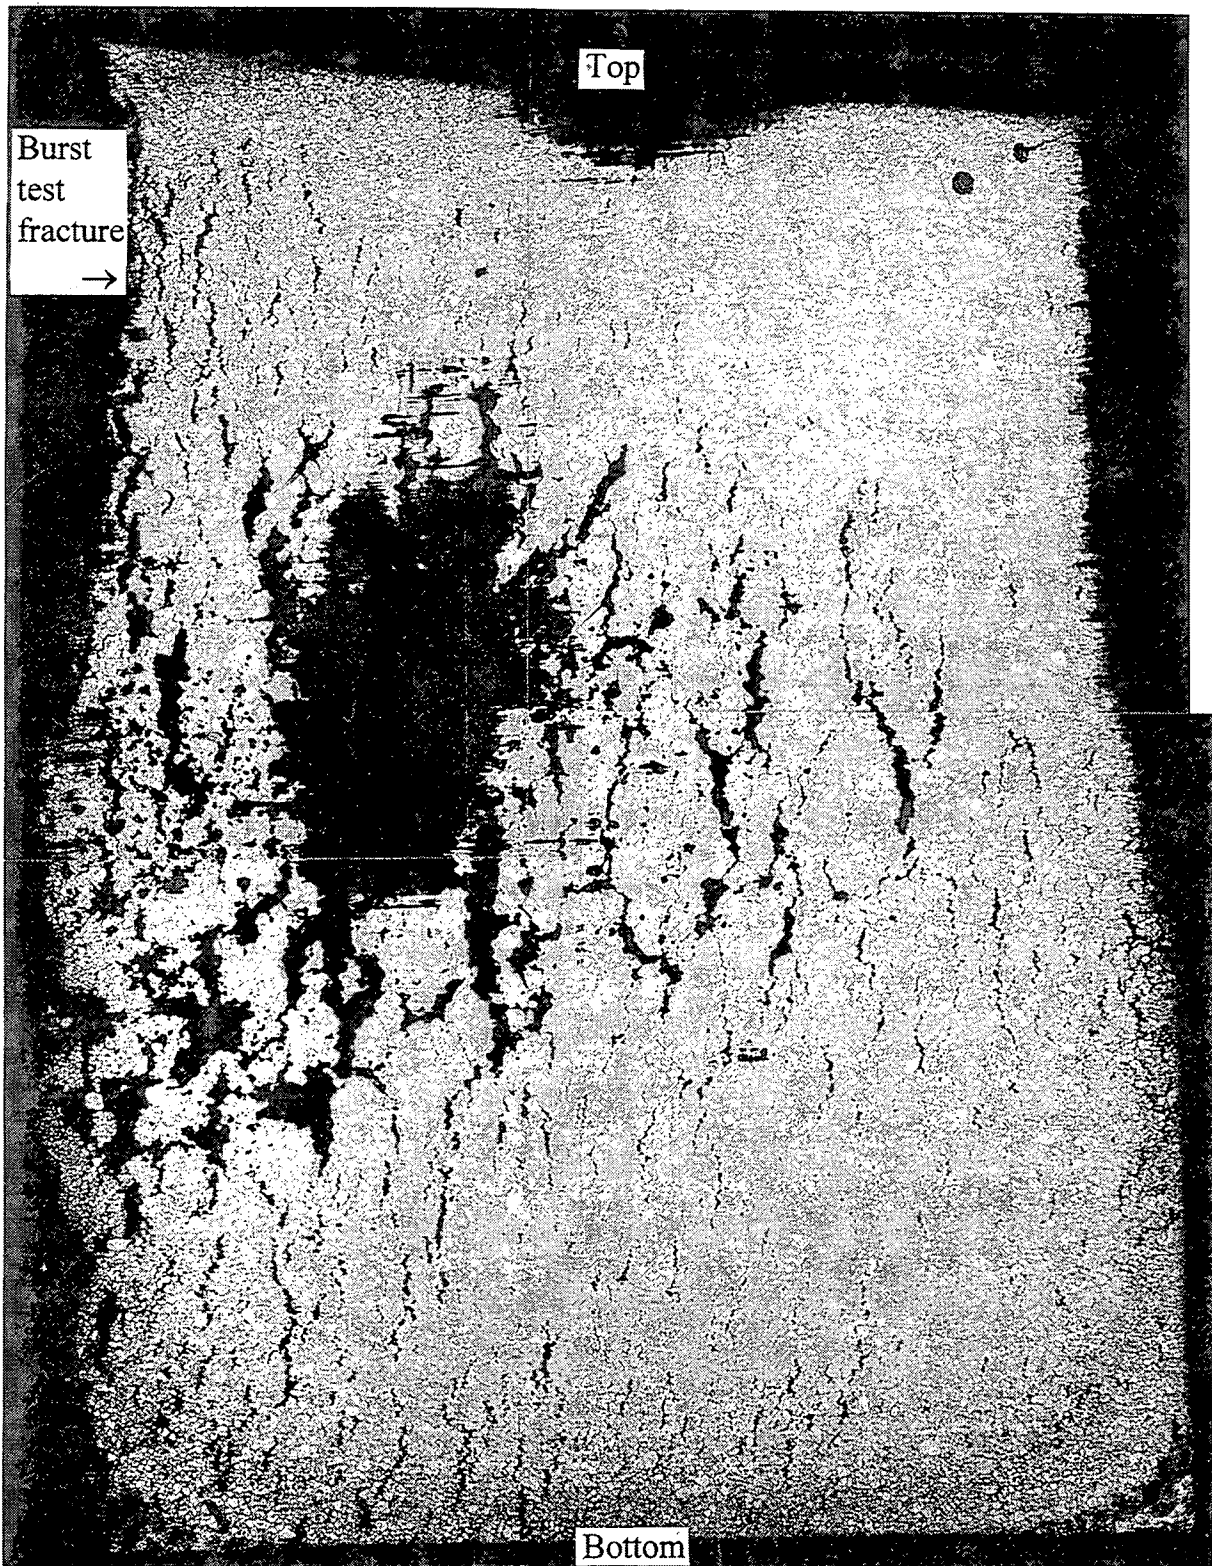
Figure 4-14 TSP1 crevice region Specimen 4B-2C of Tube R15C28. Radial metallographic sample after flattening and polishing to a depth of 0.001 inch below the OD surface. This montage is a higher magnification mirror image of Figure 4-13 because of the reversed optics of the two cameras. Mount M2161. Mag. 16X.

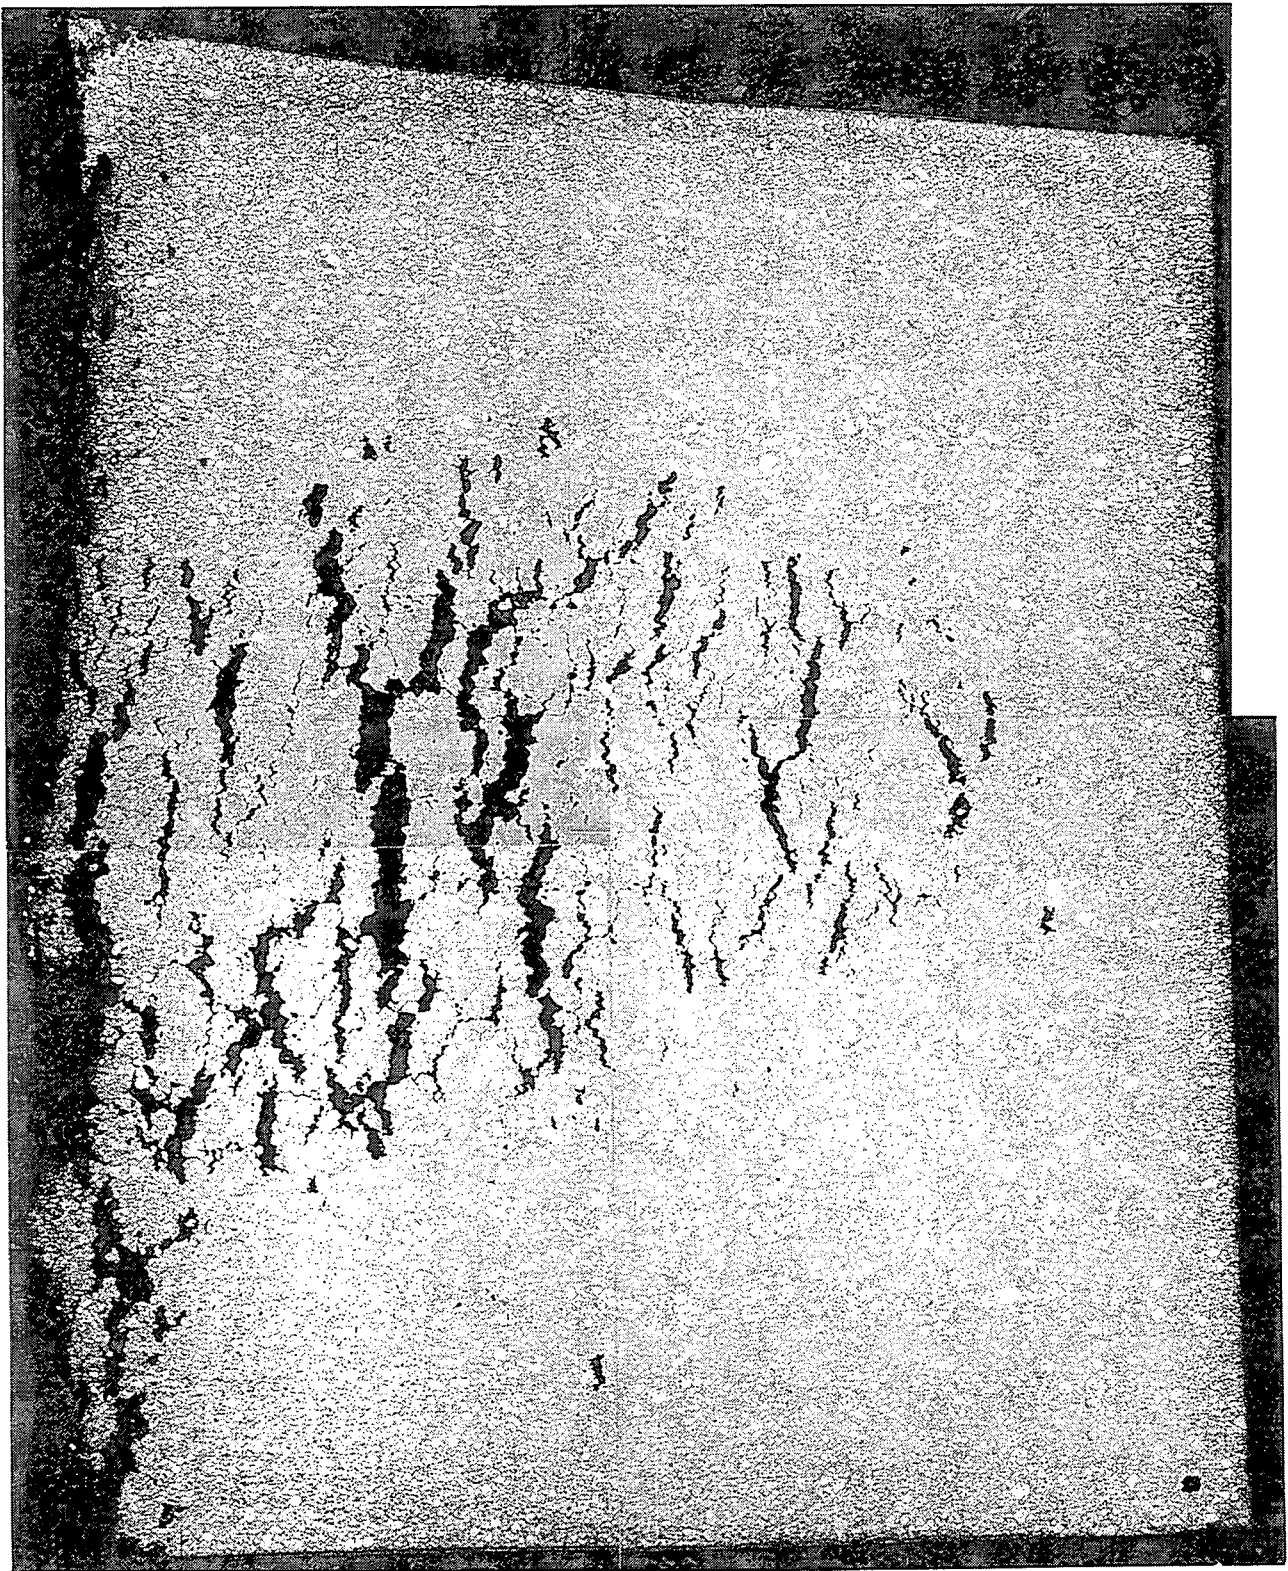
Figure 4-19 TSP1 crevice region Specimen 4B-2C of Tube R15C28. Radial metallographic sample after flattening and polishing to a depth of 0.005 inch below the OD surface. This montage is a higher magnification mirror image of Figure 4-18 because of the reversed optics of the two cameras. Mount M2161. Mag. 16X.

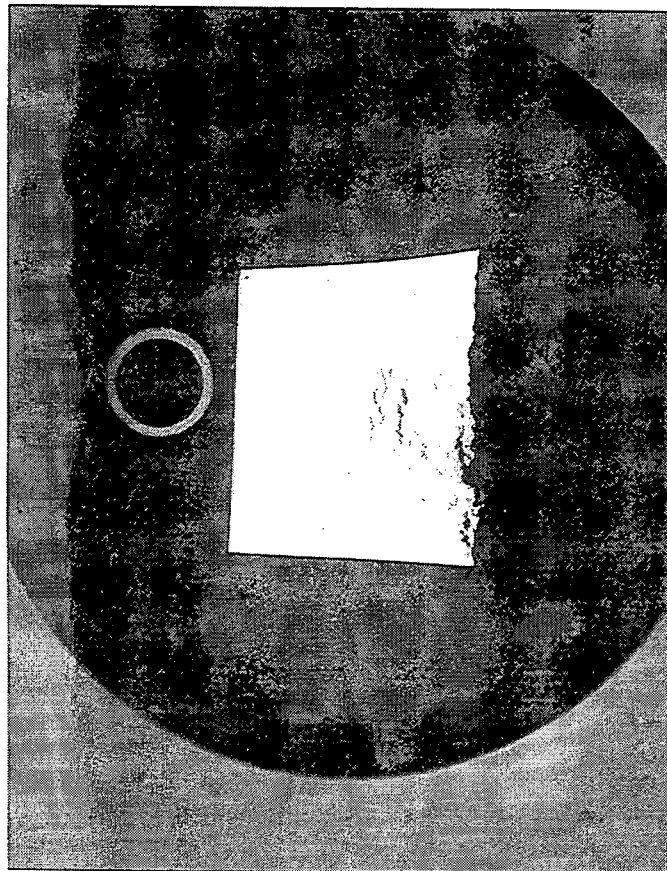
(Figures 4-23 through 4-26). The number of visible cracks was much smaller at this level, and they were predominantly axial IGSCC. Finally, the last polishing of 0.005 inch (total depth of 0.010 inch) removed the rest of the cracks, as may be seen in Figure 4-27.

Figure 4-23 TSP1 crevice region Specimen 4B-2C of Tube R15C28. Radial metallographic sample after flattening and polishing to a depth of 0.010 inch below the OD surface. Mount M2161. Mag. 3.25X.

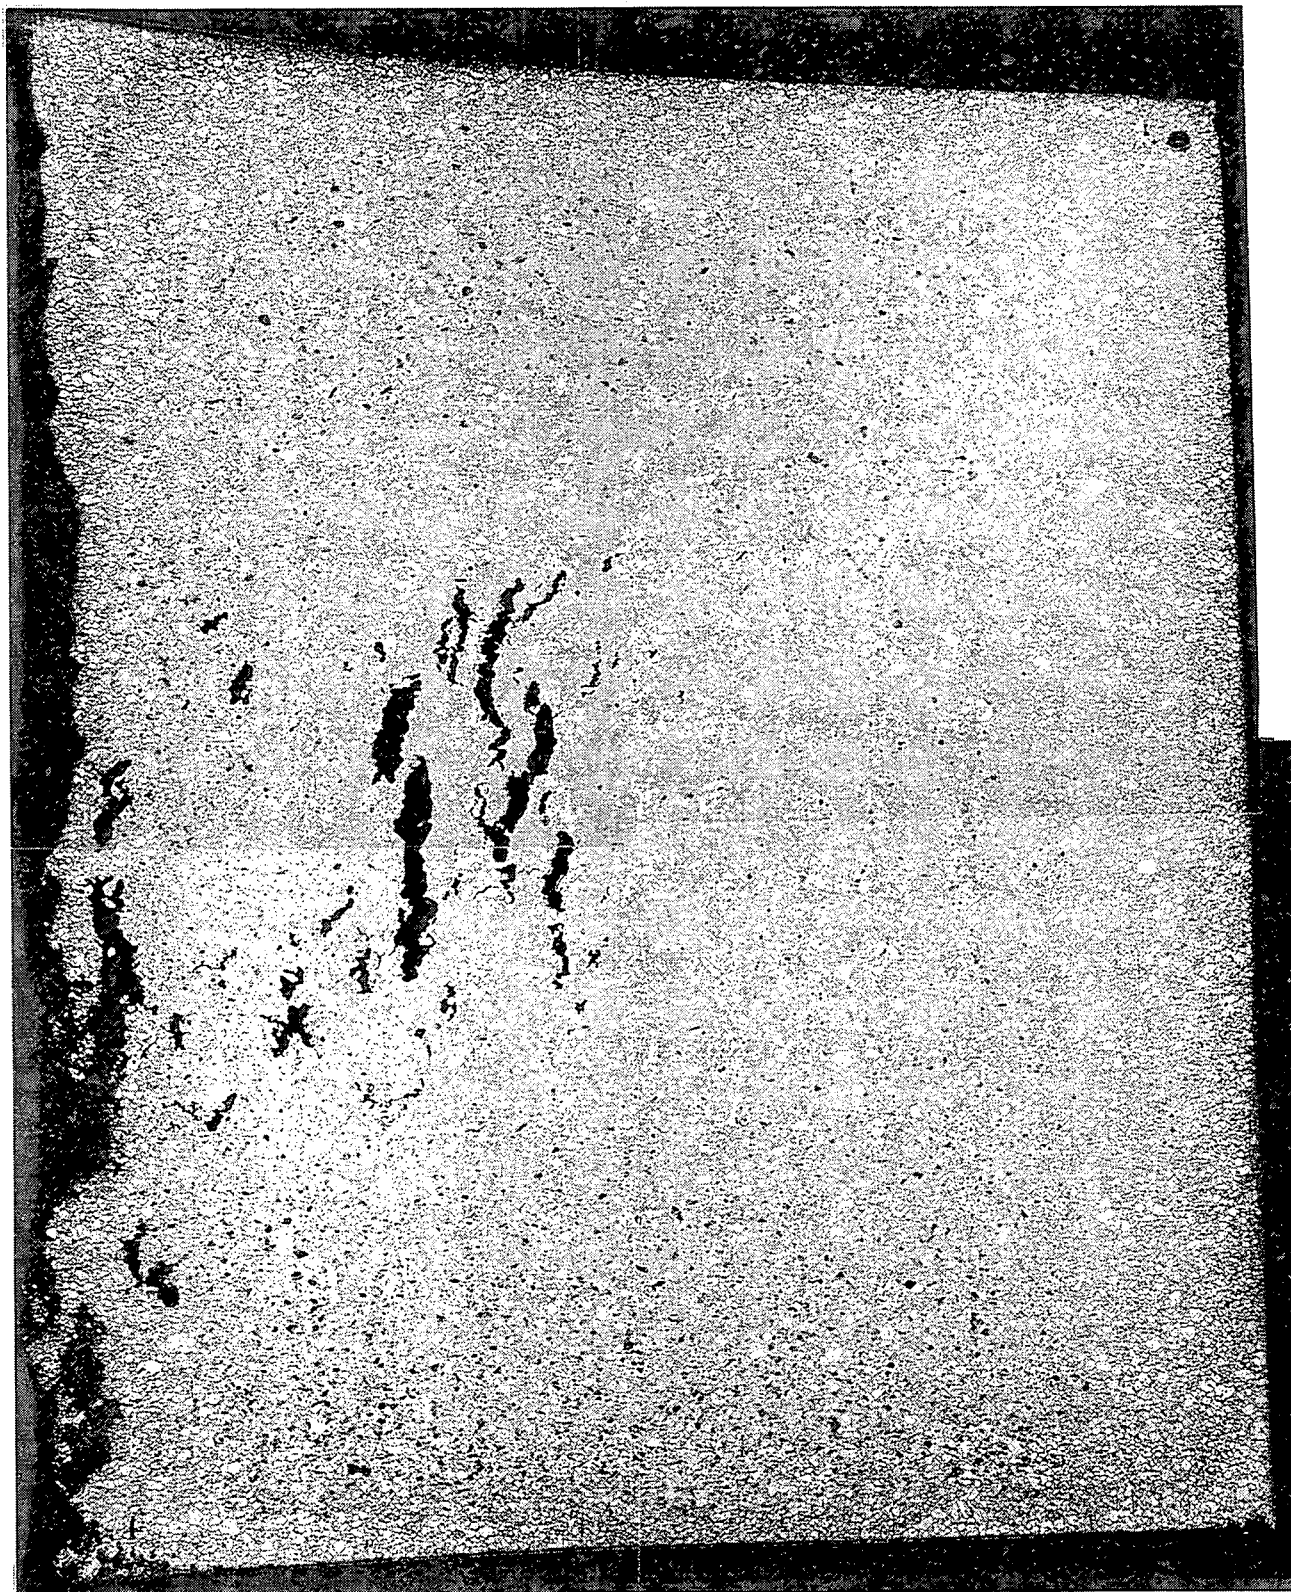
Figure 4-24 TSP1 crevice region Specimen 4B-2C of Tube R15C28. Radial metallographic sample after flattening and polishing to a depth of 0.010 inch below the OD surface. This montage is a higher magnification mirror image of Figure 4-23 because of the reversed optics of the two cameras. Mount M2161. Mag. 16X.

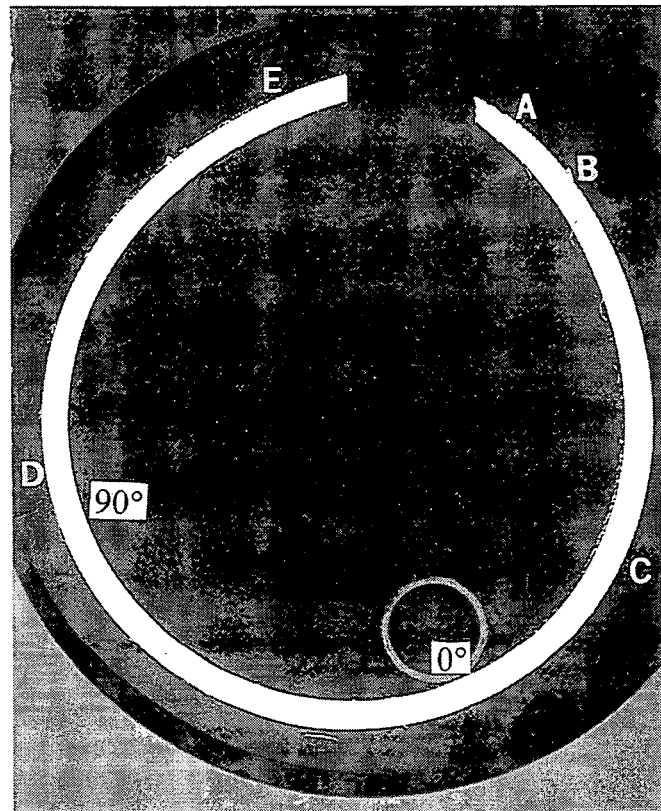
Metallography of the transverse Specimen 4B-2B is illustrated in Figures 4-28 through 4-31. Figure 4-28 shows the whole specimen. Areas A through E, marked in this figure, are shown at a higher magnification in Figures 4-29 through 4-31, where the profiles and depths of the cracks may be observed. These micrographs show clusters of very shallow, axially oriented stress corrosion cracks originating at the OD surface. The deepest crack observed by transverse metallography was 8% throughwall.

Figure 4-28 TSP1 crevice region Specimen 4B-2B of Tube R15C28. Transverse metallographic sample. Areas A through E are shown at a higher magnification in Figures 4-29 through 4-31. Mount M2160. Mag. 3.25X.

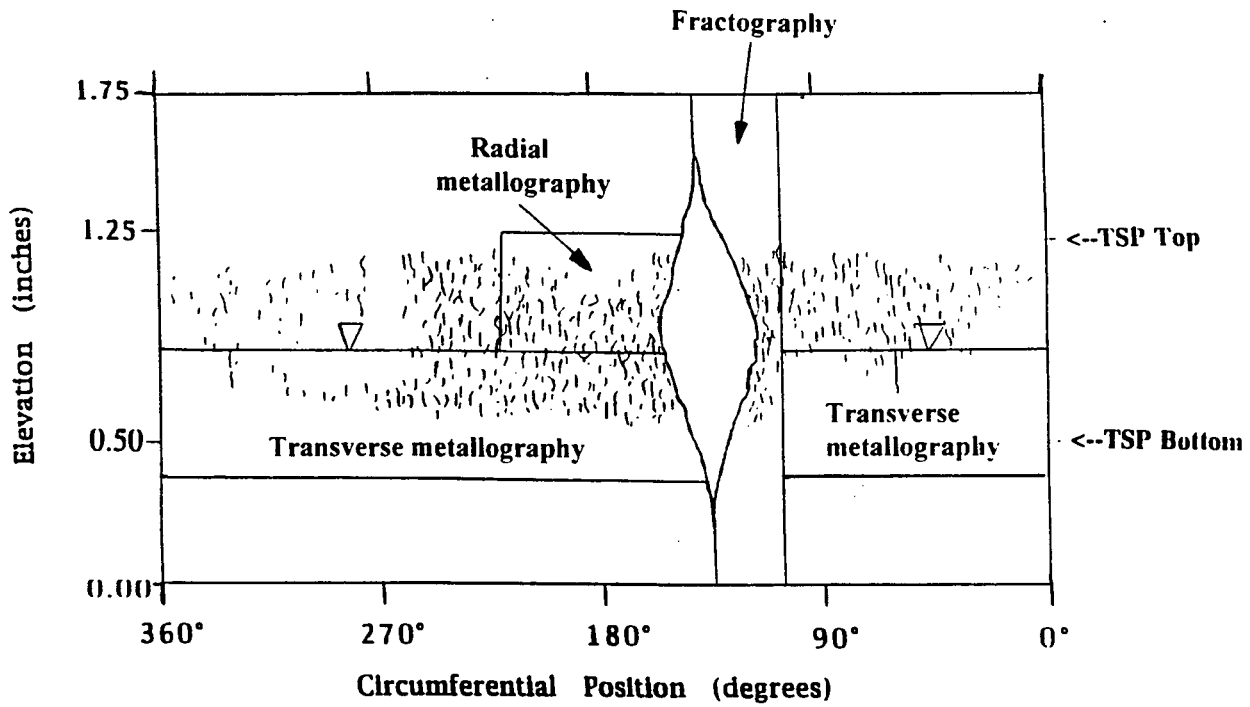
The locations of the fractographic and metallographic samples on the burst test Specimen 6B are shown on the sketch of Figure 4-32.

association of IGA with the IGSCC, since their D/W ratios were 6 to 9. (D/W ratios less than 3 suggest a high association of IGA with IGSCC; D/W ratios in the range of 3 to 20 point out to a moderate association of IGA with IGSCC; and D/W ratios greater than 20 are considered to show a low association of IGA with IGSCC). The examination has also shown that the area of cracking at the TSP2 crevice region was more extensive than that of the TSP1 crevice region (compare Figures 4-32 and 4-1).

Figure 4-32 TSP2 crevice region Specimen 6B of Tube R15C28. Sketch showing the locations of the fractographic and metallographic samples used in the study of the crack distribution and morphology.
