RE: DOCKET NO. 40-1162, LICENSE NO. SUA-56, LICENSE CONDITION
NO. 27C, TAILING RECLAMATION PLAN, COMPLETION REPORT

**SPLIT ROCK TAILING RECLAMATION
CONSTRUCTION COMPLETION REPORT**

Prepared By:
SHEPHERD MILLER, INC.
3801 Automation Way, Suite 100
Fort Collins, CO 80525

April 1999

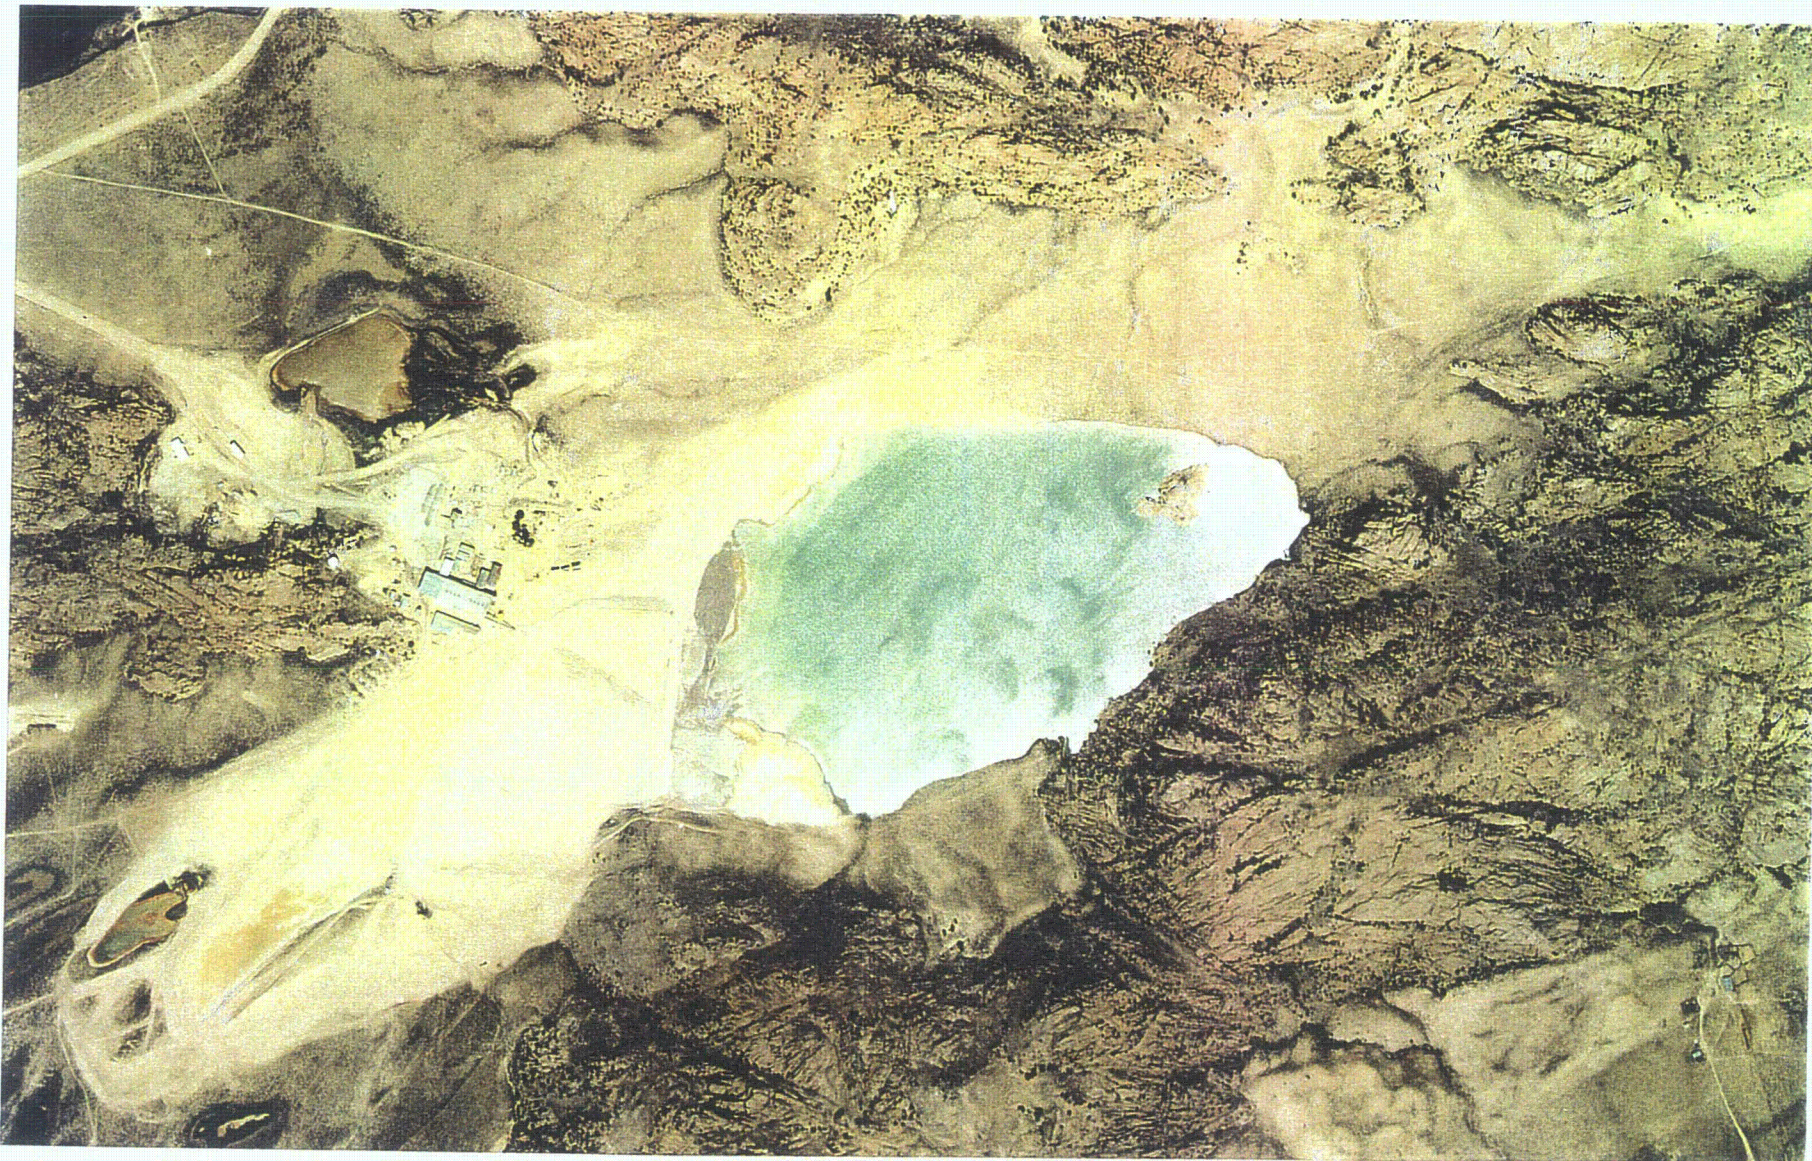
8.4.3	Management Audits	2.3.3.2.3	Field Density/Moisture Tests
		2.3.3.2.5	First Lift Thickness
		5.1	WNI Documentation
		5.2	WNI Audits
8.4.4	Radiation Work Permits	3.1	HASP Responsibilities

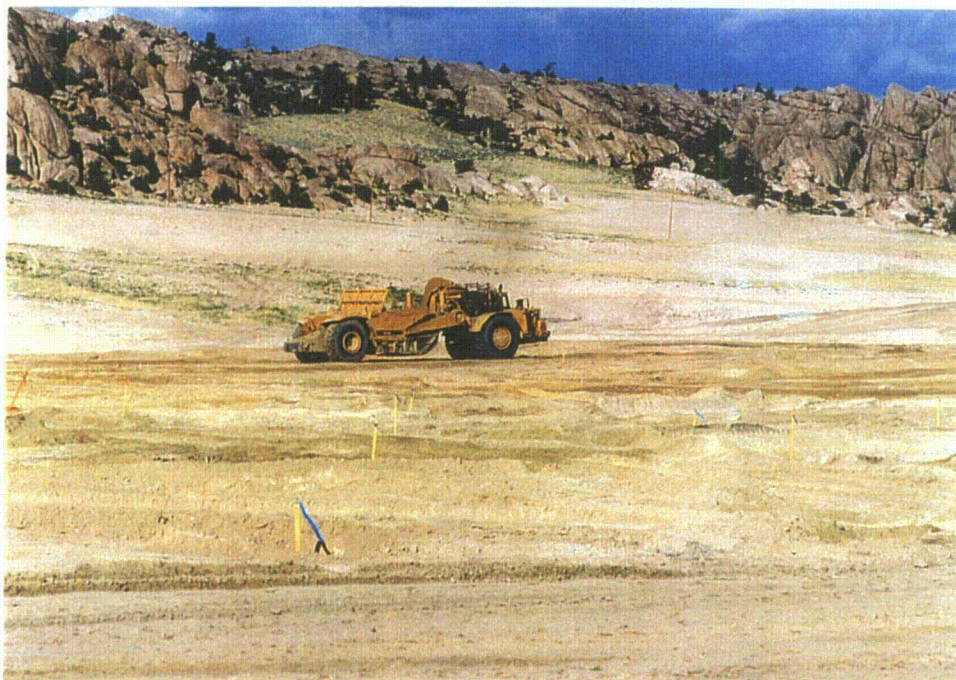
As reclamation construction activities progressed at the site it became necessary to revise certain aspects of the 2/94 TRP (WNI, 1994). There were three categories of revisions. The first category consisted of redesigning certain reclamation features, as discussed in Section 1.3.1.1 below. These changes were submitted to and approved by the NRC. The second category consisted of changes which were required because of unanticipated field conditions. In order to complete reclamation in a timely manner and to meet the required reclamation milestones in License Condition 75, field changes were not submitted to the NRC. Field changes are discussed in Section 1.3.1.2 below and justification for the changes is included in this report as Appendices C through F. The third category of changes consisted of deviations in the reclamation design which

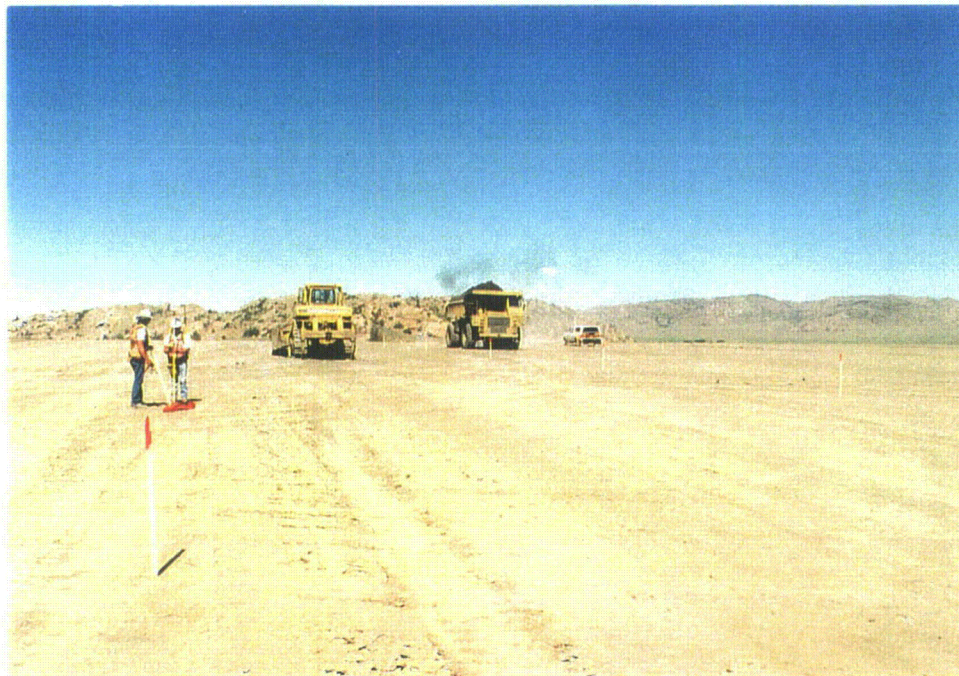
Section 7.2.3.2 of the 2/94 TRP Technical Specifications (WNI, 1994) titled, "Radon Barrier Layer Compaction Testing," required that Standard Proctor tests (ASTM D 698) be conducted at a rate of one test for every 15 field density tests. Additionally, one-point Proctor tests were to be conducted at a rate of one test for every 5 field density tests. During the first year of construction, both Standard Proctor and one-point Proctor tests were performed on the radon barrier layer (Cody Shale clay). The results of these tests indicated that the material had very uniform maximum density and optimum moisture values. Because of this uniformity, all of the Cody Shale clay material was determined to be "in the same family". Therefore, WNI proposed to the NRC that the one-point Proctor test requirement be deleted from the Technical Specifications. This proposal was approved by the NRC in Amendment 74 and License Condition 27(D) was added to SUA-56 to read as follows: "One-point Proctor tests shall not be required during placement of the Cody Shale clay."

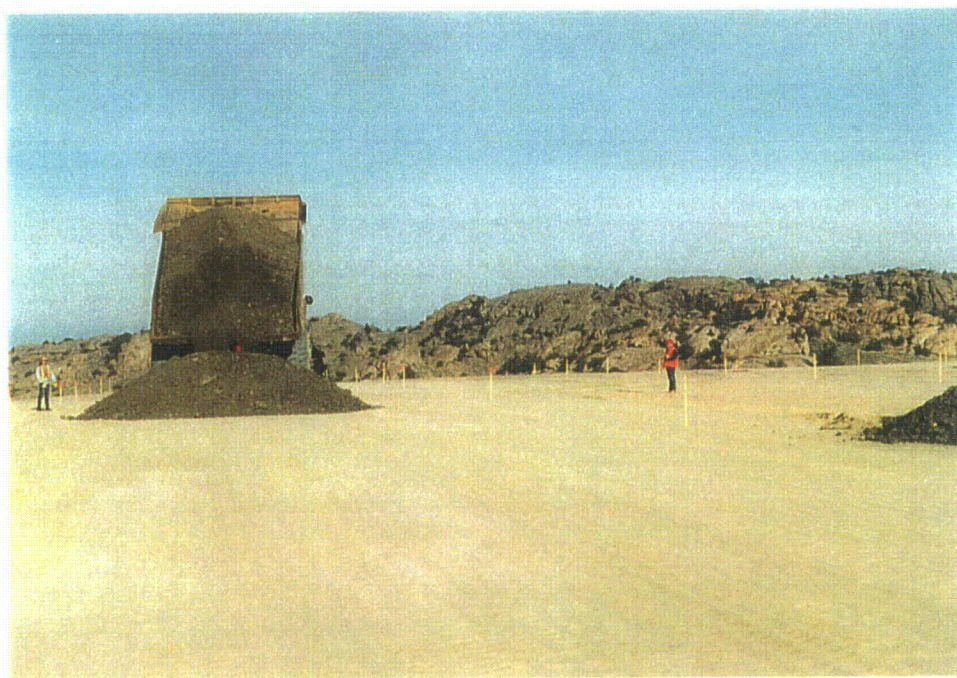
1.3.1.1.3 Approved Change in Frequency of Rock Gradation and Durability Tests

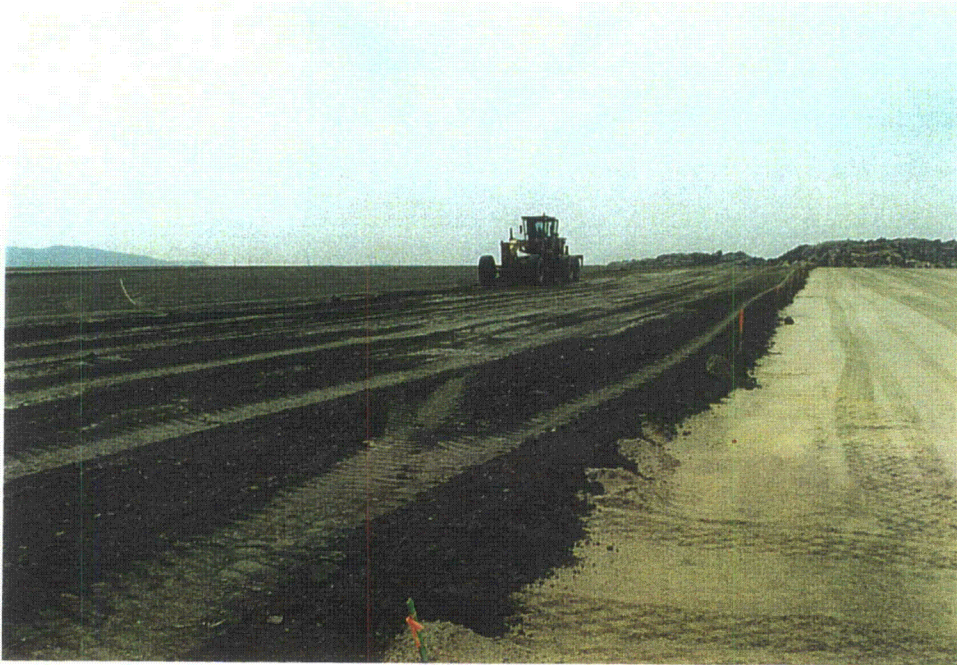
The gradation testing frequency in Table 5 of the 2/94 TRP (see Appendix Y) was revised by changing the word “placed” to “produced” and adding it as License Condition 27(G) to read as follows. “One test prior to placement and one test for every 10,000 cy of each size of material produced with a minimum of 3 tests for each material size. These gradation tests shall be performed as the material is being produced and prior to placement.”

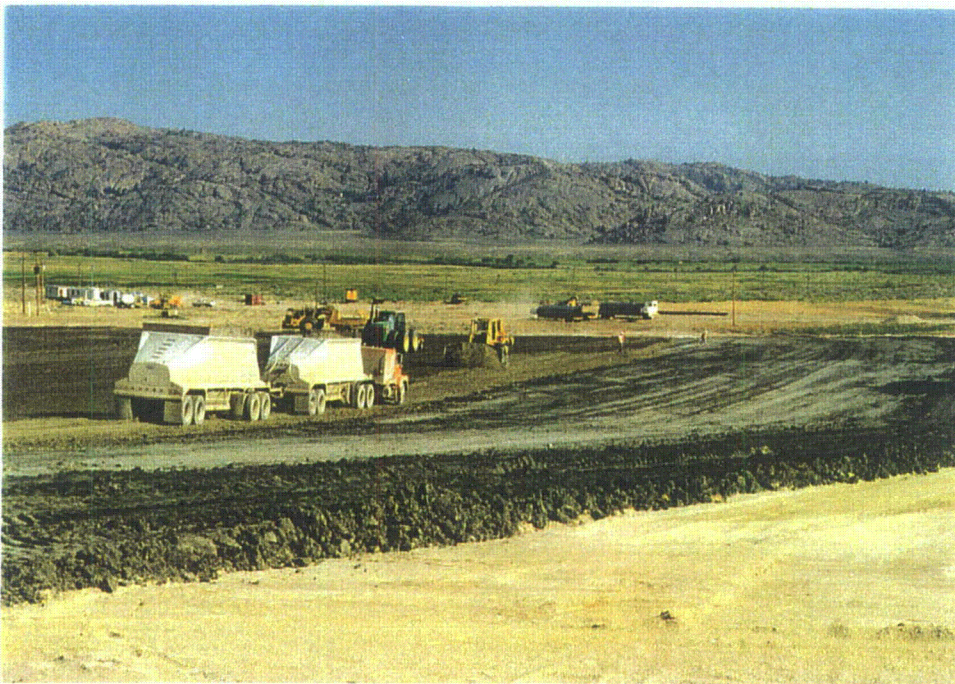
The proposed final surface configuration of the tailing impoundment is shown in Figures 4 and 5 of the 2/94 TRP (see Appendix Y). In designing this configuration, it was necessary to estimate the volume of windblown tailing or contaminated soils that would have to be cleaned up and placed over tailing. As windblown tailing cleanup progressed, it became obvious that the actual volume of windblown tailing or

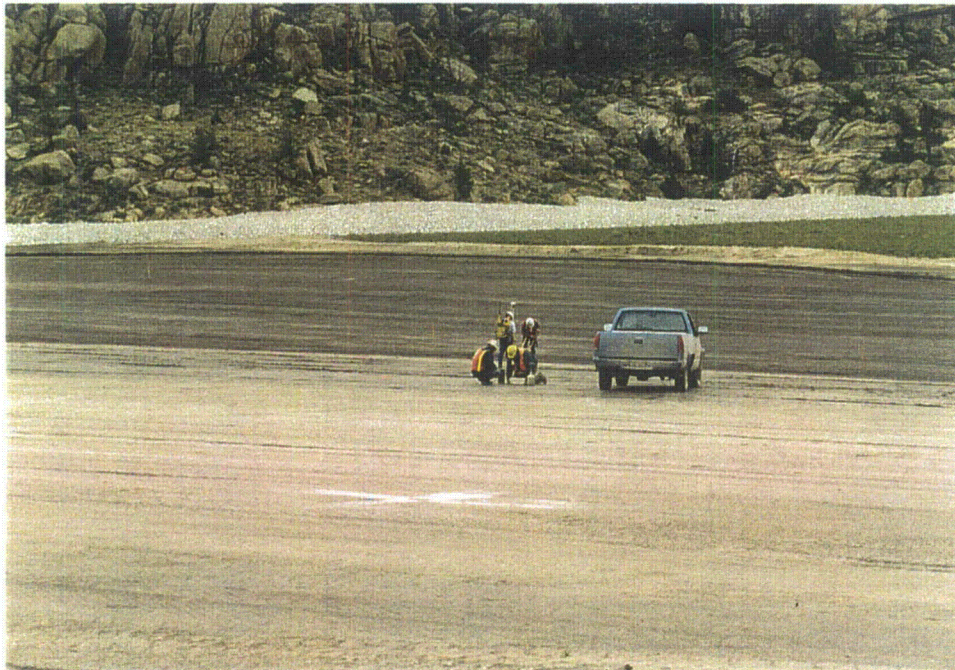
Due to the revised surface configuration and the additional thickness of windblown tailing, it became necessary to reevaluate the radon barrier designs of Areas 1A and 1B. However, since the approved radon barrier had already been placed in the southern half of these areas, only the radon barrier design in the northern half was reevaluated. For design purposes, Areas 1A and 1B were divided into northern and southern halves at the Northing 7,900 grid line. In addition, the northern half of Area 1B was further divided into a western portion and an eastern portion. These areas are as shown in Figure 2 of this report.

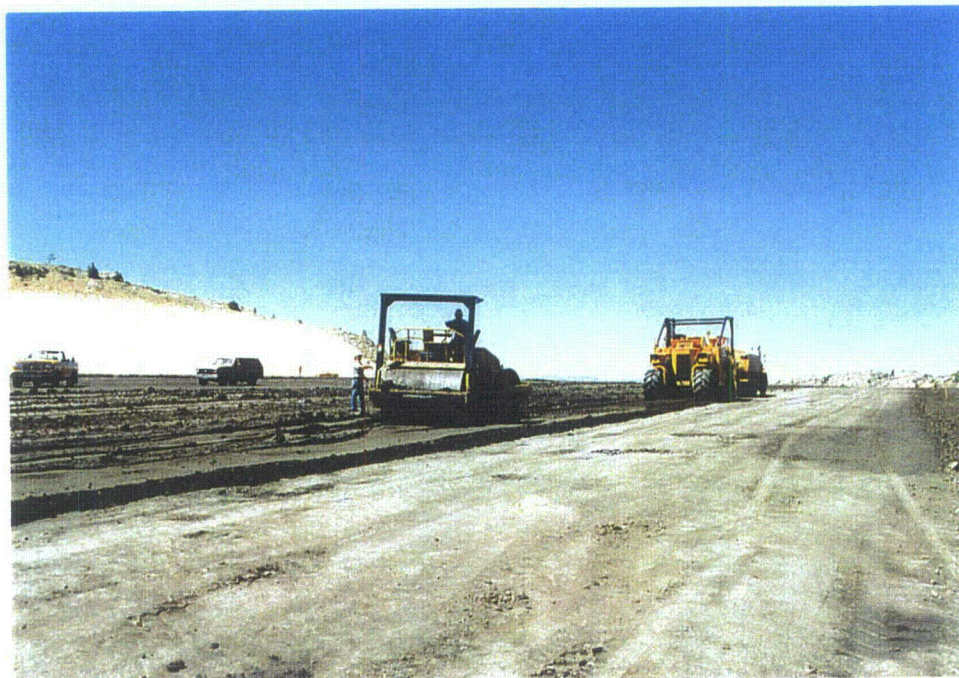
and #4." (WNI, 1997b). The reduced radon barrier layer thicknesses were approved by the NRC in Amendment 80 to SUA-56 and Condition 27(H) was added to read as follows: "The radon barrier for the northern portions of Area 1A and Area 1B shall be constructed in accordance with material types, thicknesses, and placement criteria described in the license amendment request, License Condition # 27: Revisions to Surface Reclamation Design - License Condition #33: Addendum to Radiological Verification Program, dated March 31, 1997; and the supplemental information, dated May 12, 1997 and May 30, 1997."

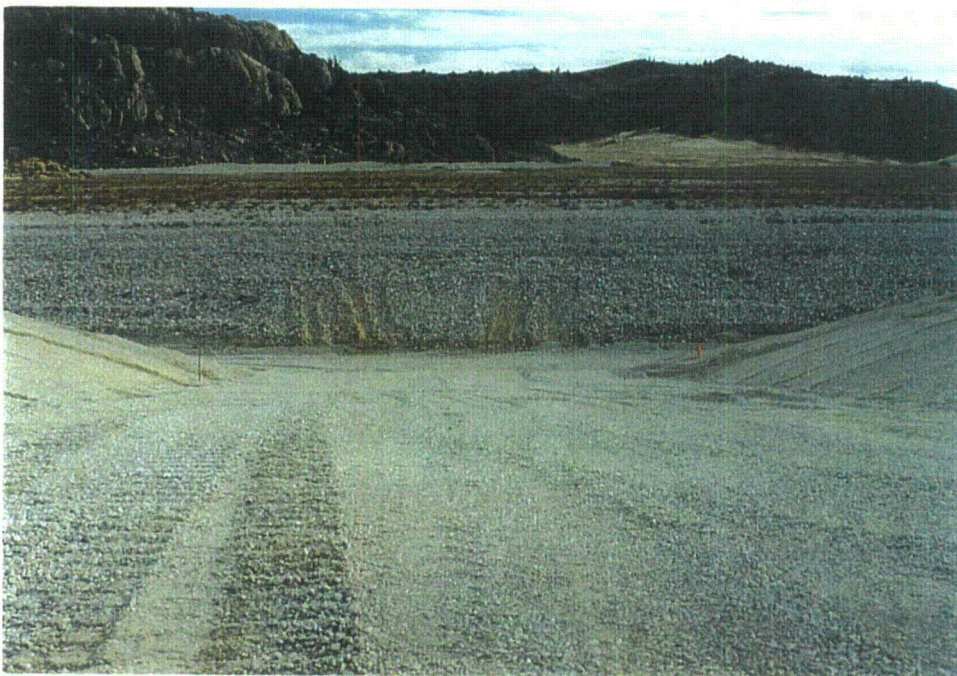
1.3.1.2.2 Field Change in Diversion Ditch Alignment

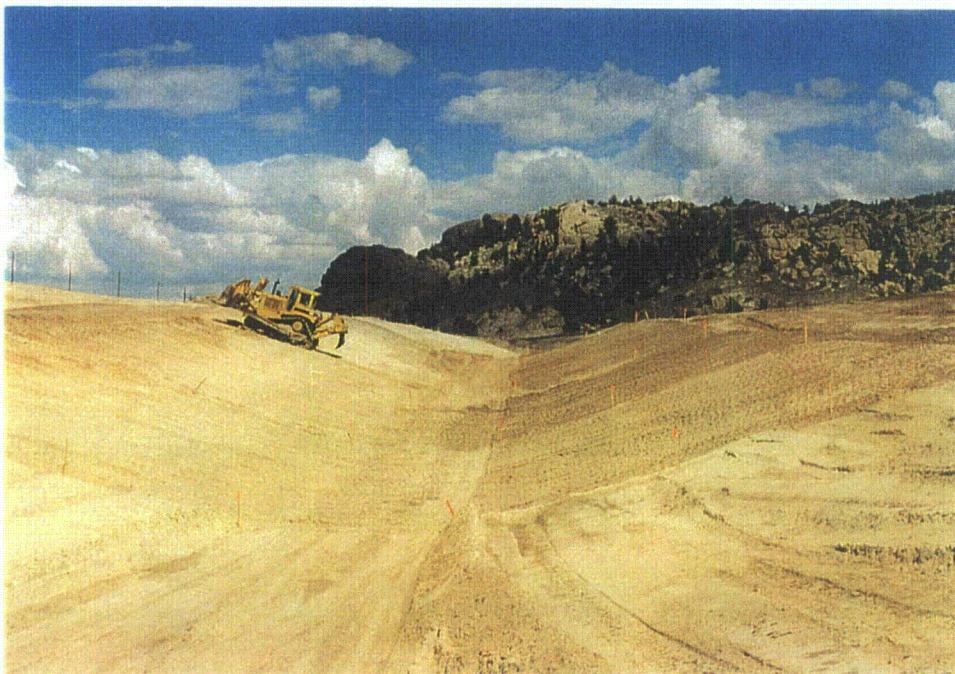
The upper end of the North Central Diversion Ditch (Station 0+00) is also Station 0+00 of the South Central Diversion Ditch (see Figure 5 of the 2/94 TRP which is included in Appendix Y of this report). Therefore, since the North Central Diversion Ditch had to be excavated an additional 1.3 feet at the upper end, so did the South Central Diversion Ditch. As a result, in the reanalysis of the South Central Diversion Ditch, both the elevations of the inlet and outlet were fixed as the inlet was 1.3 feet lower than that proposed in the 2/94 TRP and the outlet was as proposed in the 2/94 TRP which required a portion of the ditch to have a flatter slope. The slopes at the upper and lower ends of the ditch were assumed to be the same as they were in the 2/94 TRP so that the proposed riprap sizes would not have to be changed. However, the slope in the center portion of the ditch had to be reduced from 0.040 to 0.034. The results of the reanalysis which are presented in Appendix E, showed that the riprap sizes and ditch dimensions proposed in the TRP are adequate for the realigned South Central Diversion Ditch.

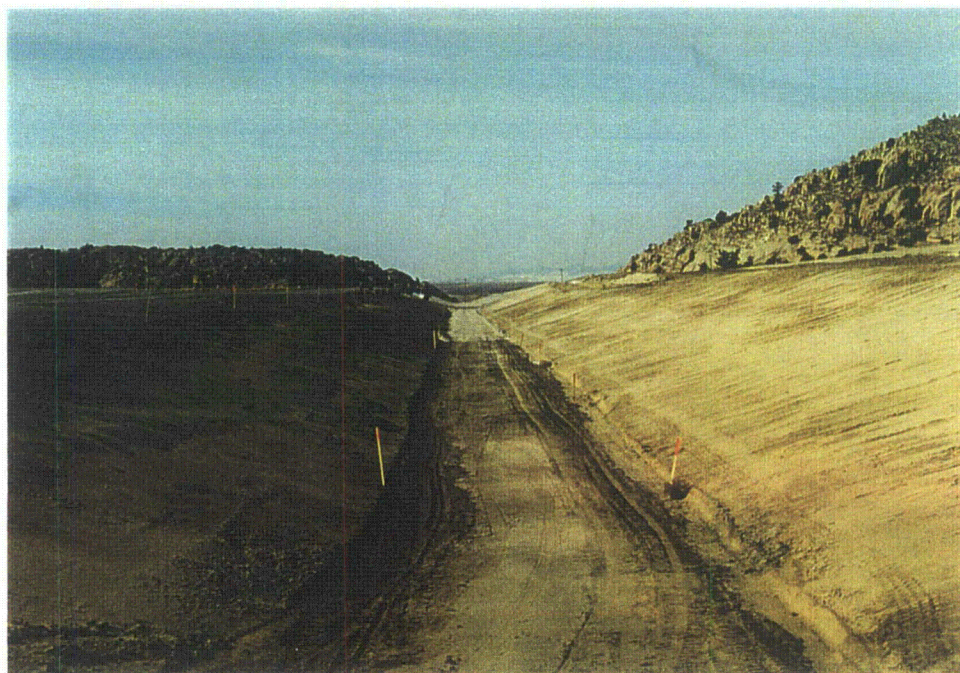
1.3.1.3.1 Deviation of Reclamation Cover
