7.3.0 Water Hammer At San Onofre

7.3.3 San Onofre Water Hammer Incident

7.3.5 Water Hammer-Induced Damage

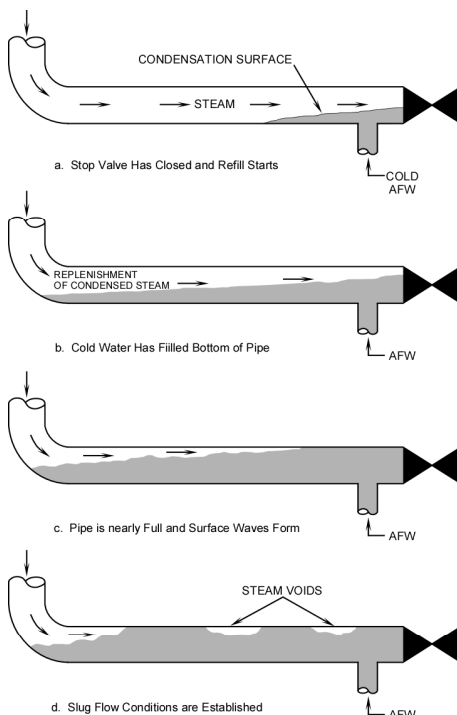
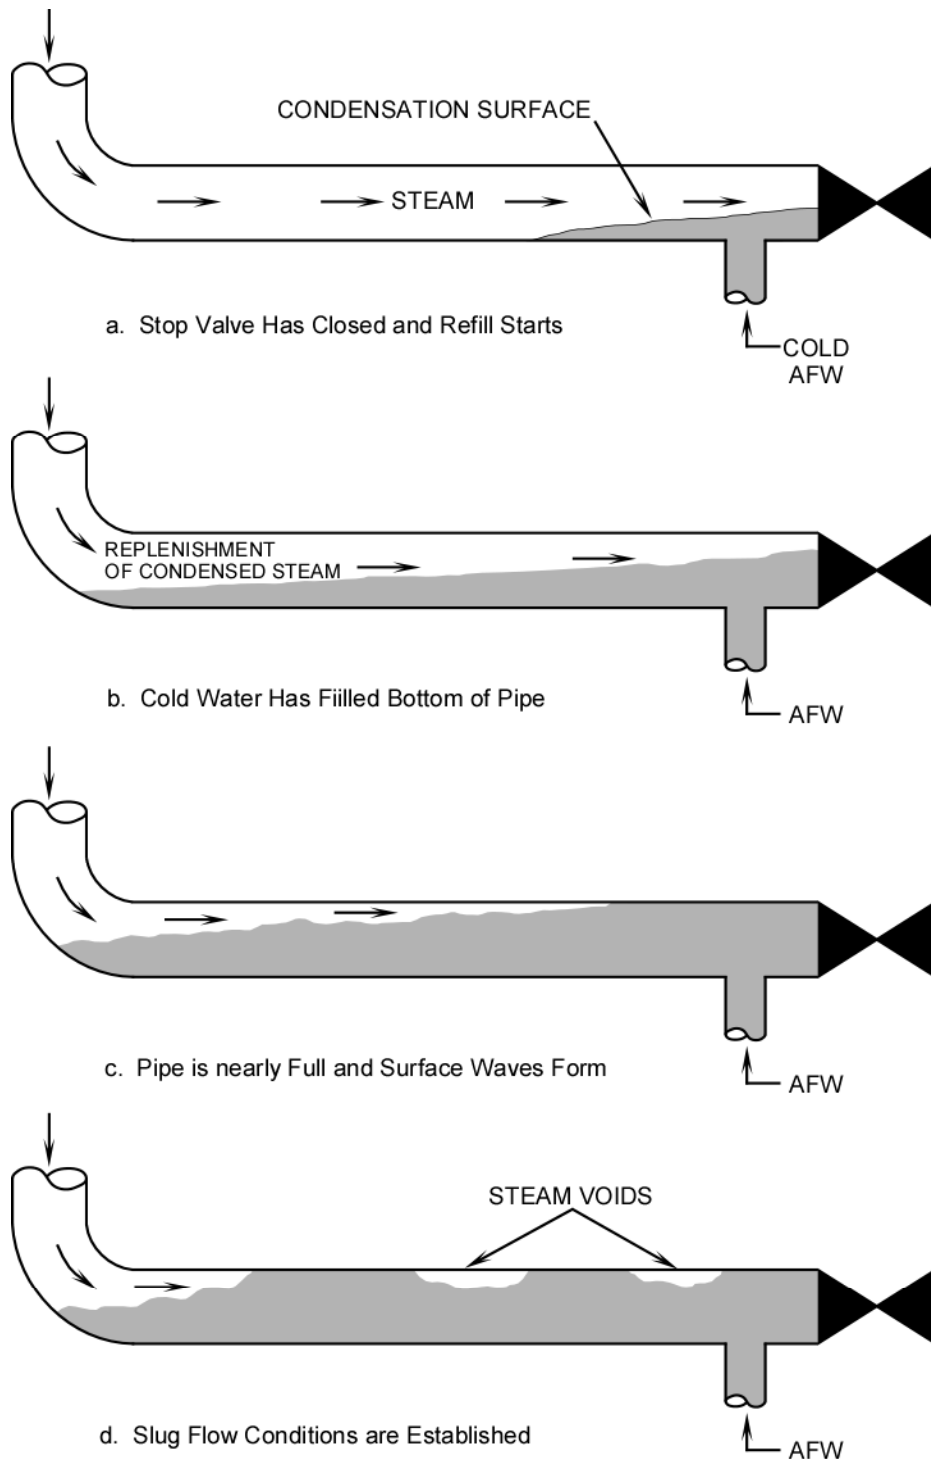
Figure 7.3-1 Filling of a Voided Feedwater Line

2. "Condensation-induced water hammer" results when cold water (such as auxiliary feedwater) comes in contact with steam. Conditions conducive to this type of water hammer are an abundant steam source and a long empty horizontal pipe run being refilled slowly with cold water. The cold water draws energy from the steam, with the rate of energy transfer being governed by local flow conditions. As the steam condenses, additional steam will flow countercurrent to the cold water, and as the pipe fills up (i.e., the void decreases) the steam velocity increases, setting up waves on the surface of the water, eventually entraining water and causing slug flow. Slug flow entraps steam pockets and promotes significant heat transfer between the steam and colder water. Figure 7.3-1 illustrates in simplified form the flow conditions which would

come about during the refilling of a voided horizontal feedwater line. Once slug flow conditions commence, a steam pocket will suddenly condense, creating a localized depressurization instantaneously. The resulting pressure imbalance across the slug (approximately 700 psi at SONGS-1) causes the slug to accelerate away from the source of pressure and toward the region of condensation.

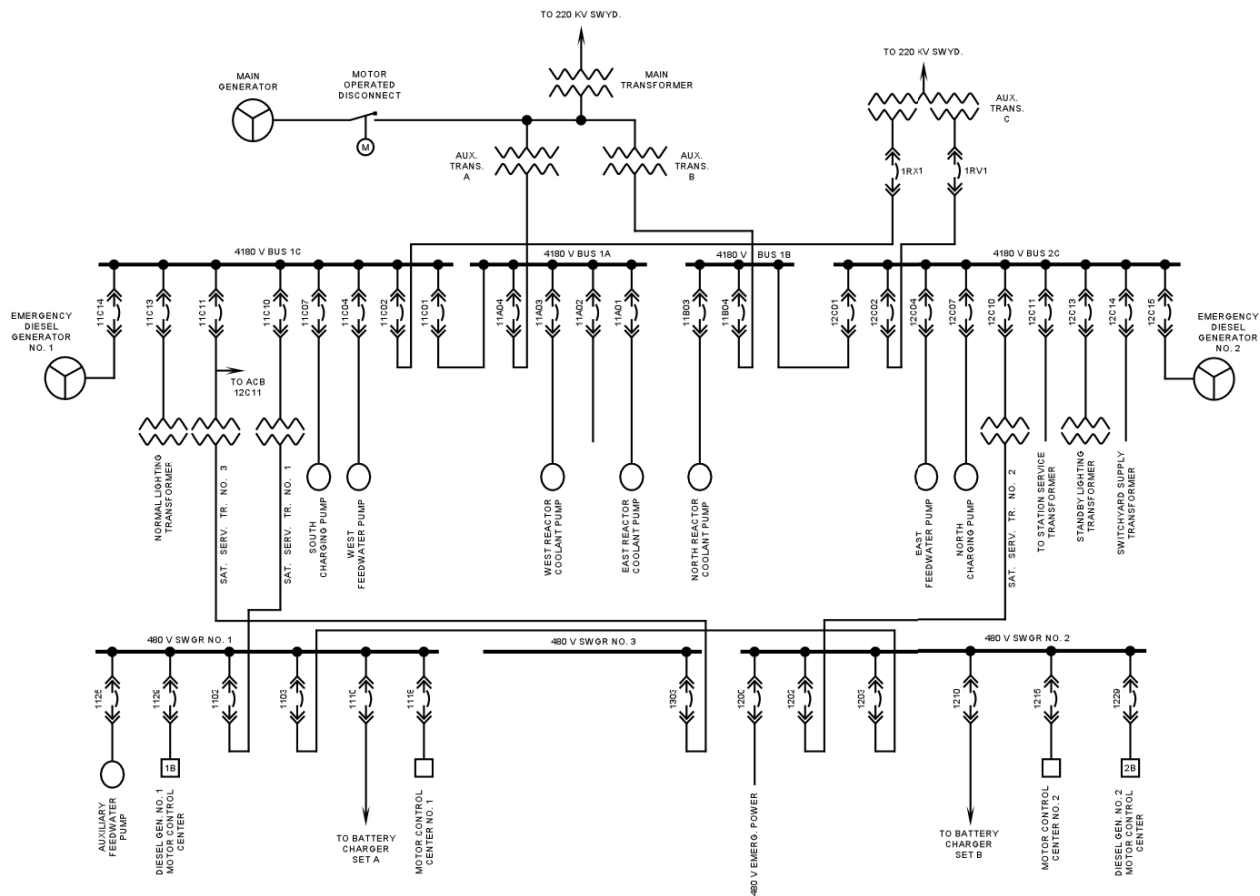
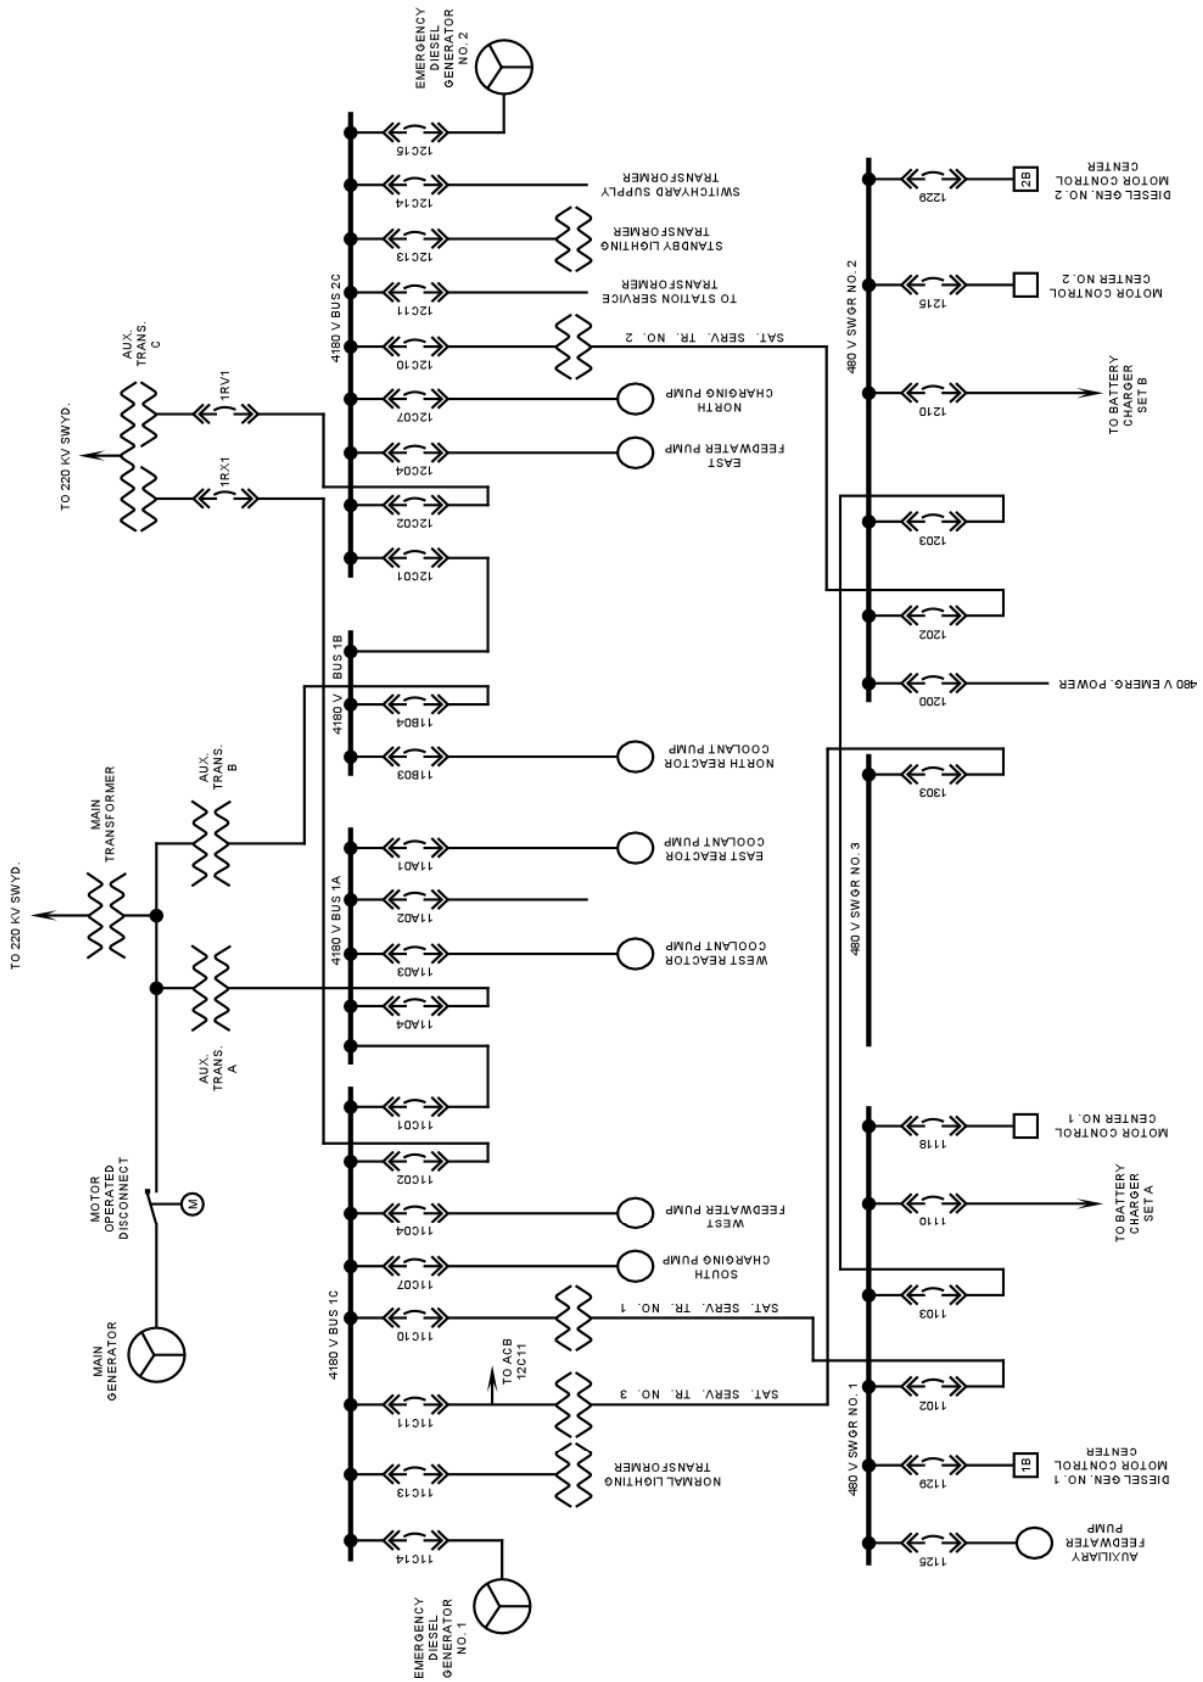
Figure 7.3-2 San Onofre Electrical System

At 4:51 a.m. on November 21, 1985, with the plant operating at 60 percent power, a ground fault was detected by protective relays associated with a transformer which was supplying power to one of two safety-related 4160-V electrical buses (see Figure 7.3-2). The resulting isolation of the transformer caused the safety-related bus to de-energize and tripped all feedwater and condensate pumps on the east side of the plant. The pumps on the west side of the plant were unaffected, since their power was supplied from another bus. The continued operation of the west feedwater and condensate pumps, in combination with the failure of the east feedwater pump discharge check valve to close, resulted in the overpressurization and rupture of an east-side flash evaporator low pressure heater unit. The operators, as required by emergency procedures dealing with electrical systems, tripped the reactor and turbine-generator. As a result, the plant experienced its first complete loss of steam generator feedwater and in-plant ac electrical power since it began operation.

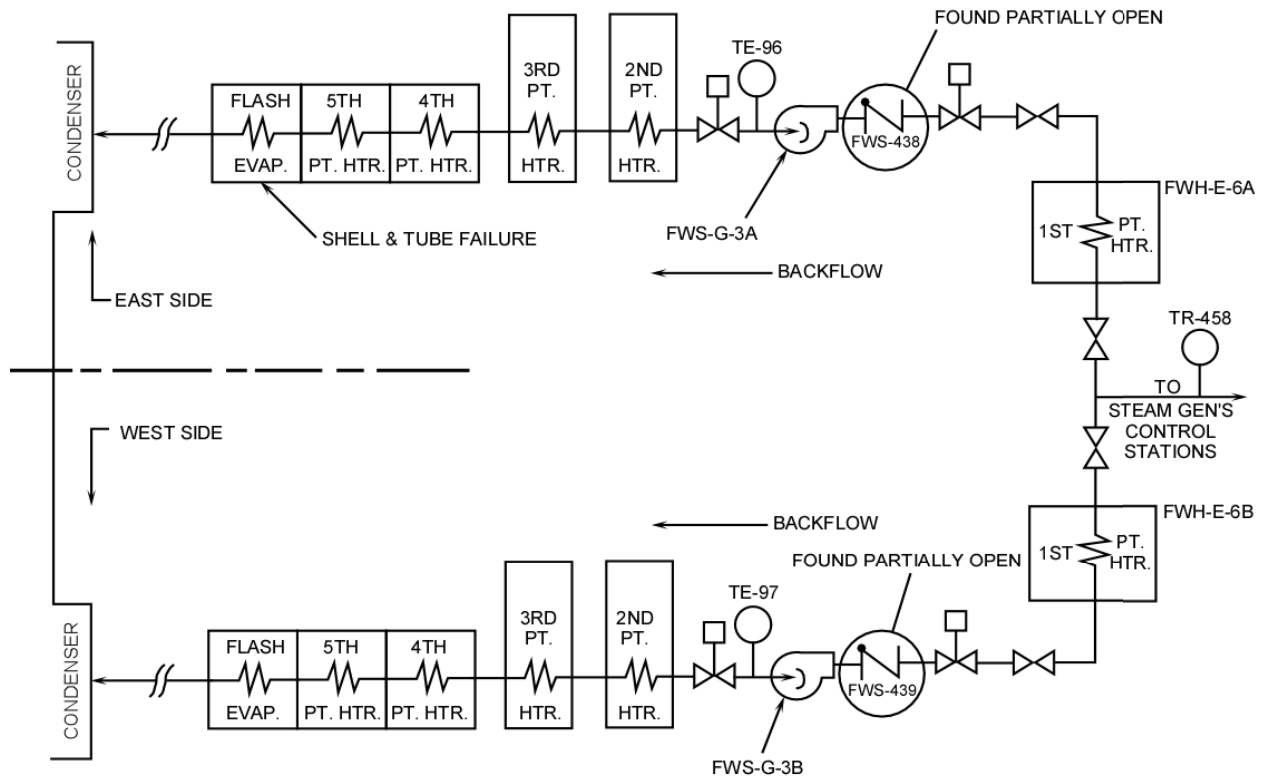
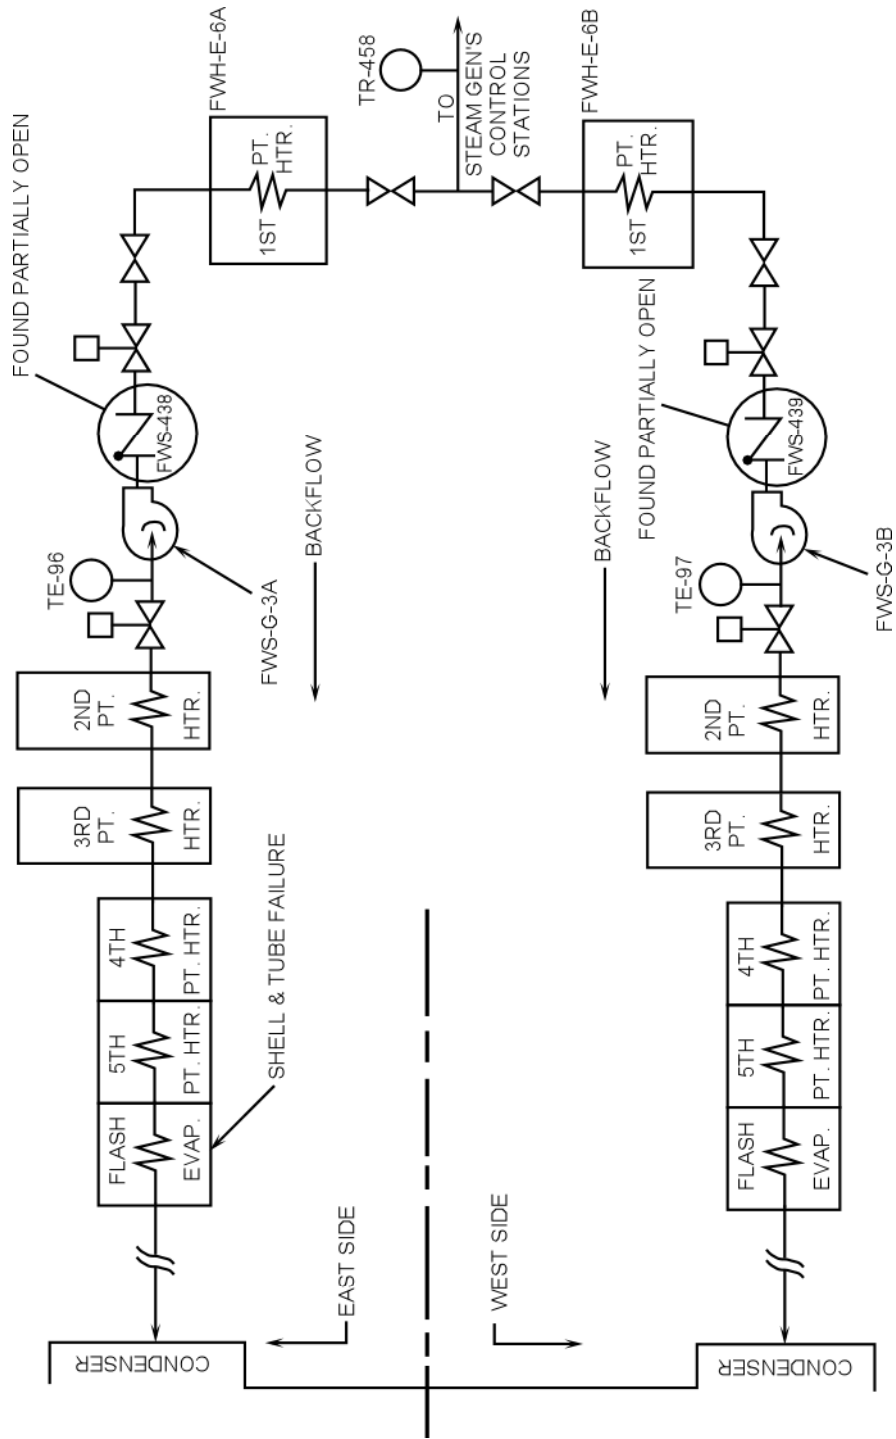
Figure 7.3-6 SONGS-1 Feedwater Flow Diagram

The plant conditions at SONGS-1 which led to a steam condensation-induced water hammer included the voiding of long horizontal lengths of feedwater lines, which allowed the backflow of steam from all steam generators before operators isolated the FW lines (by closing motor-operated valves MOV-20, 21, and 22), and the subsequent refilling of the FW lines with relatively cold (i.e., less than 100⁰F) AFW. Figures 7.3-3, 7.3-4, 7.3-5, 7.3-6, 7.3-7 and 7.3-8 illustrate the flowpaths, valves and other equipment affected by this water hammer.

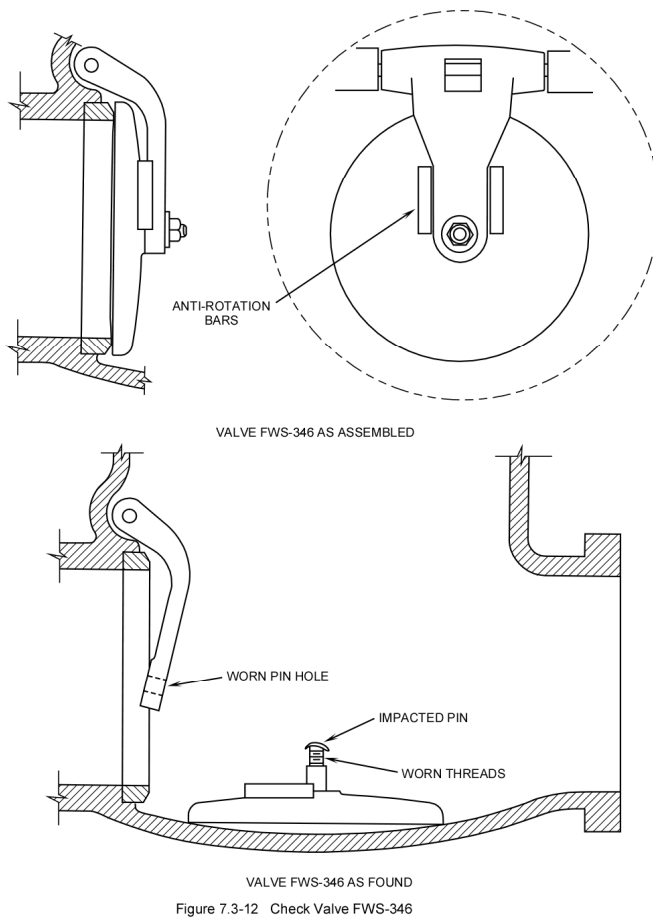
Figure 7.3-12 Check Valve FWS-346

Figure 7.3-11 shows the typical internal arrangement of a swing check valve. The water hammer originating in the feedwater line within the containment building generated a water slug which transmitted a pressure wave upstream to the loop B flow control station. Check valves FWS-346 and FWS-378, downstream of the control valves, were designed to prevent backflow, although post-event inspection revealed that the closure disk for FWS-346 (see Figure 7.3-12) was lying in the bottom of the valve chamber. Thus, any closed valve upstream of the check valve would be subjected to the water hammer loads. In addition to check valve FWS-378, flow control valve FCV-457 and motor-operated valve MOV-20 were subjected to the water hammer loads, because they had been closed by operators following the emergency operating procedures.

<u>Valve</u>	<u>Description</u>	<u>As Found</u>
FWS-345 SG A	MFW Reg Check	Disc separated from hinge arm, disc stud broken (threaded portion).
FWS-346 SG B	MFW Reg Check	Disc separated from hinge arm, disc stud deformed.
FWS-398 SG C	FW Reg Check	Disc nut loose. Disc partially open. Disc caught inside of seat ring.
FWS-438	FWP Discharge Check	Disc nut loose. Disc partially open. Disc caught inside of seat ring. (Figure 7.3-13)
FWS-439	FWP Discharge Check	Disc nut loose. Disc partially open. Anti-rotation lug lodged under hinge arm.
