SUBJECT: SUBMITTAL OF REFERENCE DOCUMENTS RELATED TO EA-11-018 FOR BROWNS FERRY NUCLEAR PLANT UNIT 1, DOCKET 50-259

Browns Ferry Unit 1 FCV-074-066
RHR Outboard Injection Valve Failure
NRC Questions (#2)

BFN 1-FCV-74-66 Valve Failure
NRC Follow-up Questions - April 18, 2011

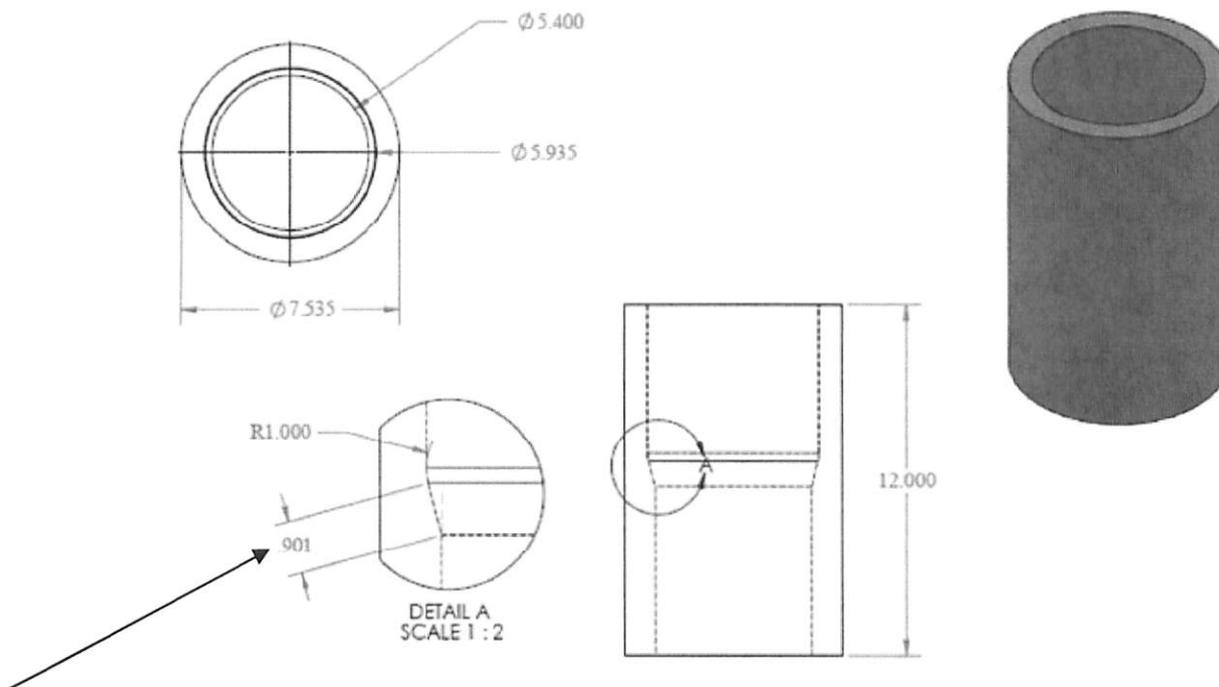
Pump vibration vane passing impulses vertically (axial stem direction) impacts the horizontal lodged disc of the horizontally oriented angle globe valve. The mock-up appropriately applied the vibration load orthogonal to the horizontal disc. The magnitude of vibration used by the mock-up was conservatively set to be less than the force per unit length of circumference measured from the actual RHR pump test; the actual 1-FCV-74-66 seat length was used for the mock-up which was 0.901 inches.

Multi-view model of the experiment 75° valve body.

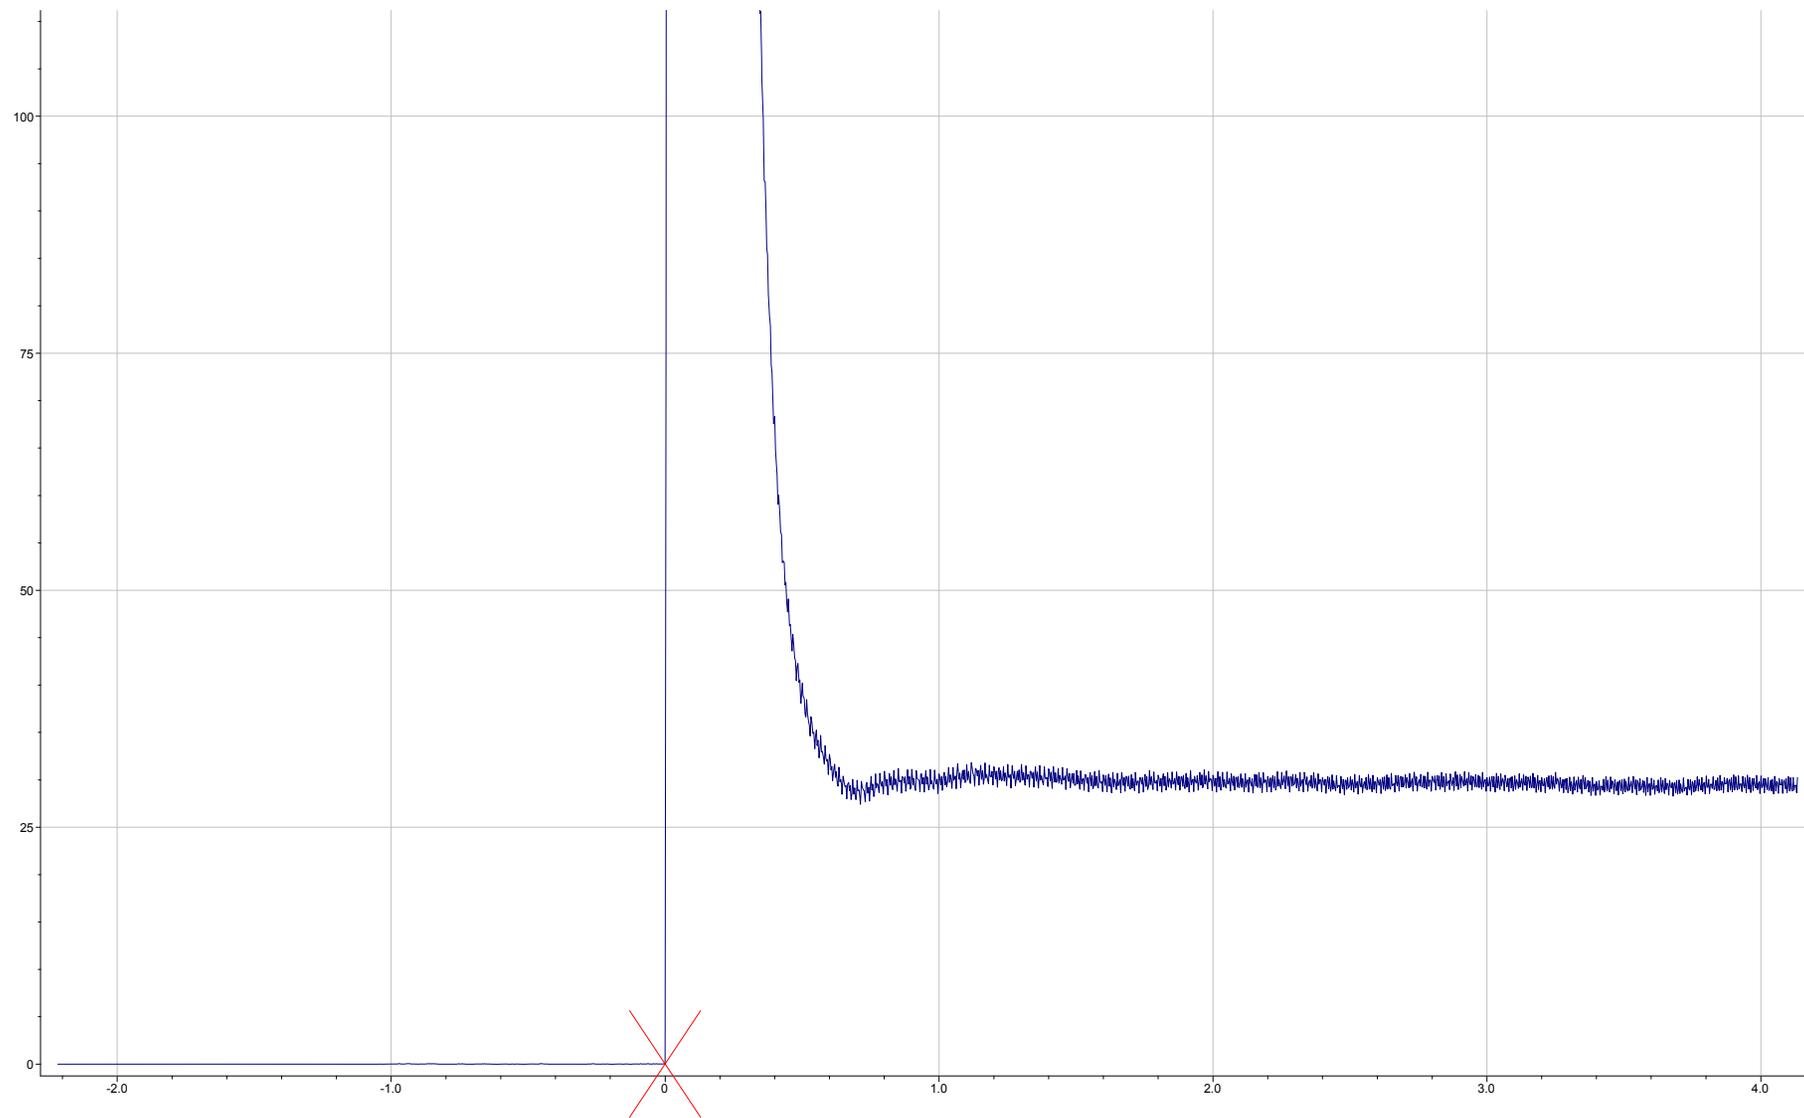
1-FCV-74-66 UNSEATING

It is true that we observed unseating in the MOVATS trace of November 12, 2010. The reason we did not observe the unseating in the past (2006) is that the stellite surface was relatively new and the COF is lower. With the additional time, the stellite surface has aged and the COF is high enough to observe the unseating. It would be anticipated that the unseating forces would be observed in 2008 however, the stem and disc were already separated. The seats were not machined in 2010 when the valve was repaired and therefore the aging stellite surfaces were not disturbed.

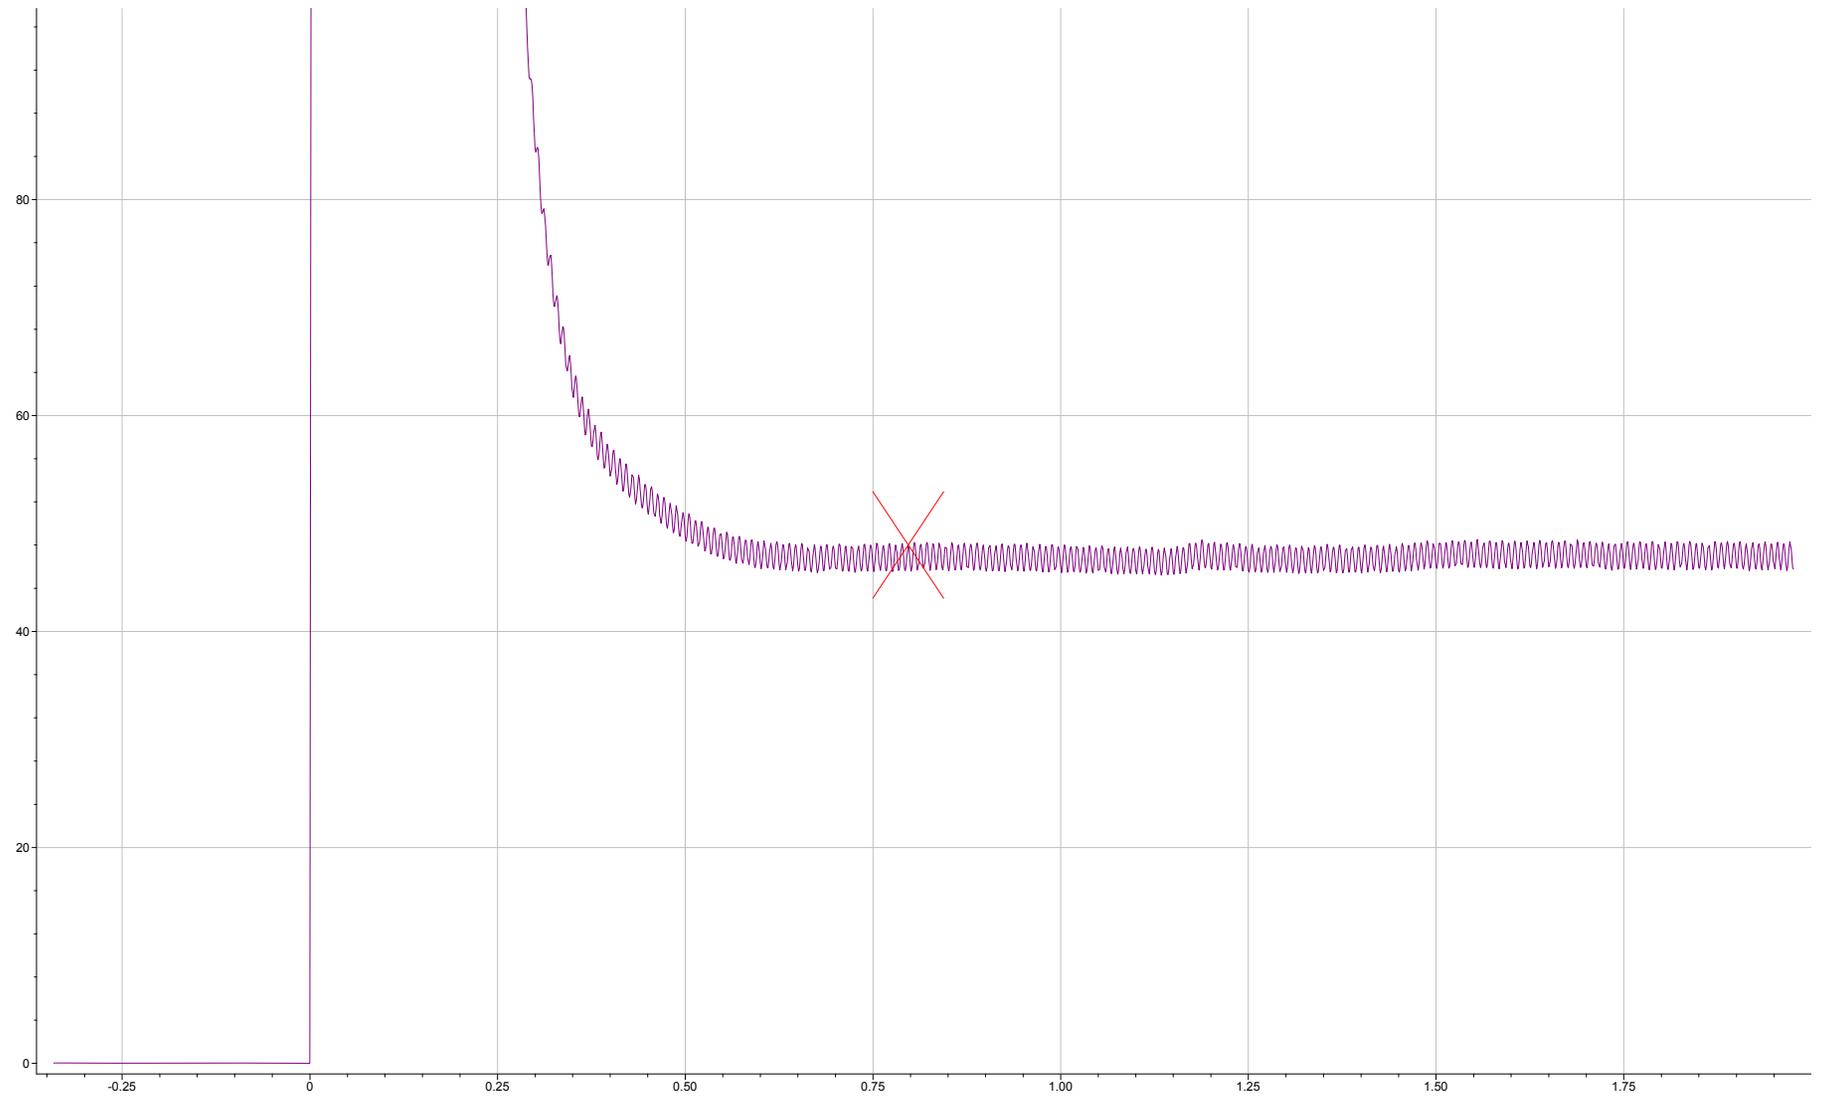
3-FCV-74-52 UNSEATING EVENT

The old maintenance data shown in Attachment 3 (Table A5.1) of the RCA, indicated that unseating events were observed for 3-FCV-074-52. However, such observations were not supported with thrust traces, rather by current traces (partial MOVATS). The Table A5.1 information was developed with the available partial MOVATS data from the past. No thrust values were available. Since these passive valves were not part of the MOV program, detailed analysis is not expected to be performed. Additionally, unseating forces are not significant for a normally open valve.

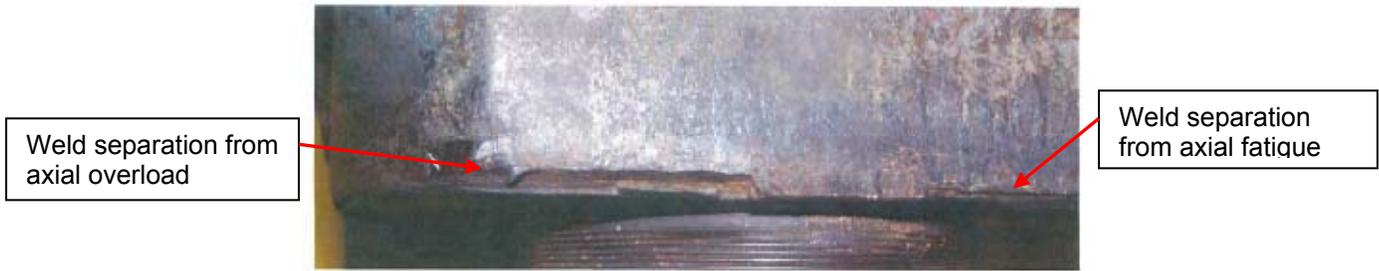
Figure 10

After the failure of valve 1-FCV-74-66, Southwest Research was retained to perform an on-site evaluation of the overall condition of the disc skirt paying particular attention to the broken tack welds and to make replicas of the fracture surface. Analysis of the replicas from the usable portions of the fracture surface indicated features consistent with fatigue (striations) and ductile tensile overload (dimpling). These features are fully consistent with initiation and initial propagation of the fracture along and across the weld cross-section due to fatigue with final failure occurring due to tensile overload (axial loading). Given the predominate crack propagation direction of the welds as discussed in the Southwest Research report (Reference 2), it is reasonable to conclude that the welds failed by axial overload or axial fatigue as discussed on page 10 of the report and evidenced in Figures 10, 29, 30 and 32.

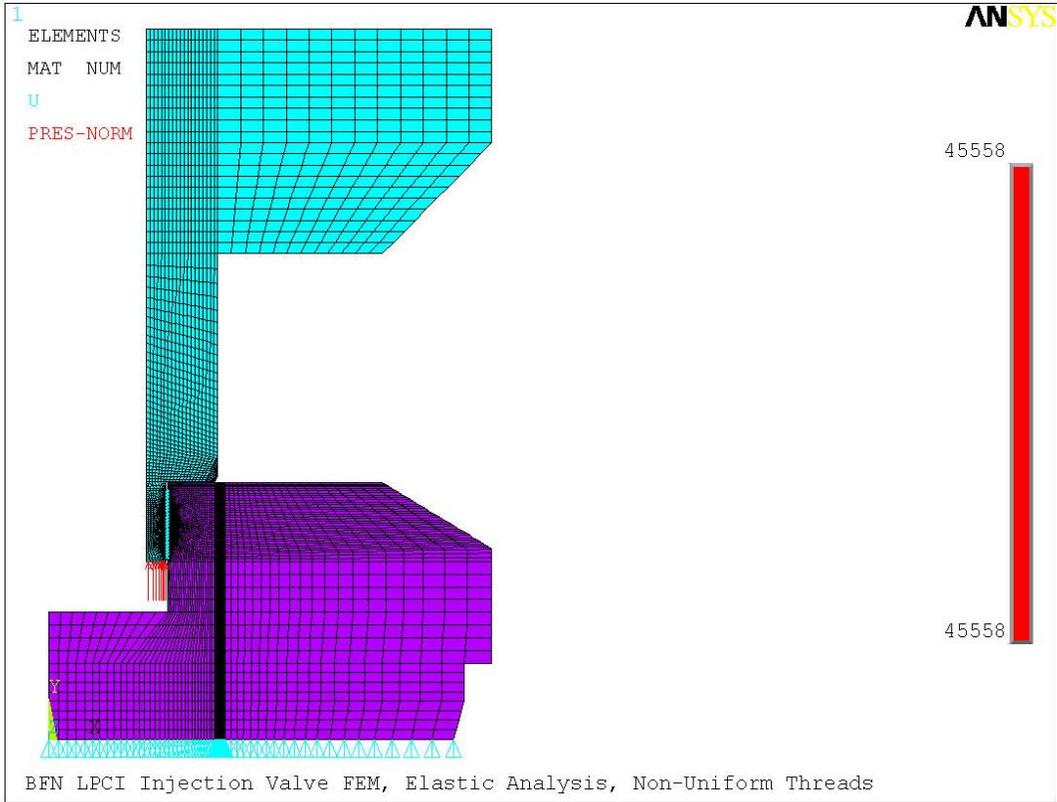
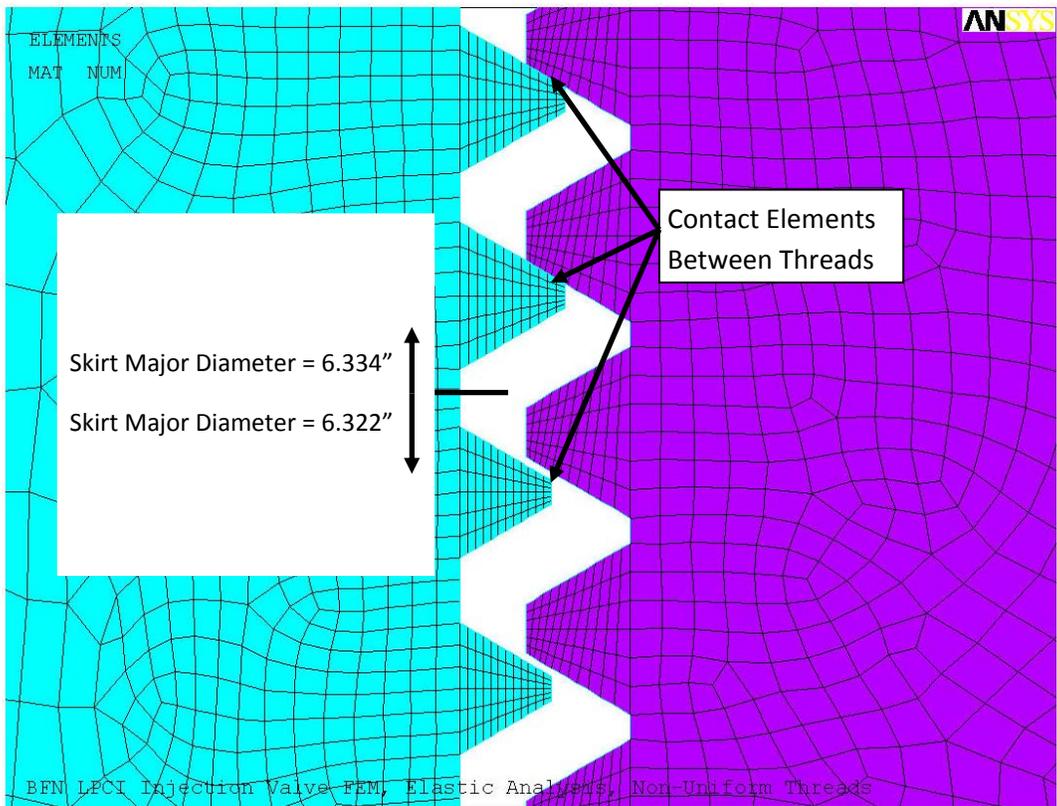
To shed further light on the above study, elastic-plastic calculations were performed [7] using the axisymmetric model developed in [2], but modifying the thread sizes to the averages of the measured thread diameters rather than the minimum. The model and thread diameters used are summarized in Figure 3. Two elastic-plastic cases were run. In Case 1, the larger diameter 6.334" (top 14) threads engaged first, followed by engagement of the 6.322" (bottom 8) threads once sufficient deformation occurred. In Case 2, the bottom eight threads were assumed to not engage, which would be consistent with slightly oversized disc threads and little or no damage to those threads during pullout. This was judged to be a reasonably conservative approximation in the axisymmetric model, based on the relative damage reported in Table 2. The results of the two analyses are presented in Figure 4, in the form of load versus displacement curves of the skirt relative to the disc.
