SUBJECT: Submits info re mod to load sequencing of ECCS equipment
 result of 850822 loss of transformer concurrence w/LOCA that
 could have defeated load sequencing logic of diesel update.

Subject: Duane Arnold Energy Center
Docket No: 50-331
Op. License No: DPR-49
Load Sequencing of ECCS Equipment
Reference: LER 85-36
File: A-118b

TITLE (4) **Emergency Diesel Generators Sequencing Design Anomaly**

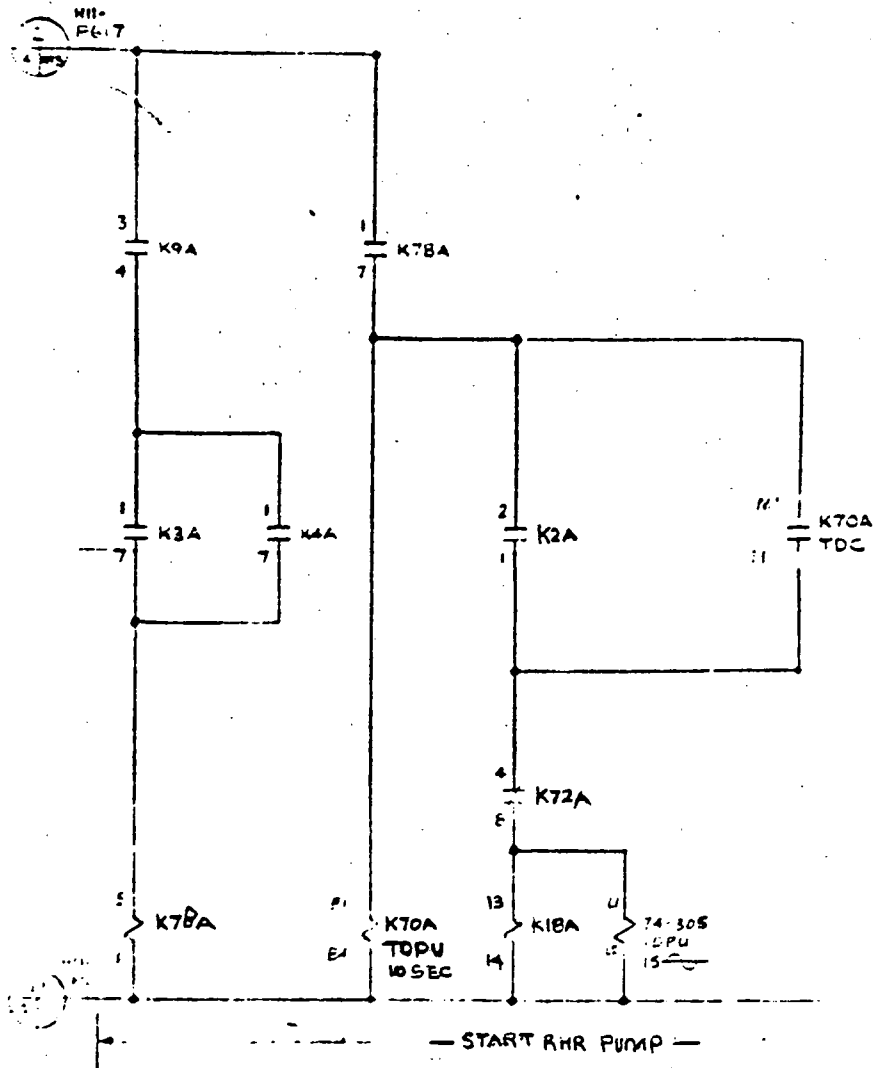
ESSENTIAL BUS 1A3 DEGRADED VOLTAGE DETECTION CIRCUIT
SCHEME 1.M32

The specifics of the logic are as follows: (see attached partial schematics). On APED drawings (GE) the core spray and RHR pumps receive autostart signals through two parallel paths, K2A contacts or K70A TDC (time delay contacts - Note relay numbers differ for core spray and the other RHR pumps). The K2A relay coil is in series with relay 195-3 contacts and is energized (195-3 contacts closed, 195-3 deenergized) by 125 V DC unless both the Startup and Standby Transformers are less than 65% voltage on their secondaries. A degraded voltage relay (vital bus voltage, 92.5%) can also deenergize relay K2A (by energizing 195-3) when the logic is satisfied (8.5 seconds below 92.5% and either transformer output breaker are closed onto the vital bus). Were the vital buses on the Standby Transformer and were only this transformer to fail, the following sequence would occur. Since the Startup Transformer still would have normal output voltage on its secondaries, the series logic would not energize relay 195-3. Similarly, 195-3 would not energize on degraded voltage (92.5% with 8.5 second delay) since the vital bus breakers would be open. Therefore, K2A contacts would remain closed and the pumps would be immediately loaded onto the diesel when it achieved nominal output.
