Subject: 10CFR21 Reporting of Defects and Non-Compliance -  
Engine Systems, Inc. Report No. 10CFR21-0102, Rev. 0

Air Start Motors with Friction-Clutch Inertia Drives

**Report No. 10CFR21-0102**

**10CFR21 REPORTING OF DEFECTS  
AND NON-COMPLIANCE**

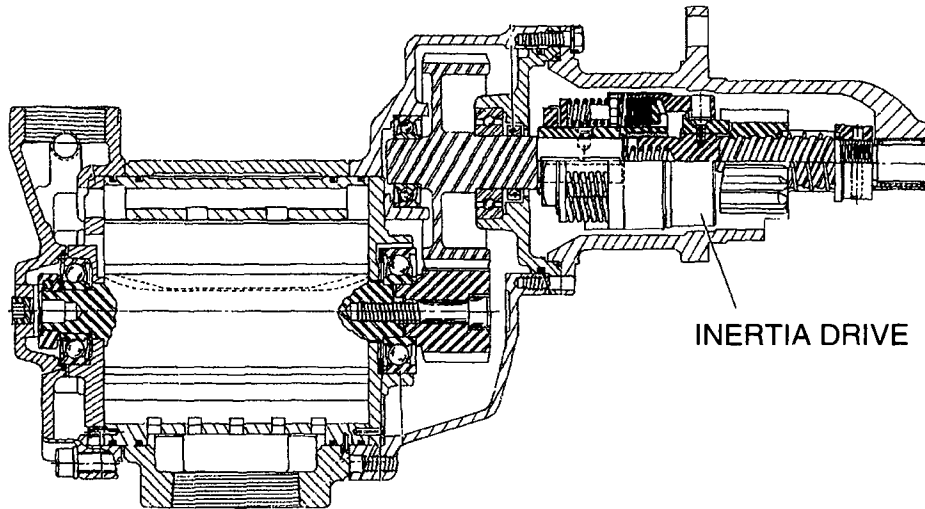
**TYPICAL AIR START MOTOR ASSEMBLY**

The evaluation was concluded on 08/01/11 and determined the air motor failure to be a reportable defect as defined by 10CFR21. The starter drive failure was attributed to excessive torque adjustment of the clutch assembly. This overstressed the clutch disc plates which lead to eventual failure of the friction-clutch inertia drive assembly. Failure of the clutch drive renders the air start motor inoperative. Depending upon the configuration of the engine’s starting system, an inoperative air start motor could cause excessive starting times or a start failure. Either scenario has the potential to prevent the emergency diesel generator from performing its safety related function.

Users should return any of the suspect air start motors in their inventory to ESI for verification of the inertia drive clutch torque setting. These starters can then be used to replace currently installed starters once the torque setting is verified.
