METALLURGICAL INVESTIGATION OF
CRACKING IN A REACTOR VESSEL NOZZLE SAFE-END

SWRI PROJECT 02-5389-001

INTERIM REPORT

Iowa Electric Power
Cedar Rapids

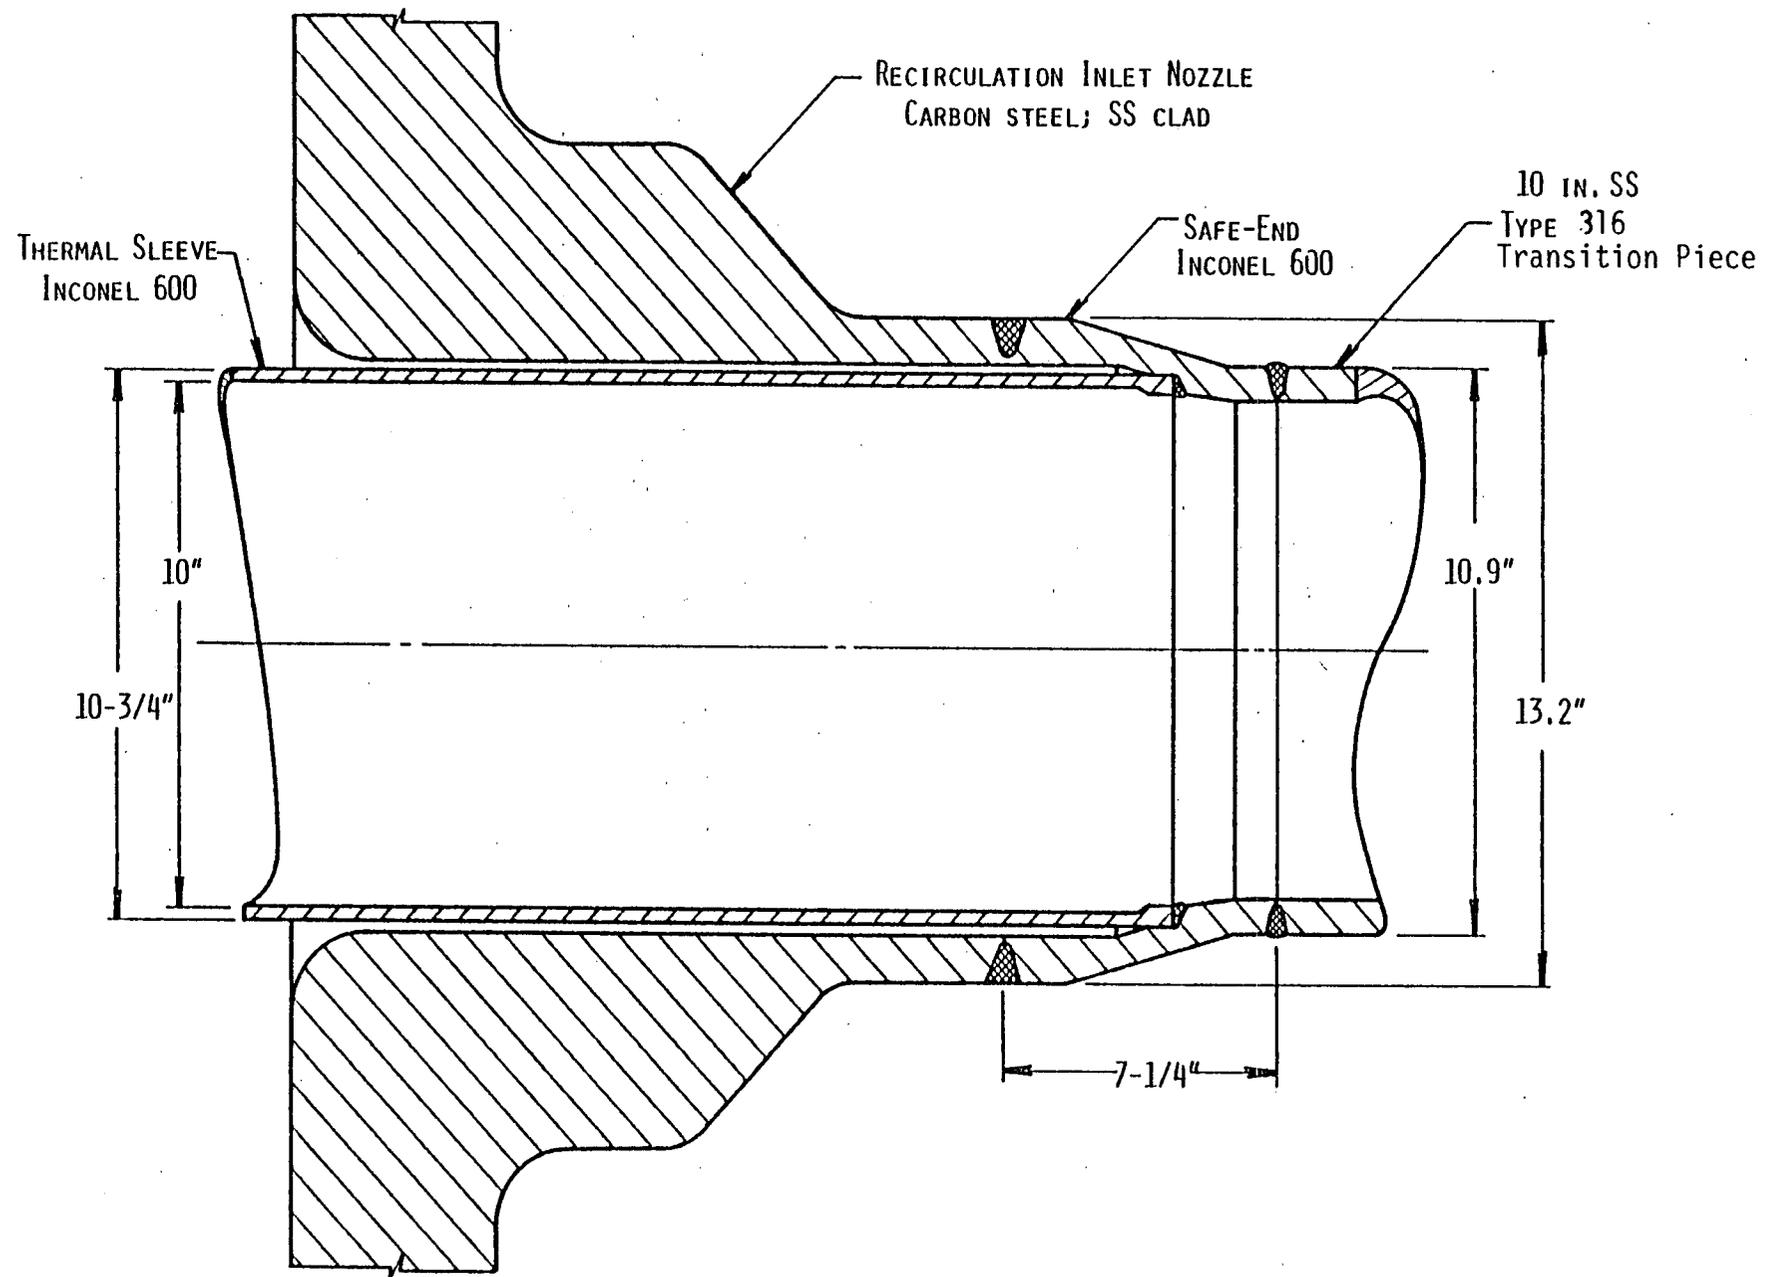
FIGURE 1-1. RECIRCULATION INLET NOZZLE

A safe-end forging, removed from a recirculation inlet nozzle of the reactor vessel at the Duane Arnold Energy Center was submitted to SwRI by Iowa Electric Light and Power Company. A diagram of the recirculation inlet nozzle with the attached safe-end and thermal sleeve is shown in Figure 1-1. The safe-end sample, shown in Figure 1-2, was identified as recirculation unit nozzle 2A. Through-wall cracking had developed in service over approximately 85° of the outside circumference (from 75° clockwise to 160°). The appearance of the crack on the outside surface is shown in Figure 1-3. A metallurgical examination of the safe-end was initiated to establish the nature and extent of cracking and to identify the mechanism and cause of failure. This report is submitted to present the data and information obtained to date in the investigation.

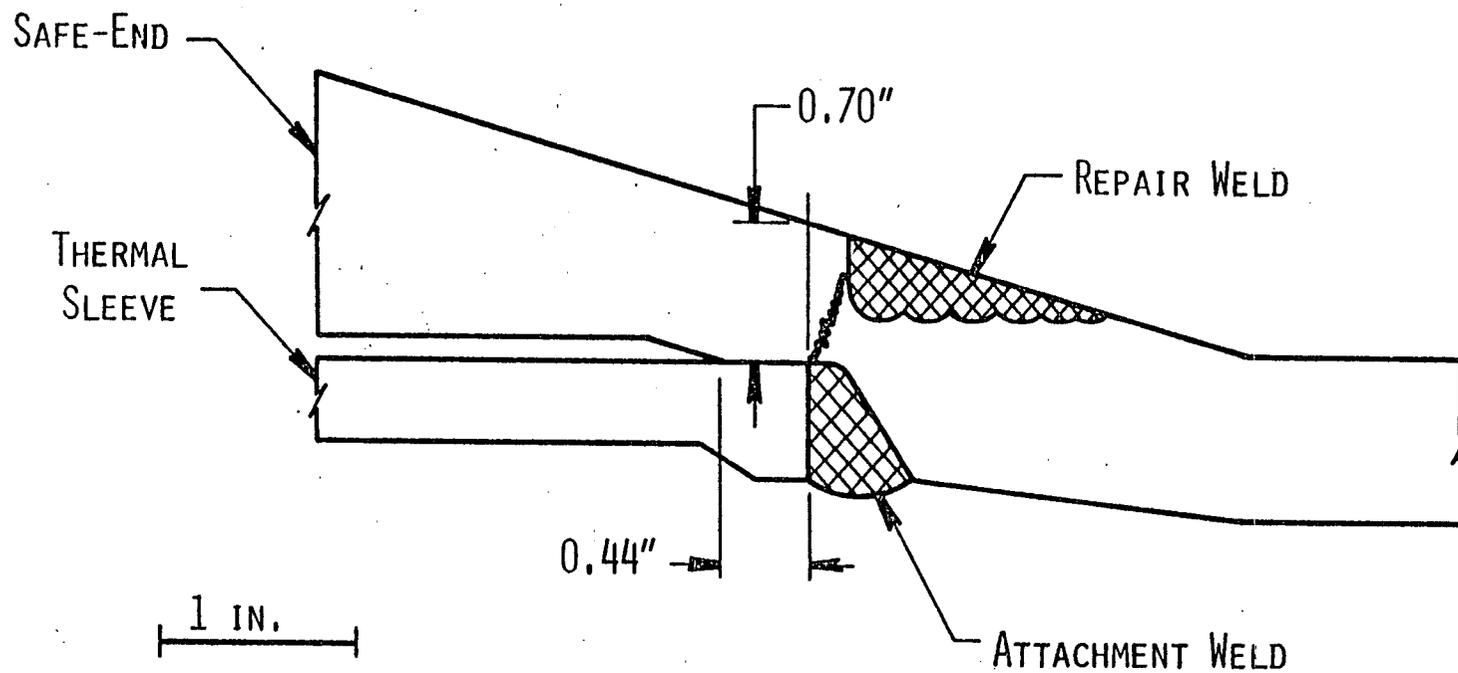
FIGURE 2-1. TYPICAL LONGITUDINAL SECTION THROUGH THERMAL SLEEVE ATTACHMENT AREA

A diagram of a typical longitudinal section, showing the relative positions of the attachment weld, crevice, and repair weld is shown in Figure 2-1. Macrographs of representative sections are shown in Figures 2-2, 2-3, and 2-4. Additional macrographs are included in Appendix B.

Significant cracking was evident in all of the sections examined. At all locations, the crack originated in the general area of the tip of the crevice adjacent to the attachment weld and extended outward through the safe-end wall. In that portion of the through-wall crack extending from approximately 125° to 160° , the later stages of cracking
