Report No. IE-116

Metallurgical Examination and Stress Evaluation of Recirculation Inlet Nozzle Safe-End Cracking

Duane Arnold Energy Center

PARAMETER, Inc.

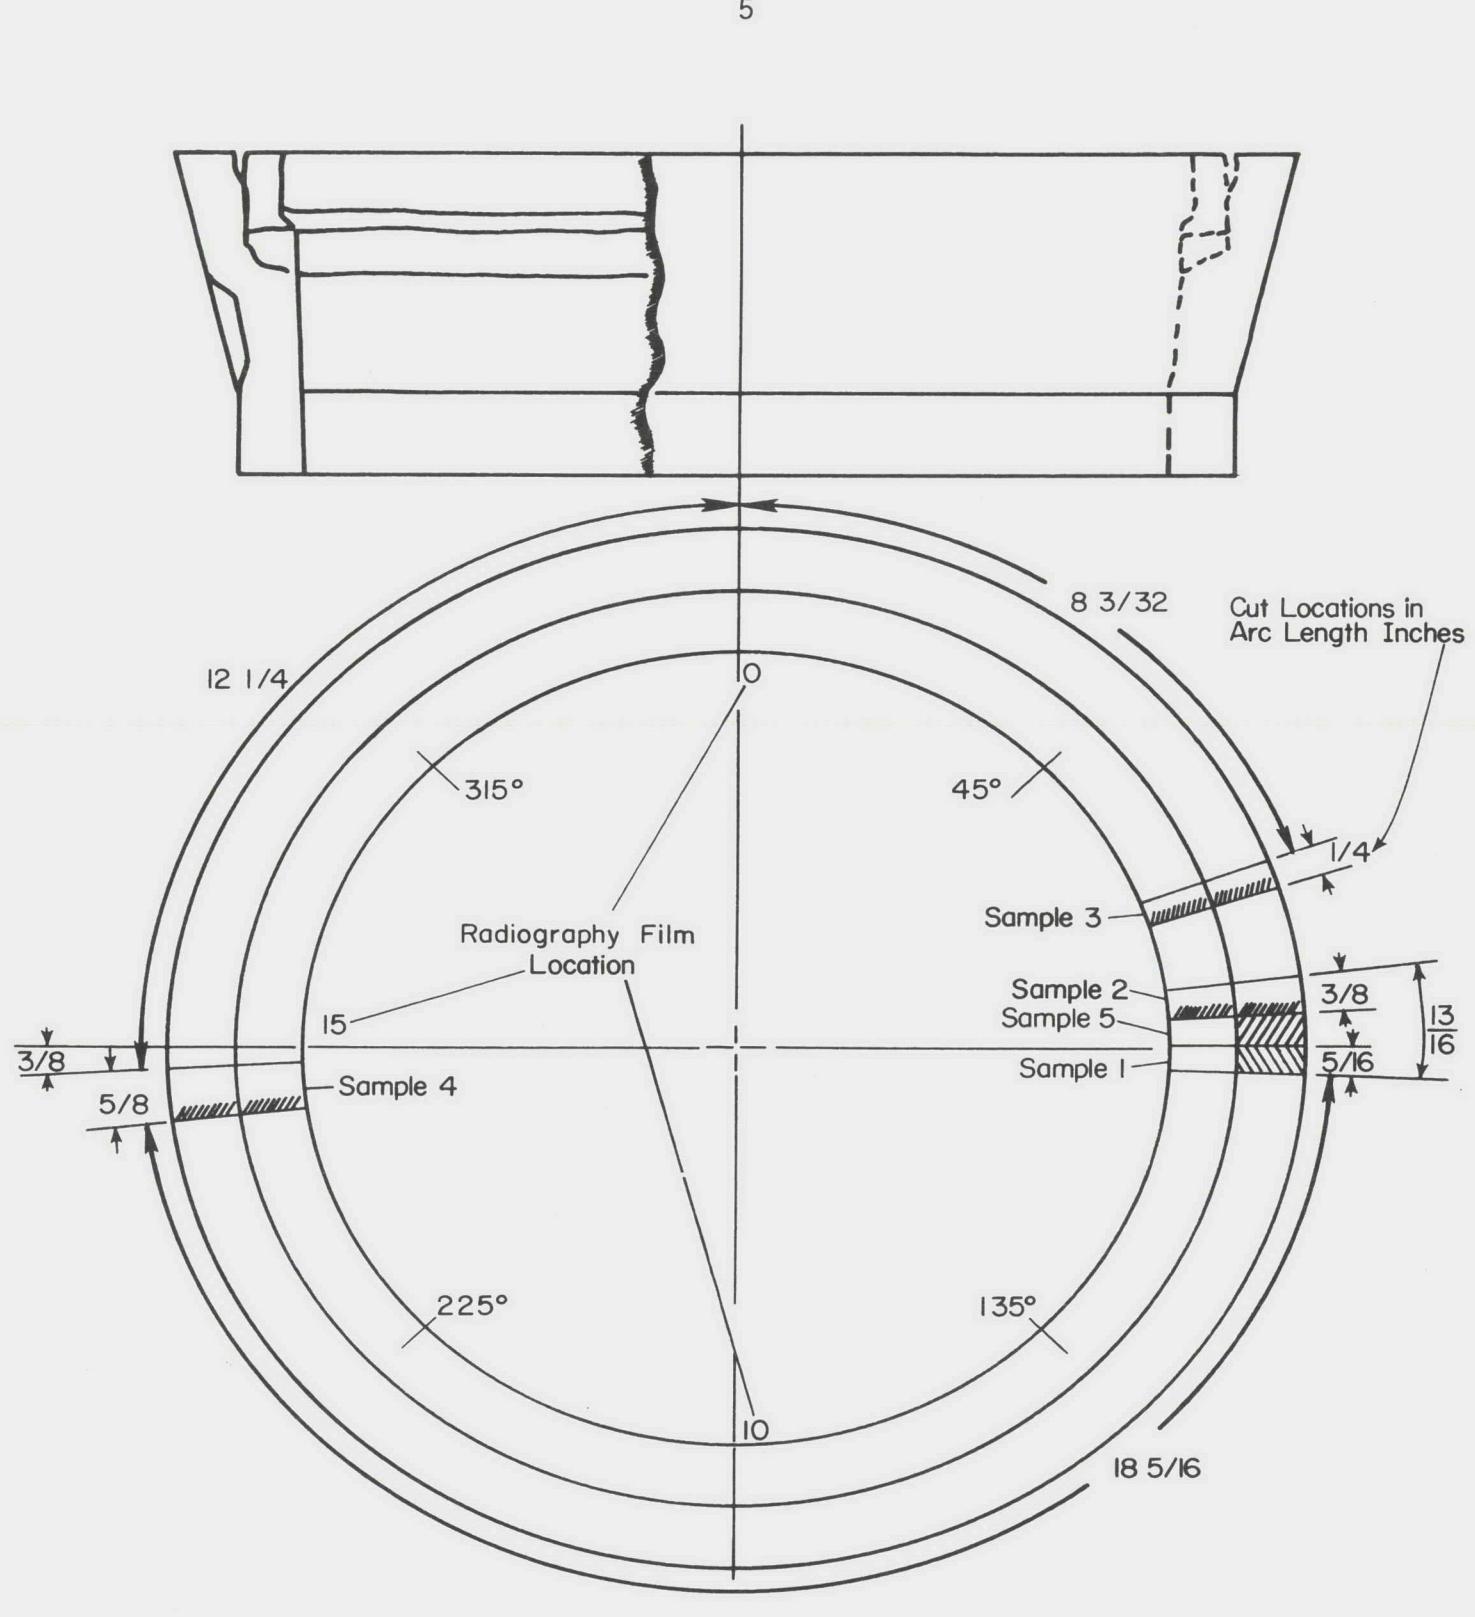
FIGURE 2. LOCATION OF METALLOGRAPHIC AND SEM SPECIMENS ON DUANE ARNOLD SAFE END N2-E

2.4.1 Specimen Sectioning. The specimen was marked for sectioning according to the cutting diagram supplied by Parameter Incorporated. Five thin samples were cut with a band saw. Locations of the samples are shown in Figure 2. Figure 3 shows the samples cut from the safe end.

Sample No. 1 - At radiography location 5 Sample No. 2 - Between radiography location 4 and 5 Sample No. 3 - Between radiography location 3 and 4 Sample No. 4 - Between radiography location 14 and 15 Sample No. 5 - Between samples 1 and 2.

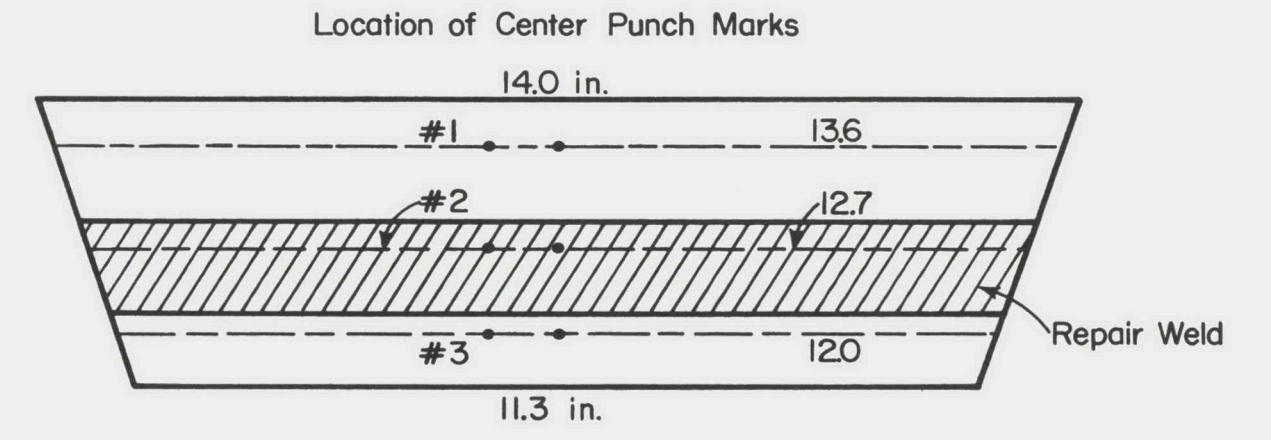
While the first cut for Sample No. 1 was being made, it was found that the cut closed tightly and the band saw blade could not be pulled out. The frame was removed and the blade was left in the cut. A new blade was inserted and the second cut made. After completing this cut the sample had to be pried loose. The distance between the centerpunch marks was measured after the sample was cut out. The measurements obtained before and after are shown in Figure 4. Also shown are the locations of the marks.

Before Cut	After Cut	Change
No. 1 0.9230	0.8754	0.0476
No. 2 1.0220	0.9250	0.0970
No. 3 0.9650	0.8800	0.085

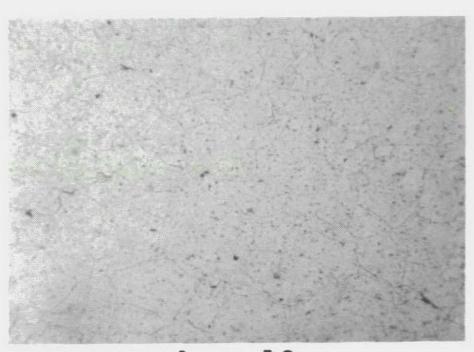
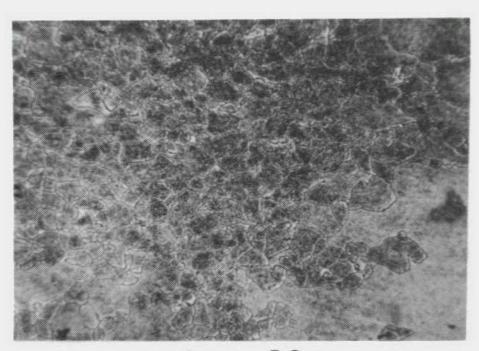
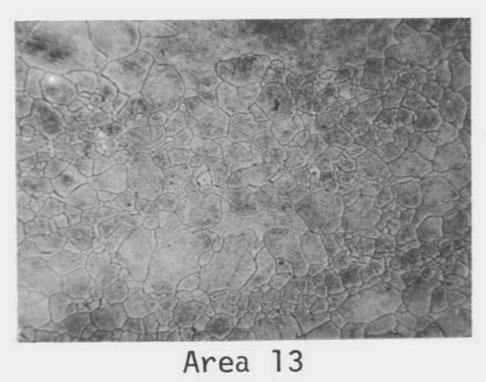
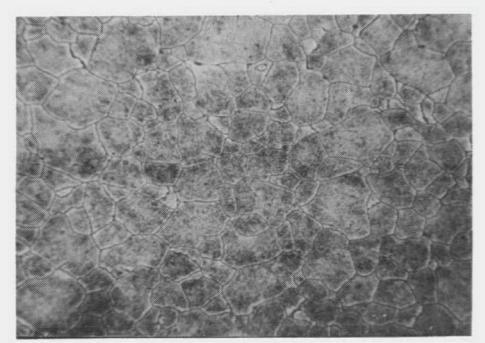
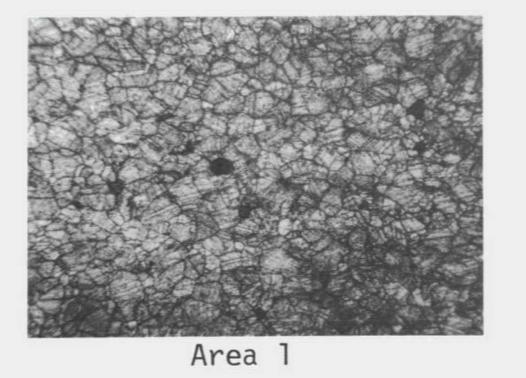
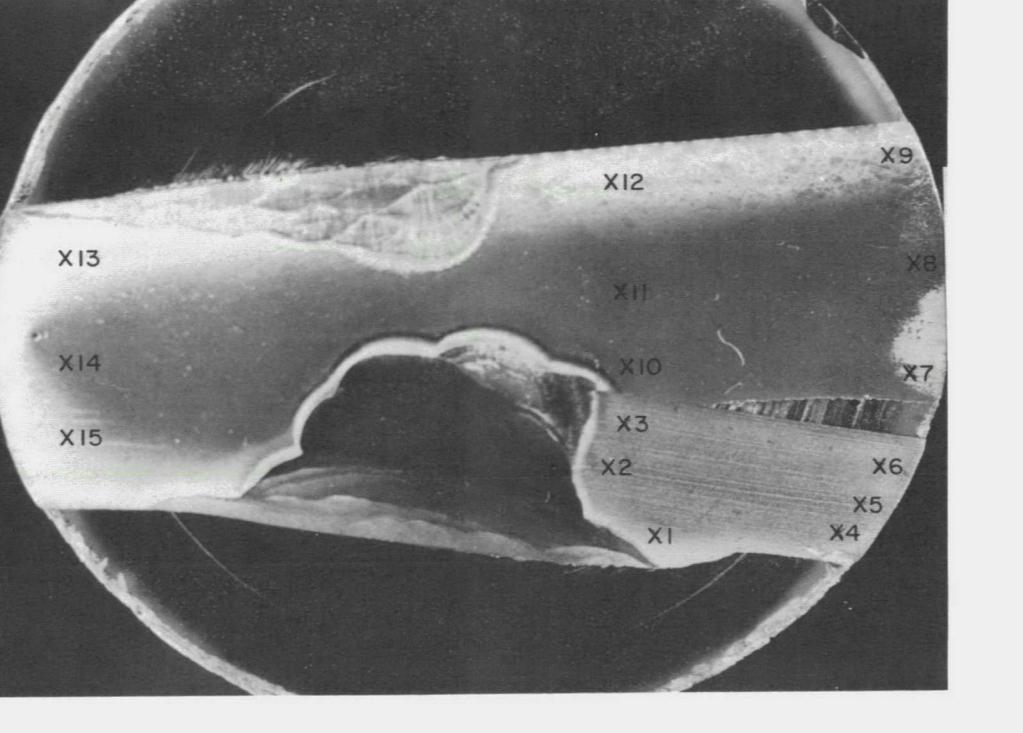
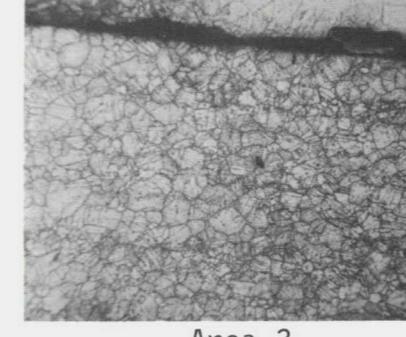
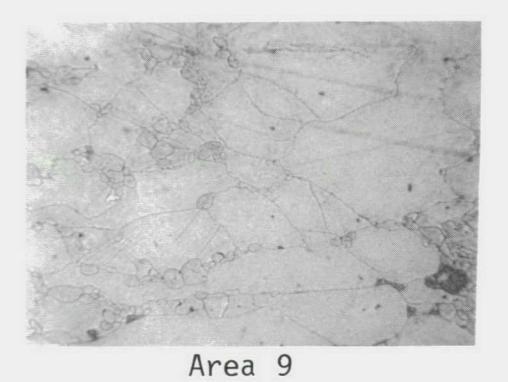
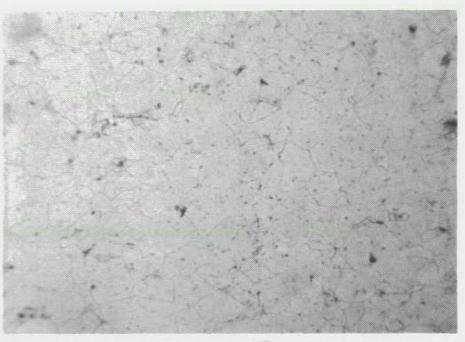
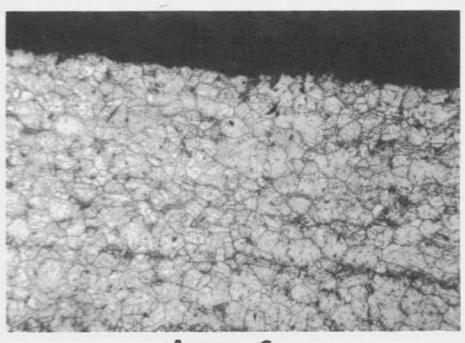
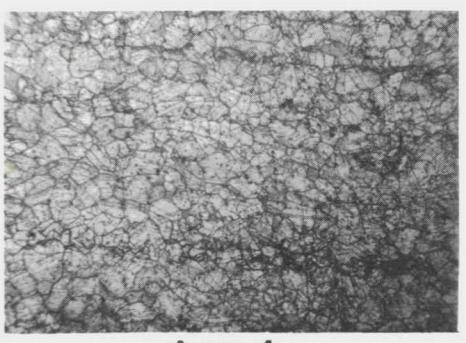
FIGURE 7. TYPICAL MICROSTRUCTURES AT VARIOUS LOCATIONS OF SAMPLE 3 CROSS SECTION

Sample 3 was examined in detail to characterize the microstructure of various parts of the sample. Figure 7 shows the results. The photomicrographs show that no major abnormalities are apparent in the microstructure of the safe end with the exception of sensitization near the sleeve to safe end weld. However, it appears that the thermal sleeve is sensitized (as evident from carbides precipitated at grain boundaries) rather uniformly even away from the weld.

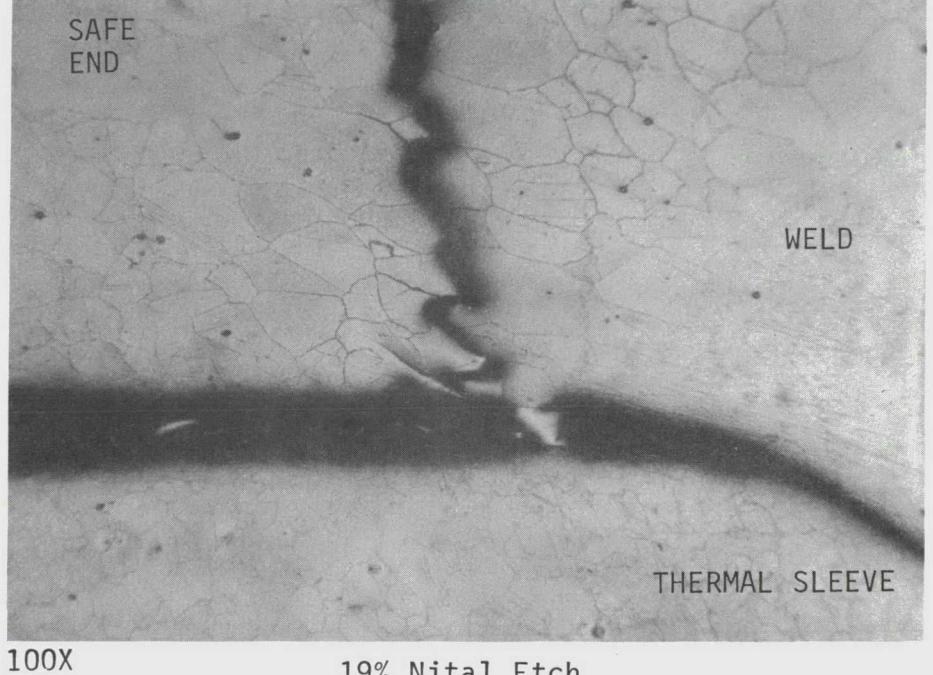
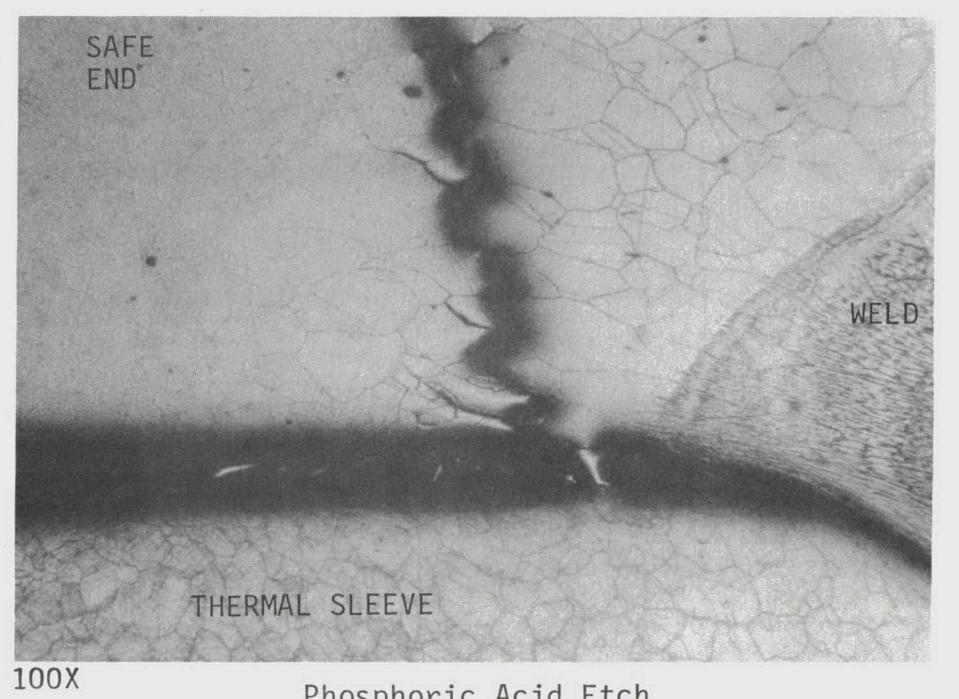
FIGURE 10. MICROGRAPHS OF AREAS B AND C FROM FIGURE 8 FROM ETCHED SAMPLE 3

Sample 3 was subsequently reprepared and etched with a mixture of 20 ml H_20 , 20 ml HNO_3 , and 80 ml HCl. The purpose of this procedure was to clearly identify the location of the crack with respect to the weld and heat affected region. With this technique, the crack initiation site was found to be in the re-solution treated region of the heat affected zone. Figures 8 through 10 show details of the crack location and crack characteristics.

- The location of the cracks in all cases were in the re-solution treated region of the heat affected zone of the weld joining the safe end to the sleeve. See Figures 9 and 11.

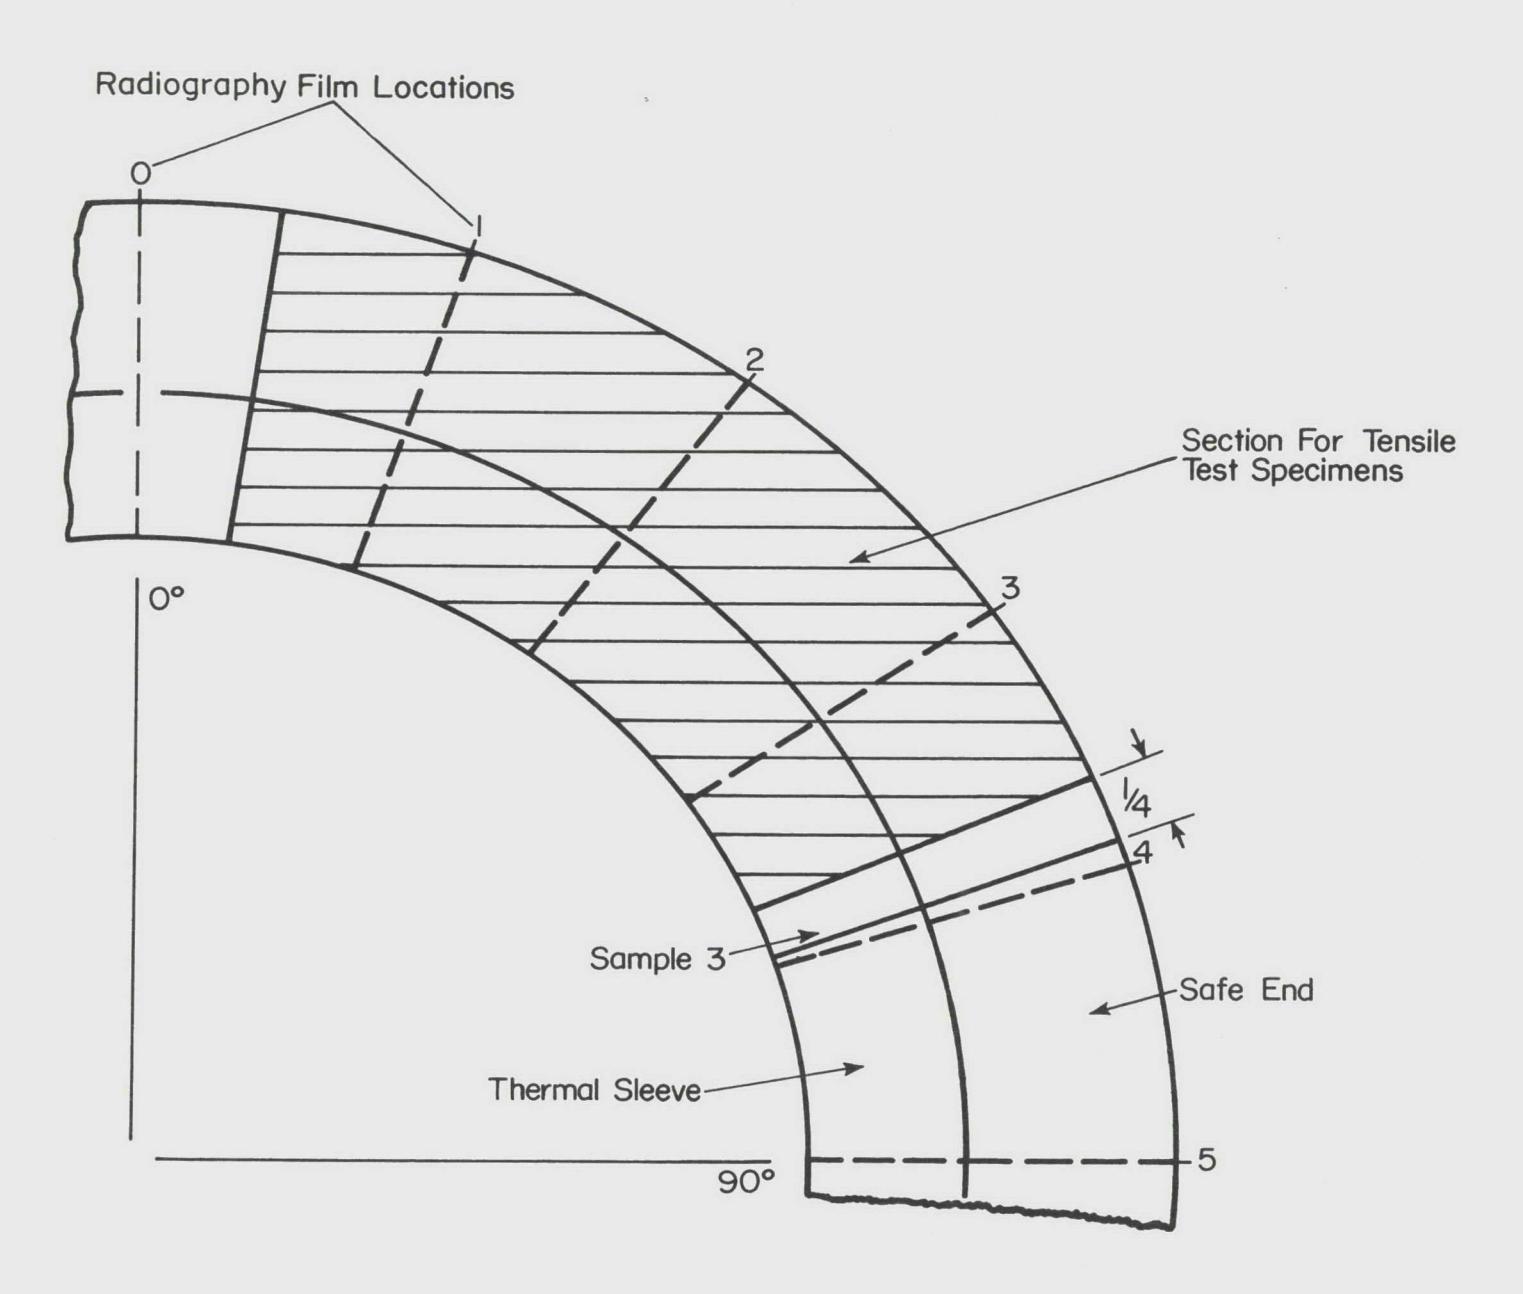
FIGURE 13. LOCATION OF THE SECTION FROM WHICH TENSILE TEST SPECIMENS WERE MACHINED

From the remaining parts of the Inconel safe end a large piece was sectioned so that specimens for tensile tests could be machined. The large piece was cut between radiography locations 0 and 4 as shown in Figure 13. The cut piece was decontaminated and ultrasonically cleaned and five tensile test specimens were machined. Figure 14 shows schematically the location of the specimens in the safe end and Figure 15 shows the dimensions of the tensile specimens used.

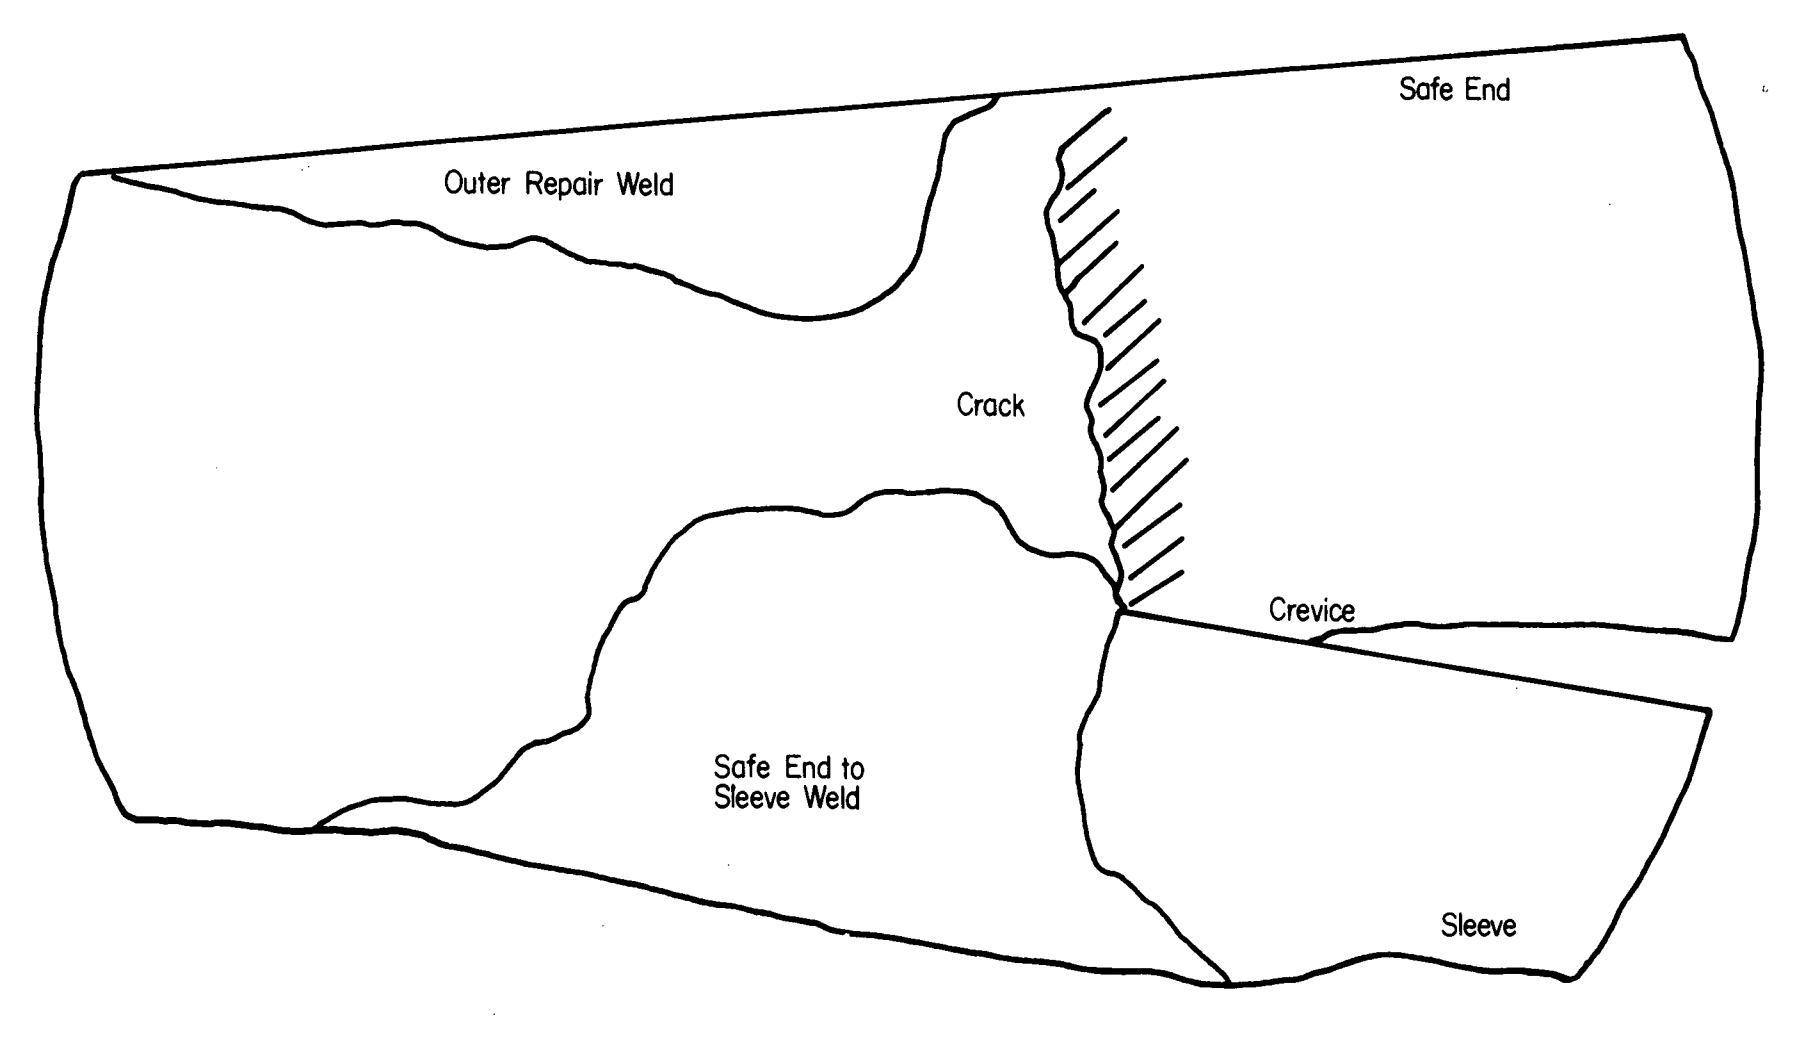
FIGURE 20. SCHEMATIC DIAGRAM OF SAFE END SAMPLE 5 INDICATING FRACTURE SURFACE EXAMINED BY SEM

Detailed SEM examination was performed on the entire fracture surface. Figure 22 presents SEM fractograph montages at the beginning (near crevice) middle, and tip of the crack along the fracture surface. The mode of cracking, as indicated by the SEM fractographs, was intergranular fracture.
