SUBJECT: LER 86-024-01: on 861121, outboard HPCI sys valve closed due to signal from pressure differential indicating switch PDIS2245. Caused by switch compartment moisture. Compartment dried & switch calibr. W/870722 ltr.

TITLE (4)
High Pressure Coolant Injection System Isolation from Steam Flow dP Switch Internal Leak

Subject: Duane Arnold Energy Center
Docket No. 50-331
Op. License DPR-49
Licensee Event Report No. 86-024, Revision 1

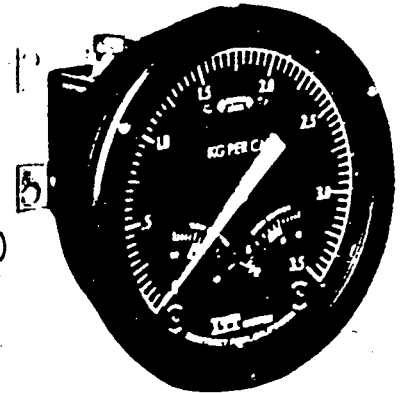
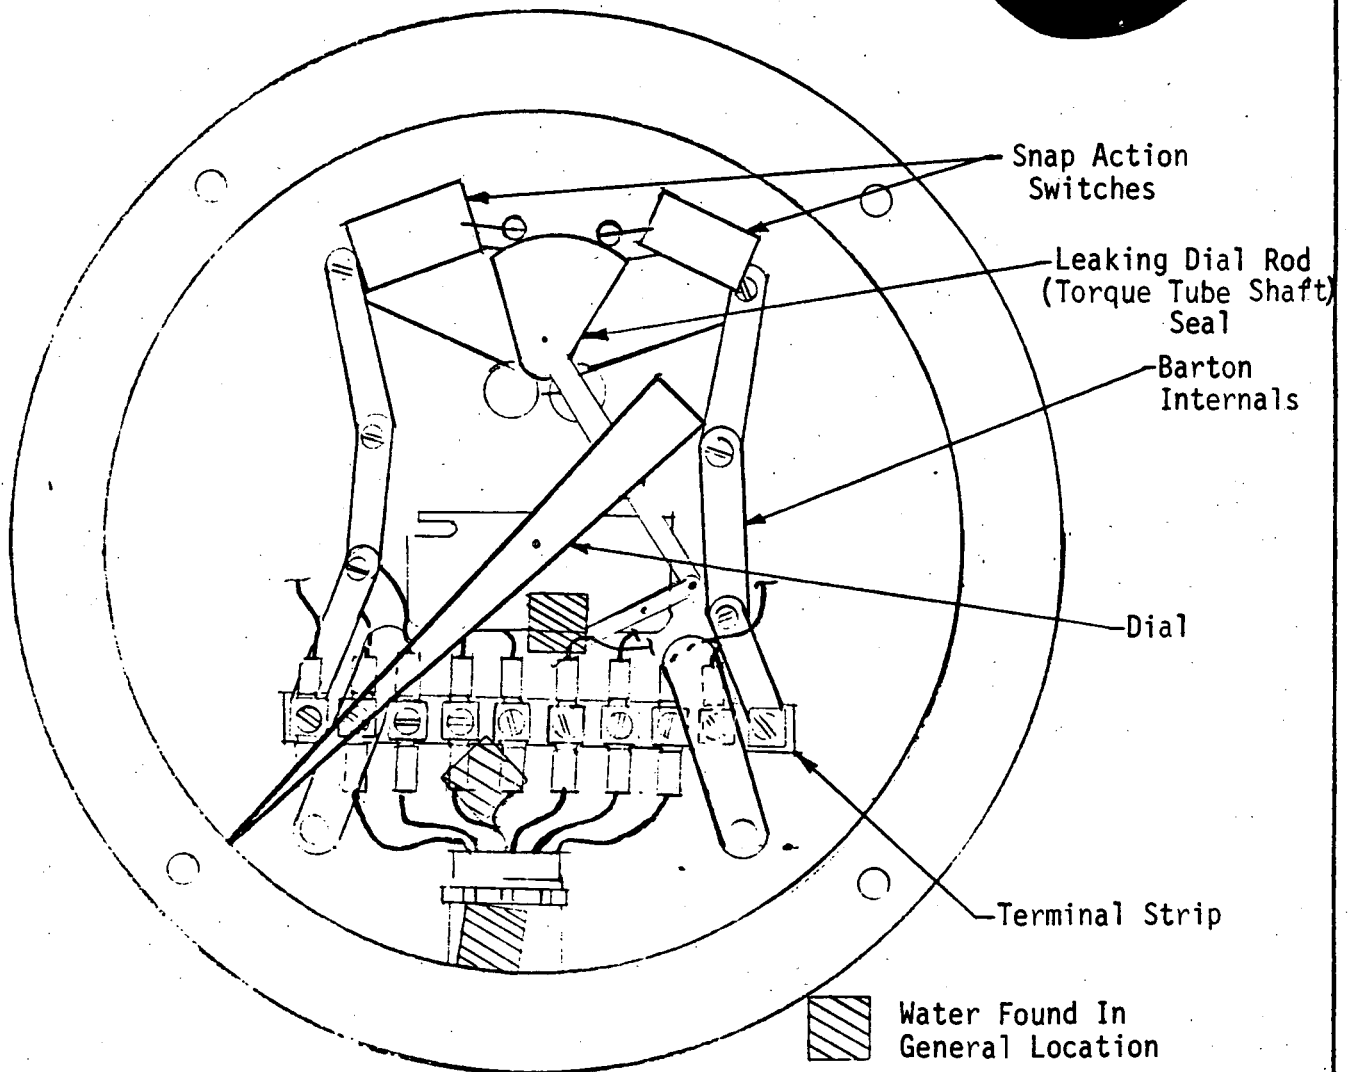
FIGURE 1. Barton 288A (PDIS-2245)
General Representation of Barton 288 Switch Internals

When PDIS2245 was examined on November 21, 1986, a small amount of water was found in the switch compartment. An amount approximately equal to one drop was seen in the area of the dial rod (torque tube shaft) seal, and on the terminal strip. Several drops were found to have accumulated in the lowest area of the switch compartment. (See Figure 1, 2, and 3.) The switch compartment was dried and PDIS2245 recalibrated successfully. The suspected point of water leakage into the switch compartment was the dial rod seal, as the rod extends into the Differential Pressure Unit behind the switch where the water filled bellows are located. However the rod seal area was observed for approximately two hours with no further leakage apparent.

(Front Scale Not
Identical to PDIS-2245)

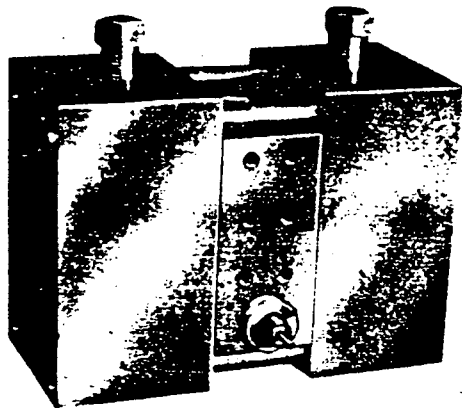
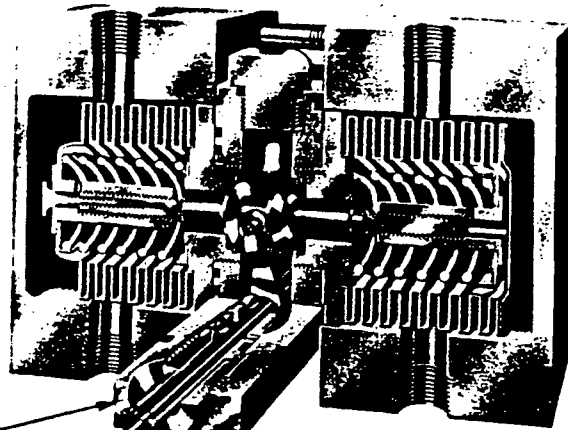
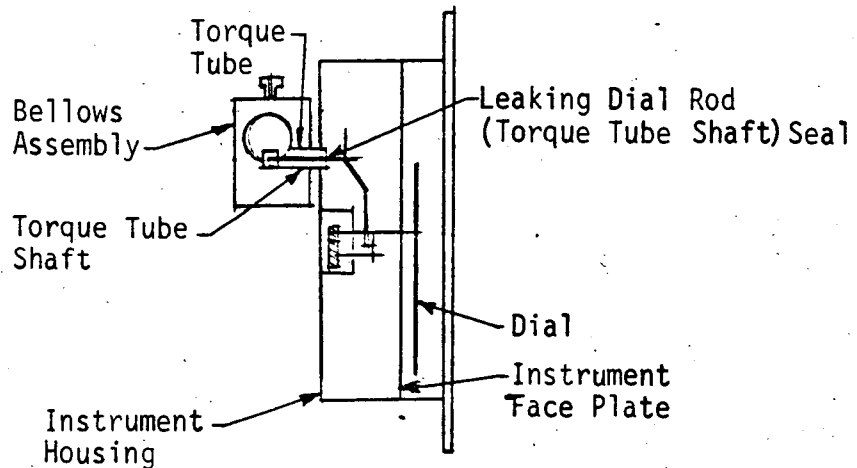
Figure 2. DPU 224 and Mounting Schematic

The root cause of the HPCI isolation signal from PDIS2245 on November 21, 1986 is deemed to be the intrusion of water from the leaking manifold above the switch into the switch compartment via the torque tube seal. This is based on the visual evidence obtained during the inspection of PDIS2245 and its bellows assembly, which indicated an outside source for the water, the previous
