SUBJECT: LER 86-024-01: on 861121, outboard HPCI sys valve closed due to signal from pressure differential indicating switch PDIS2245. Caused by switch compartment moisture. Compartment dried & switch calibr. W/870722 ltr.

LICENSEE EVENT REPORT (LER)

FACILITY NAME (1) Duane Arnold Energy Center (DAEC)										DOCKET NUMBER (2) 0 5 0 0 0 3 3 1					PAGE (3) 1 OF 1							
TITLE (4) High Pressure Coolant Injection System Isolation from Steam Flow dP Switch Internal Leak																						
EVENT DATE (5)			LER NUMBER (6)				REPORT DATE (7)			OTHER FACILITIES INVOLVED (8)												
MONTH	DAY	YEAR	YEAR	SEQUENTIAL NUMBER	REVISION NUMBER	MONTH	DAY	YEAR	FACILITY NAMES None				DOCKET NUMBER(S) 0 5 0 0 0									
1	1	2	1	8	6	8	6	0	2	4	0	1	0	7	2	2	8	7	0 5 0 0 0			
OPERATING MODE (9) N		THIS REPORT IS SUBMITTED PURSUANT TO THE REQUIREMENTS OF 10 CFR 8: (Check one or more of the following) (11)																				
POWER LEVEL (10) 01914		20.402(b)				20.406(c)				60.73(a)(2)(iv)				73.71(b)

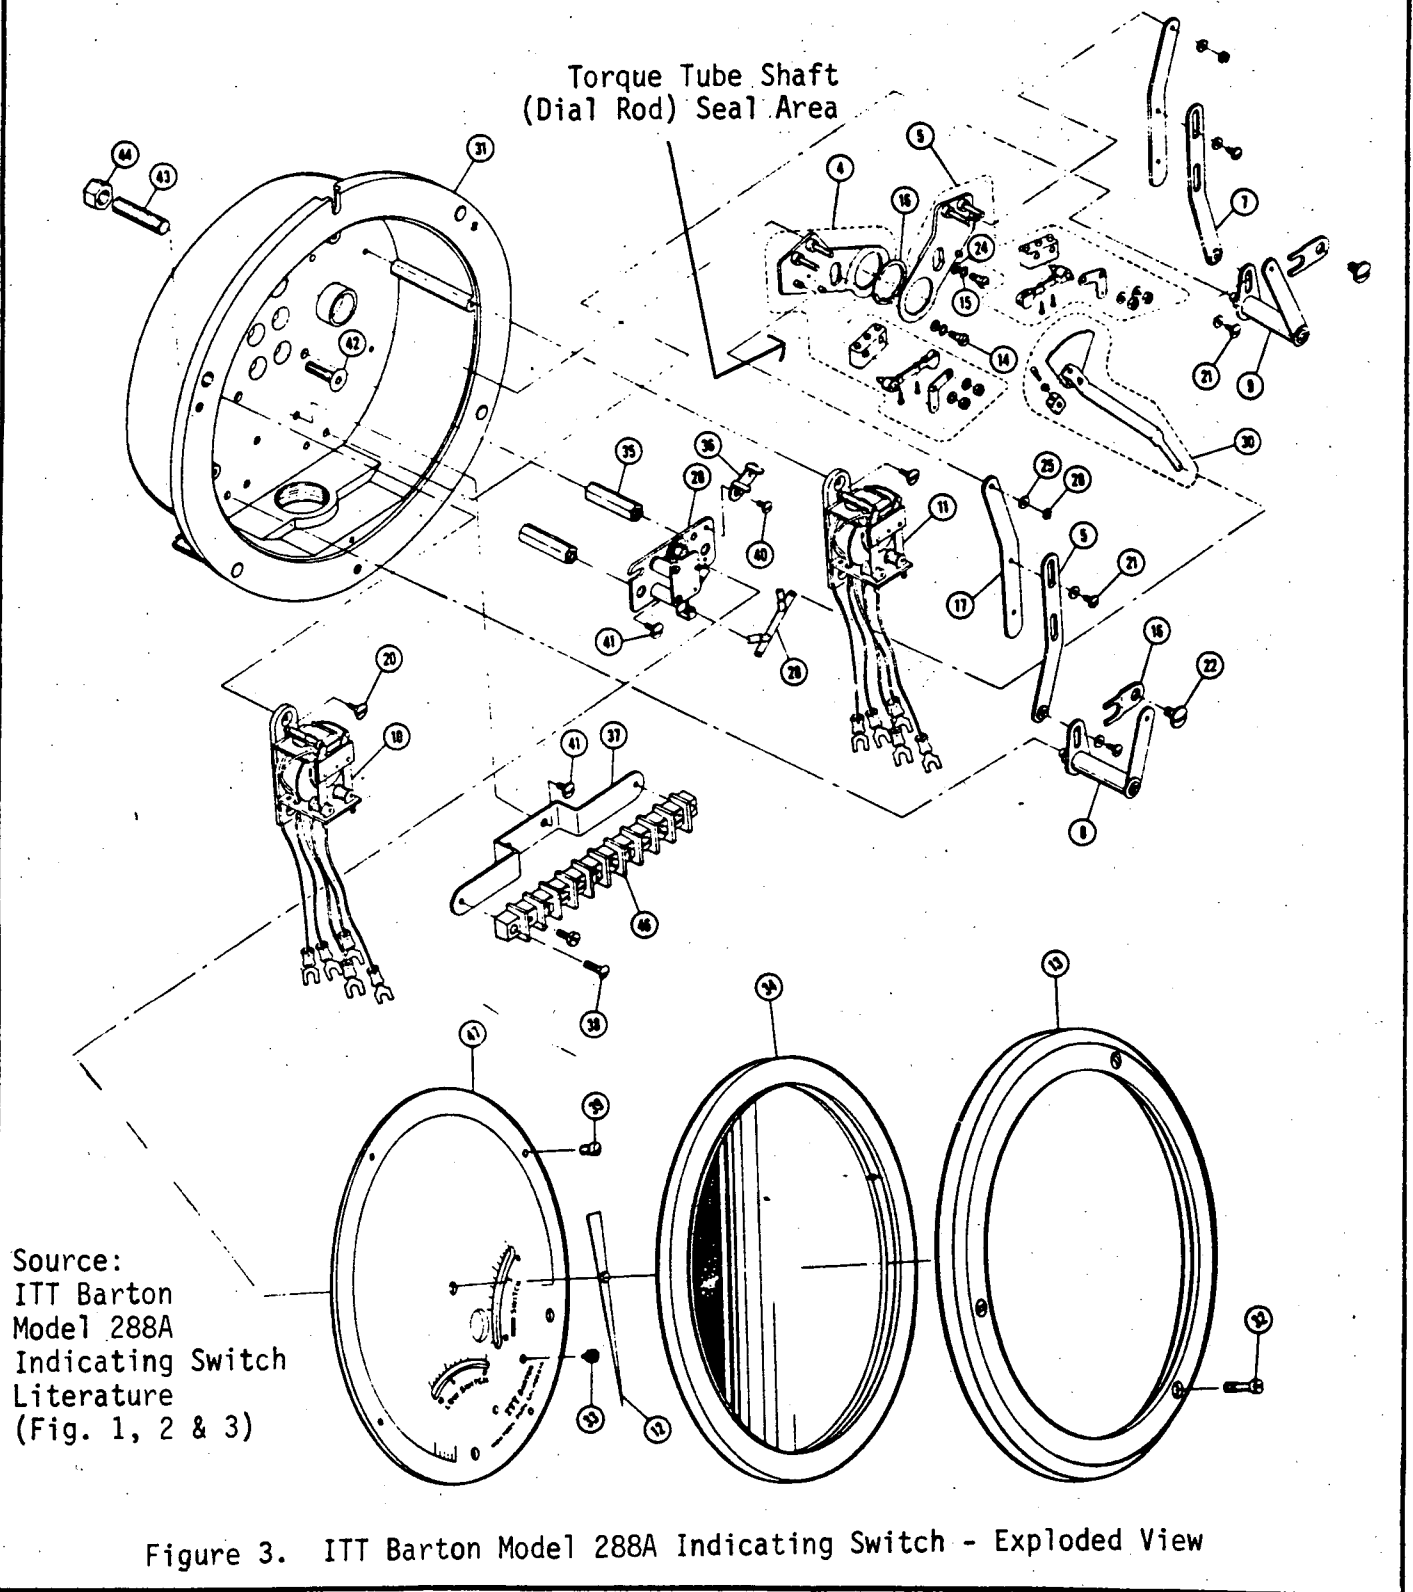
The instrument water line manifold directly above PDIS2245 was noted to be leaking during the 1987 refueling outage, and was replaced on April 1, 1987. A pathway exists for leakage from this manifold to the back side of PDIS2245 where the bellows assembly is attached. From there, the water could seep in between the PDIS and bellows assembly. Per discussions with the manufacturer the torque tube seal into the PDIS switch compartment is not a hermetic seal, and water introduced into this area on the back side of the PDIS could eventually work its way into the switch compartment.

The root cause of the HPCI isolation signal from PDIS2245 on November 21, 1986 is deemed to be the intrusion of water from the leaking manifold above the switch into the switch compartment via the torque tube seal. This is based on the visual evidence obtained during the inspection of PDIS2245 and its bellows assembly, which indicated an outside source for the water, the previous

Water Intrusion into
Barton 288 From Leaking
Overhead Manifold:
Two Views
