Characterization of Flaws in U.S. Reactor Pressure Vessels

Validation of Flaw Density and Distribution in the Weld Metal of the PVRUF Vessel

Pacific Northwest National Laboratory

NUREG/CR-6471, Vol. 2 PNNL-11143B

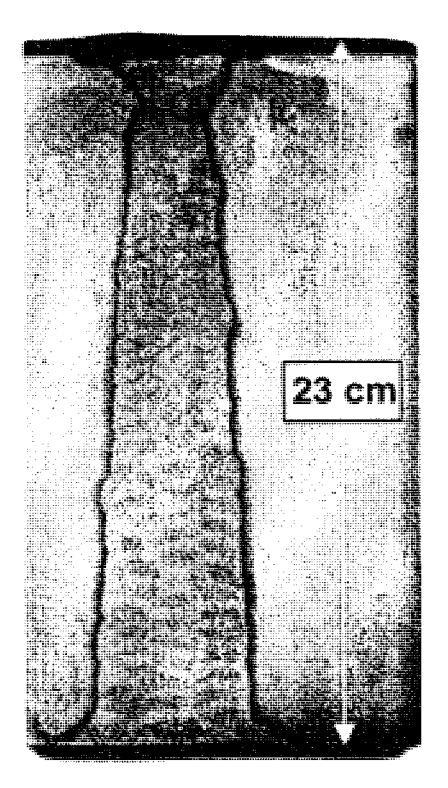
After the PVRUF specimens were received at PNNL, it was possible to confirm the weld cross section and the volume of weld metal inspected. Figure 2.4 shows the weld cross section for a specimen from the beltline weld of the PVRUF vessel. This photograph was taken after the weld specimen was polished and acid-etched. The weld is shown to be single Vee in design. The top of Figure 2.4 shows the cladding layer as a dark band that is somewhat thicker over the weld than over the base metal. The cross-sectional area of the weld metal within the near-surface zone (25 mm from the wetted [inside] clad surface) is 4.9 cm². The cross-sectional area of the weld outside the near-surface zone is 73 cm².

Figure 2.4 Weld Cross Section for Beltline (Lower-to-Intermediate Shell) Weld

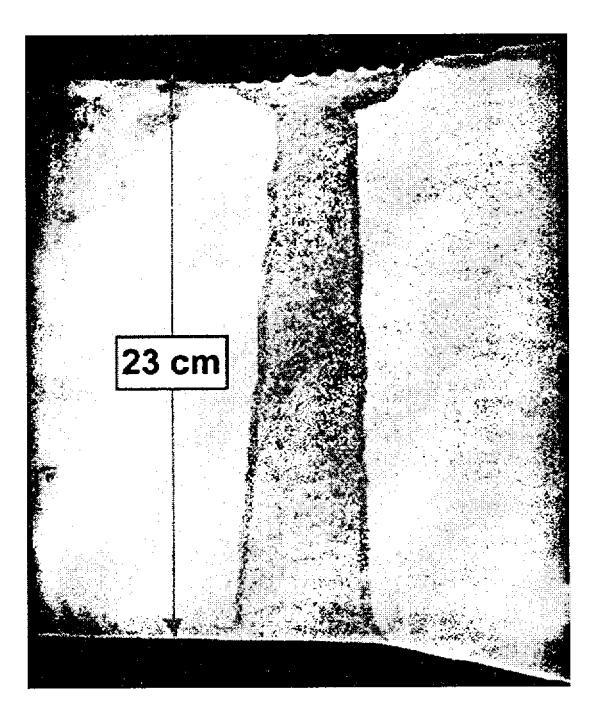
Figure 2.5 shows the weld cross section for the circumferential weld (girth seam) between the upper and intermediate shell courses. The vessel makes a thickness transition at this weld. The upper shell course, which contains the nozzle penetrations, is thicker and shown to the right of the weld in Figure 2.5. The cross-sectional area of the weld metal within the near-surface zone (25 mm from the wetted clad surface) is 7.7 cm². The cross-sectional area of the weld outside the near-surface zone is 81 cm².

Figure 2.5 Weld Cross Section for Intermediate-to-Upper Shell Girth Weld

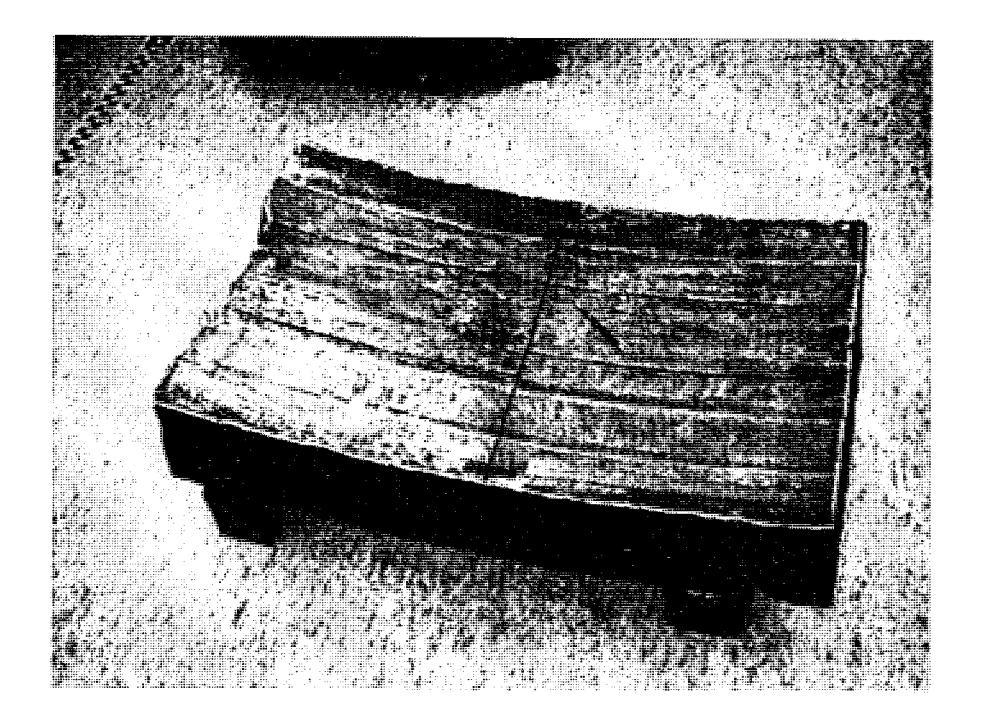
Figure 2.6 shows one of the 12 large PVRUF specimens as it was prepared for removal of the weld metal. The black cut lines in Figure 2.6

were placed to avoid large indications and clusters of small indications. Two specimens containing the entire weld metal were removed from each block, as shown in Figure 2.7.

Figure 2.6 PVRUF Block Prepared for Removal of Weld Metal

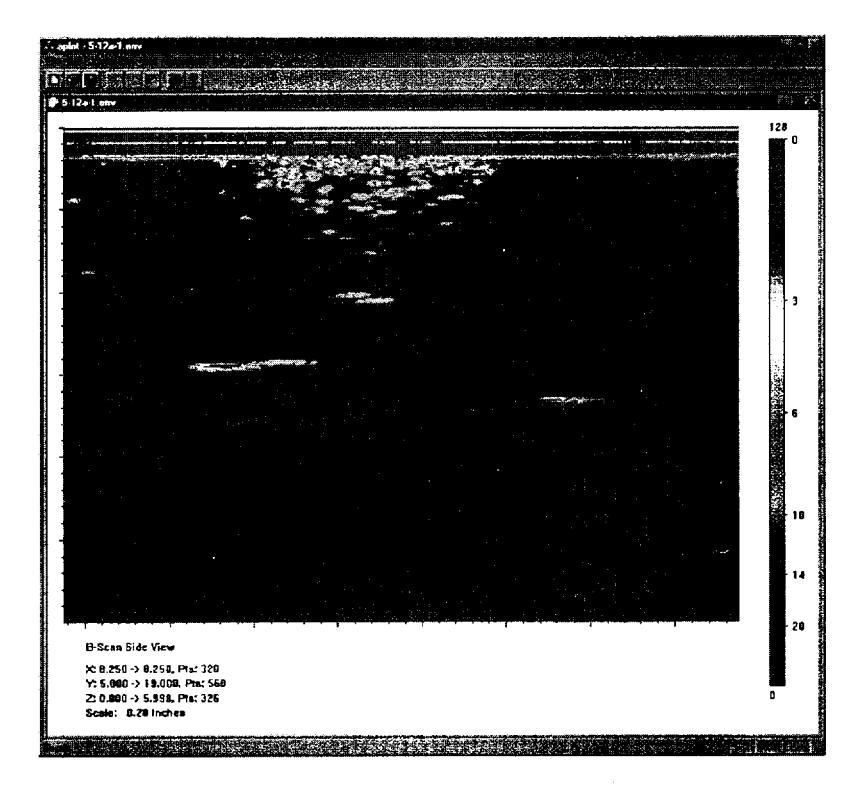
Figure 2.9 shows a typical example of weldnormal ultrasonic data. The clad surface of the specimen is to the right in Figure 2.9. The single Vee weld profile is evidenced by the ultrasonic signals from the small flaws on the fusion lines.

Figure 2.9 SAFT-UT Image from Ultrasonic Inspection Normal to Weld

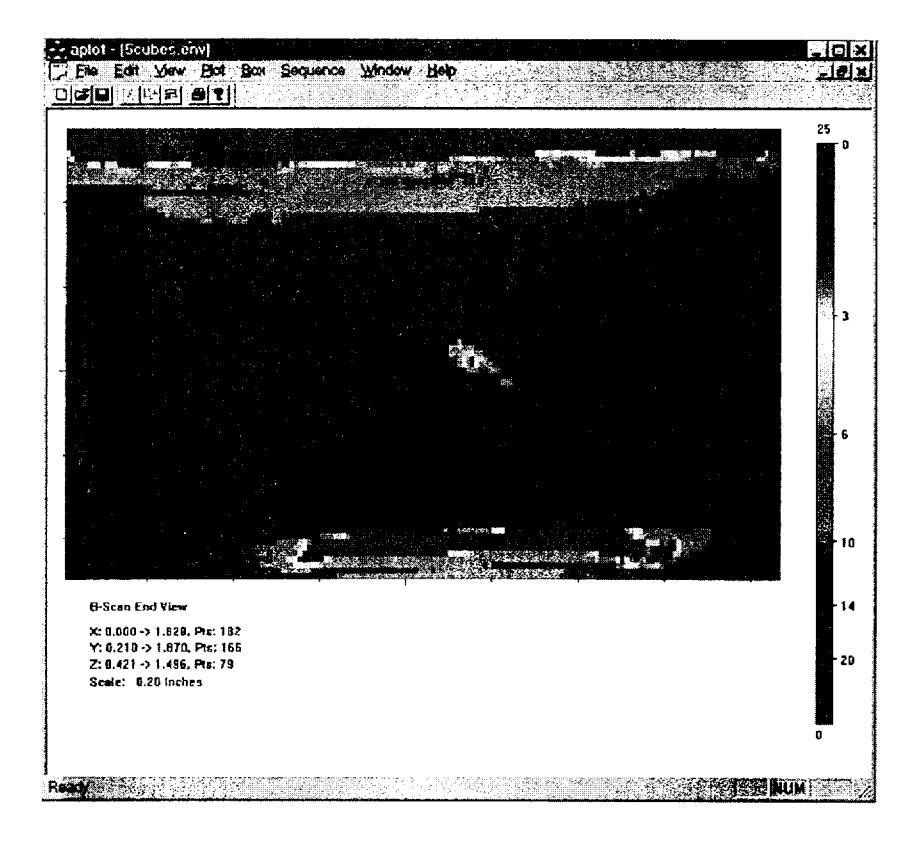
Ultrasonic testing was performed on the nearsurface zone cubes to inspect for under-clad cracks. The flaws had been located in the plates using weld-normal ultrasound, but the proximity to the clad surface introduced errors into the characterization and sizing of the flaws. Fourteen near-surface zone cubes were removed from the plates of PVRUF material, and Figure 2.13 shows an example of ultrasonic testing results on a nearsurface zone cube.

Figure 2.13 Ultrasonic Image of Flaw Indication in Near-Surface Zone Cube

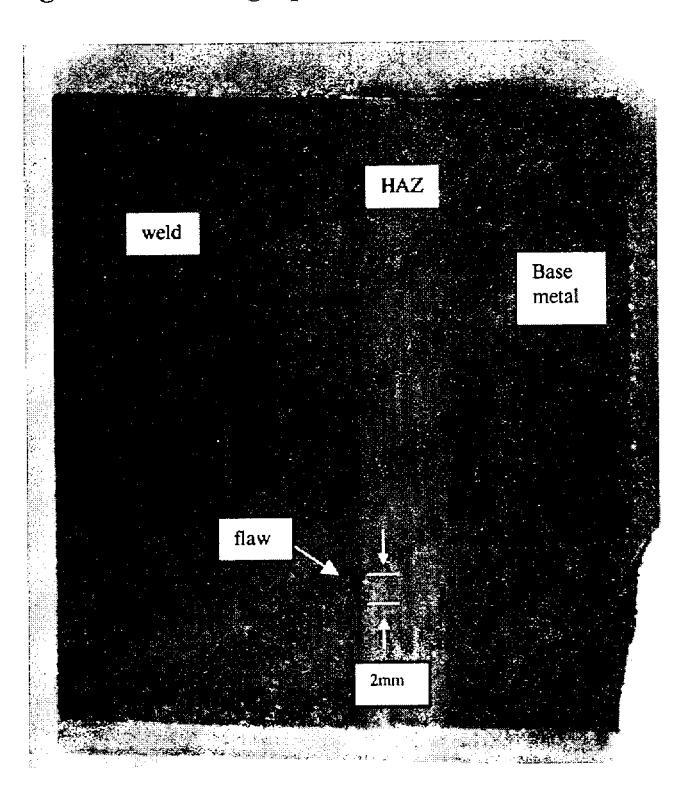
Figure 2.15 shows a micrograph of the complete face of a 25-mm cube. A 2-mm flaw is revealed as a lack of fusion just inside the weld metal (there is weld metal on both sides of the flaw).

Figure 2.15 Micrograph of 25-mm Cube. Micrograph shows 2-mm flaw (dark), weld metal, HAZ, and base metal.

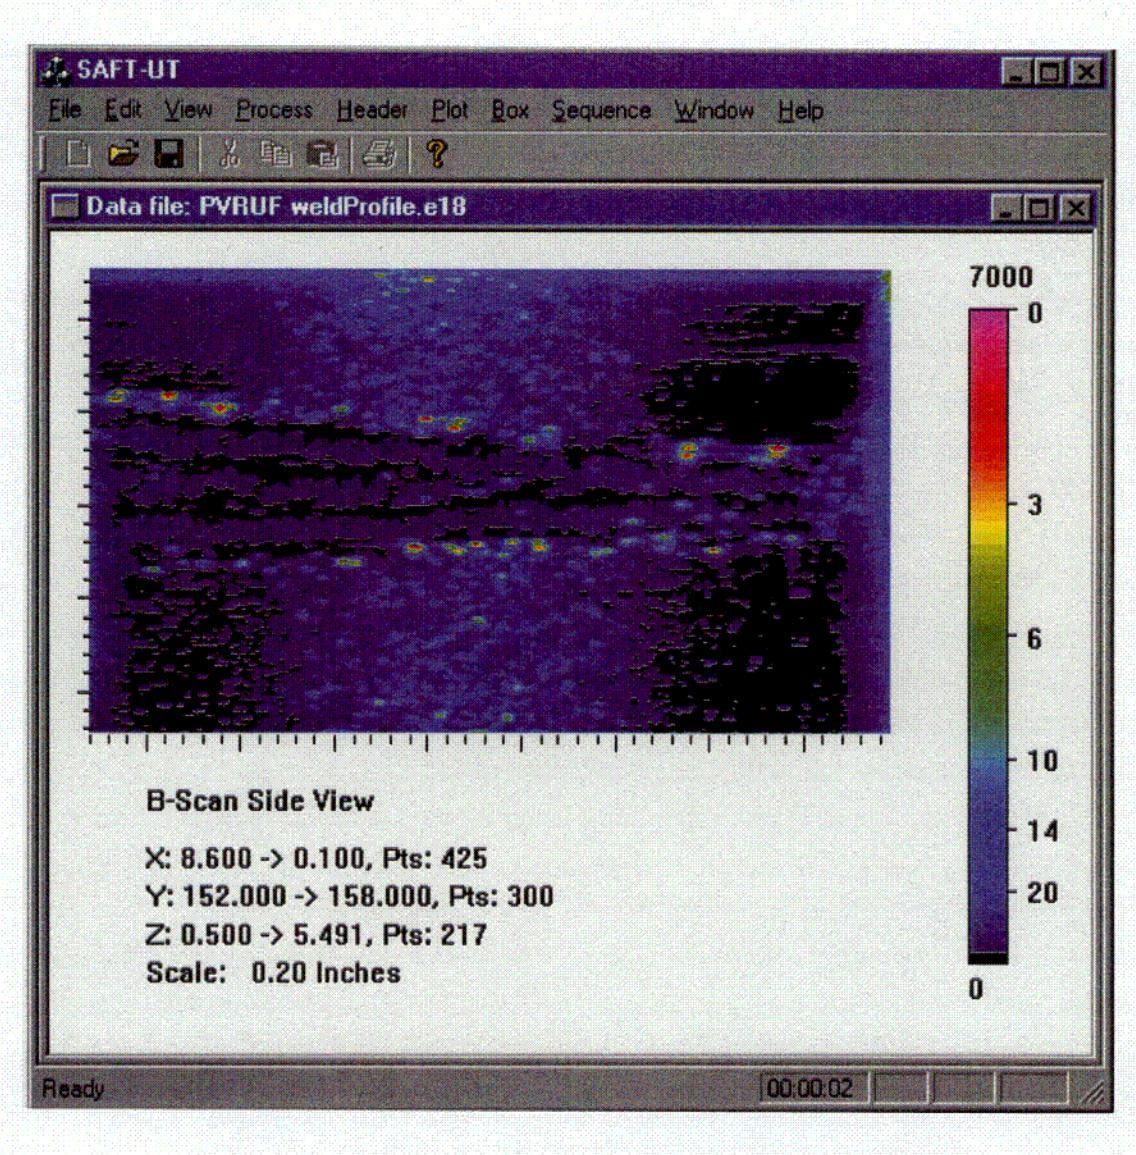
Figure 3.1 Side View of Weld-Normal Ultrasonic Test Showing Weld Profile as Evidenced by Small Flaw Indications

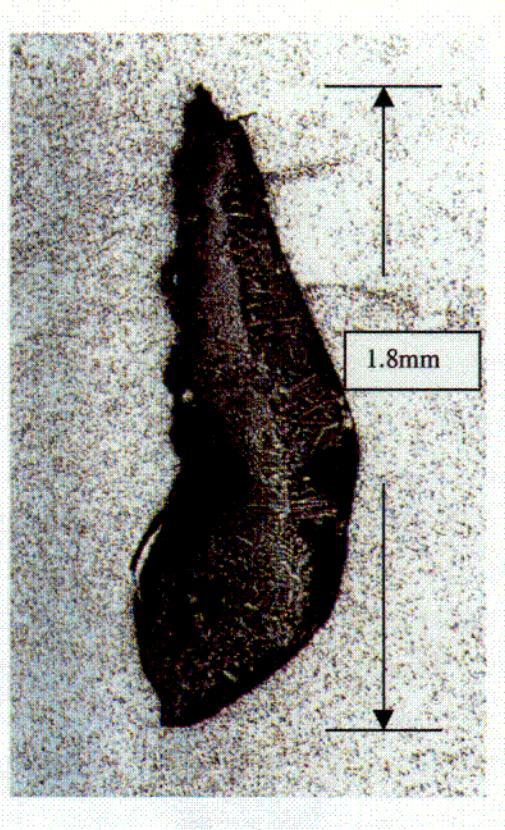
Figure 3.56 Micrograph of Flaw from the Cluster Shown in Figure 3.54. Flaw is shown to be inter-run slag.

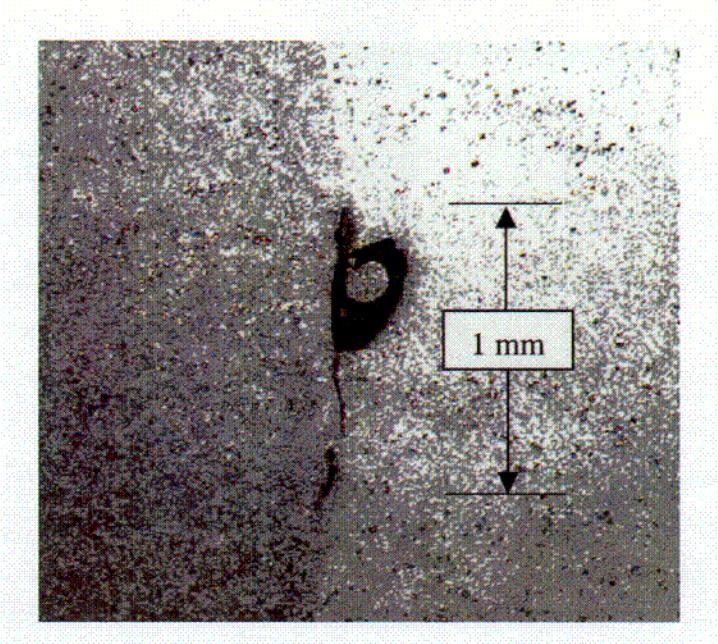
Figure 3.57 Micrograph of Small Flaw Shown in Figure 3.56. Flaw has vertical extent of 0.8 mm and planar features between the weld beads.

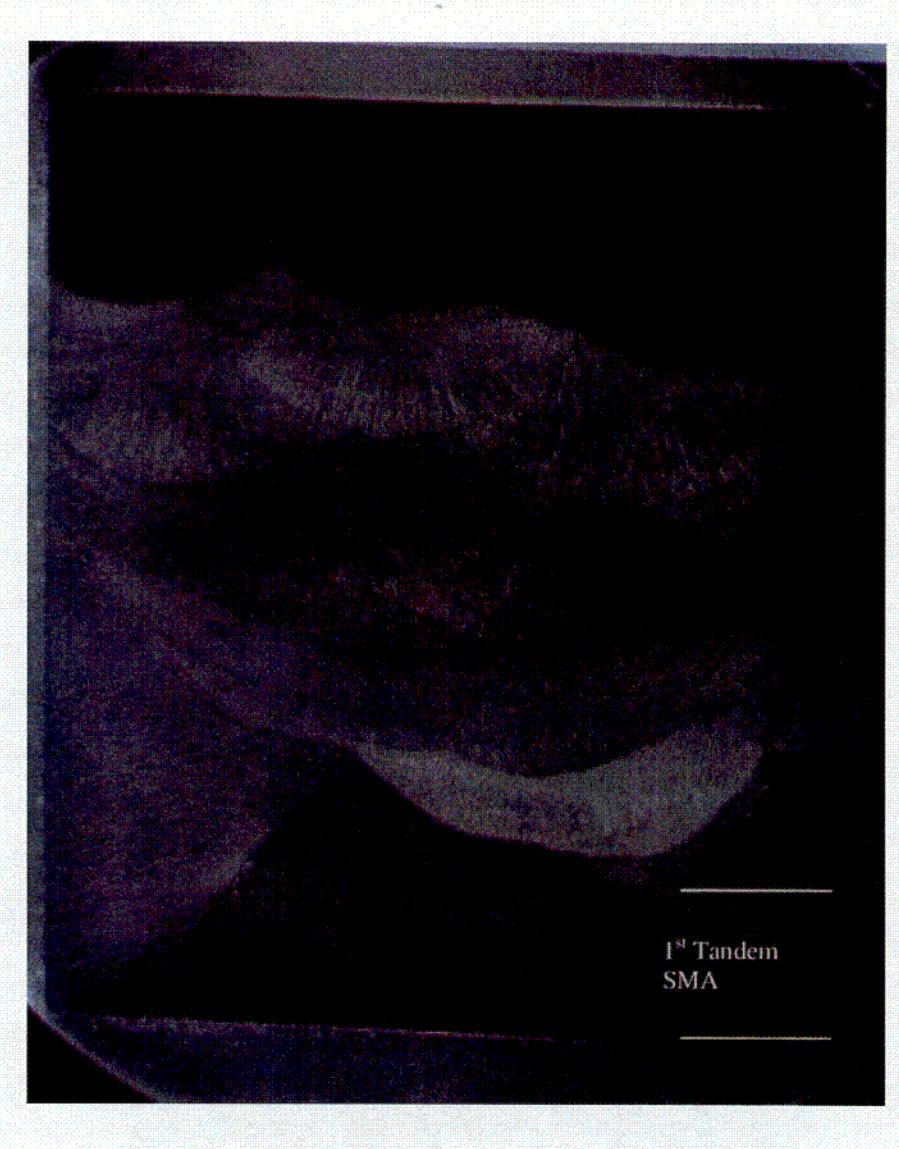
Figure 3.61 Micrograph of Cube 5-10EB1-IIbIIc Showing Shallow Back Gouge

Figure 3.61 shows a micrograph of Cube 5-10EB1-IIbIIc. The back gouge is somewhat shallower in this cube than that shown in Figure 3.58, and the first machine-made weld pass was not completely removed. Figure 3.62 shows a digitized image of a radiograph of Cube 5-10EB1-IIbIIc. The vessel through-wall direction is into the image. The vessel elevation is oriented horizontally in the image.

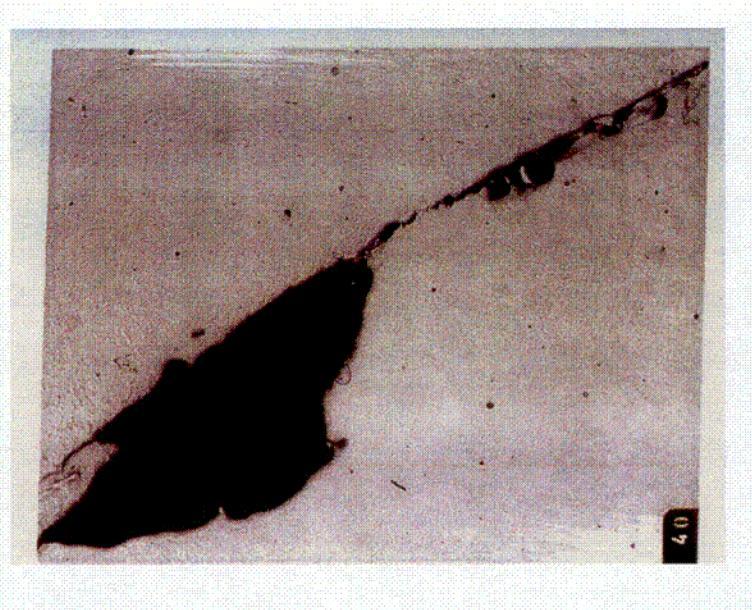
Figure 3.64 Micrograph of Lack of Side-Wall Fusion

Figure 3.63 shows a micrograph of the cube exposing a complex flaw associated with the first tandem arc weld passes. This figure shows a lack of fusion with slag on the weld side wall and a horizontal inter-run lack of fusion/contamination above the first tandem weld passes. Figure 3.64 shows a micrograph of a magnified portion of the lack of side-wall fusion with slag.

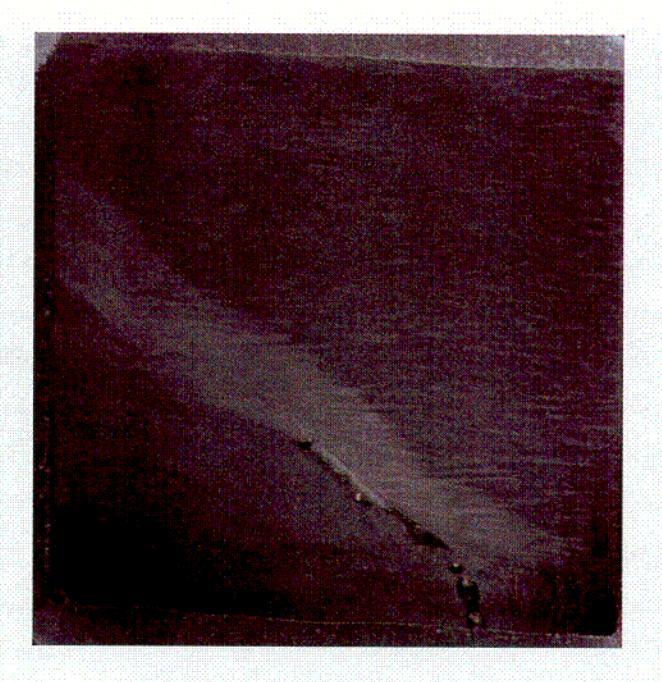
The micrographs of the cubes 5-12AC5 and 5-12AC6 show the composition characteristics of the 17-mm flaw. Figure 3.72 shows a micrograph of a portion of the 17-mm repair flaw as polished and etched. The composition is taken to be slag, porosity, and contamination. Figure 3.73 shows a micrograph of a portion of the 17-mm flaw. A crack-like feature is evident in the figure. Figure 3.74 shows a micrograph of a magnified portion of the 17-mm flaw as polished and etched. The figures show slag in a small interbead region with crack-like features.

Figure 3.72 Micrograph of a Portion of the 17-mm Flaw. The composition of the flaw is taken to be slag, porosity, and contamination.

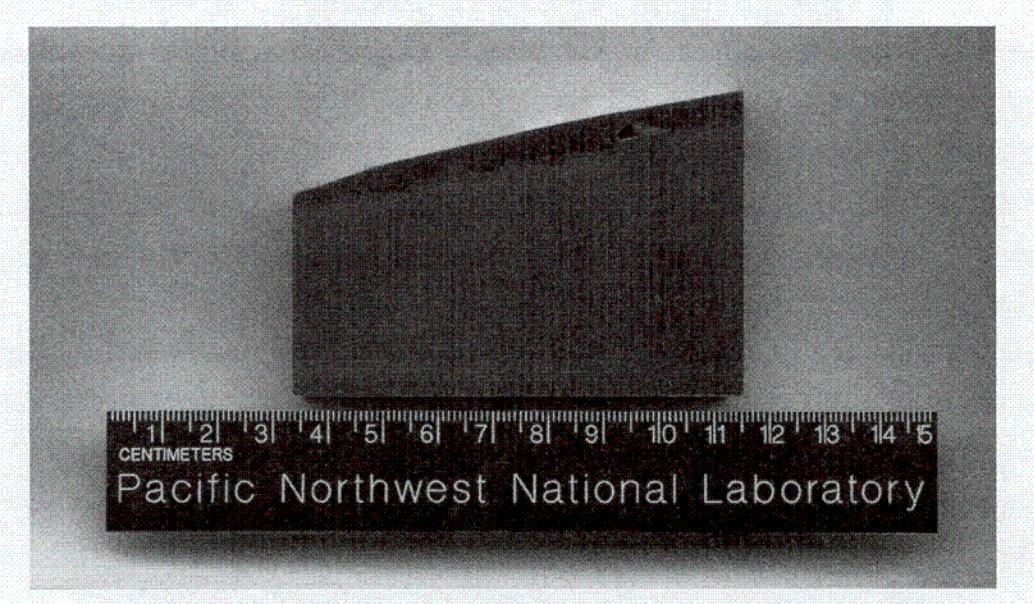
Figure 3.80 shows the largest flaw found in the validation of the cladding flaws. This flaw was found at the location of Volume 1 flaw *planar #1 in the near surface base metal*. The flaw is 4-mm through-wall and appears to be contained entirely

Figure 3.80 Photograph of PVRUF Specimen 4-5DBAC-Z5 as Machine Cut. The photograph shows 4-mm through-clad lack of fusion with slag.

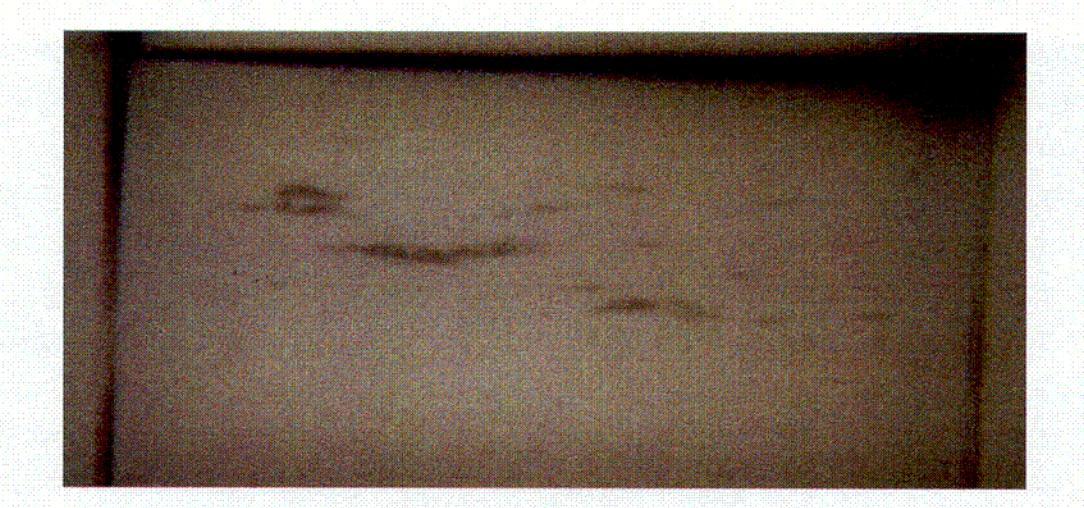
Figure 3.81 shows the results of a radiographic test of a Volume 1 base-metal flaw indication. The RT flaw indication is characterized as a mid-wall lamination cluster. The through-wall extent of the cluster is 8 mm. This mid-wall lamination cluster is shown in the distribution table for the base metal in Chapter 4.

Figure 3.81 Digitized Image of Radiograph Showing of Base Metal Lamination Cluster. Vessel through-wall direction is oriented vertically in the image. Vessel elevation is oriented horizontally in the image.

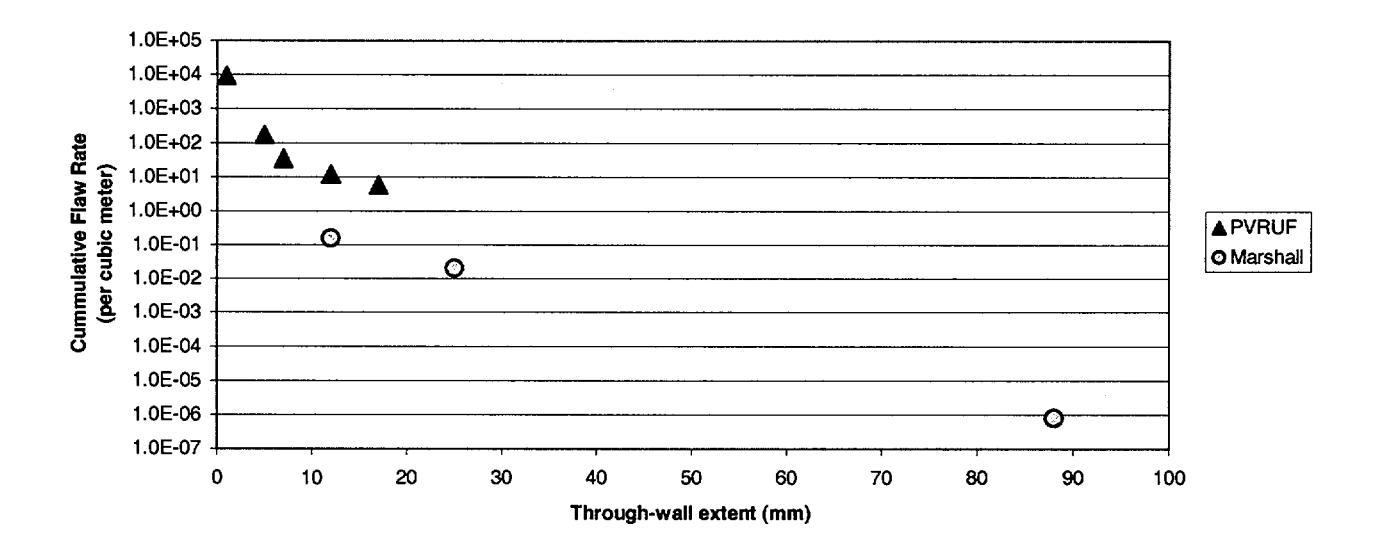
Figure 4.1 shows the PVRUF cumulative flaw rate as calculated from the entries in Tables 4.1, 4.4, and 4.6. The data from the Marshall reports (Marshall 1976, 1982) are also shown in Figure 4.1 for comparison. Some discussion of what data the Marshall committee was considering is appropriate for this comparison.

Figure 4.1. Comparison of Validated PVRUF and Marshall Cumulative Flaw Rates. This semi-log plot shows the individual data points from the PVRUF validation Tables 4.1, 4.4, and 4.6 and the Marshall data (Marshall 1976).

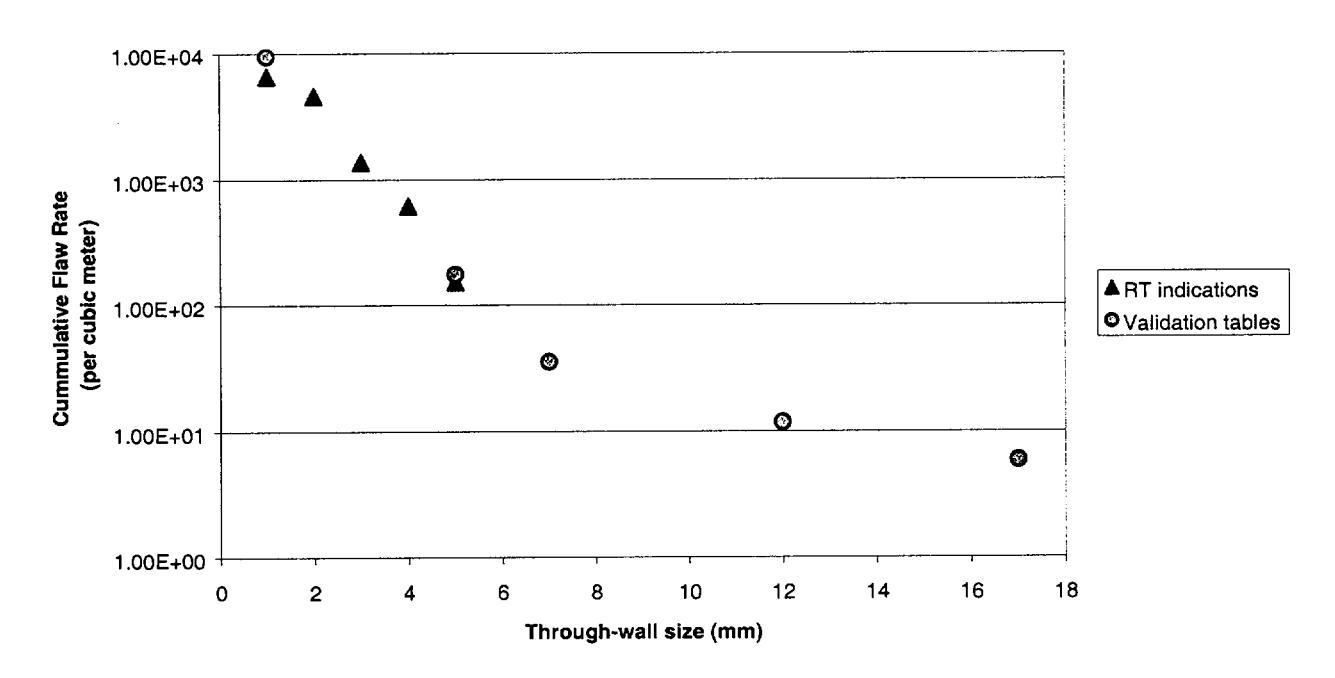
Figure 4.2. Size Distribution of Small Flaws in PVRUF Vessel as Measured by Radiographic Testing of 25-mm Thick Plate

Figure 4.2 shows the cumulative flaw rate for small flaws from the RT examinations along with
