VIRGINIA ELECTRIC AND POWER COMPANY
RICHMOND, VIRGINIA 23261

September 17, 2011

VIRGINIA ELECTRIC AND POWER COMPANY (DOMINION)
NORTH ANNA POWER STATION UNITS 1 AND 2
NORTH ANNA INDEPENDENT SPENT FUEL STORAGE INSTALLATION
SUMMARY REPORT OF AUGUST 23, 2011 EARTHQUAKE RESPONSE AND
RESTART READINESS DETERMINATION PLAN

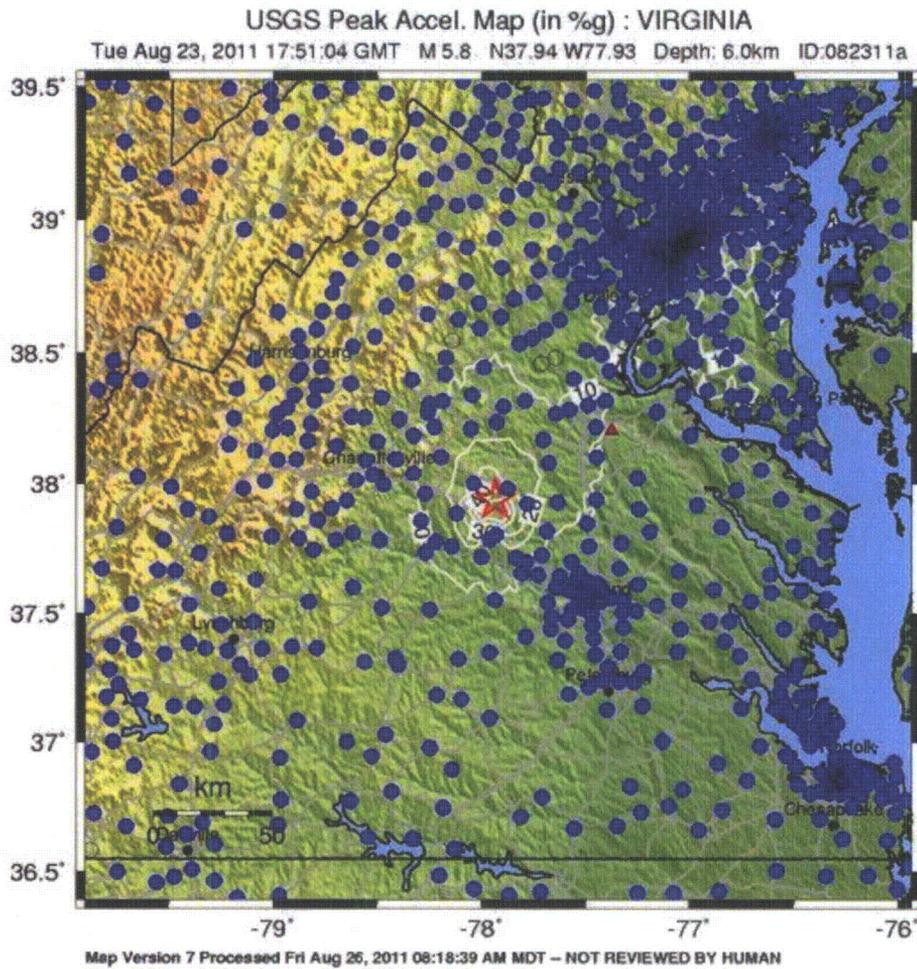
Based on the above PGA shake map, the location of the plant is just outside of the 0.3g contour plotted above. This appears to be consistent with the peak ground acceleration measured by the Kinematics recorder at the Containment basemat (see Attachment 3).

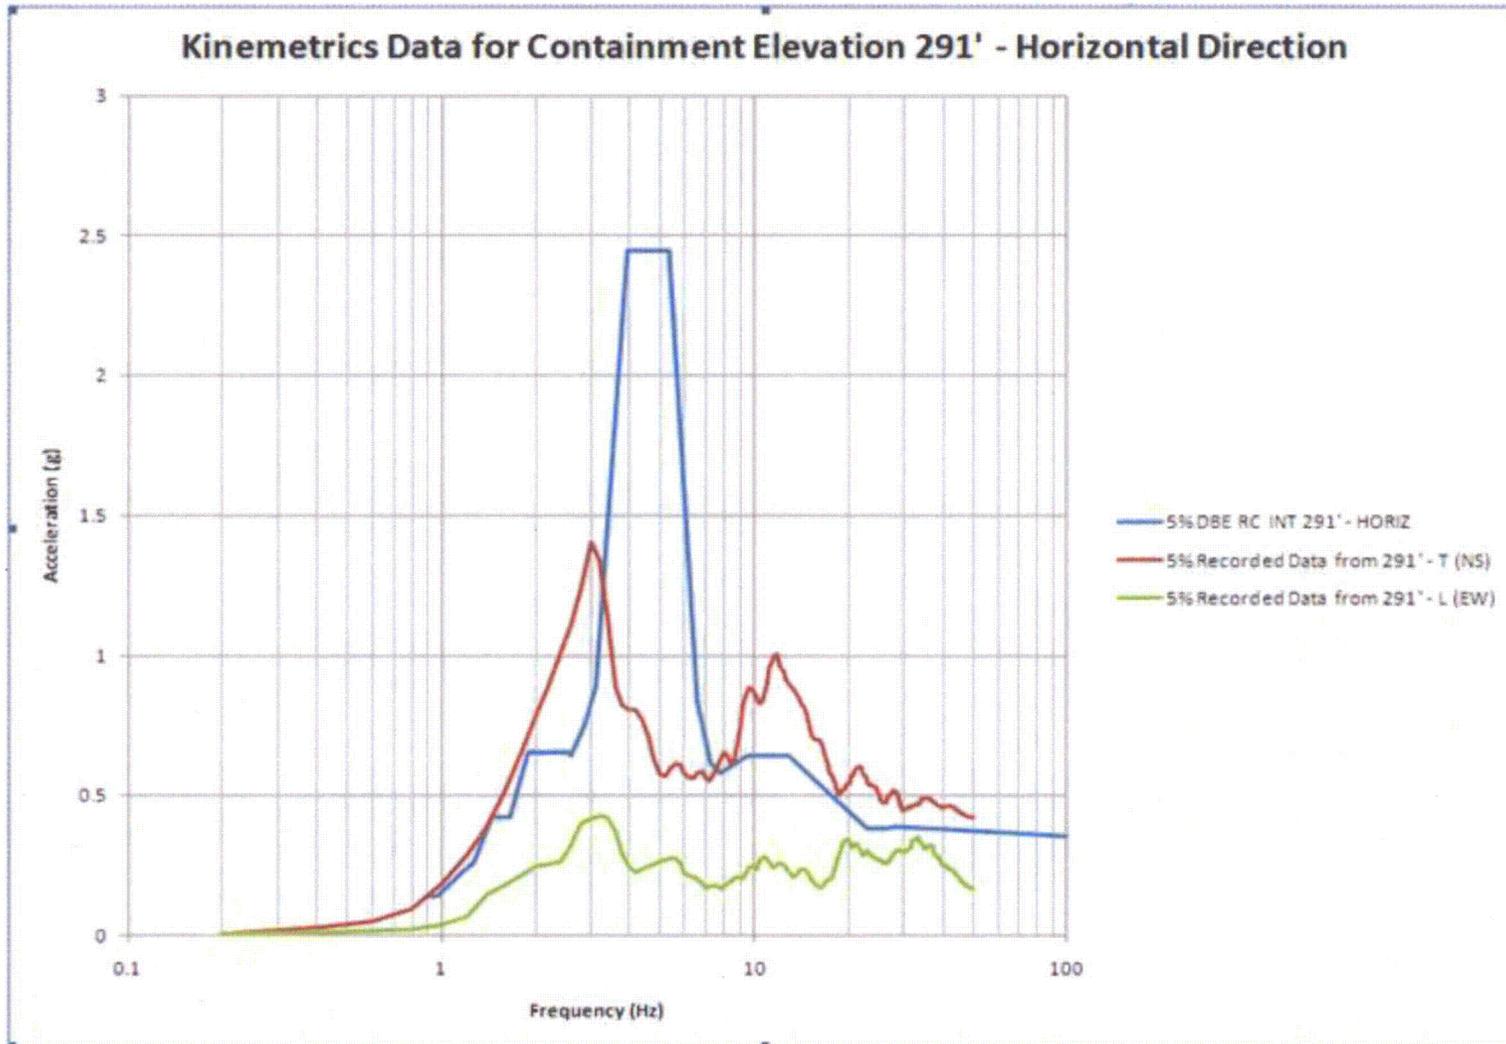
Figure 3.3 – Containment 291' Elevation - Horizontal

See Figures 3.3 and 3.4 for horizontal and vertical comparison, respectively.
