**Wenck Associates, Inc., "Engineering Evaluation of Hesco Barriers Performance at
Fargo, ND 2009," May 2009**

**DOS K12 CRASH TEST AND EVALUATION OF THE
HESCO C-3315 FLOOD BARRIER**

Contract No.: P2005003
Project/Test No.: 400001-HBL2
Test Date: 12-17-2004

April 2005

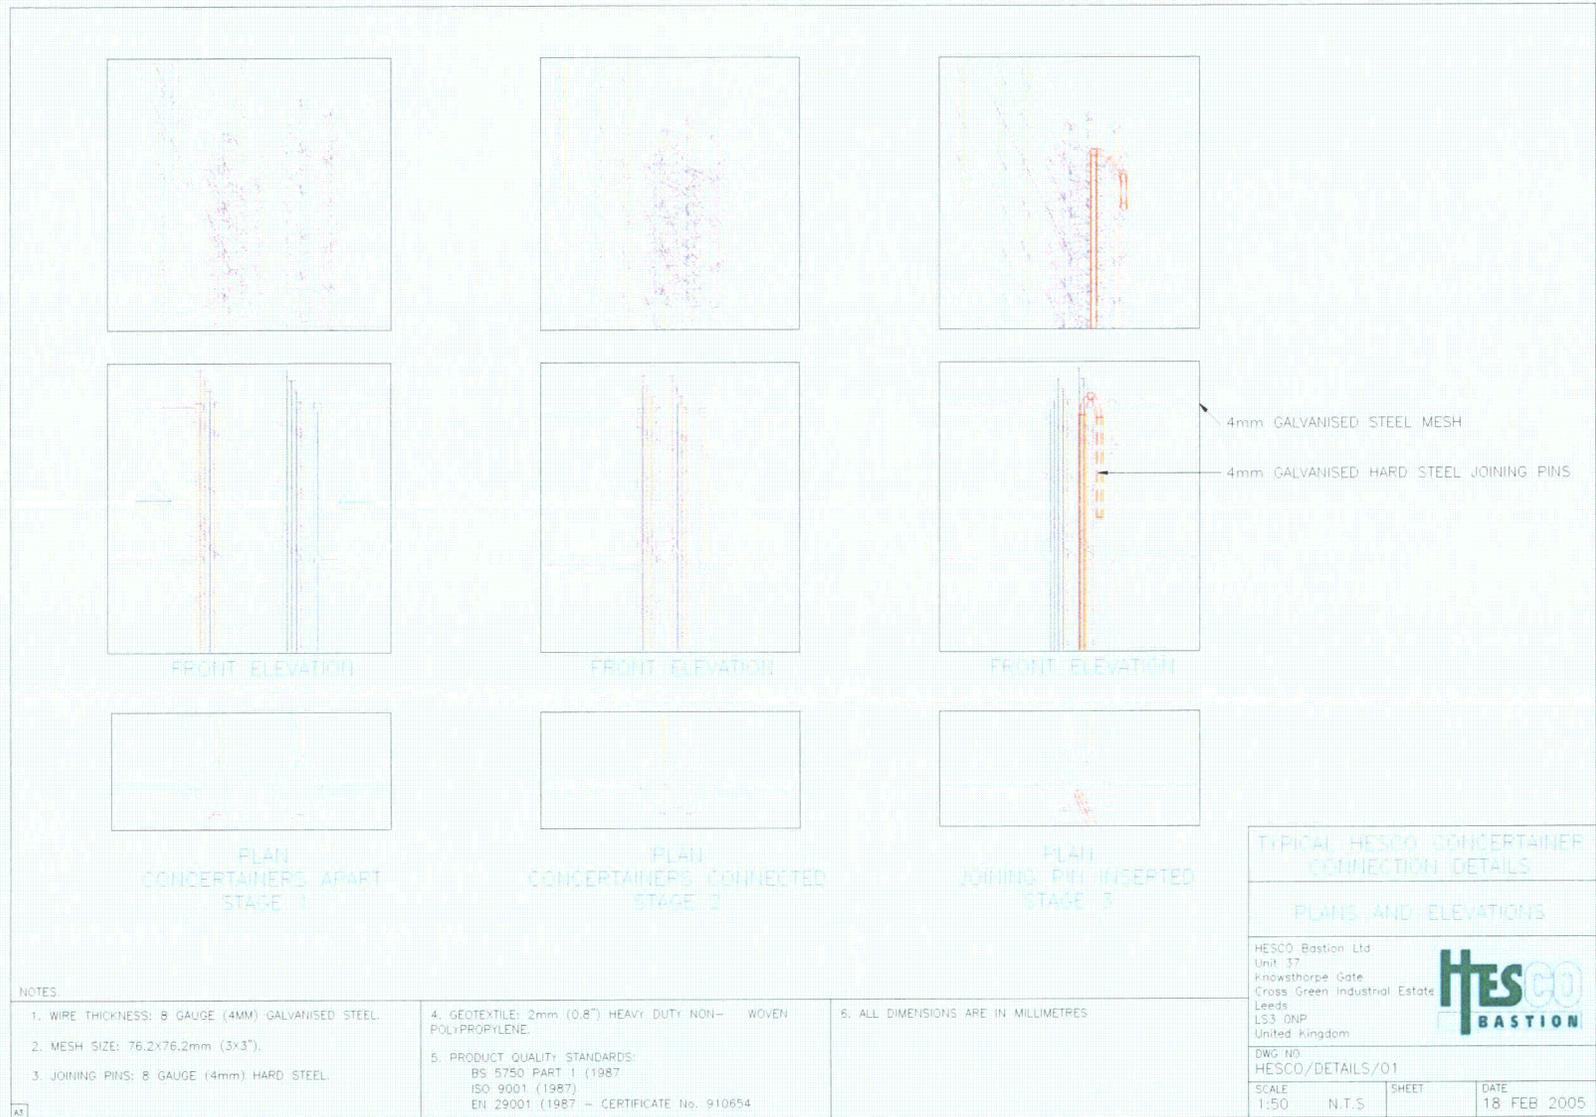
Figure 2. Connection details of HESCO C-3315 flood barrier.

The HESCO Bastion Ltd. C-3315 flood barriers are constructed with welded wire sheets to form open top cubes that measured 0.91 m (3.0 ft) wide by 0.91 m (3.0 ft) tall. The welded wire was 4mm (0.158 in) diameter and was welded on a 76 mm x 76 mm (3.0 in x 3.0 in) grid. A series of 5 cubes came pre-assembled and lined with 2mm (0.8 in) non-woven polypropylene geotextile fabric. Corners of the HESCO Bastion Ltd. C-3315 flood barriers are formed with coiled 4 mm (0.158 in) wire. The coils are 32 mm (1.25 in) diameter with a coil pitch of 25 mm (1.0 in). Pre-assembled units are joined with adjacent units by overlapping wire coils and placing a 4mm (0.158 in) joining pin in the overlapped section of coils.

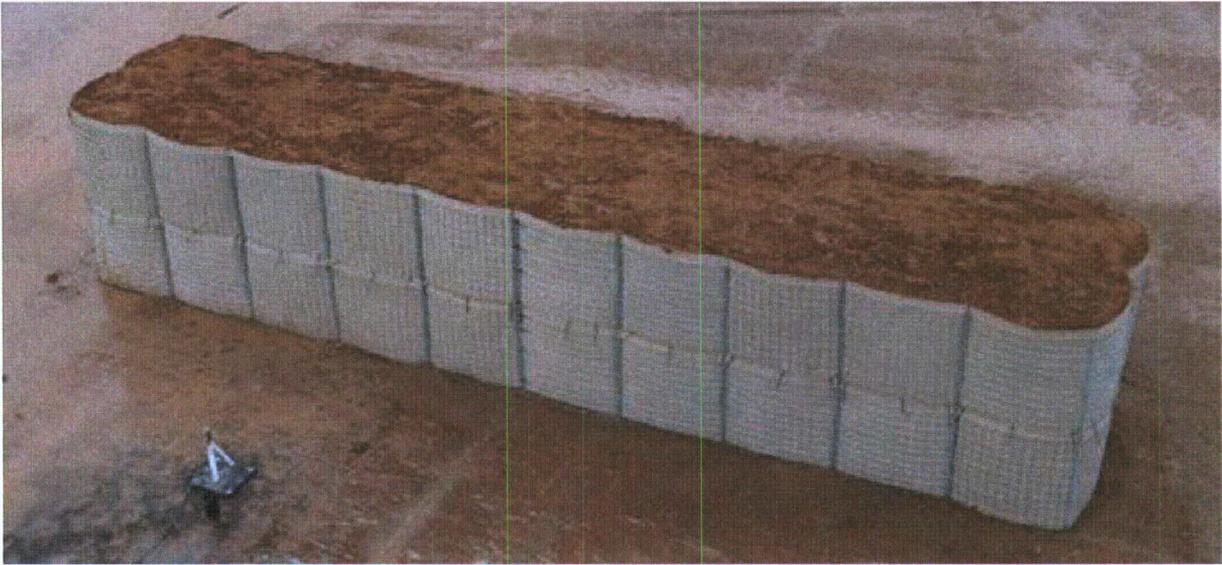
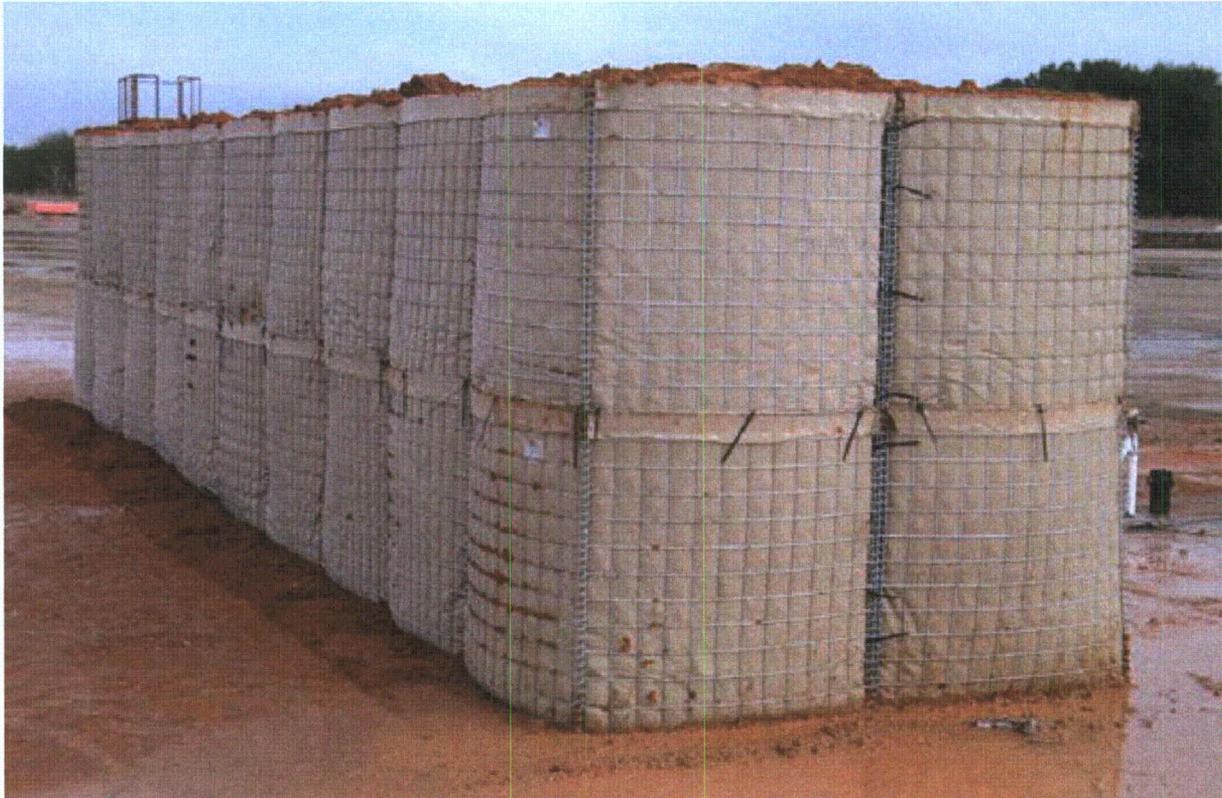
Figure 3. HESCO C-3315 flood barrier prior to testing.

The HESCO Bastion Ltd. C-3315 flood barriers were filled with a reddish-tan silty, clayey sand, designated as select fill from the Kelly Burt pit. The density of the fill material was 1900 kg/cubic meter (118.5 lbs/cubic ft) and was manually tamped by HESCO installers. Details of the installation are shown in figures 1 and 2. Photographs of the completed installation are shown in figure 3.

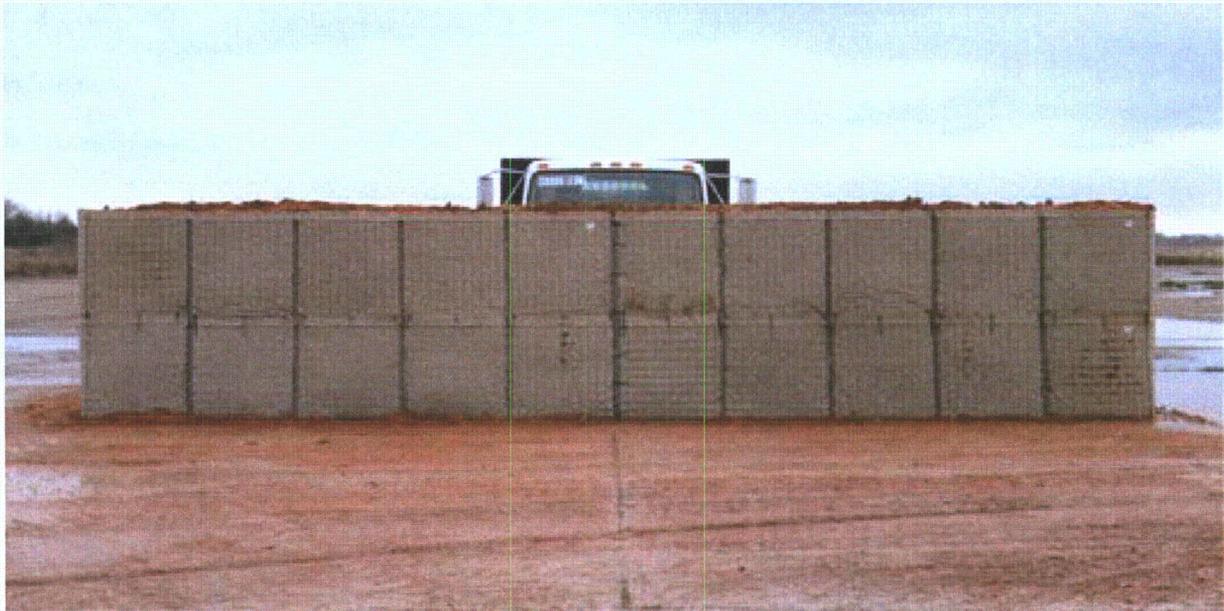
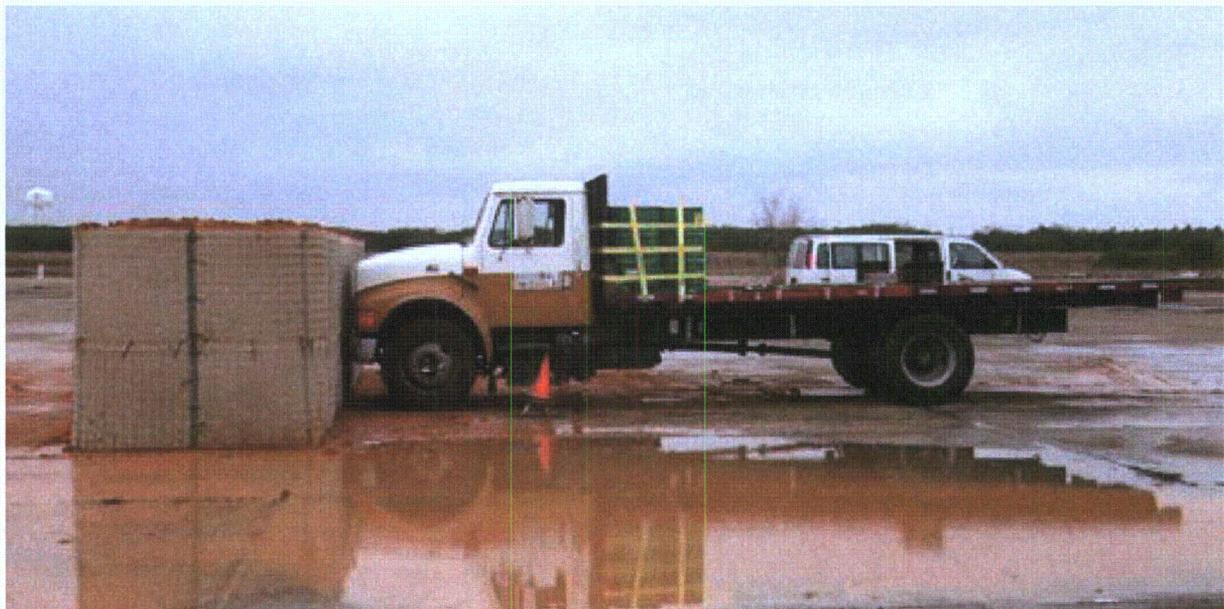
Figure 4. Vehicle/installation geometrics for test 400001-HBL2.

A 1995 International 4700 single-unit flatbed truck, shown in figures 4 and 5, was used for the crash test. Test inertia weight of the vehicle was 6867 kg (15,140 lb). The height to the lower edge of the vehicle front bumper was 514 mm (20.25 inches), and the height to the upper edge of the front bumper was 800 mm (31.5 inches). Figure 11 in appendix B gives additional dimensions and information on the vehicle. The vehicle was directed into the installation using the cable reverse tow and guidance system, and was released to be free-wheeling and unrestrained just prior to impact.

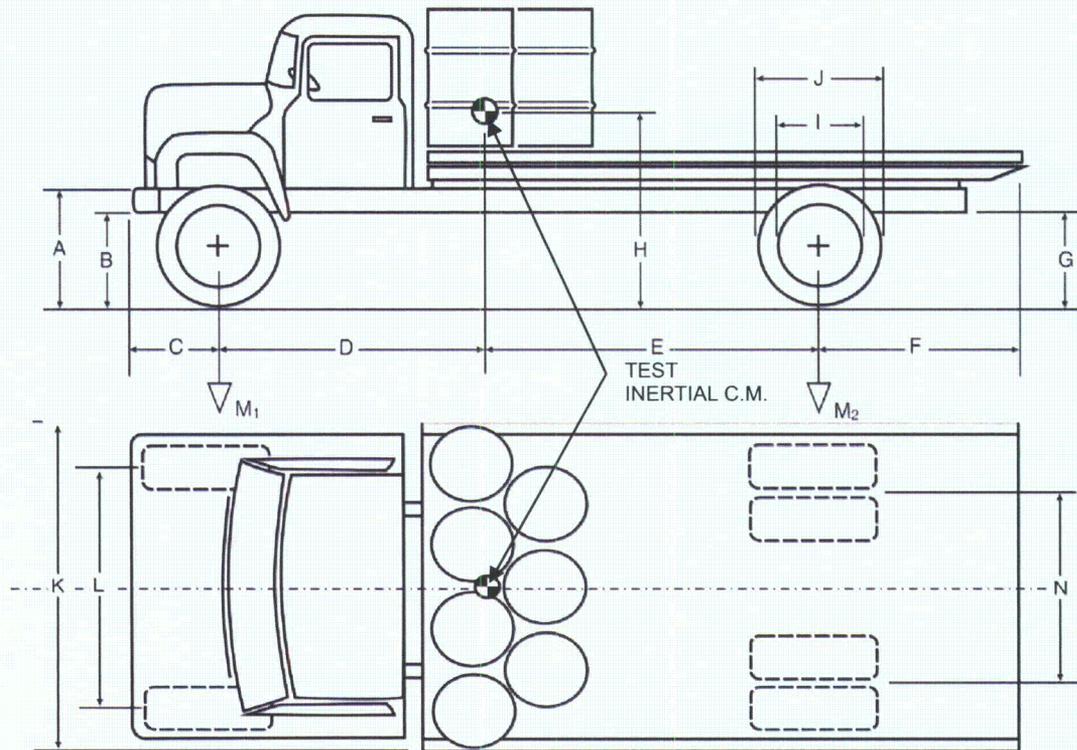
Figure 11. Vehicle properties for test 400001-HBL2.

DATE: 12-17-2004 TEST NO.: 400001-HBL2 VIN NO.: 1HTSCABN2SH207933
 YEAR: 1995 MAKE: International MODEL: 4700
 TIRE SIZE: 275/80/R22.5 ODOMETER: 025522

A 800 B 514 C 775 D 2623 E 2534 F 2794 G 737
 H _____ I 597 J 1003 K 2445 L 2045 N 1854

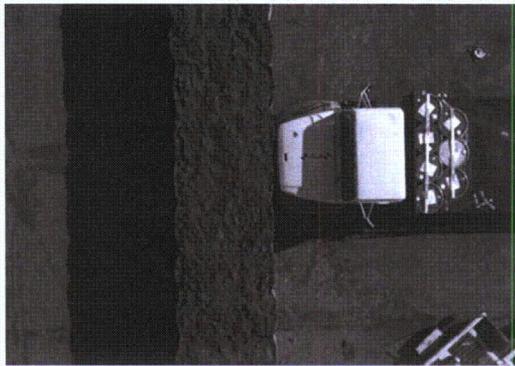
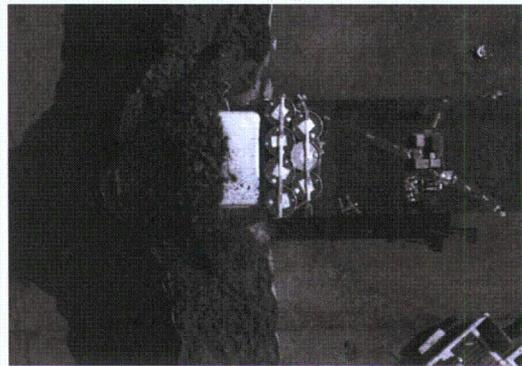
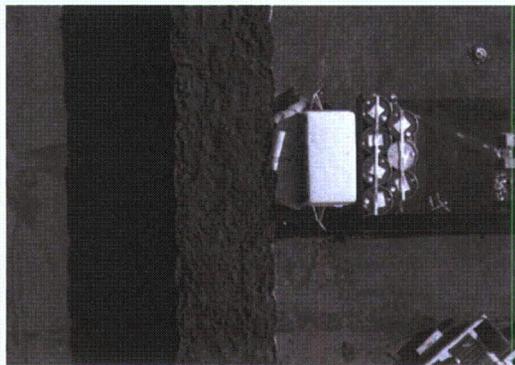
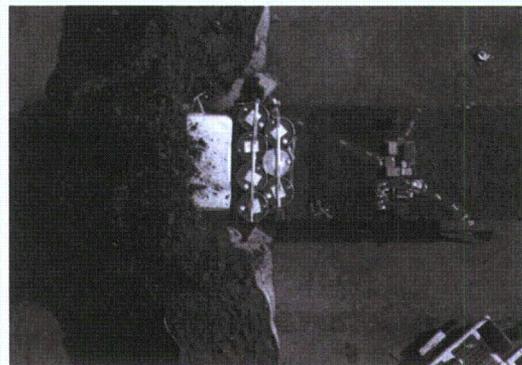
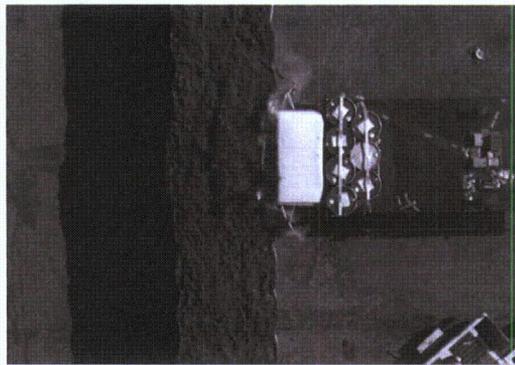
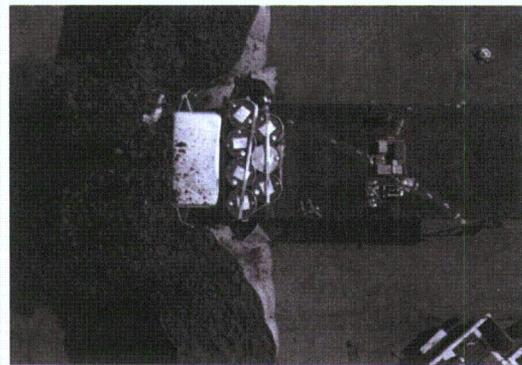
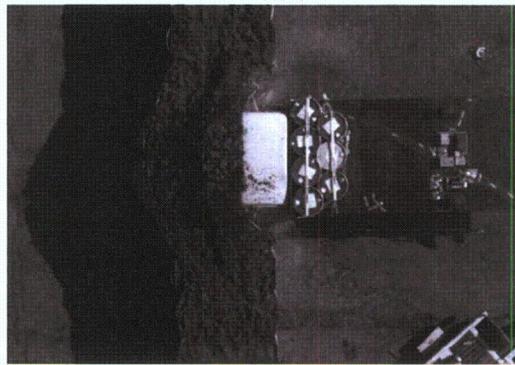
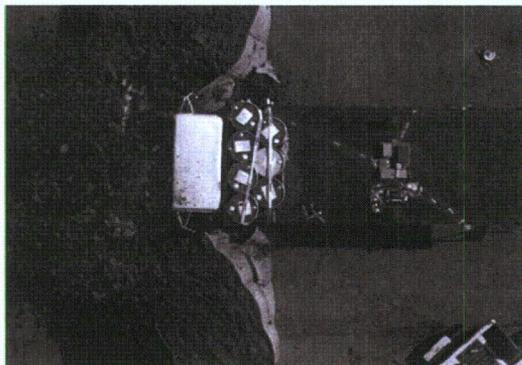
Figure 12. Sequential photographs for test 400001-HBL2 (overhead view).

The 1995 International 4700 single-unit flatbed truck, traveling at a speed of 81.0 km/h (50.3 mi/h), impacted the HESCO Bastion Ltd. C-3315 flood barrier at an impact angle of 90.8 degrees, with the centerline of the vehicle aligned with the centerline of the barrier. Shortly after impact, the hood of the vehicle separated from the vehicle near the cab. At 0.054 s, the head rack of the truck bed contacted the rear of the cab. The inside edge of the bottom row of box units began to move toward the inside of the barrier at 0.060 s, and the top row began to move toward inside of the barrier at 0.078 s. The strap on the front row of the box units separated at 0.560 s. At 0.800 s, the vehicle reached maximum penetration of the front of the truck bed of 1.1 m (3.7 ft) into the barrier (or 0.8 m (2.9 ft) from the impact side of the inside edge of the barrier). The vehicle subsequently backed up slightly and came to rest with the front of the cargo bed 0.85 m (2.8 ft) to the impact side of the inside edge of the barrier. The front of the cargo bed did not reach inside edge of the barrier. Appendix C, figures 12 and 13, show sequential photographs of the test period.

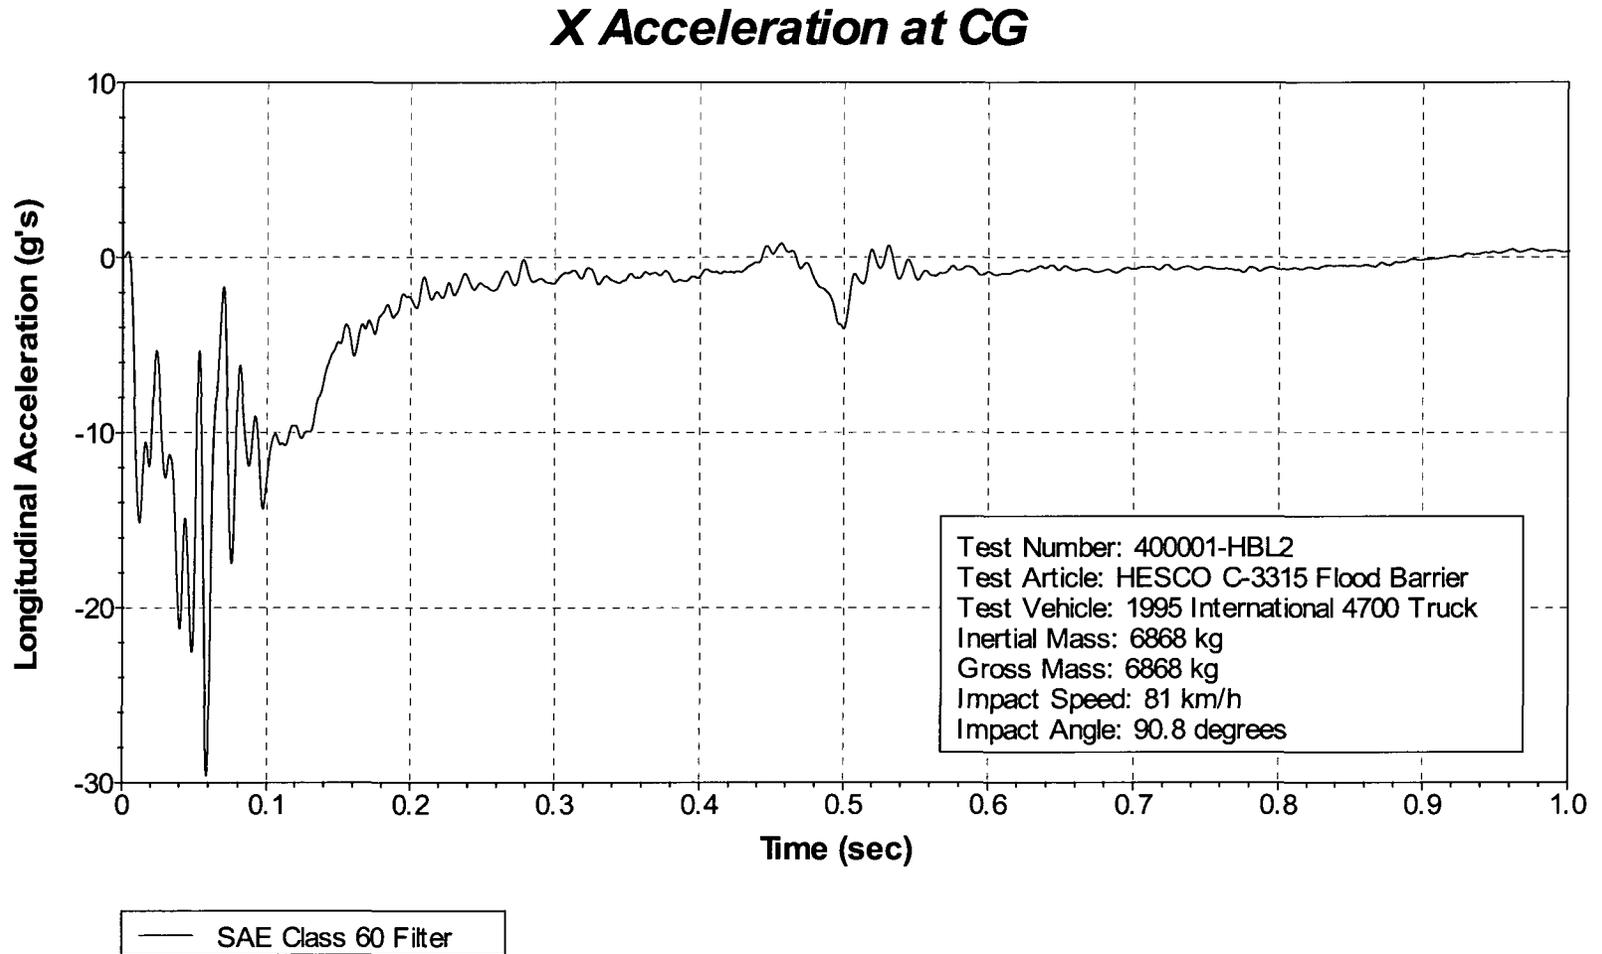
Figure 14. Vehicle longitudinal accelerometer trace for test 400001-HBL2 (accelerometer located at center of gravity).

Data from the accelerometer, located at the vehicle center of gravity, were digitized for evaluation of occupant risk for informational purposes only. In the longitudinal direction, the occupant impact velocity was 11.9 m/s (39.0 ft/s) at 0.106 s, the highest 0.010-s occupant ridedown acceleration was -10.6 g's from 0.106 to 0.116 s, and the maximum 0.050-s average acceleration was -14.4 g's between 0.011 and 0.061 s. In the lateral direction, the occupant impact velocity was 0.4 m/s (1.3 ft/s) at 0.106 s, the highest 0.010-s occupant ridedown acceleration was 3.0 g's from 0.113 to 0.123 s, and the maximum 0.050-s average was -1.5 g's between 0.024 and 0.074 s. These data and other pertinent information from the test are summarized in figure 10. Vehicle angular displacements and accelerations versus time traces are presented in appendix D, figures 14 through 19.
