**UNITED STATES
NUCLEAR REGULATORY COMMISSION**
REGION III
2443 WARRENVILLE ROAD, SUITE 210
LISLE, IL 60532-4352

EA-11-243

**SUBJECT: PALISADES NUCLEAR PLANT - NRC SPECIAL INSPECTION TEAM (SIT)
REPORT 05000255/2011014 PRELIMINARY YELLOW FINDING**

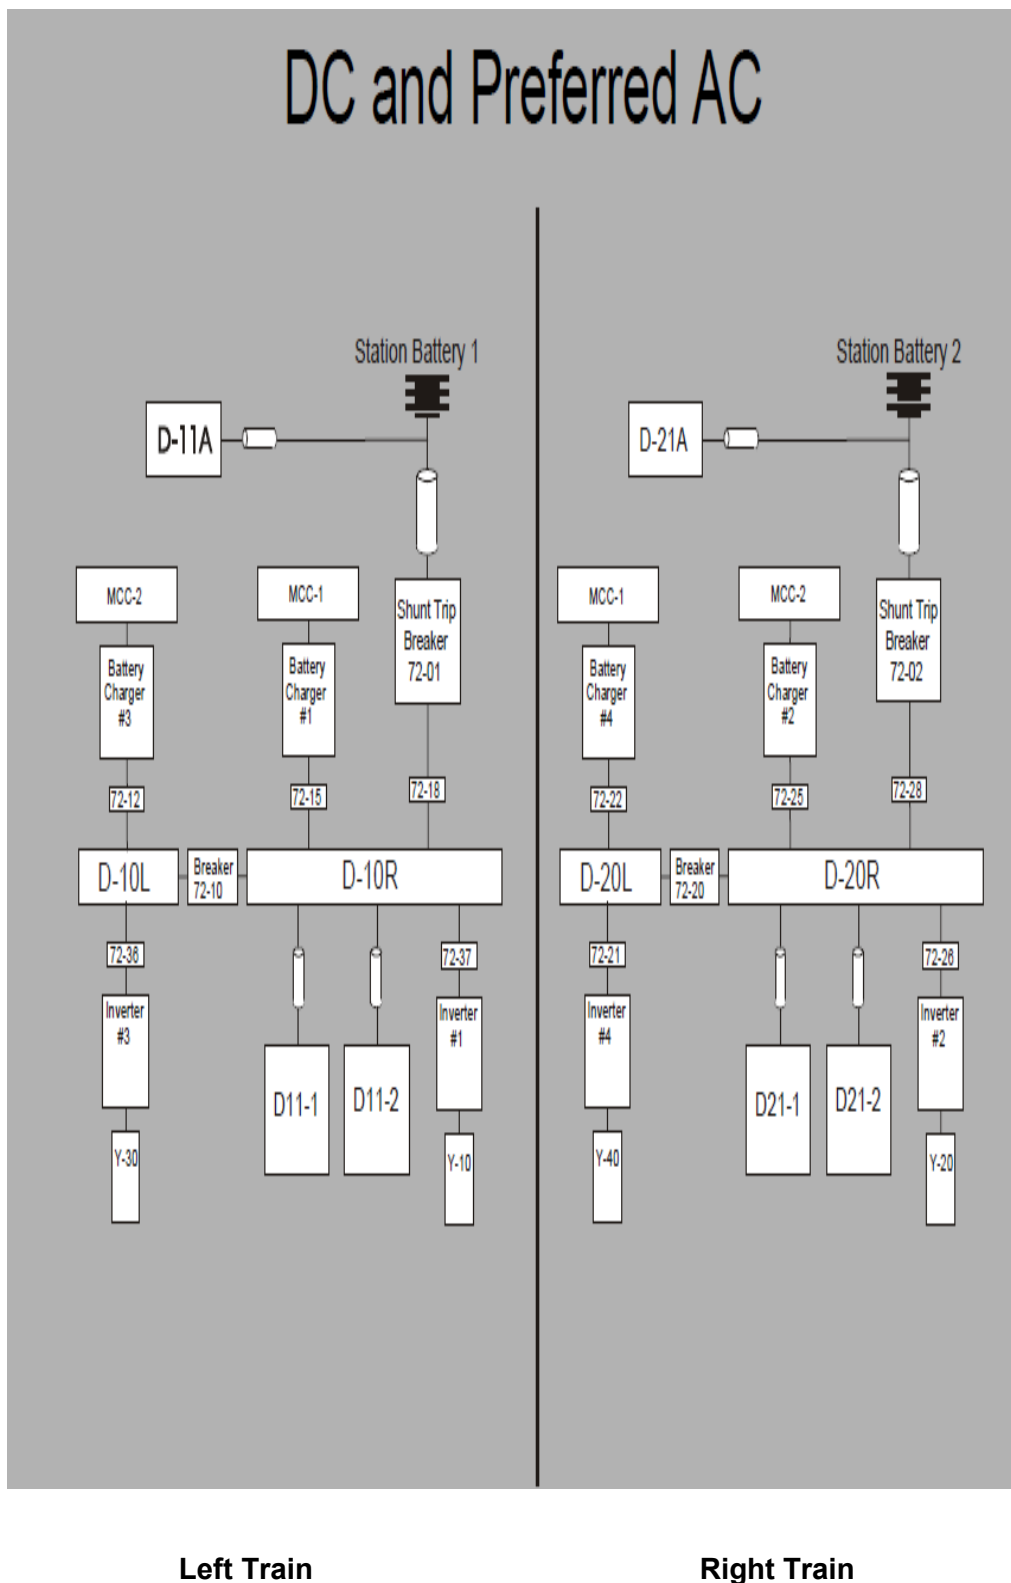
FIGURE 1 - SIMPLIFIED DIAGRAM OF PALISADES 125-VOLT DC SYSTEM

During the work, a horizontal bus bar slipped out of an electricians hand, causing an electrical fault on the left train of DC power distribution (reference Figure 7 in Attachment 5 of this report). Each train was comprised of a set of batteries, two chargers, instrumentation, and two inverters (reference Figure 1 in Attachment 4 of this report). The inverters provided AC power to the preferred AC busses, which in turn provided power to approximately 50 percent of the control room indications and controls.
