Ginna Reactor Vessel Bottom Mounted Instrumentation Paint Cracking Analysis

October 5, 2011

Written by: Maureen Kuchta
Maureen Kuchta,
Materials Lab, Engineering Programs

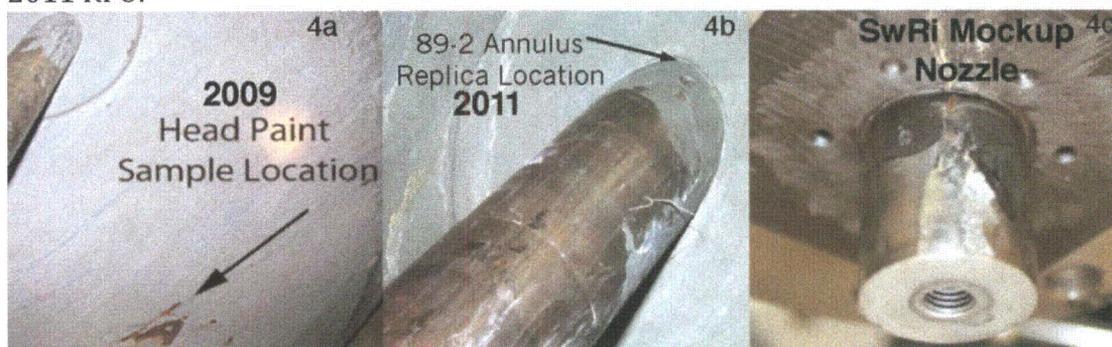
Figure 4a through 4c
Ginna Nozzle Paint Test Locations and SwRi Mockup

Figures 4a through 4c below show images of the Ginna head and annulus paint sample locations and an SwRi mockup used for leakage testing. Attachment 1 at the end of this report shows the location of the nozzles that were replicated during the 2011 RFO.

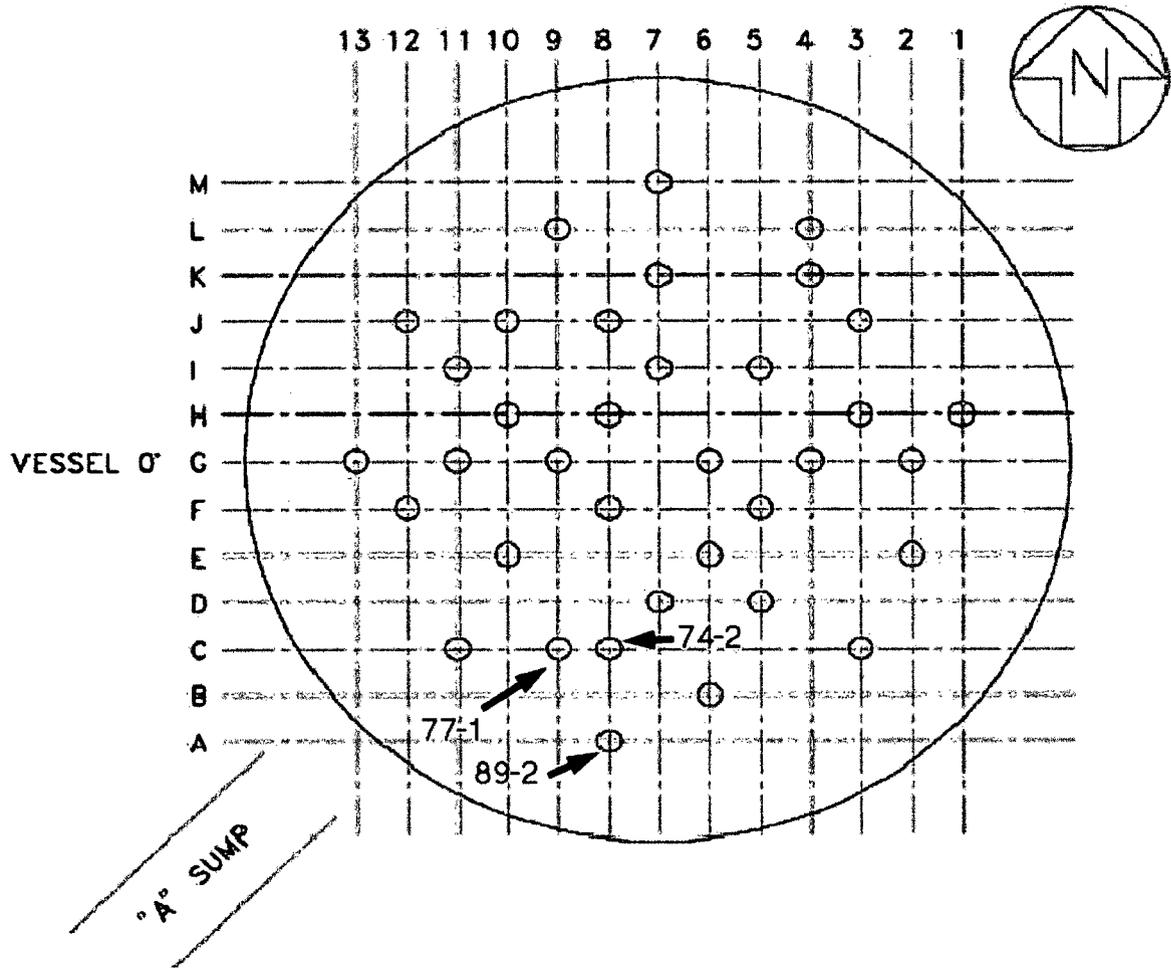
Lower Head BMI Location Map

Replication of the BMI annuli was done at locations 77-1, 89-2, and 74-1.
