# Root Cause Evaluation Report

Service Water Pump 7-C Line Shaft Coupling Failure

CR-PLP-2011-03902, EVENT DATE: 08-09-2011

REPORT DATE: 09-08-2011, Rev. 0

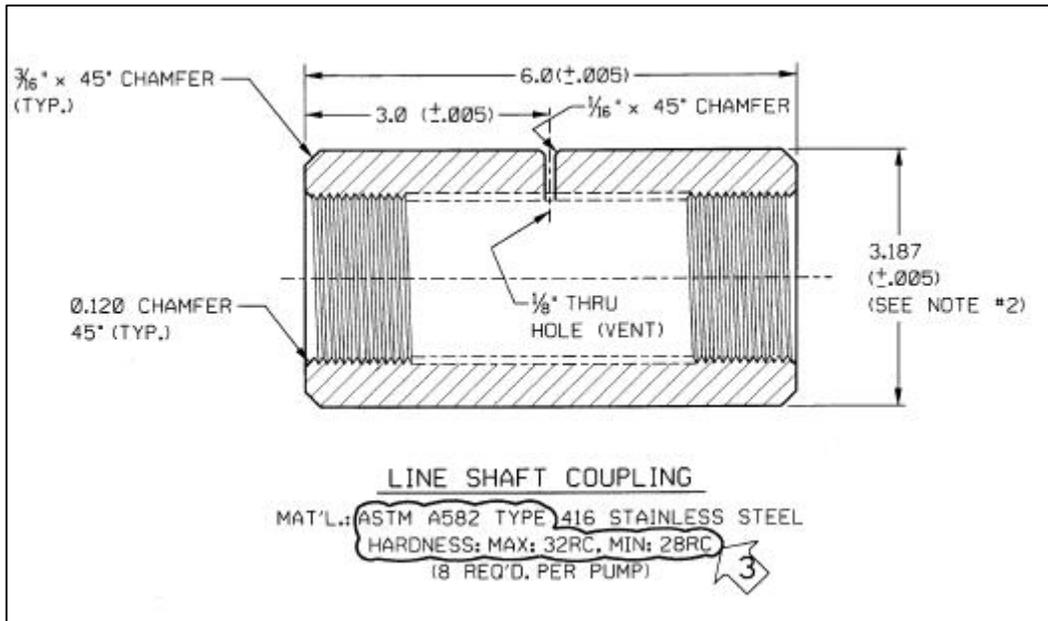
Figure 2: Coupling Drawing from VEN M-11 Sheet 55

The original SWS pumps were purchased to Specification M-11. The three 50% capacity service water pumps were rated at 8000 GPM and 140 ft Total Developed Head (TDH) each. At Palisades in May, 1999, FES-99-001 was approved to change SWS pump line shafts from carbon steel to 416 SS at the recommendation of the vendor at that time, Rotating Equipment Repair. The rationale for the change was improved corrosion resistance and improved material strength.

The specification for line shaft couplings for P-7A, P-7B, and P-7C was changed from carbon steel to 416 SS under EC 5000121762 in December 2007. EC-5000121762 was an update to the SWS configuration to allow the use of stainless steel couplings and shafts. According to the EC, 416 SS was chosen due to its strength, wear resistance and corrosion resistance. The couplings were also redesigned to incorporate an alignment hole that allows visual verification of proper shaft installation. The line shaft couplings for P-7A were replaced per EC-5000121762 under WO 51637416 on April 2009. The line shaft couplings on P-7B were replaced during a rebuild under Palisades PO 10246213 to HydroAire and P-7B was installed under WO 20082 in June 2010. The line shaft couplings for P-7C were changed from carbon steel to stainless steel through the PO 10237148 to HydroAire in June 2009.

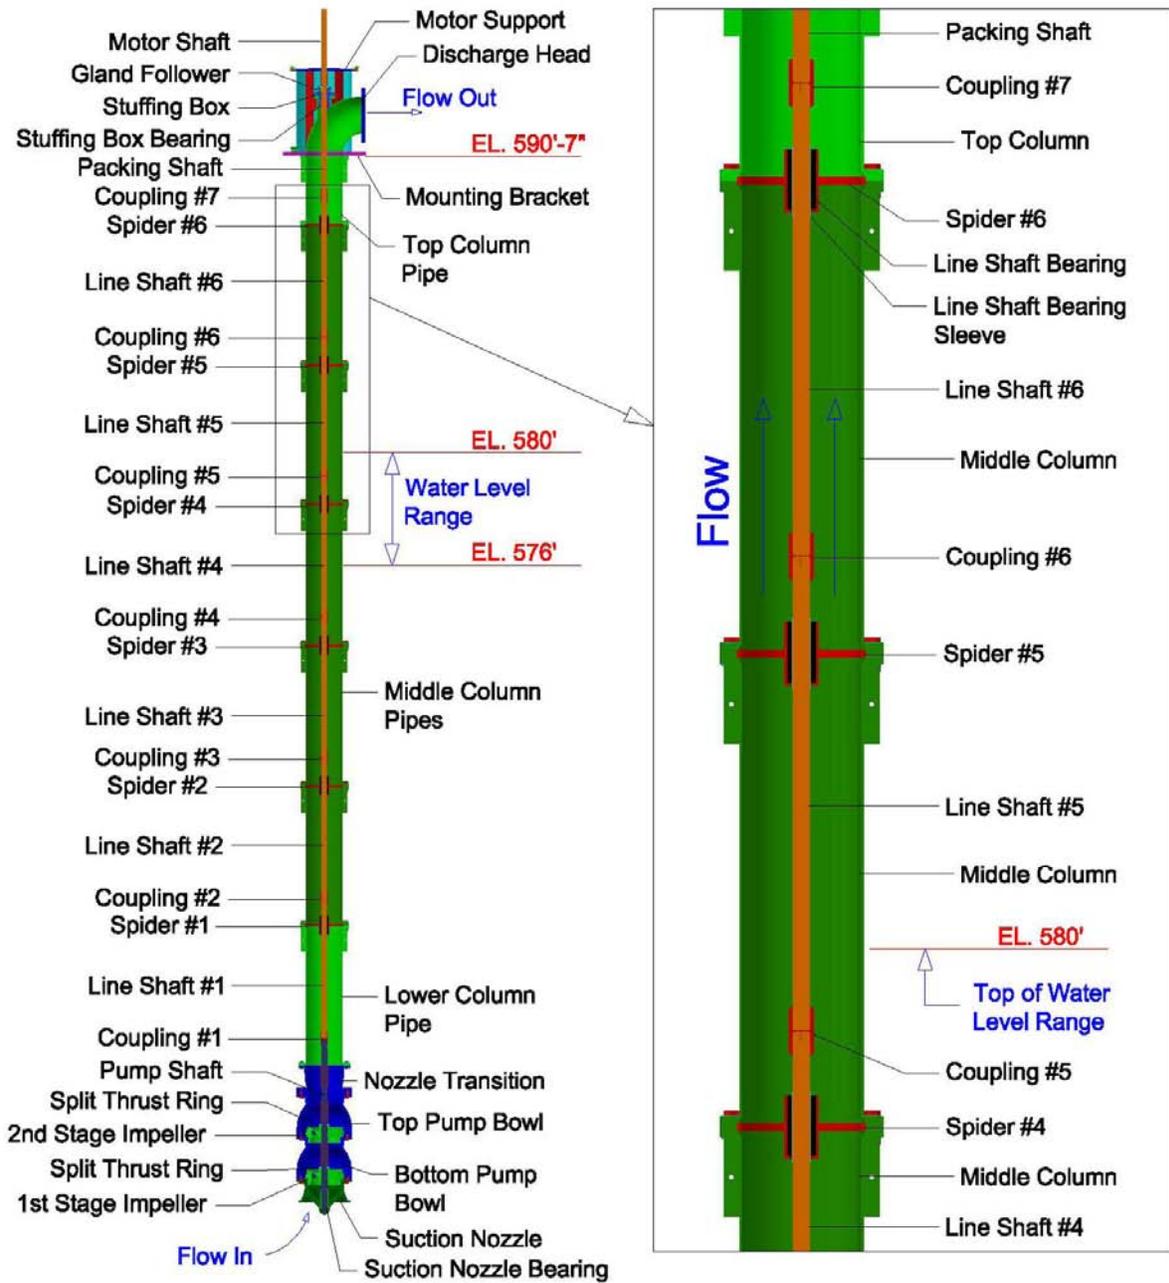
Figure 0-4: PLP SWS Pump Rendering

The SWS comprise of three motor driven vertical multistage pumps, tagged P-7A, P-7B and P-7C, supplying water from Lake Michigan to three service water headers. All three SWS pumps are similar in design in that they are comprised of two stage stainless steel impellers coupled to the motor through six line shafts, a packing shaft and a motor shaft for a total height of over 40 feet from suction to discharge. Figure 0-3 shows the shaft and coupling arrangement for the SWS pumps and identifies couplings 09-P7C-7F and 11-P7C-6F. As can be seen in Figure 0-3, the 09-P7C-7F is coupling #7 and the 11-P7C-6F is coupling #6. A rendering that identifies the pump components (excluding the motor) is provided in Figure 0-4.

Note: Spider refers to intermediate shaft guidance bushing.

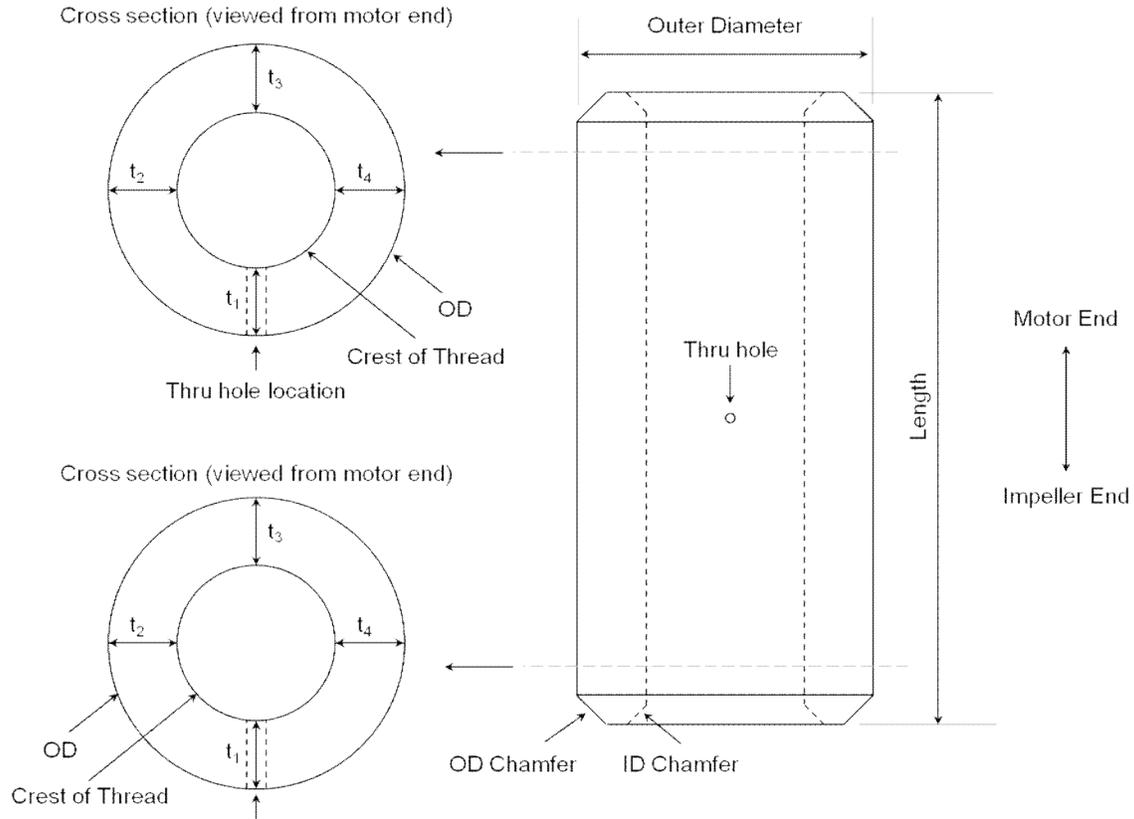
**Figure 0-2: Coupling Dimensioning Scheme**

To evaluate the concentric threading of each coupling, the wall thickness (from the outer diameter to the thread crest) was measured around the diameter on each coupling end, as shown in Figure 0-2. Table 0-2 gives the measured wall thicknesses. Coupling 11-P7C-4 exhibited the highest eccentricity (0.007 in.), occurring at its motor end. Couplings 11-P7C-5 and 11-P7C-6F were sectioned prior to dimensional analysis and subsequently some wall thickness measurements were not available

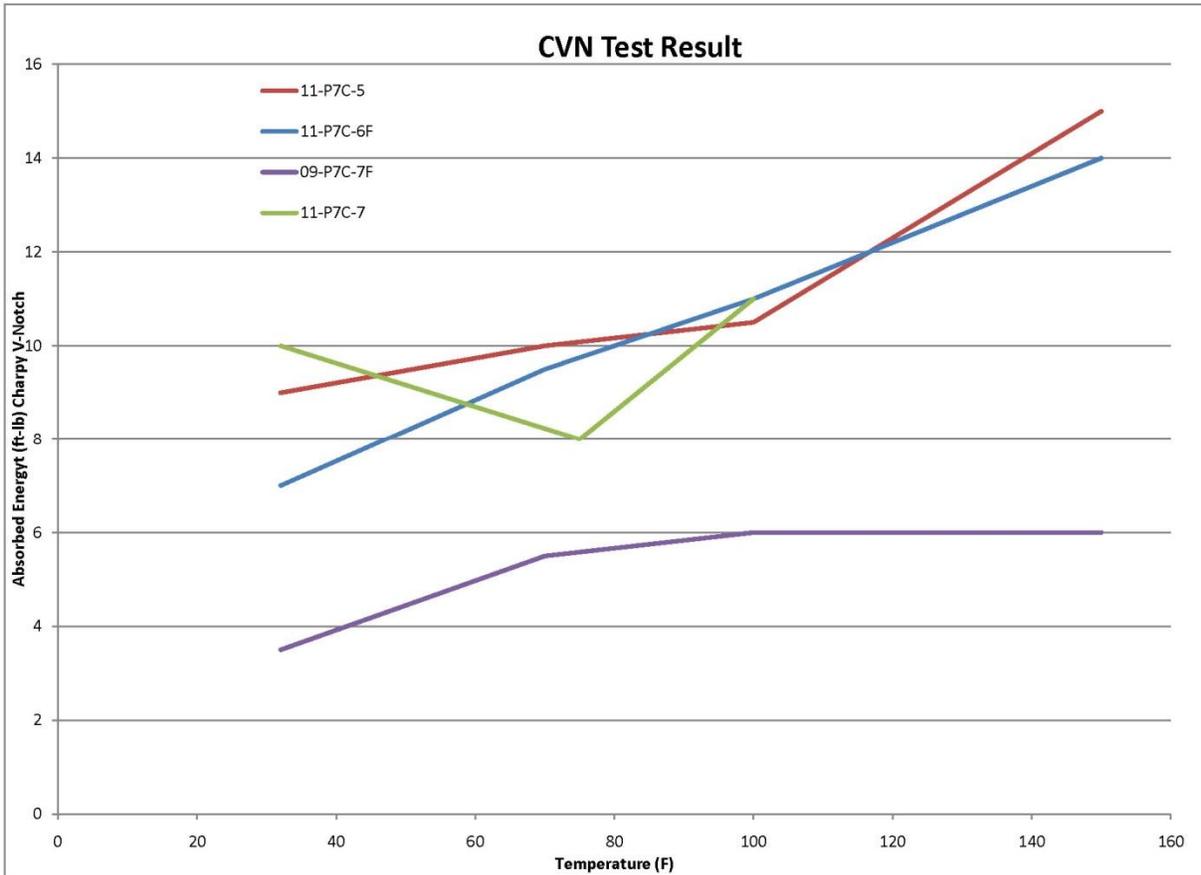
Figure 0-13: Charpy Test Result

Charpy V-Notch (CVN) impact test specimens with radial notches facing the inner diameter were machined from couplings 11-P7C-5, 11-P7C-6F, 11-P7C-7 and 09-P7C-7F. Impact testing was performed on the coupling material in accordance with ASTM Standard E23 [9] over a temperature range of 32°F to 152°F. Results of impact testing are given in Table 0-7. A plot of the CVN data is provided in Figure 0-13.

Coupling	Specimen Identification	Test Temperature (°F)	Absorbed Energy (ft-lb)	Lateral Expansion (in.)	Percent Shear (%)
11-P7C-5	5-C2	32	9	0.005	<10
	5-C4	32	9	0.006	<10
	5-C1	70	10	0.007	10
	5-C6	70	10	0.007	10
	5-C8	70	10	0.007	10
	5-C3	100	11	0.007	20
	5-C5	100	10	0.006	20
	5-C7	150	15	0.011	50
11-P7C-6F	6-C2	32	6	0.003	<10
	6-C4	32	8	0.006	<10
	6-C1	70	9	0.005	10
	6-C5	70	10	0.006	10
	6-C3	100	11	0.007	10
	6-C6	150	14	0.008	50
11-P7C-7	7-C2	32	10	0.003	<10
	7-C1	75	8	0.008	10
	7-C3	100	11	0.008	10
09-P7C-7F	709-C3	32	4	0.004	<10
	709-C4	32	3	0.004	<10
	709-C1	75	5	0.005	<10
	709-C2	75	6	0.002	<10
	709-C5	100	6	0.003	<10
	709-C6	152	6	0.006	<10

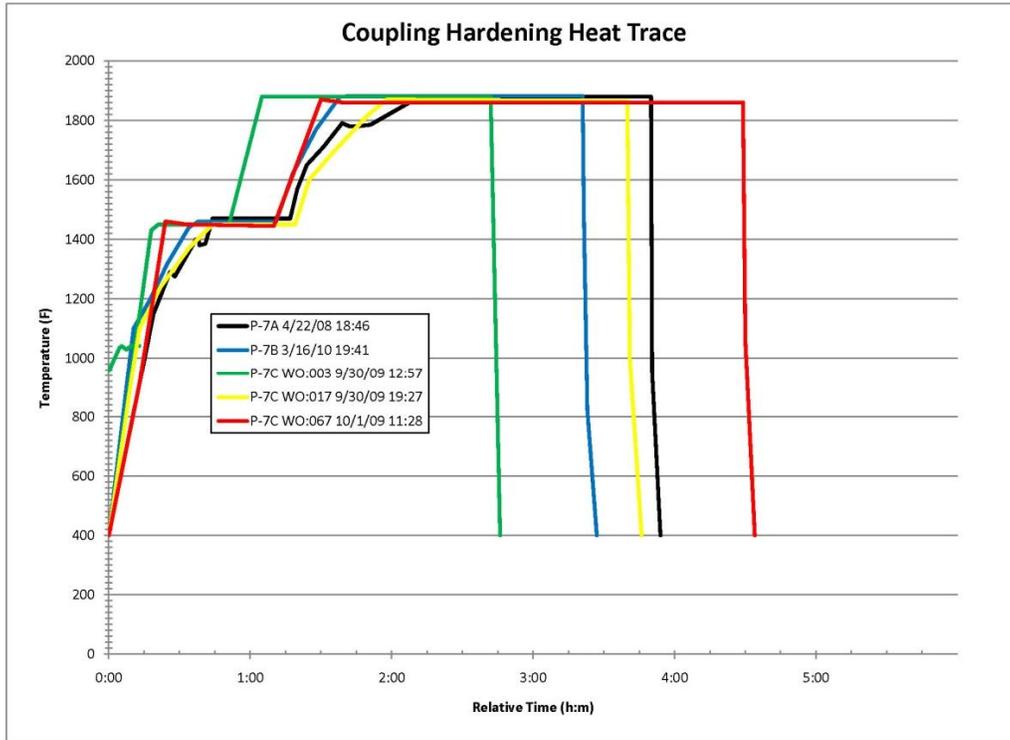
Figure 0-1: Hardening Heat Traces

For hardening, the guide indicates that the parts should be preheated at 1400-1455°F, austenitized at 1695-1850°F and oil quenched. A review of the provided BodyCote travelers provided for HydroAire Job #5912 (the couplings that were in P-7C when it failed in August 2011) indicate that they were hardened (per the guide).
