Root Cause Evaluation Report

Plant Trip During Panel ED-11-2 Maintenance

CR-PLP-2011-4822: 09-25-11

Entergy Nuclear Operations Palisades Plant

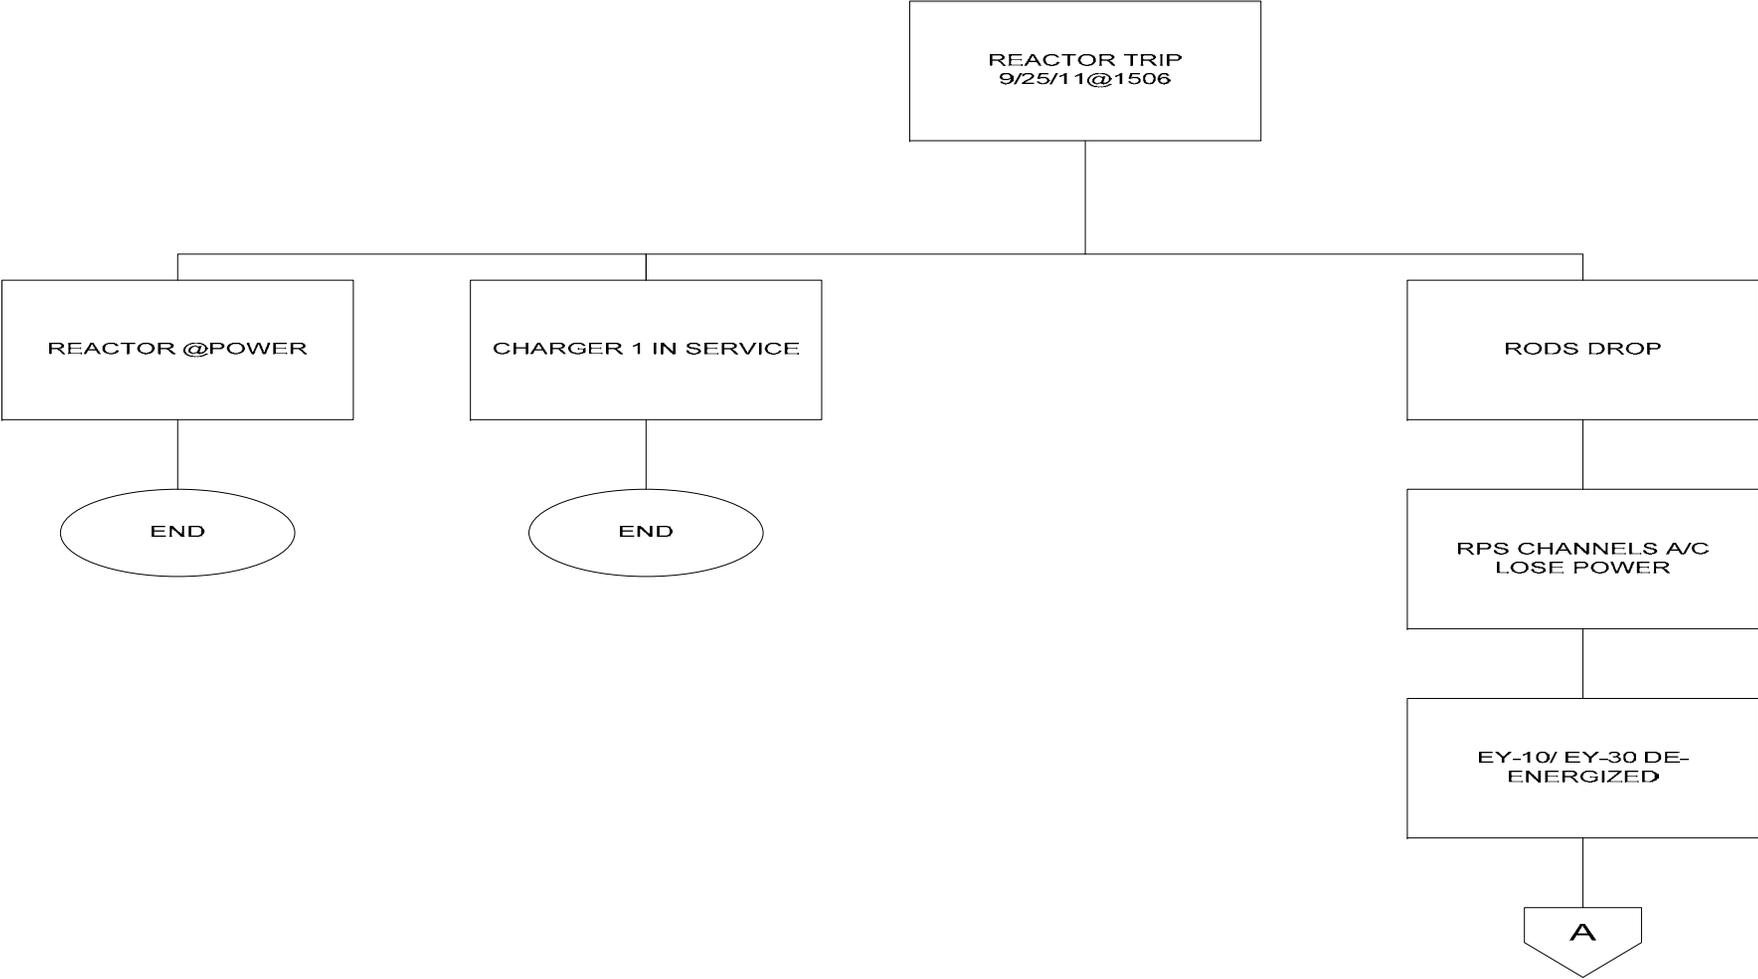
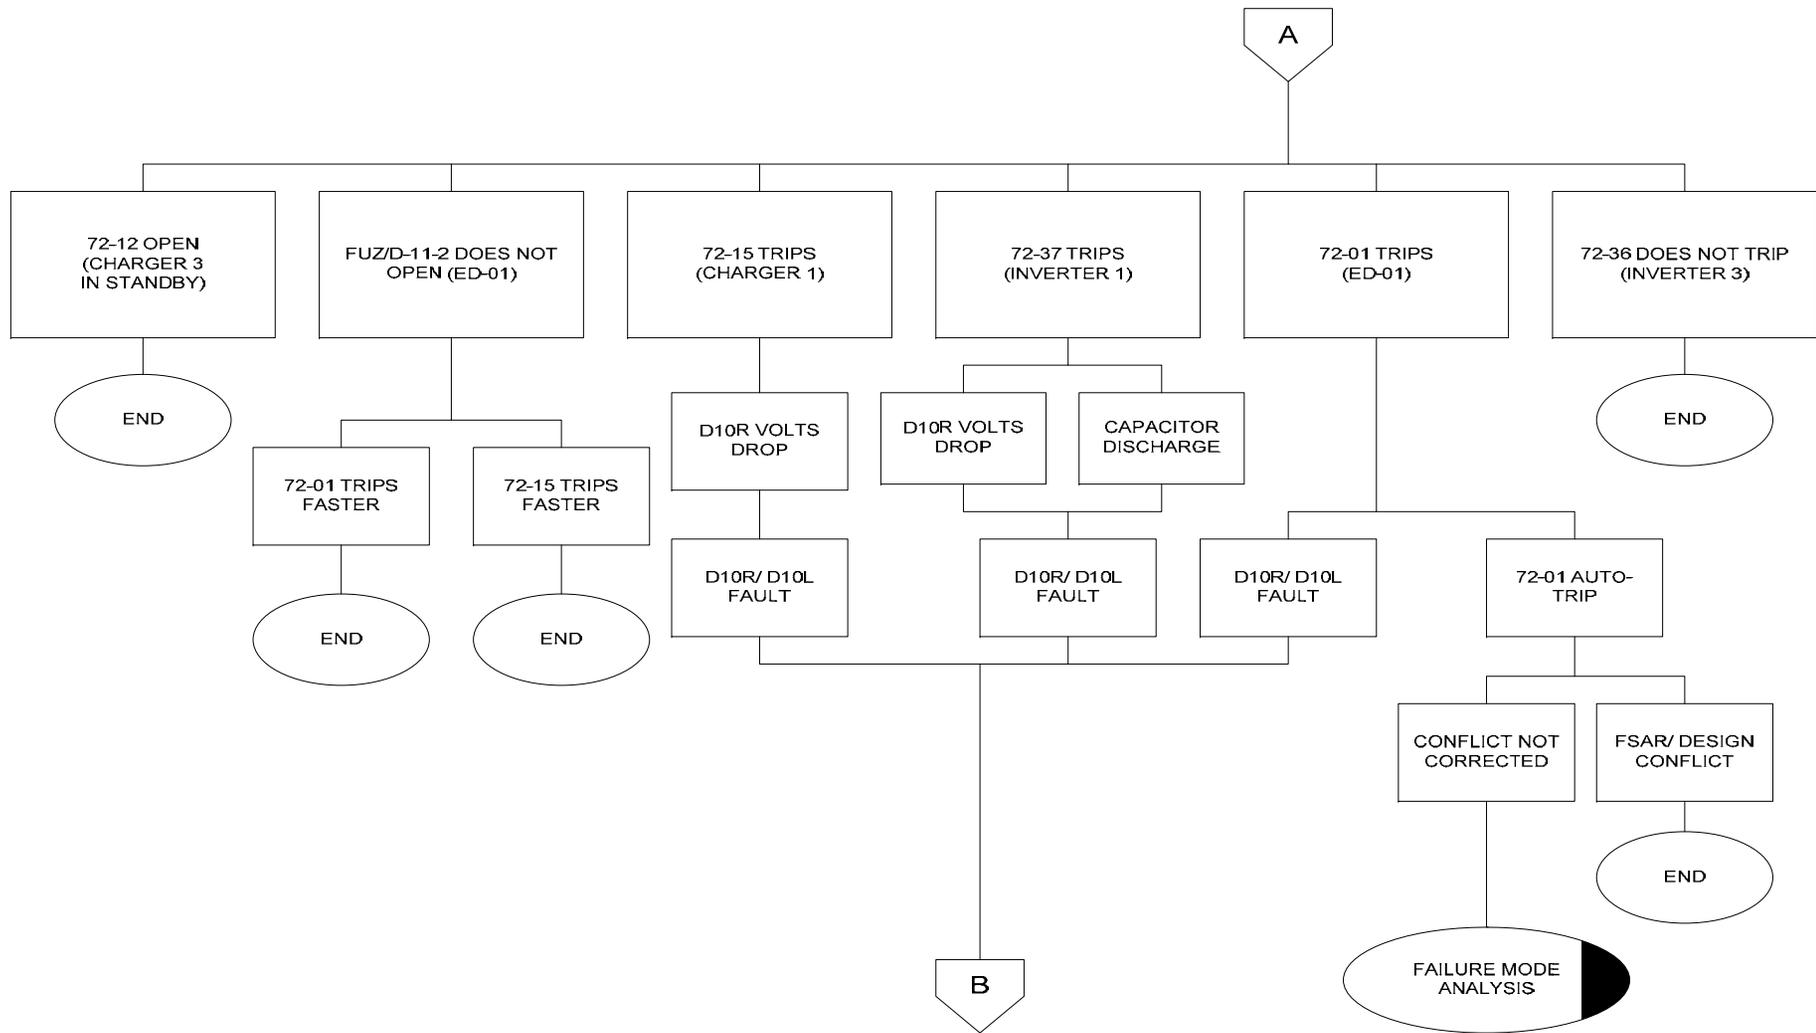
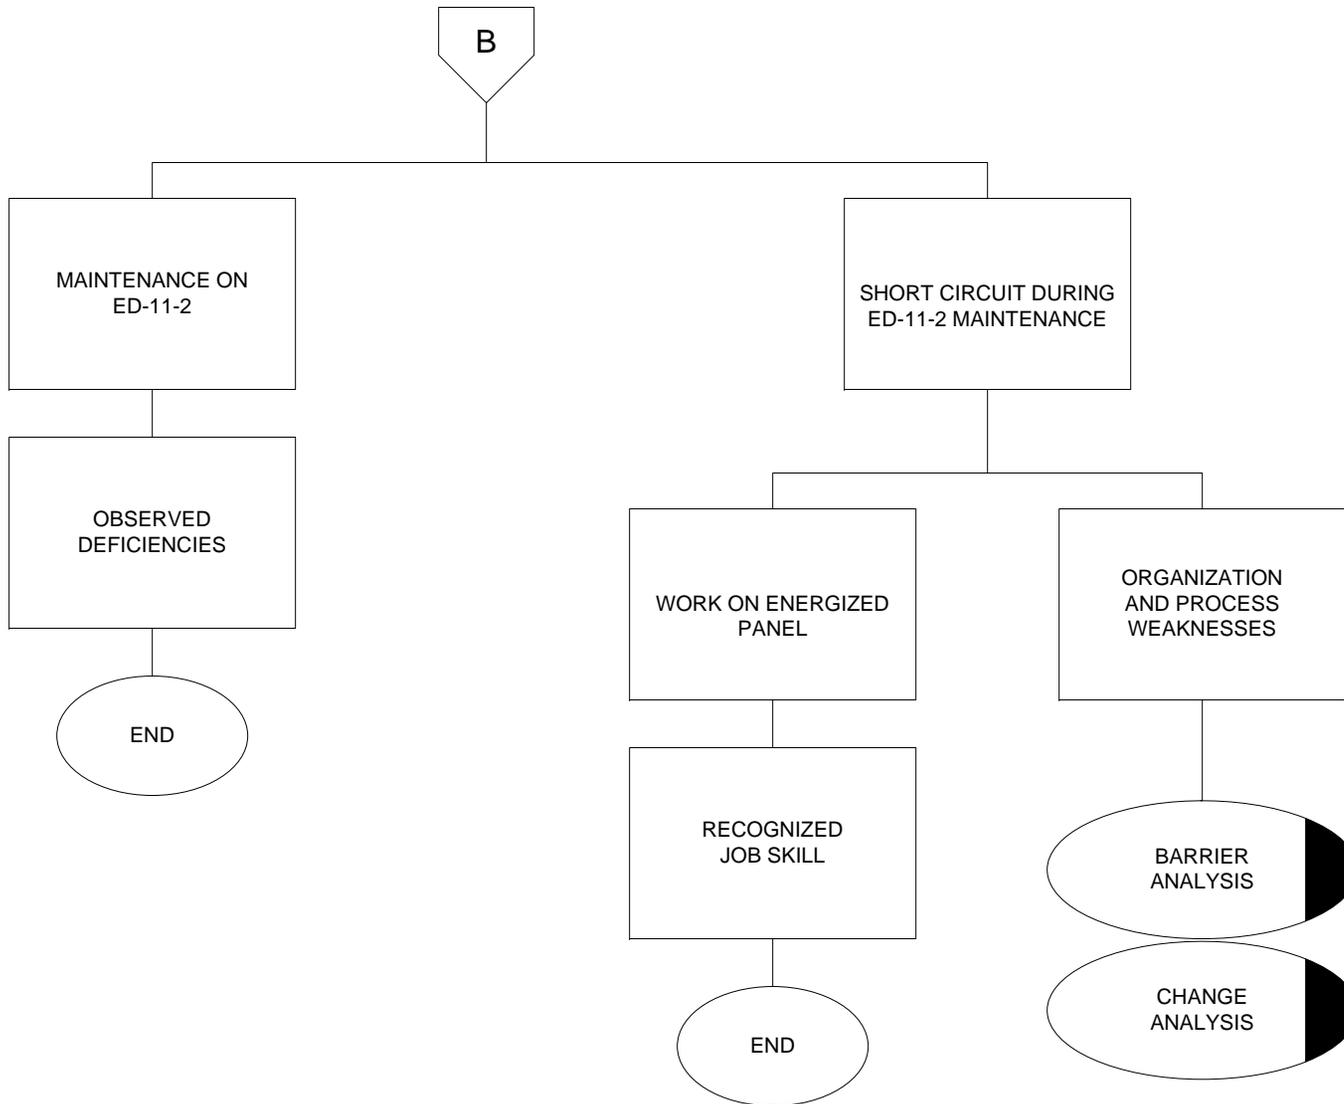
Attachment 3 - Failure Modes Chart

Summary: The Failure Mode: A (+) to (-) short occurred in ED-11-2 (125 VDC Panel) or any of the loads connected to this panel, was considered to be the credible failure which resulted in loss of Electrical Power to DC Bus ED-10L and ED-10R. Specifically, the short was due to the contact of opposite polarity copper stand-offs, one of which was in the process of being removed by Electrical Maintenance when the fault occurred. **References:** Dwg. E-8 Sh. 1 and Operators Statements regarding the Plant Trip **Notes:** None
