LT - Apparent Cause Evaluation Report

ANO1 Steam Generator (E-24 A&B) Tube to Tube Wear

CR-ANO-1-2011-2609; Event Date: 11-07-2011

REPORT DATE: 12-01-2011, Rev 0

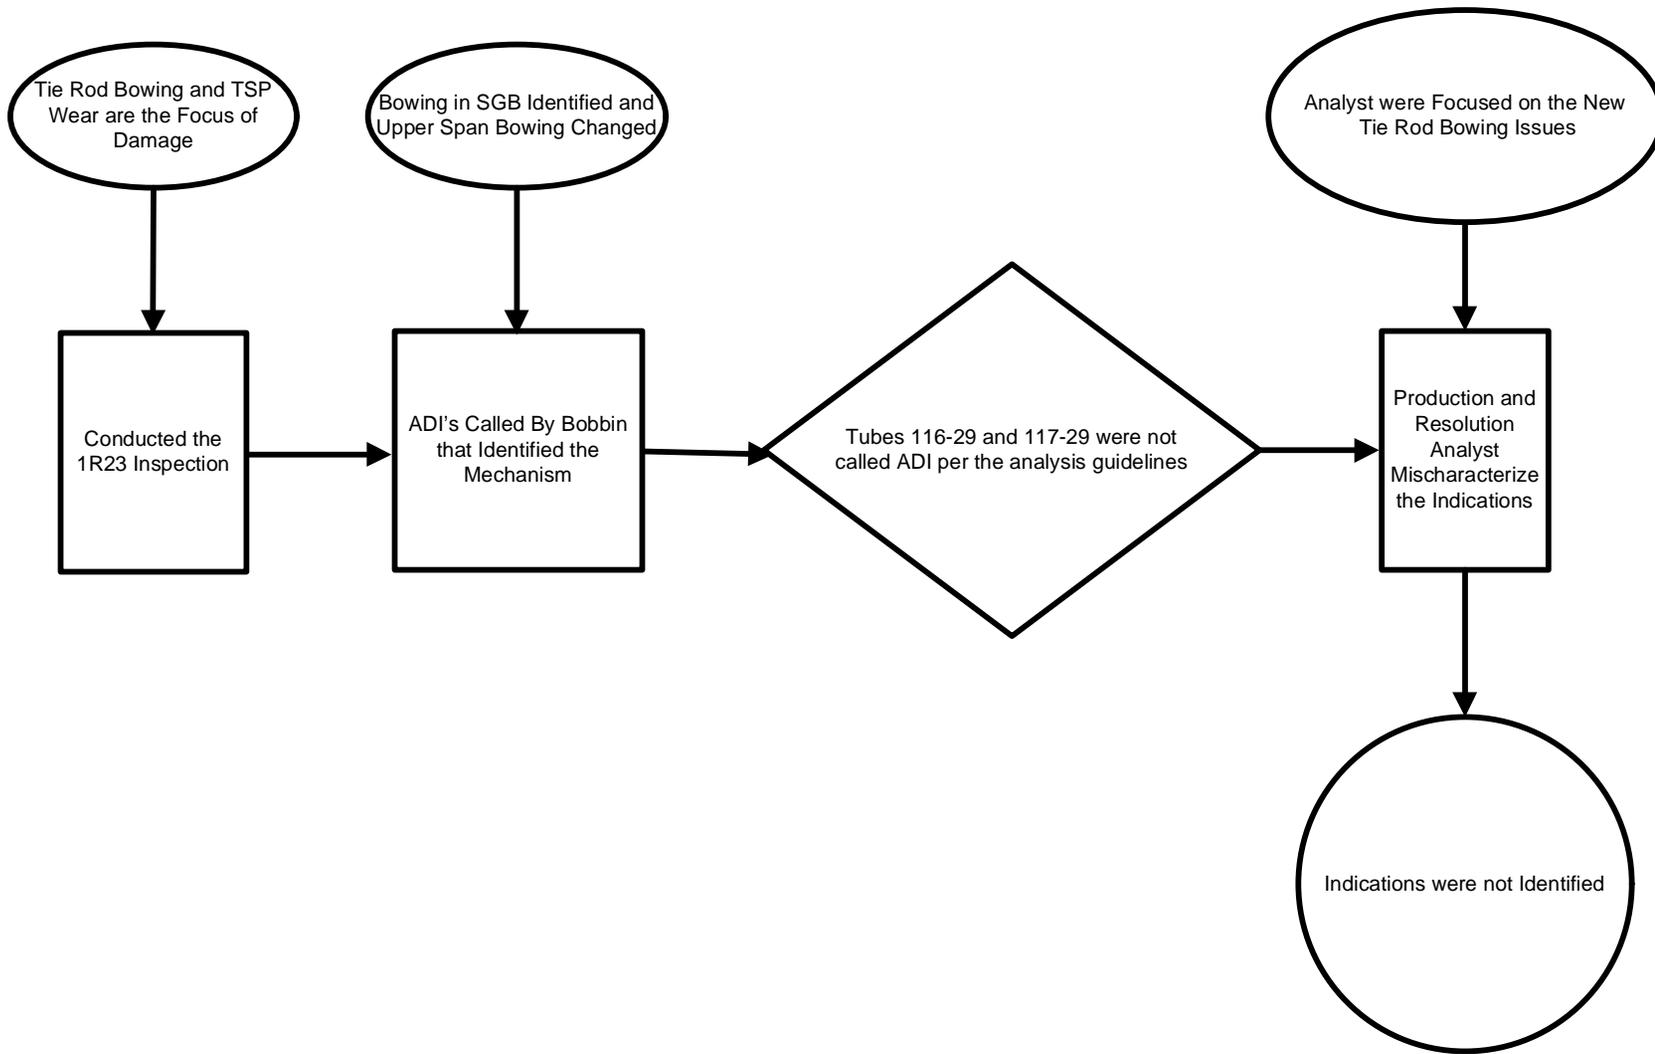
Event and Causal Factor Chart

The tube to tube wear was very gradual and extended over a long area. Because of this the wall loss difference is insufficient to produce an imbalance between the differential coils.
