EA-PSA-SDP-P7C-11-06
Attachment 9

LPI Ref. F11358-LR-001, Rev. 0

SUBJECT: Past Operability Assessment of Service Water Pumps P-7A and P-7B associated with As-found Evaluation of Pump Shaft Couplings – Palisades Nuclear Plant

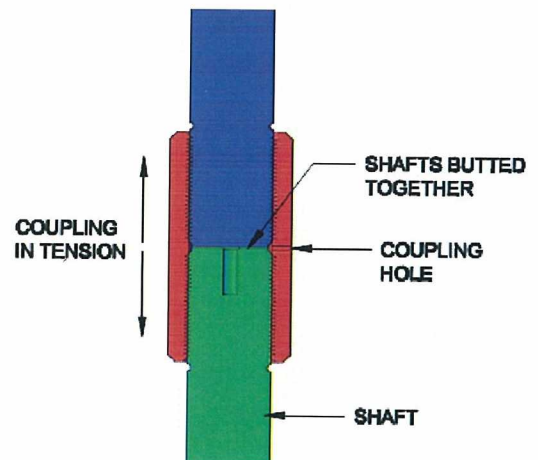
The coupling and shafts are assembled to ensure equal threading of the two shafts within a coupling by the use of an alignment aid inserted in the 1/8" hole on the side of the coupling. Once the shafts touch the alignment aid it is removed and motor torque is relied upon to tighten up the shaft-coupling assembly. With application of motor torque the two shafts will tighten and bear against each other within the coupling (see figure to right)

which will induce compression on the shaft. The shaft compression is reacted as tension across the coupling. Also when the shafts butt up against each other within the coupling, a circumferential gap between the shaft and coupling is created due to the end geometry of the two shafts. The gap in conjunction with the alignment hole would enable deposits to collect at the exposed thread roots of the shaft intersecting plane.

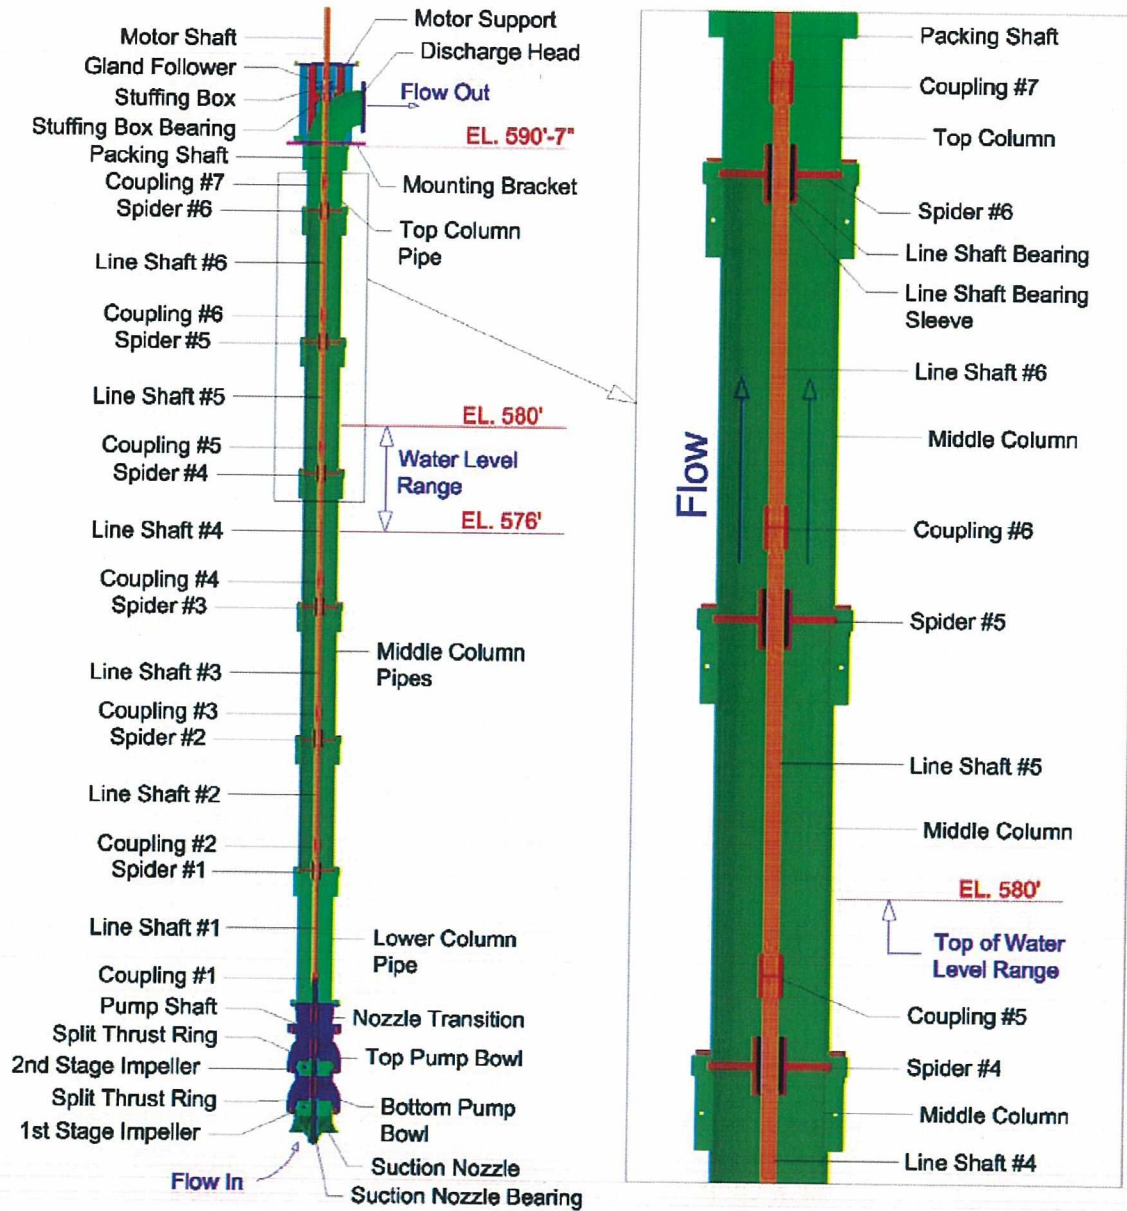
Figure 1-1: SWS Pump Sketch

Each SW pump features eight (8) couplings, numbered 1 through 8. The present assessment has been focused on coupling Nos. 5, 6, and 7 for all service water pumps, since they are subjected to wet and dry cycles. Couplings 6 and 7 are subjected to wet and dry cycles dependent only upon pump usage state (i.e. on or off). Coupling 5 at approximately elevation 579' is dependent upon pump usage and water level (see Figure 1-1). Depending upon the time of year, water level in the service water basin (i.e. Lake Michigan level) ranges from elevation 576' to 580'. It is postulated in LPI report F11358-R-001 [3] that the wet/dry cycle enables the chlorides in the service water to concentrate at the thread roots of the coupling when the water drains from the coupling. This postulate is supported by fluorescent magnetic inspection testing (MT) of coupling 4 of each pump resulting in no indications. Unlike couplings 5, 6 and 7, coupling 4 is continuously submerged and does not typically experience wet/dry cycles.

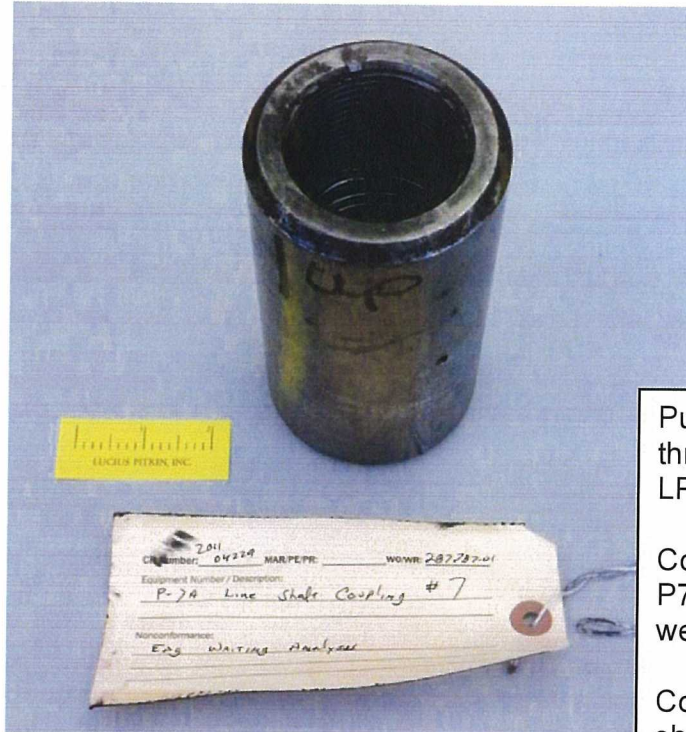
Pump P-7A Coupling No. 1 through 8 were submitted to LPI.

Coupling Nos. 5, 6 and 7 (11-P7A-5, 11-P7A-6, 11-P7A-7) were selected for analysis

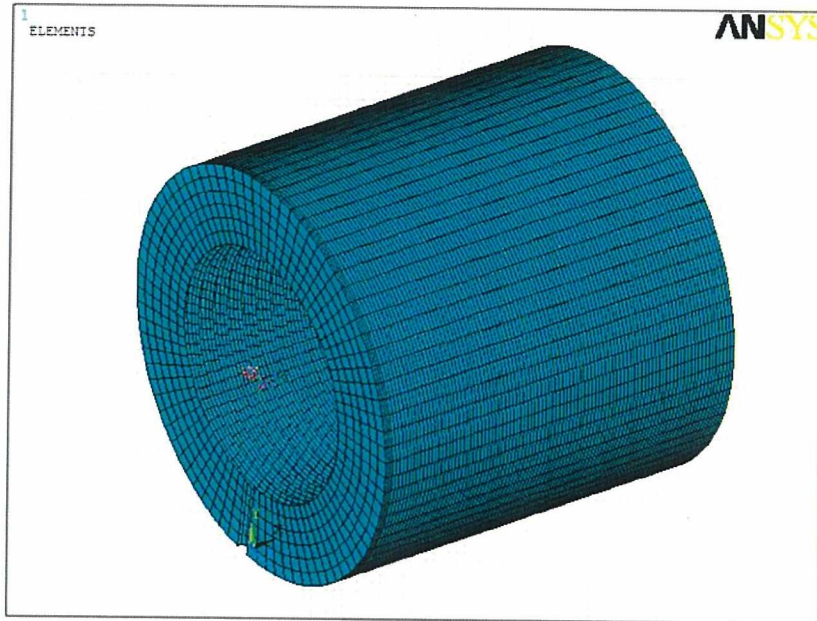
Figure 3-4: Half FEA model of coupling

Finite element analysis (FEA) was used to model tensile stresses in couplings, which must be present for SCC to occur, along with a susceptible material and corrosive environment. The calculated peak tensile stresses at the thread root were estimated to be around 70 ksi, which is judged to be sufficient to enable SCC. However, the presence of pits may have increased the stress intensity such that SCC could occur at lower stress.

To estimate the tensile stress across the coupling, a finite element analysis (FEA) model of a coupling was developed. A half FEA model of an intact coupling was developed using ANSYS and consists of the steel body, alignment hole and threads. The model was constructed of the eight-node brick element, SOLID45 (see Figure 3-4). The symmetric boundary condition, $U_z=0$ and $U_\theta=0$, is applied on the inner surface as shown in Figure 3-5. ASTM A582 Type 416 stainless steel material property for the coupling FEA model is as follows:

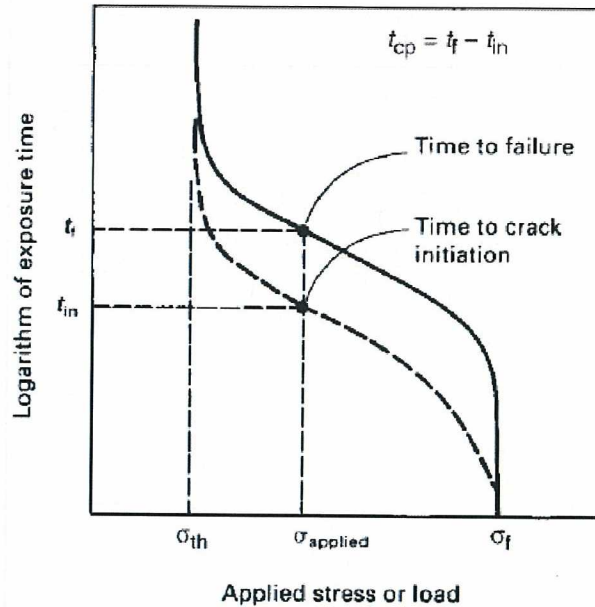
Figure 3-7: Time to Failure vs Applied Stress [8]

The time to failure of a susceptible material in a given environment is dependent on the applied tensile stress, as can be seen in Figure 3-7. The plot compares applied stress or load to the logarithm of exposure time in an

environment and illustrates the time to failure increases significantly with decreasing applied stress. The crack propagation time, t_{cp} is taken to be the difference between the time of failure, t_f , minus the time of initiation, t_{in} . The time at failure is typically known. However, the time of initiation is highly alloy-environment and applied stress dependant and thus is an unknown without specific test data. The initiation time is also highly dependent upon pre-existing flaws that may have been introduced during heat treatment or thread fabrication. Therefore, predicting initiation time is difficult. Unless there are preexisting flaws, a distribution of 80% initiation and 20% propagation is considered reasonable for the life of a component subject to SCC process as suggested by Figure 3-8.

a shorter initiation time. Also, based purely on the concept provided in Figure 3-7, coupling 09-P7C-7F would have been subjected to higher stresses than 11-P7C-6F to produce the initiation time disparity.

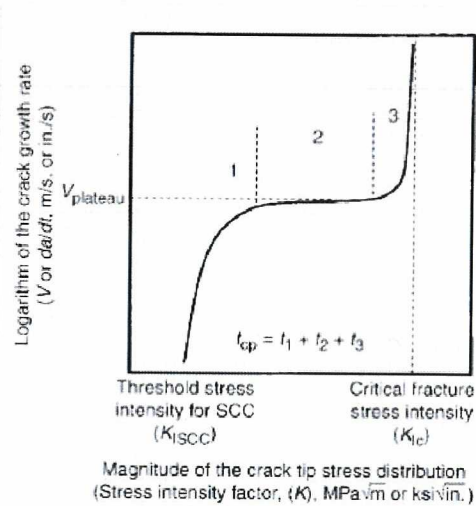
Figure 3-9: Crack Growth Rate (da/dt) versus stress intensity w/Three Stages of Crack Growth [8]

A typical plot of crack growth rate (da/dt) versus stress intensity illustrating the three stages of SCC propagation is presented in Figure 3-9. The figure illustrates a threshold stress-intensity, K_{1SCC} , for SCC initiation and stage 1 propagation. The threshold stress-intensity is dependent upon interaction of the alloy and environment (alloy-environment). Stage 1 propagation is followed by Stage 2 crack propagation where the crack growth velocity is independent of stress intensity. Stage 2 crack growth velocity is limited to the alloy-environment interaction such as the mass transfer of corrosive environmental elements up the crack to the crack tip. Stage 3 propagation is dependent upon stress intensity, until the critical level, K_{1c} to produce mechanical overload of the remaining ligament. The crack propagation time is the sum of the time at each stage, $t_{cp}=t_1+ t_2+ t_3$.

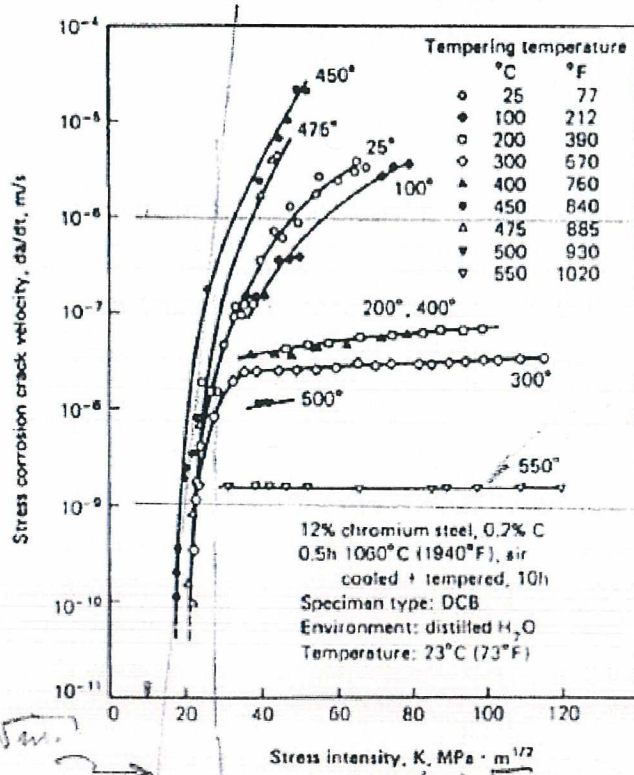
Figure 3-10: Effects of Tempering Temperature and Applied Stress-Intensity factor on Velocity of Stress-Corrosion Cracking [7]

A plot of crack growth rate (da/dt) versus stress intensity for 12% chromium and 0.2% carbon alloy at various tempering temperature per [7] is provided in Figure 3-10. The generic categorization of 12% Cr and 0.2% C would cover the 416 SS coupling material. Based on tempering heat traces for the P-7A and P-7B couplings presented in Figure 3-11, the 550°C (1022°F) curve is appropriate. Figure 3-10 show that the threshold stress-intensity, K_{1SCC} for

Using the stage 2 stress intensity independent crack growth rate (CGR) of $2.3E-4$ in/hr from Figure 3-10, and applying it to the as-found cracks of examined couplings from P-7B, it would require approximately 66 days to propagate through the wall⁵ of the deepest flaw found on the P-7B couplings, i.e. 11-P7B-6K (evaluation is shown in Figure 3-12). Using the same CGR, and assuming a crack initiated at the time the examined P-7A couplings were removed from service, it would require 90 days to propagate through wall. Applying this simplistic approach to couplings 09-P7C-7F and 11-P7C-6F would result in the same 90 days to propagate through thickness (see Figure 3-12).

Based on the above assessment, a reasonable crack growth rate for the SWS pump couplings is in the range of 1.91E-4 in/hr to 3.81E-4 in/hr. This range encompasses the stress intensity independent CGR of 2.3E-4 in/hr for 12%Cr, 0.5%C steel tempered at 550°C in distilled water per [7] (see Figure 3-10). However, the CGR of 1.91E-4 in/hr is the most reasonable in terms of initiation and propagation distribution life for failed coupling 11-P7C-6F and all cracked couplings. This means that coupling 09-P7C-7F is anomalous (e.g. preexisting flaw) and is postulated to have propagated shortly after installation. Barring specific CGR for the alloy-environment interaction of the SWS pump couplings, using a CGR of 2.3E-4 in/hr is considered as a reasonable mean value and 3.81E-4 in/hr is considered a bounding value for this evaluation.

Considering the coupling material and environment, a stress intensity, K independent crack growth rate (CGR) of $3.81E-4$ in/hr is considered a reasonable bounding value for this evaluation. This CGR encompasses the stress intensity independent CGR of $2.3E-4$ in/hr for 12%Cr, 0.5%C steel tempered at $550^{\circ}C$ ($1022^{\circ}F$) in distilled water per [7] (see Figure 3-10). Using a CGR of $3.81E-4$ in/hr, in conjunction with the as-found flaws on the P-7B couplings, it would require approximately 40 days to propagate through the wall for the deepest flaw found on coupling 11-P7B-6K. Since no flaws were found on examined P-7A couplings, it is concluded that it would require approximately 54 days for a flaw to propagate through wall if, conservatively, a crack initiated at the time they were removed from service. Also since pits are a precursor to cracks (as observed on the examined P-7B and P-7C couplings that exhibit cracks) and no cracks were found on the examined P-7A coupling, it is postulated that the life of examined couplings extracted from P-7A could be greater than 54 days to allow for pit formation.
