SAFETY CULTURE COMPONENT	DESCRIPTION	CR-PLP-2011-4822– Plant Trip During Panel ED-11-2 Maintenance
8. Environment For Raising Concerns	An environment exists in which employees feel free to raise concerns both to their management and/or the NRC without fear of retaliation and employees are encouraged to raise such concerns.	No safety culture weakness determined for any of the identified causes

SDP Assessment of DC Panel D11-2 Fault

EA-PSA-SDP-D11-2-11-07, Revision 1

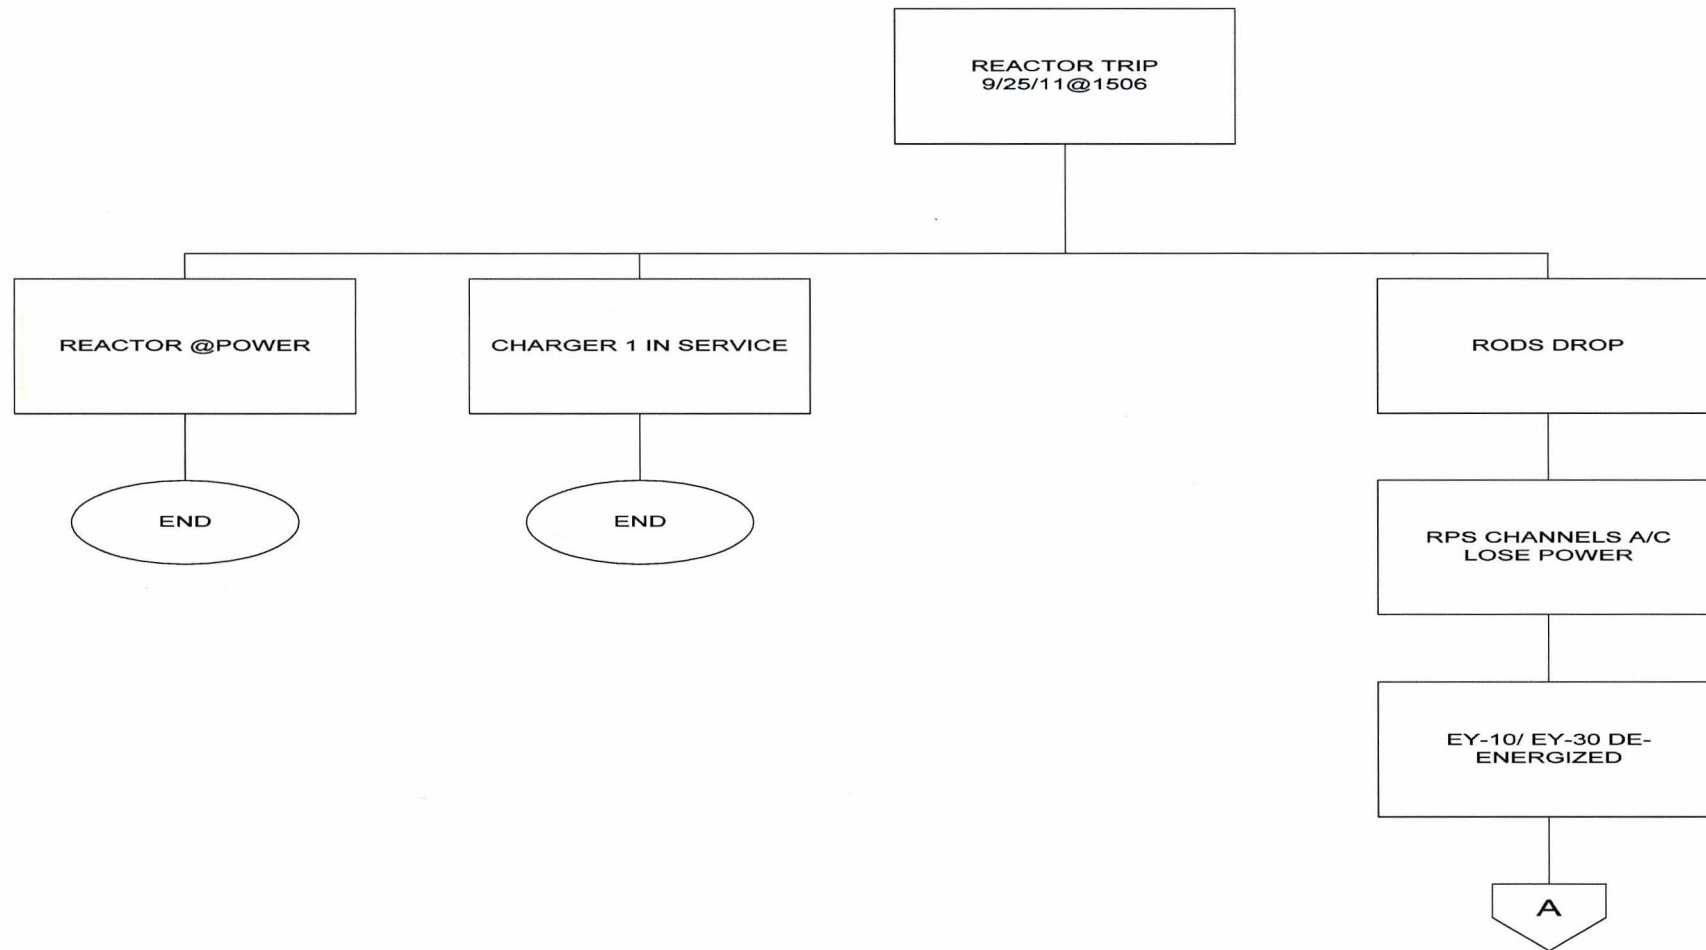
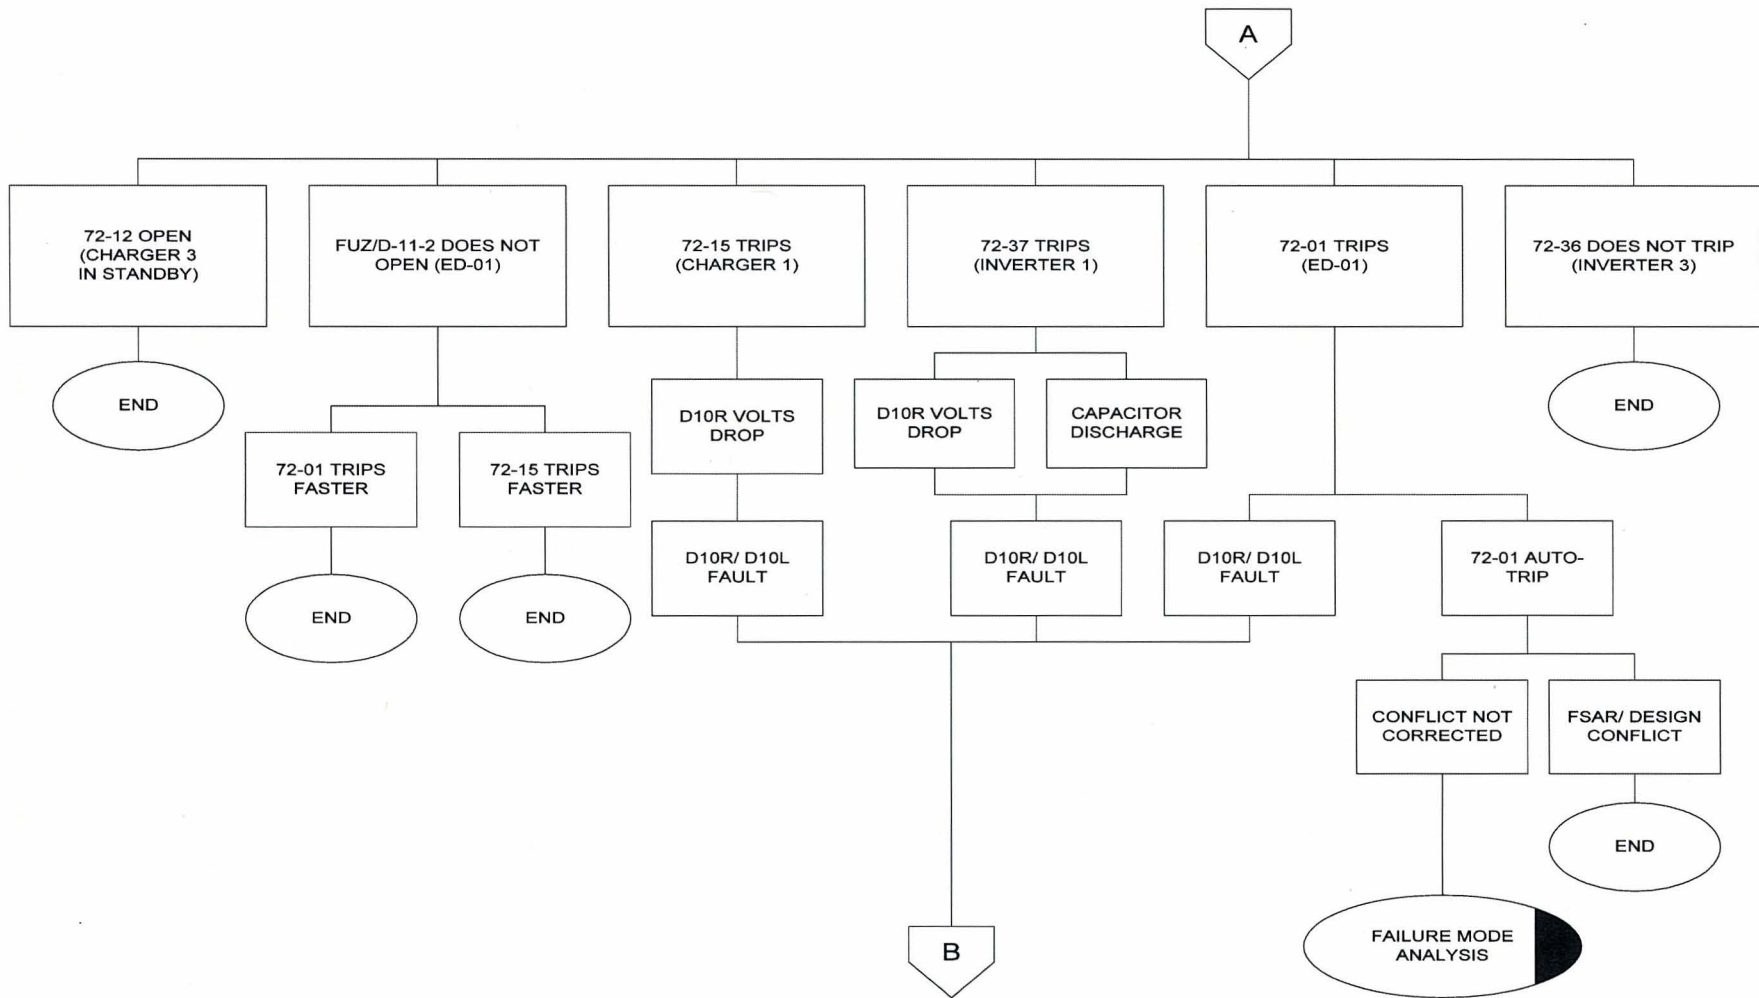
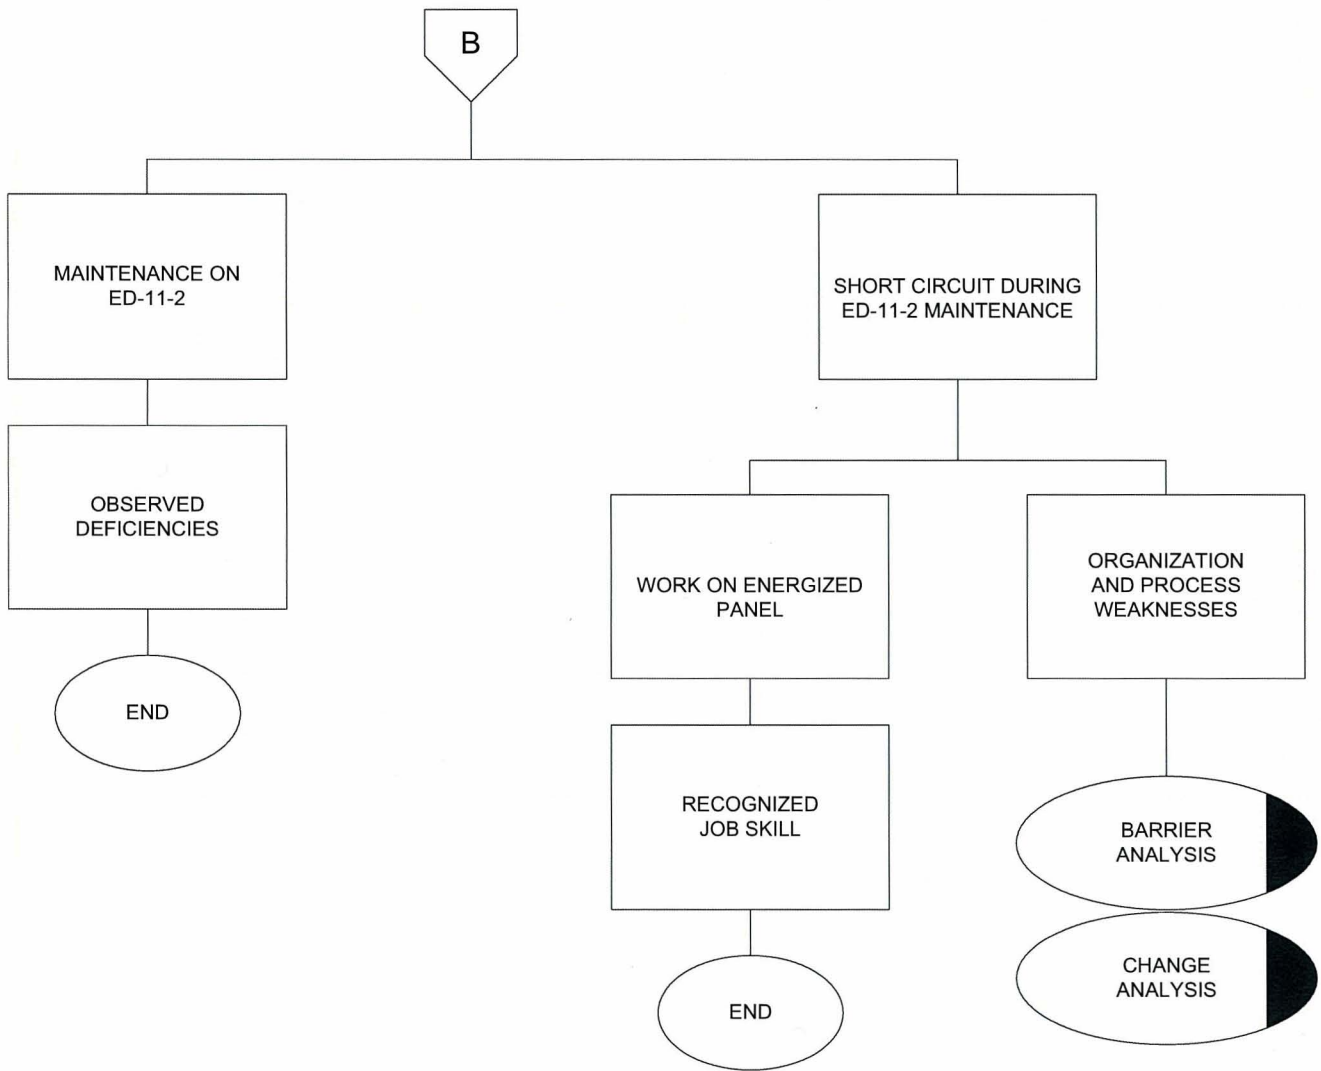
Attachment 3 - Failure Modes Chart

Summary: The Failure Mode: A (+) to (-) short occurred in ED-11-2 (125 VDC Panel) or any of the loads connected to this panel, was considered to be the credible failure which resulted in loss of Electrical Power to DC Bus ED-10L and ED-10R. Specifically, the short was due to the contact of opposite polarity copper stand-offs, one of which was in the process of being removed by Electrical Maintenance when the fault occurred. **References:** Dwg. E-8 Sh. 1 and **Operators Statements regarding the Plant Trip Notes:** None
