**IP3 ASME SECTION XI,  
IWL CONCRETE CONTAINMENT INSPECTION  
FOR 2009**

<b>IPEC</b>	IP-RPT-09-00069	REV. 0
		Page 3 of 192	
IP3 ASME Section XI, IWL Concrete Containment Inspection for 2009

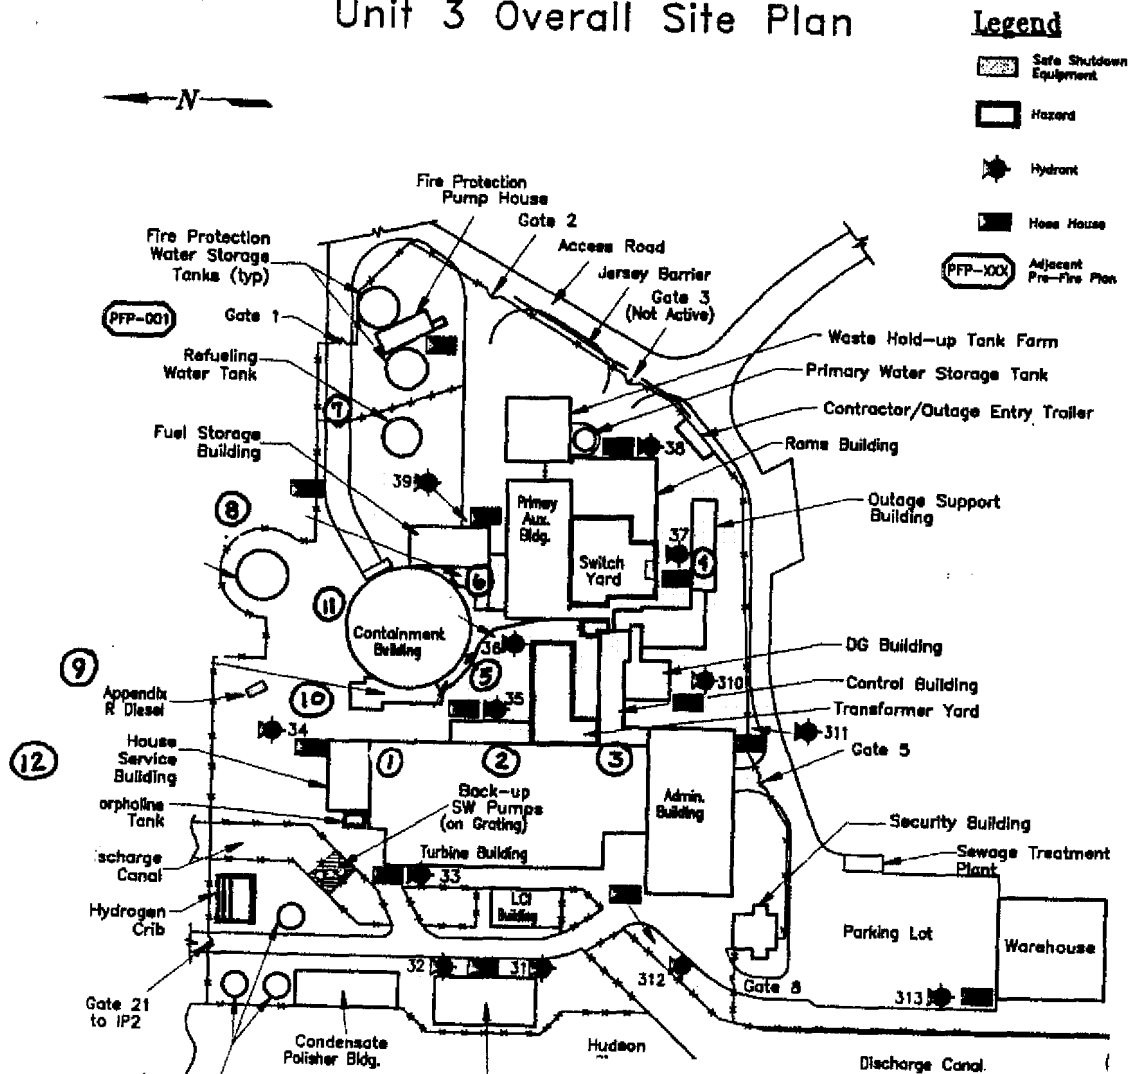
VANTAGE POINTS  
**FIGURE 1**  
 Unit 3 Overall Site Plan

Vantage Point	Description
1	Turbine Building Roof (Northeast Corner)
2	Turbine Building Roof (East parapet @ center line)
3	Turbine Building Roof (Southeast Corner)
4	Outage Support Building Roof
5	Electrical Tunnel Roof
6	Alley between Fan House and Containment
7	Roadway leading to 95' equipment hatch
8	Roadway just North of old NYPA property line
9	Superheater Structure
10	Roadway leading to transformer yard
11	Areas at and below 95' equipment hatch, including stairs
12	Top of stack

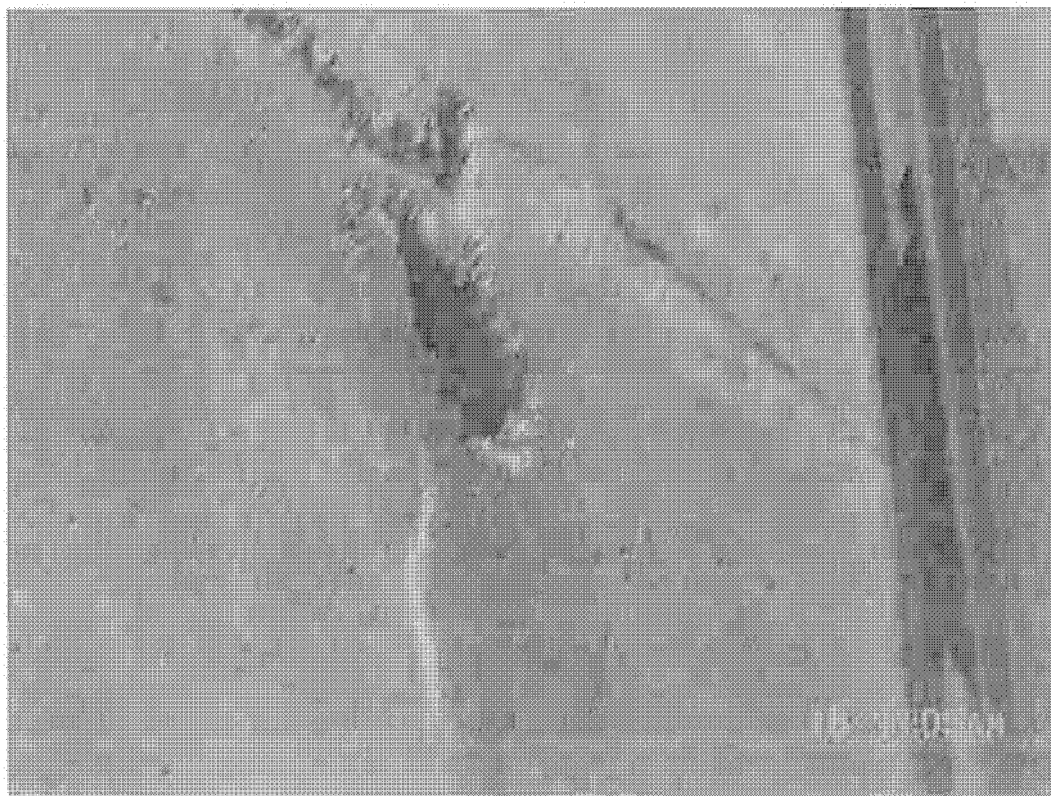
U3-017202

No.	Comment	Initials
1	Numerous bugholes, minor vertical and joint cracks, leaching, scaling, and spalling. These are general conditions noted on containment that have NO impact to the structural integrity and fall below the requirement for thorough characterization of indications for future monitoring. However, this condition was noted prior and continues to be note worthy only.	<i>TMB</i>
2	Approximately 2" to 3" pop out at El. 48'-0" no more than 1" deep. See photo U3-017201.	<i>TMB</i>
3	Scaffold connection hole spalled exposing the steel plate backing with surface corrosion and rust staining, approximately 6" x 8" with over 5' long rust stains (previously identified with no significant change). See photo U3-017202.	<i>TMB</i>

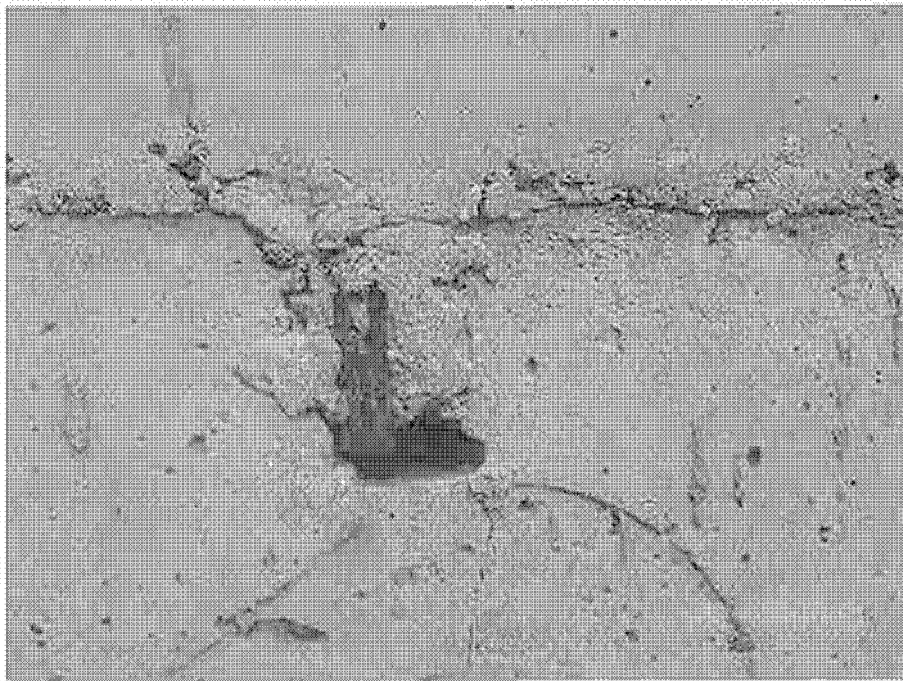
U3-037282

2001 Inspection during removal of wood
