South Texas Project
Unit 2
Docket No. STN 50-499
Request for Relief from ASME Boiler and Pressure Vessel Code,
Section XI Requirements for the Essential Cooling Water System
(Relief Request RR-ENG-3-08)

**SOUTH TEXAS PROJECT
UNIT 2
REQUEST FOR RELIEF FROM ASME BOILER AND PRESSURE VESSEL CODE,
SECTION XI REQUIREMENTS FOR THE ESSENTIAL COOLING WATER SYSTEM
(RR-ENG-3-08)**

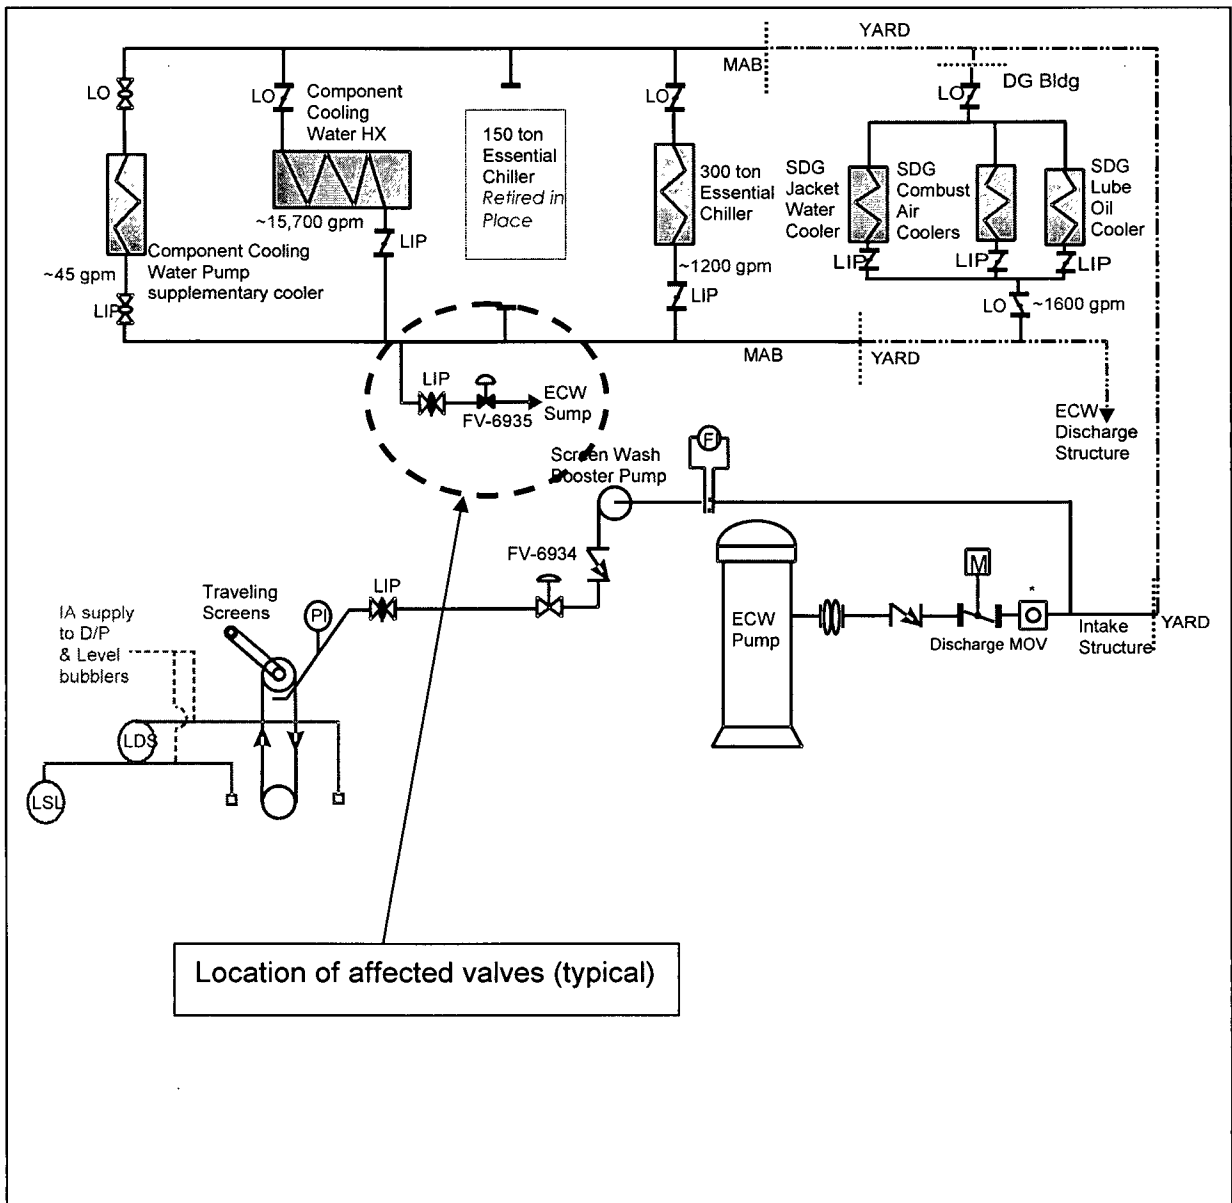
FIGURE 1: PIPING DIAGRAM FOR ESSENTIAL COOLING WATER SYSTEM

Figure 1 describes the valve location, and a schematic of the valve is provided as Figure 2.
