# Byron Station Single Phase Failure

NRC Meeting  
March 22, 2012

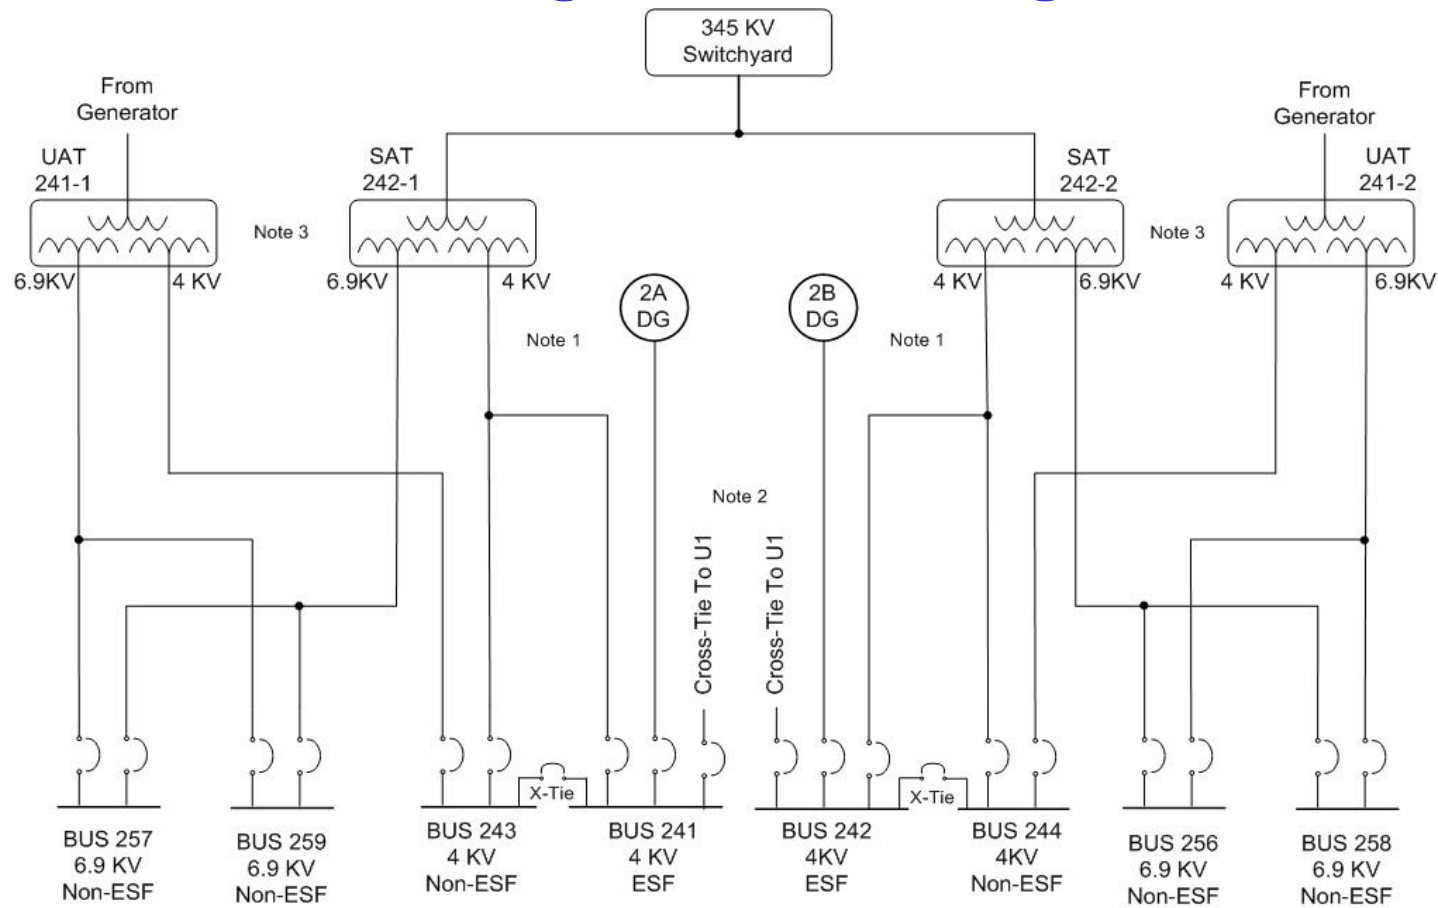
# Byron Unit 2 Single Line Diagram

- 1) 4KV ESF buses are powered by SAT and EDG
- 2) Second off-site source to 4KV ESF buses is through opposite unit cross-tie breakers
- 3) Non-ESF buses have UAT and SAT feeds with Fast Bus Transfer scheme
