Entergy Operations, Indian Point Energy Center, Unit 2

Root Cause Evaluation Report

IP2 Turbine Trip/Reactor Trip Due to 21 Main Transformer Fault

CR-IP2-2010-6801; Event Date: 11-07-2010

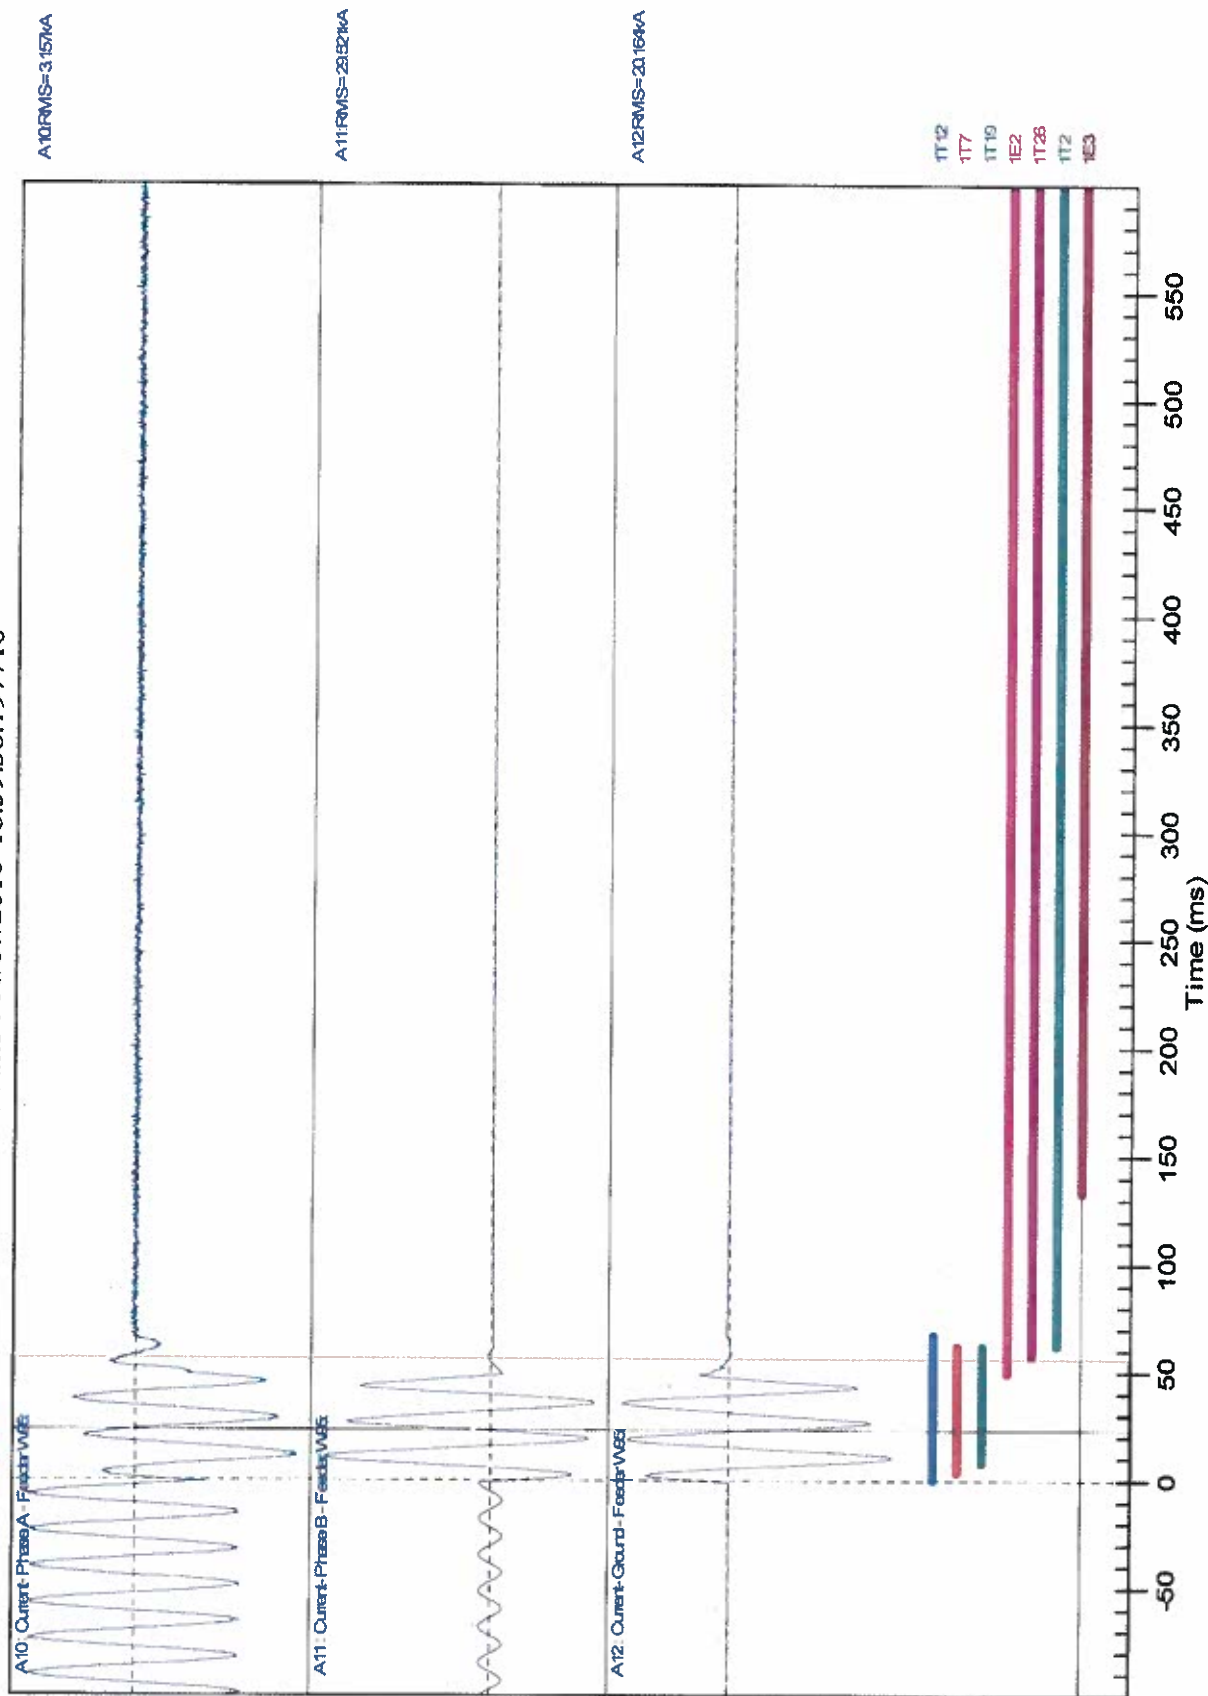
Page 1 of the Attachment 1 shows 345kV feeder W95 phase A, phase B and ground currents for Indian Point Unit 2. From the DFR plot it is apparent that 345kV feeder W95 phase B current rises from pre-fault level and peaks at 29.521kA and after approximately 3.5 cycles it levels at zero. Again, it must be noted that any DFR current value shown for 345kV feeder W95 is required to be scaled by $3000/2000=1.5$ thus $29.521\text{kA}/1.5 = 19.680\text{kA}$. Thus, it is stated that phase B experienced a fault and the breakers interrupted the fault in approximately 3.5 cycles. From the DFR plot it is also apparent that 345kV feeder W95 phase A current during the phase B fault experienced a shifted neutral and after 3 cycles it levels at zero. It can be stated that phase A has not experienced a fault and the current levels at near zero following a breaker opening. Phase C has not been plotted but feeder W95 ground fault has been plotted from which it can be seen that feeder W95 ground fault current level peaks at $20.164\text{kA}/1.5=13.442\text{kA}$ while feeder W95 phase B fault current peaks at $29.521\text{kA}/1.5=19.680\text{kA}$. Since feeder W95 phase A has not developed a fault then phase C had to be faulted to balance the ground fault current values shown on the plot.

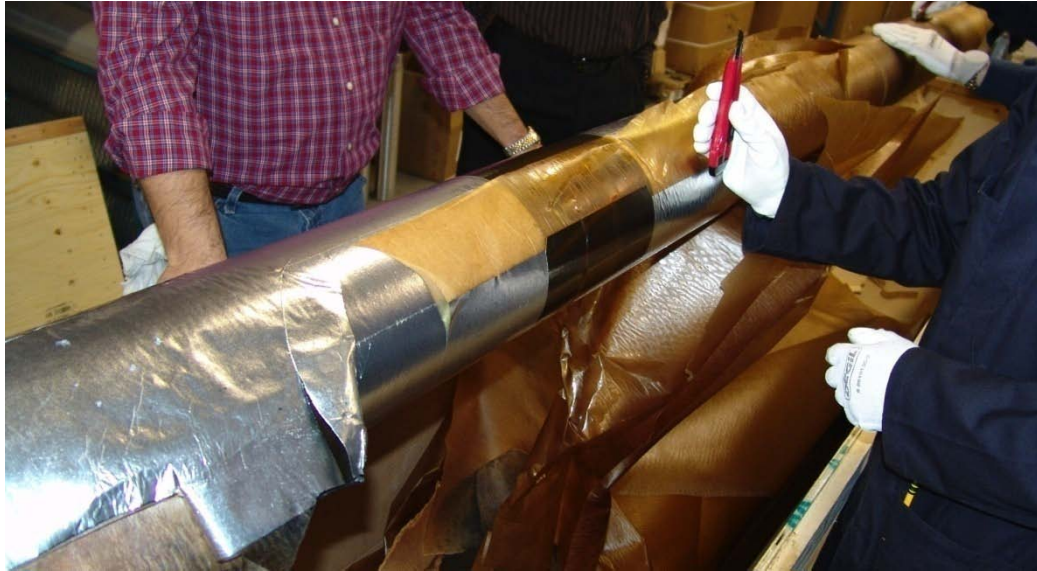
The capacitor assembly process was shown during the visit. The aluminum foil sections are manually measured and hand-cut into rectangular sections as observed in Fig. 15. The outer corners are removed to reduce electric stress concentration. The foils have a bare face and a blue-tinted adhesive face. The paper is continuously fed from rolls into the assembly press that consists of two heated pinch rollers. The rolling operation is interrupted to insert aluminum foil sheets between the paper layers. The layer is then thermally bonded such that the adhesive layer of foil is hot-pressed into the paper and the process is continued until all of the layers have been incorporated. The

Fig. 15: Overview photo of bushing's capacitor structure as witnessed upon teardown

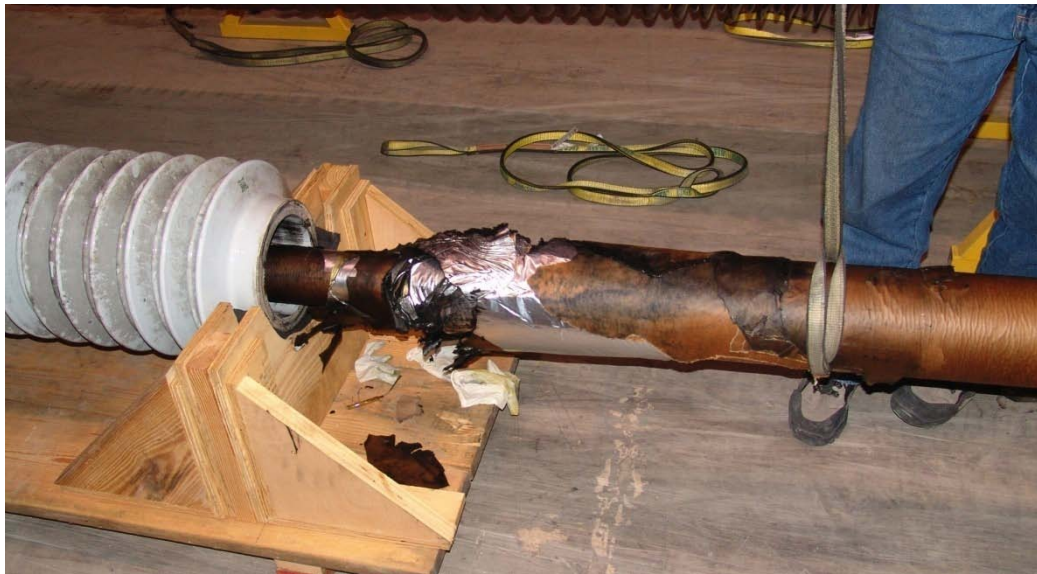
As part of the tear-down disassembly process, the bushing core was removed from the housing, as shown in Fig. 16. The failed “B” phase HV bushing (S/N 05F9080-04) internal assembly, also known as the capacitor assembly, was removed from the housing and installed between roller supports for unwrapping of the layers. The lower section of the capacitor was badly damaged, both electrically and thermally as Fig. 17(a) shows. A radial electrical puncture was found through the layers at the upper edge of the lower capacitor section, based on measurements and side-by-side comparison to a scale assembly drawing. The puncture is shown in Fig. 17(b). The paper layers were found well wetted throughout the length of the capacitor. This confirmed that the oil level in the bushing was correct. The capacitor layers were unwound and inspection was conducted at each layer. During disassembly, a faintly discolored line was noted in the paper, immediately adjacent to the aluminum foil on the outside edge. This observation was examined in more detail and electrical treeing was found. It was the opinion of the Trench representatives that this was evidence of the ‘copper deposition’ problem identified as the root cause for the previous Trench (France) bushing failures.

Fig. 16: Removal of core from bushing at Ajax Trench facility

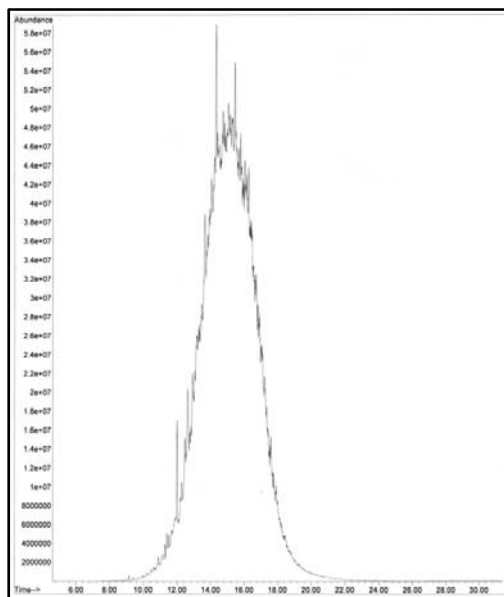
The oil in both the “B” phase and “C” phase bushings was found to be identical. Results from the GC/MS analysis for the “B” phase bushing is provided in Fig. 20, and Fig. 21 has the GC/MS for the “C” phase extracted oil. The oil is a hydrocarbon type mineral oil. The small sharp peaks evident in Fig. 20 and Fig. 21 are indicative of an antioxidant. The oil is free of significant corrosive ions (i.e. chlorates, sulfates, etc.), and contains a hindered phenol antioxidant added as a stabilizer. Mass spectroscopy of the antioxidant oil additive is shown in Fig. 22. A specific mass spectral match to a commercial antioxidant was not found for the oil sample used in Fig. 22, however MS analysis shows a good correlation between the additive and 2,6-di-terciary butyl-p-cresol. For the MS analysis of the “B” phase bushing oil, a good match with butylated hydroxytoluene (BHT) was obtained for the oil additive. BHT is a common commercially available antioxidant often used in oils due to its low cost and high solubility. This type of antioxidant protects against high temperature exposure. Additionally, this is not a metal-deactivating type of antioxidant that would inhibit the adverse effects of metal

Fig. 20: GC/MS results from the “B” phase bushing oil extracted from the insulating paper in Layer 19

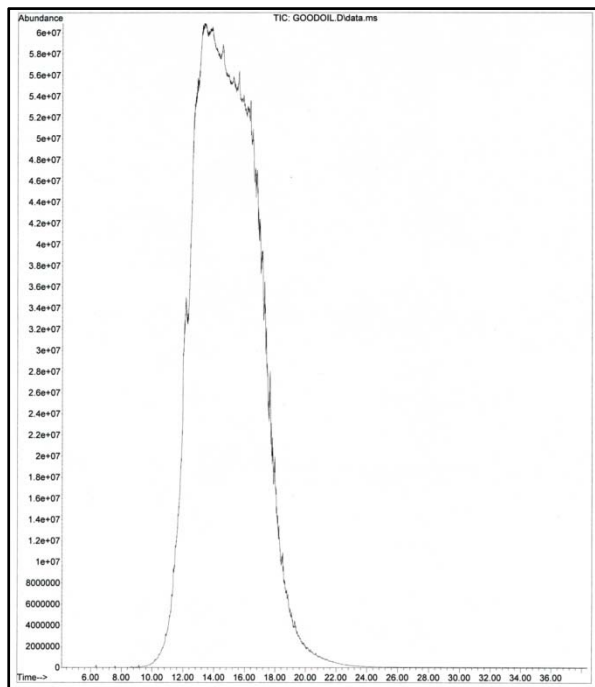
Fig. 21: GC/MS results from the extracted “C” phase bushing oil

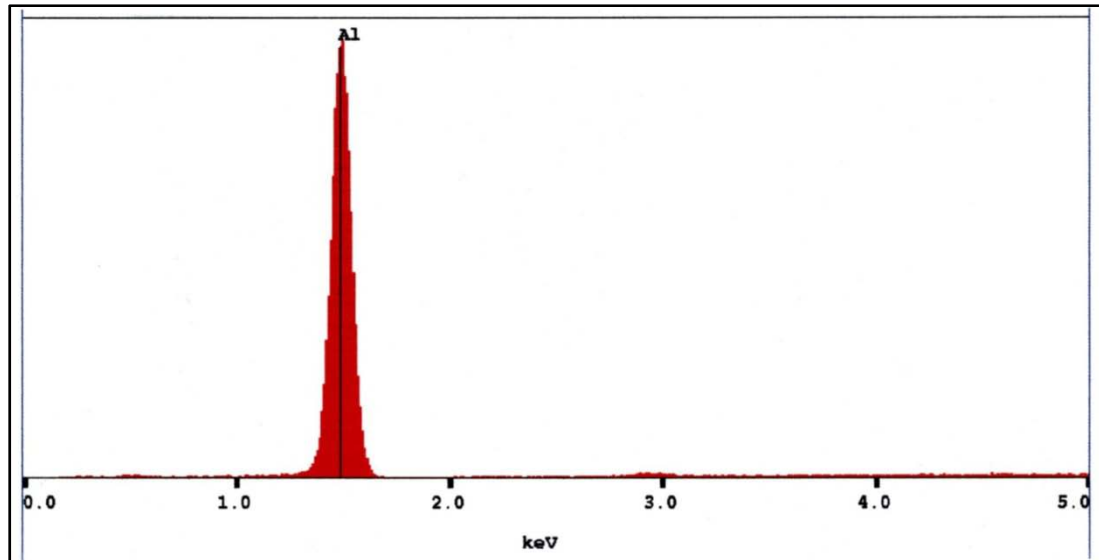
The EDX spectrum for the non-used aluminum foil sample provided by Trench is shown in Fig. 23. The aluminum foil is pure aluminum on one face. This is probably aluminum alloy 1145, a typical capacitor foil. It is free of any significant copper. This alloy is approximately 99.5% aluminum with traces of other elements.

Fig. 23: EDX spectrum of representative aluminum foil sample used in the bushings at the Ajax Trench facility

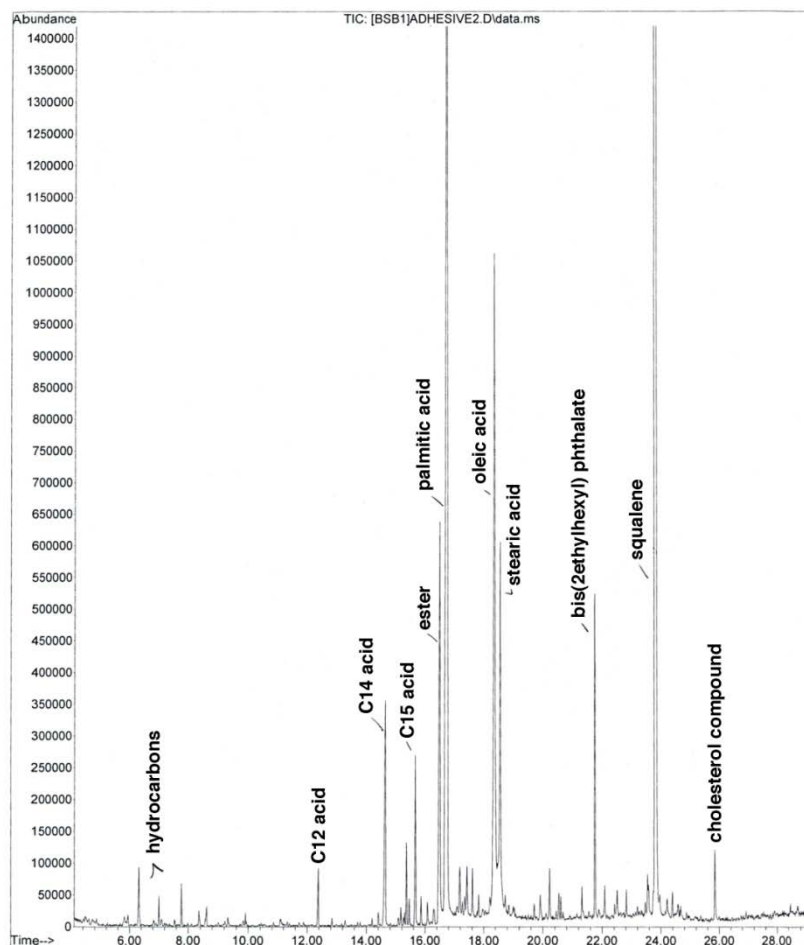
Fig. 24 contains the GC/MS results for the aluminum foil adhesive layer provided by Trench from a non-used piece of foil representative of the foil material that would have been present in the 21MT HV bushings. GC/MS analysis of the adhesive layer indicated the presence of fatty acids, a phthalate plasticizer, and traces of other compounds. The effect of these compounds on electrical treeing is not known. Based on the FTIR results provided in Fig. 25, the 'heat-activated' adhesive side of the foil consists of polyvinyl butyral, a vinyl polymer, and blue colorant. The vinyl polymer melts upon application of heat and some of the adhesive extrudes beyond the edge of the foil in some locations. There is no curing process and there are no unreacted organic compounds that might serve an adverse electrical role. The colorant is an organic dye. The EDX analysis of the blue adhesive foil layer is shown in Fig. 26, and is consistent with the results of the GC/MS analyses. The EDX analysis was conducted to determine if the blue adhesive layer was a copper-containing compound, which could help explain previously reported findings by Trench of copper in the electrically treed regions of prior failed bushings. However, no traces of copper were observed. Only carbon and oxygen were found.

Fig. 24: Gas Chromatography (GC)/ Mass Spectroscopy (MS) results from representative foil adhesive layer provided at Ajax Trench facility

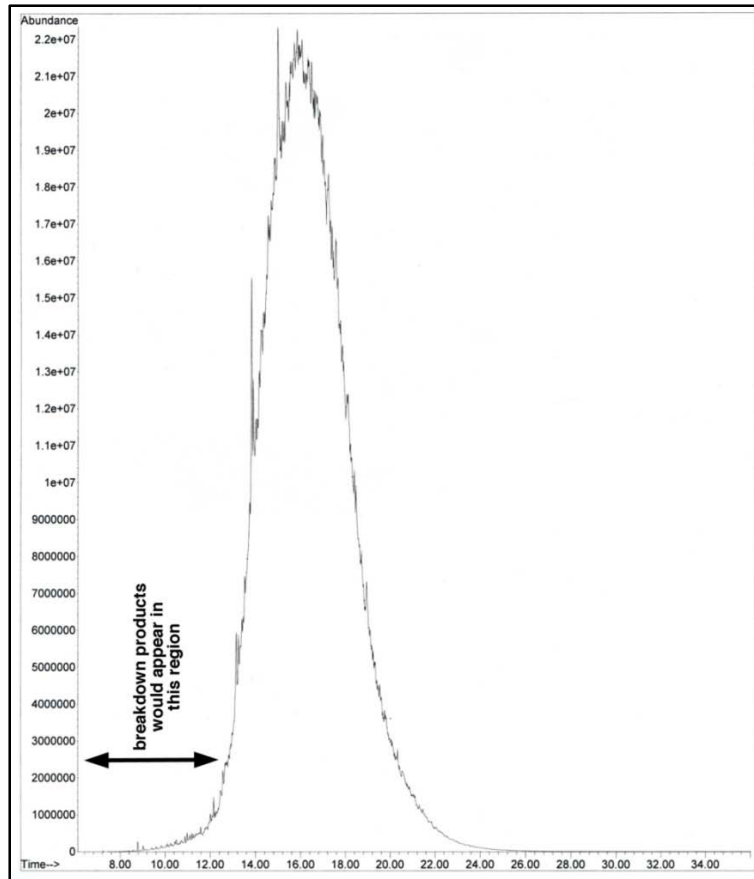
Fig. 27 is a photograph taken with an optical microscope documenting evidence of electrical treeing in the paper insulation removed from the "B" phase bushing. Fig. 28 shows the results for the GC/MS analysis of a sample taken from an electrically treed paper region in the "B" phase bushing. Fig. 28 shows that there is no chemical breakdown of the paper, and no local oil breakdown. These findings are consistent with

electrical treeing, where the breakdown occurs on a microscopic scale. However, these findings are inconsistent with bulk dielectric breakdown on the paper due to thermal degradation, moisture-induced chemical aging, or other bulk dielectric breakdown phenomenon. The location of where typical breakdown products, such as furans, would have been found had they been present is indicated in Fig. 28. Fig. 29 contains the EDX spectrum for the treed area along the foil edge of layer 19 in the “B” phase bushing. There was no elemental trace of copper found in this sample, only carbon and oxygen.

Fig. 28: GC/MS result from electrically treed area of paper removed from “B” phase bushing
