INSPECTION CHECKLIST

Piping / Tank 120' EL. (approx. grade) 10-inch City Water Line from Catskill Water Supply
 ELEVATION: 120' EL. (approx. grade) LOCATION DWG: 9321-F-41933, zone D-5 INSPECTION DATE: 10/29/09
 INSPECTOR: J. Peterson

COMMENTS (Inspector): 10-inch city water line from the City Water Storage Tank was inspected at excavated location. Line runs approximately parallel with the 16-inch city water line (also excavation under the same modification, EC 13314). Approx. 8 foot length of pipe inspected.

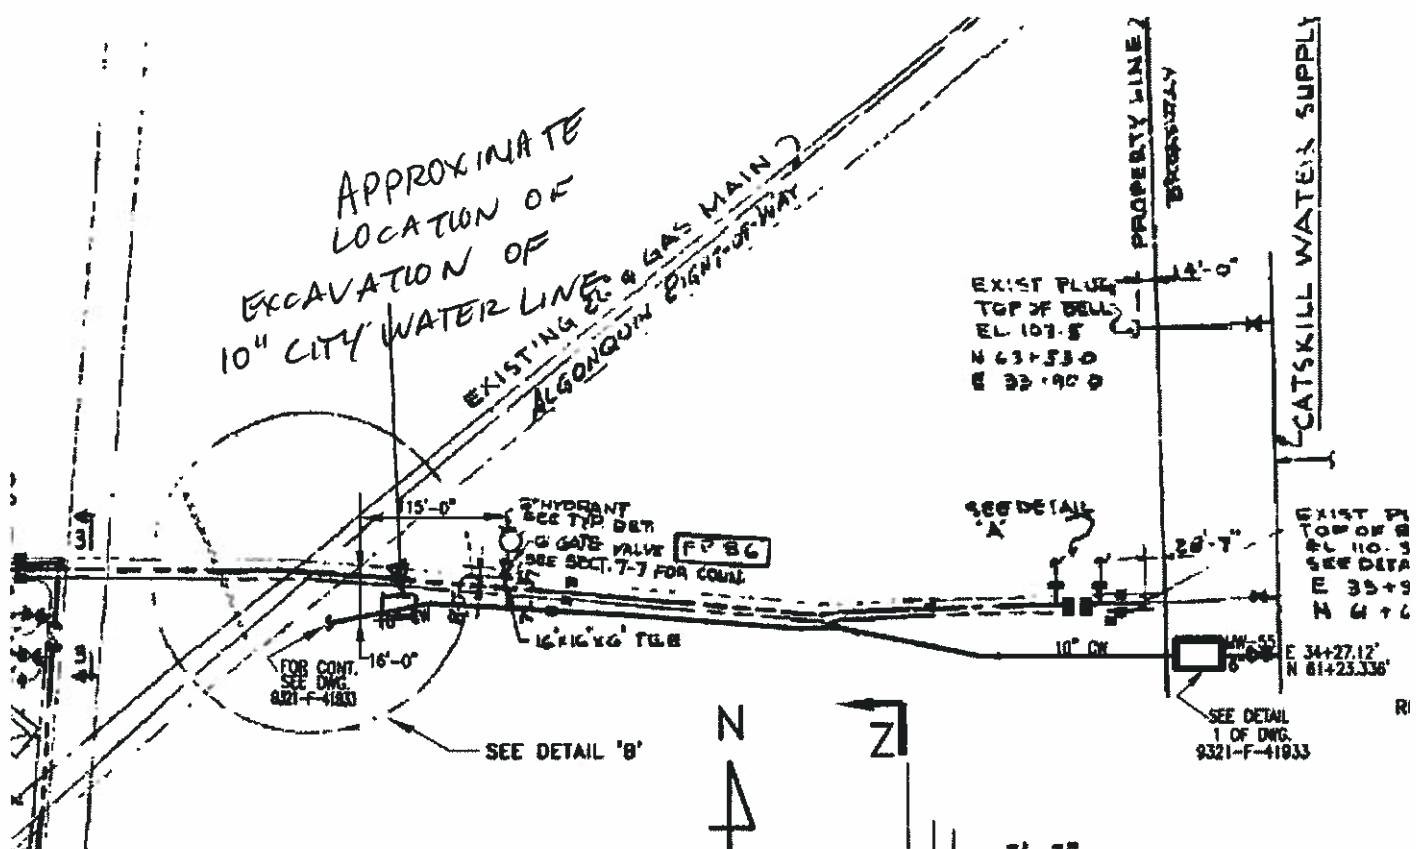
REF: DWG 138057

GENERAL APPEARANCE (Inspector): Exterior pipe coating found in good condition, with no observable discontinuities, peeling, blistering, separation, embrittlement, flaking, etc. Coating also having good adhesion to the pipe with no bubbled spots (i.e., gaps between pipe and coating). See attached photo documentation and Notes. Photo included of the backfill material, showing absence of any large rocks, or foreign material.
