ENTERGY	ENGINEERING STANDARD	EN-EP-S-002-MULTI	REV. 0
	Buried Piping and Tanks General Visual Inspection	PAGE 12 OF 12

INSPECTION CHECKLIST

Piping / Tank IP3 CST Supply to AFW Pumps (12-inch Line 1070) (Ref. WO # 279578-03) INSPECTION DATE: 12/9/2011

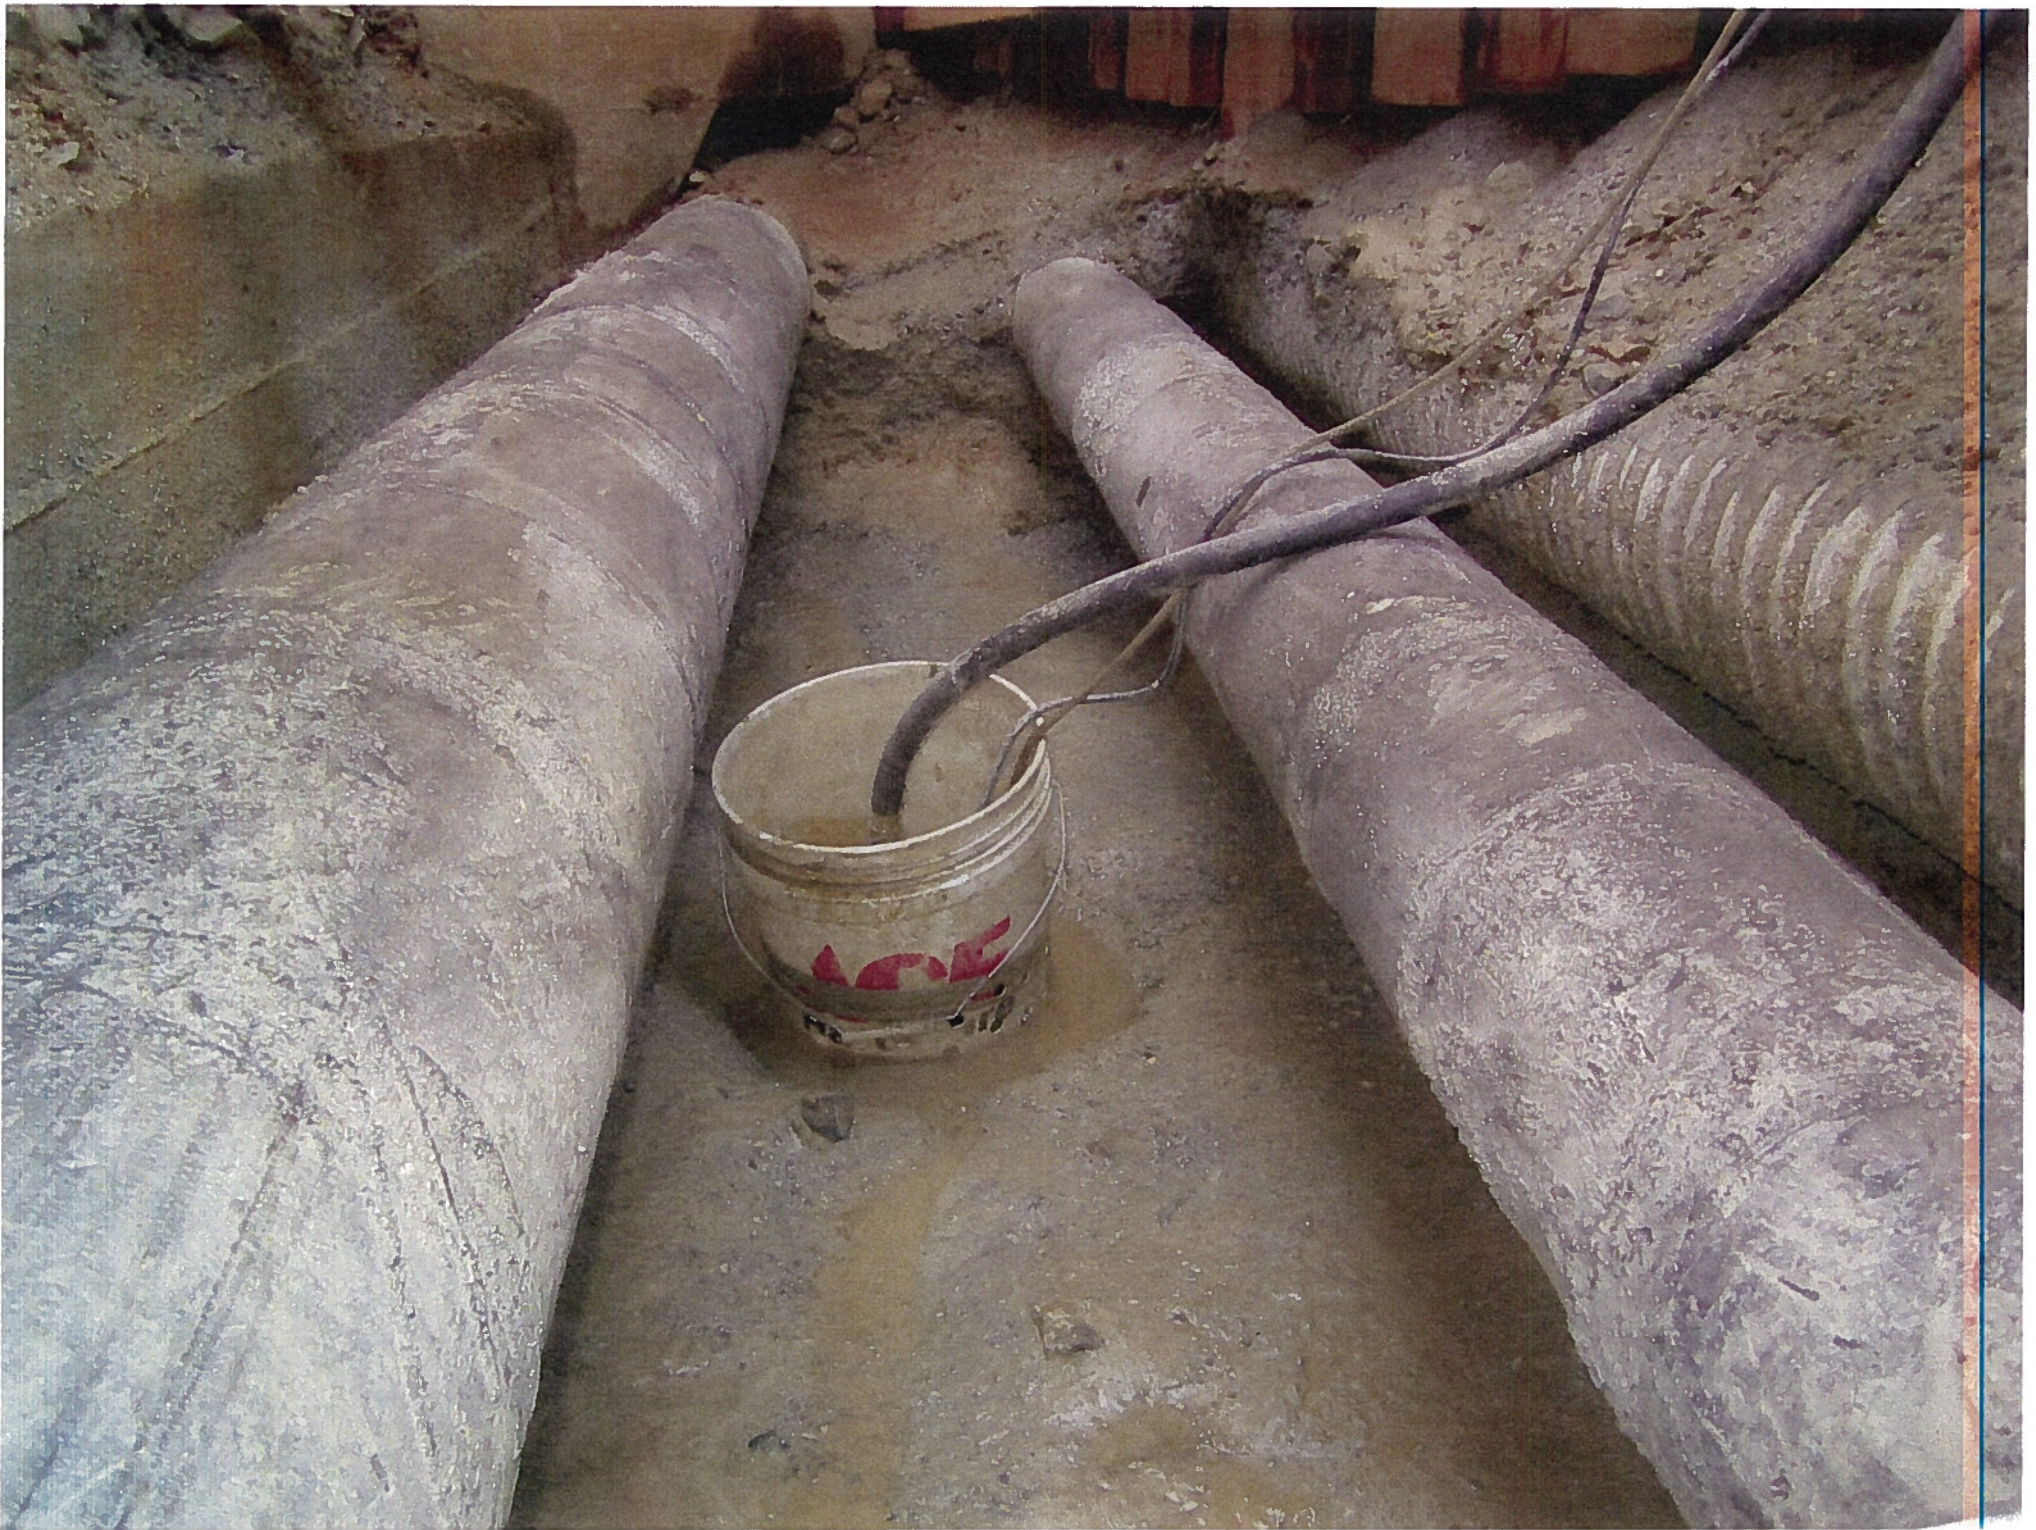
GENERAL APPEARANCE (Inspector): An approx. 14 ft length of 12-inch dia. Line 1070 was excavated, of which approx. 12 ft was exposed for its full circumference. The coating appearance was uniform in color, with no indications of degradation (blistering, peeling, flaking, cracking or separation of coating from the metal surface). The coating outerwrap appeared to be evenly applied, with the edges of overlapping layers of the wrap sealed with the coal tar enamel. Further, there was no discoloration or evidence of corrosion product under or at the edges of the wrap, and the coating surface was solid to the touch. Photos are attached.
