ENTERGY	ENGINEERING STANDARD	EN-EP-S-002-MULTI	REV. 0
	Buried Piping and Tanks General Visual Inspection	PAGE 12 OF 12

INSPECTION CHECKLIST

Piping / Tank IP2 Service Water 24-inch Line INSPECTION DATE: 11/23/11  
409 (WO # 279576-02)

IP2 Service Water Lines 408 & 409 Inspections (Nov. 2011)

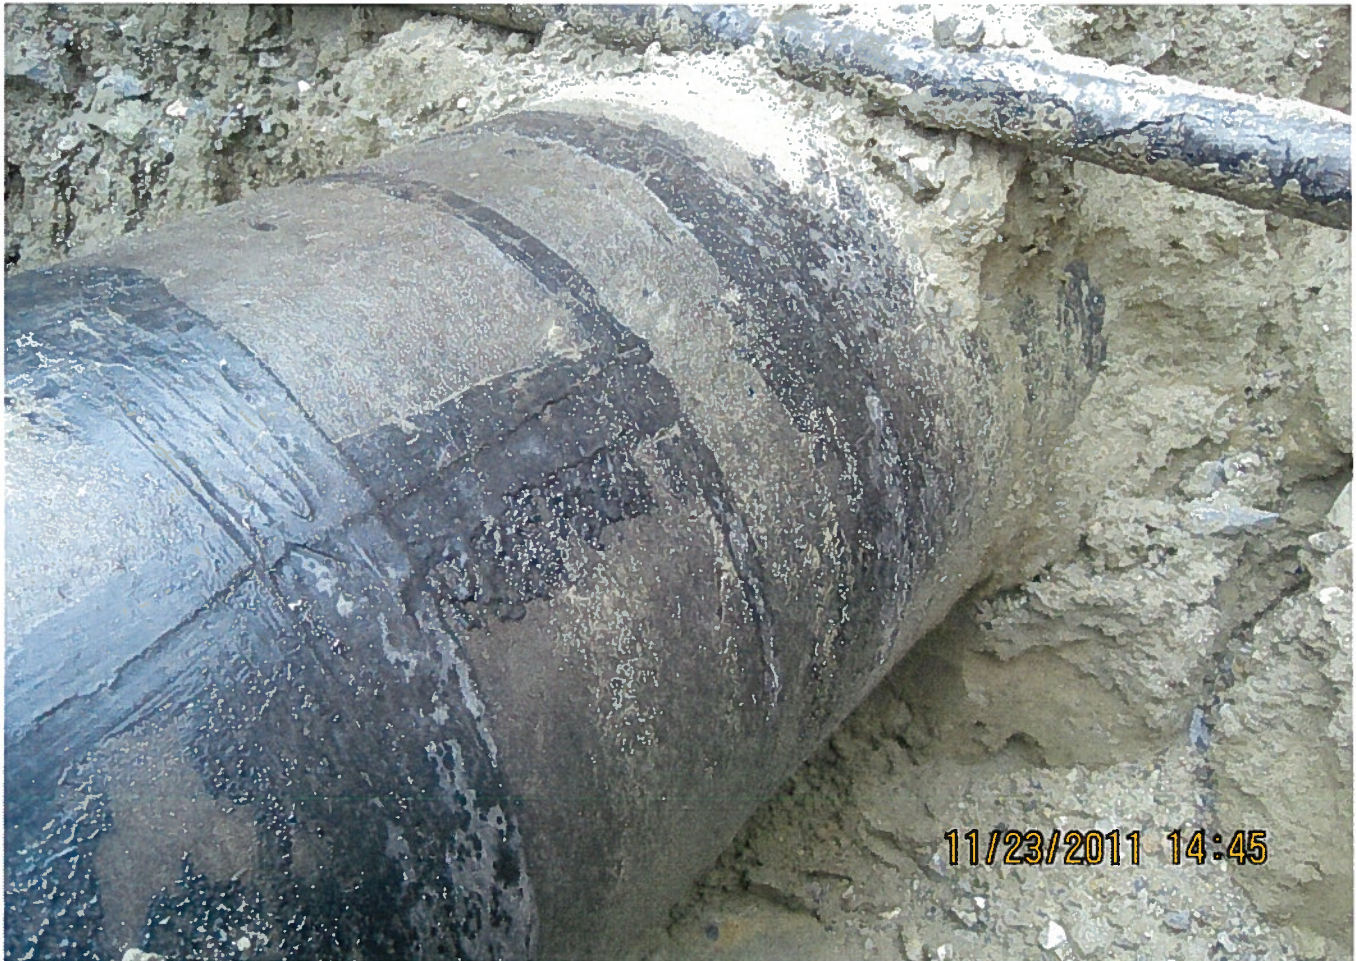
2" STATION AIR LINE CROSSING @ 90°

24" SW LINE 409

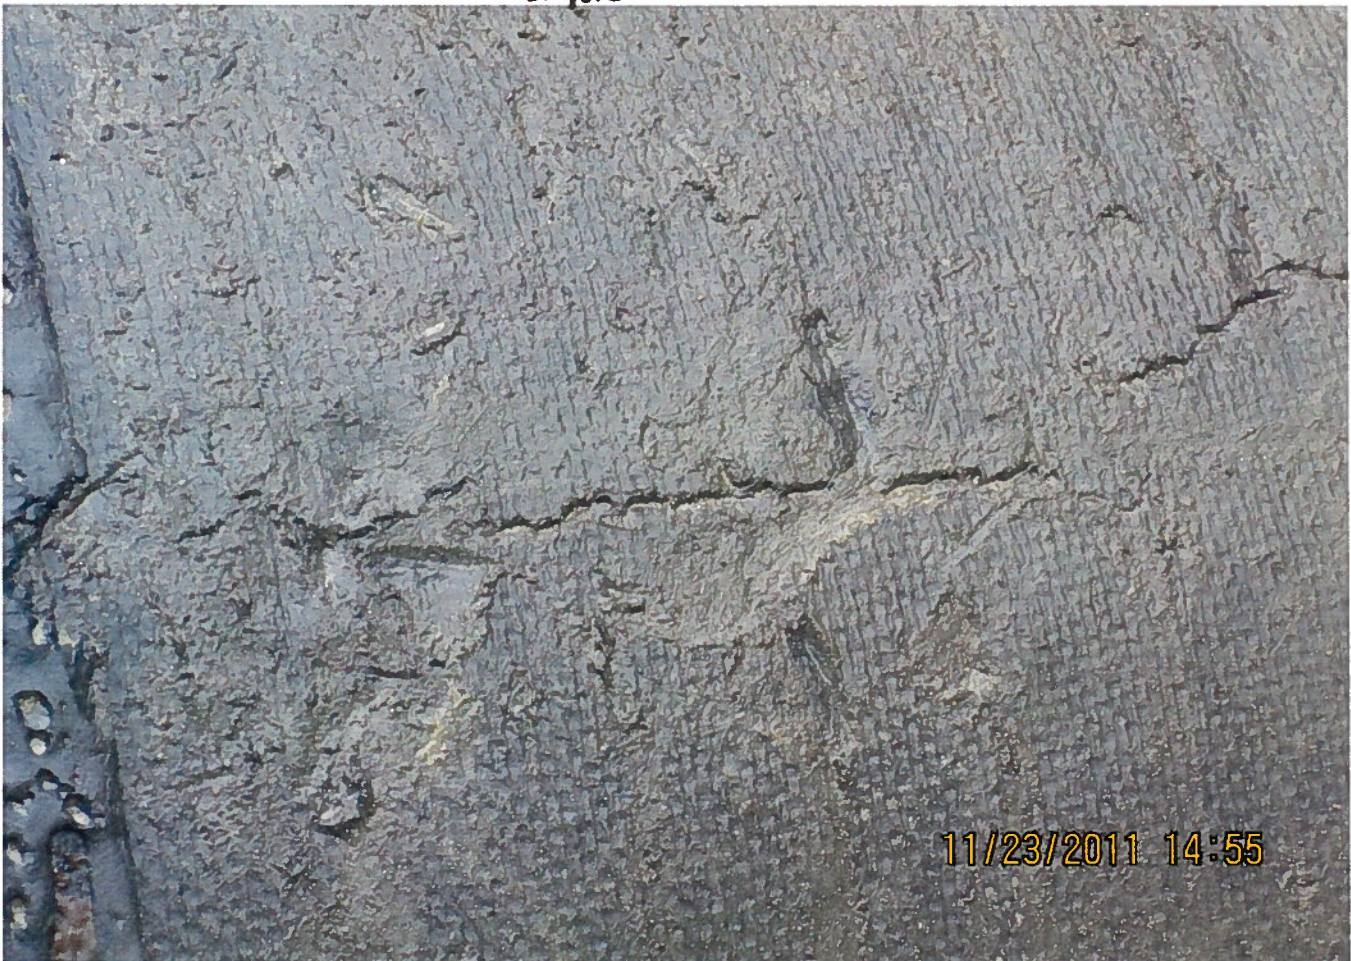
| 6. ANY EMBEDDED ROCKS (COATING AND/OR METAL)? | YES <input type="checkbox"/> | NO <input checked="" type="checkbox"/> | <u>small, fine cracks in top layer of wrap, but no unprotected metal</u> |

FINE CRACKS IN TOP LAYER OF WRAP ↓
