SEABROOK STATION UNIT 1: DAMAGE TO GENERATOR STEP-UP TRANSFORMER IDENTIFIED 10 NOVEMBER 1998 IMMEDIATELY FOLLOWING GEOMAGNETIC STORM SHOCKS OF NOVEMBER 7-9, 1998

SEABROOK STATION UNIT 1 DAMAGE TO GENERATOR STEP-UP TRANSFORMER IDENTIFIED 10 NOVEMBER 1998 IMMEDIATELY FOLLOWING GEOMAGNETIC STORM SHOCKS OF NOVEMBER 7-9, 1998

Comments of the Foundation for Resilient Societies, prepared by William R. Harris January 19, 2012

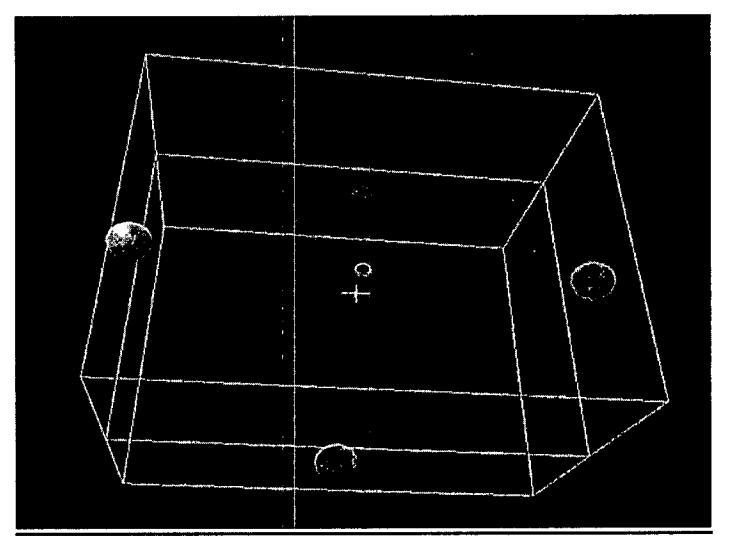
Locating the source of PD or arcing is made easy using 4 acoustic sensors and a software process that uses time of arrival of the AE signal. The software triangulates and puts a spot (pink ball) in a virtual 3D transformer on the computer screen. Figure 2 gives an example of this where the larger balls indicate sensor location on the surface and the smaller, interior ball indicates the source of the PD. Each AE sensor is color coded, measurements of the transformer size and location of the sensors are entered into the software to produce the below 3D graphic. This is a top down view; the graphic can be rotated in any desired position during this process for ease of source location.

Figure 2: Top view of transformer indicating location of sensors, (large balls), and source, (small interior ball) This is only possible when 3 or more sensors detect the source. An X-Y source location method is used when only 1 or 2 sensors detect the fault.

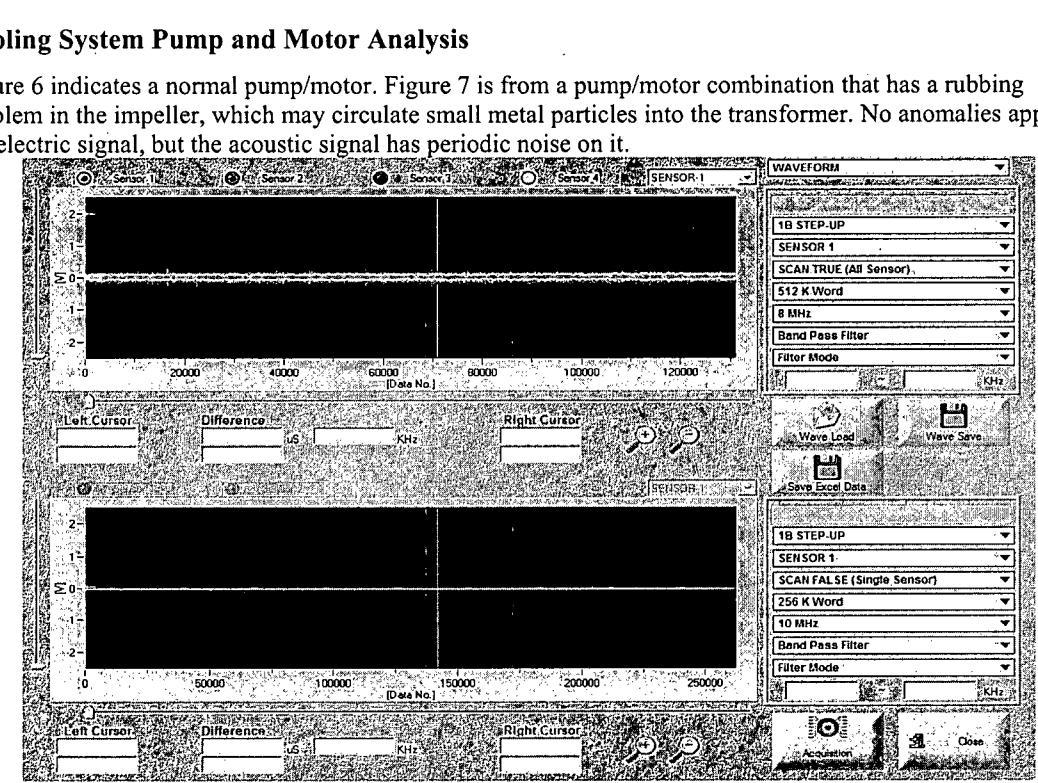
Figure 6 indicates a normal pump/motor. Figure 7 is from a pump/motor combination that has a rubbing problem in the impeller, which may circulate small metal particles into the transformer. No anomalies appear in the electric signal, but the acoustic signal has periodic noise on it.

Figure 6: Acoustic (top) and electric signature of a normal transformer oil circulating pump/motor combination.

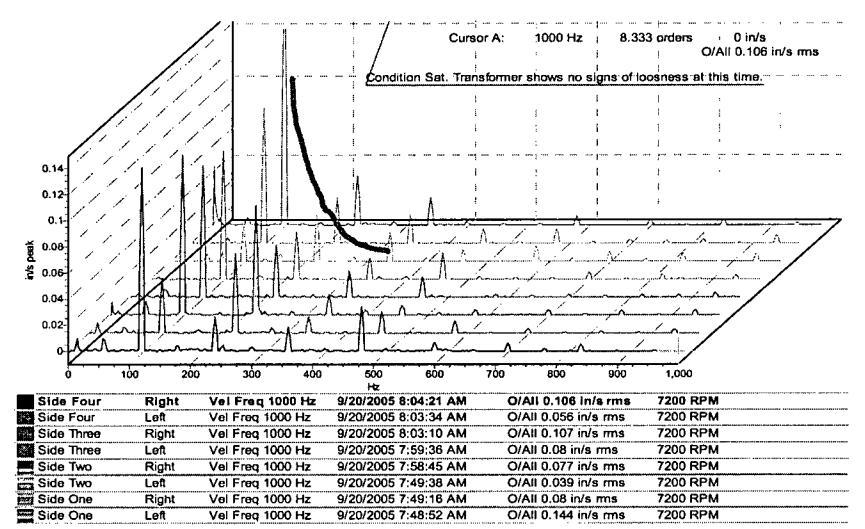
Case study #1 whose vibration waterfall plot is shown in Figure 17 is a fully loaded GSU. It is a 408/456 MVA unit with 1190 MW, the average sound level is 91 dbc. Notice that the 120 Hz is greater than the 240, 360 or 480 Hz and the left axis maximum is set at .15 ips. The sound level is taken at the same time the vibration is taken. Normal sound levels for a non-GSU transformer are approximately 70 to 80 db. The sound level is taken in C weighted to capture all of the 120 Hz which is being produced by the normal transformer action.

Figure 17. Case Study #1. Normal shell form transformer waterfall vibration plot. The hand drawn red line shows the normal slope of a tight transformer.

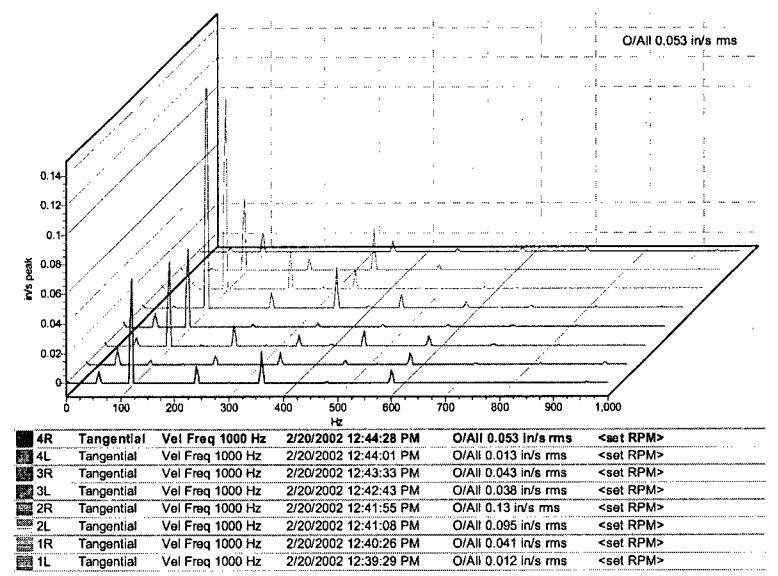
Figure 20 shows the vibration waterfall plot of case study #3.1, the sister unit to the transformer in Case Study #3 above. The load on this 100 MVA unit at the time for this test was 6 MW, the same as the above unit. The average sound level on this unit was 68 db. This spectrum is shown as a comparison. At the time of this test, the entire load was shifted from the above transformer to this one. There was very little increase to the sound or vibration from this unit. The substation became almost silent. The waterfall plot in Figure 20 shows a tight transformer signature.

Figure 20. Case study #3.1, sister transformer to case study #3. Waterfall plot shows a tight transformer.

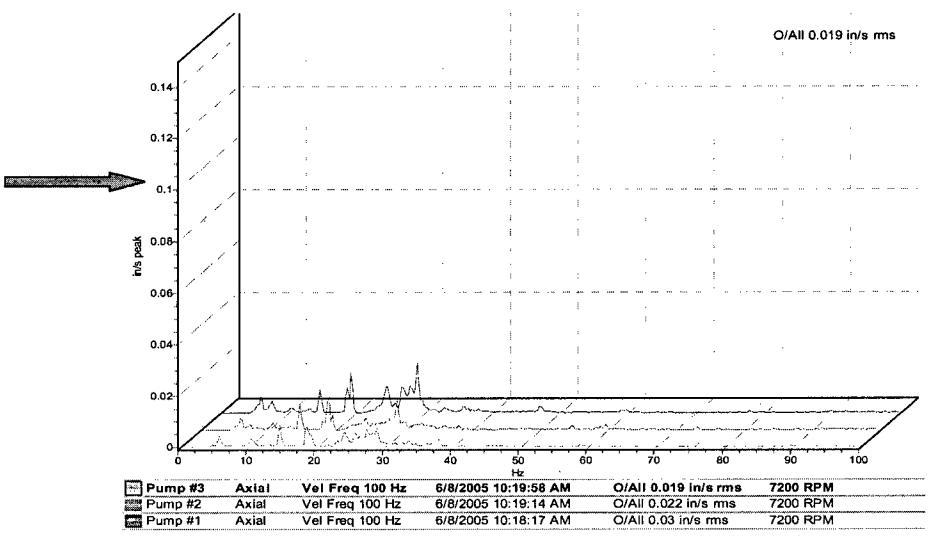
Below are two examples of pump vibration. The first one is normal and the second one is in severe danger of a failure and the good possibility of metal particles being pumped into the transformer. The arrow indicates the first level of alarm at 0.1 ips.

Figure 21. Waterfall vibration plot of normally operating cooling oil circulating pumps.
