Davis-Besse Nuclear Power Station, Unit 1  
Docket Number 50-346, License Number NPF-3  
Submittal of Contractor Root Cause Assessment Report

Root Cause Assessment

Davis-Besse Shield Building

Laminar Cracking

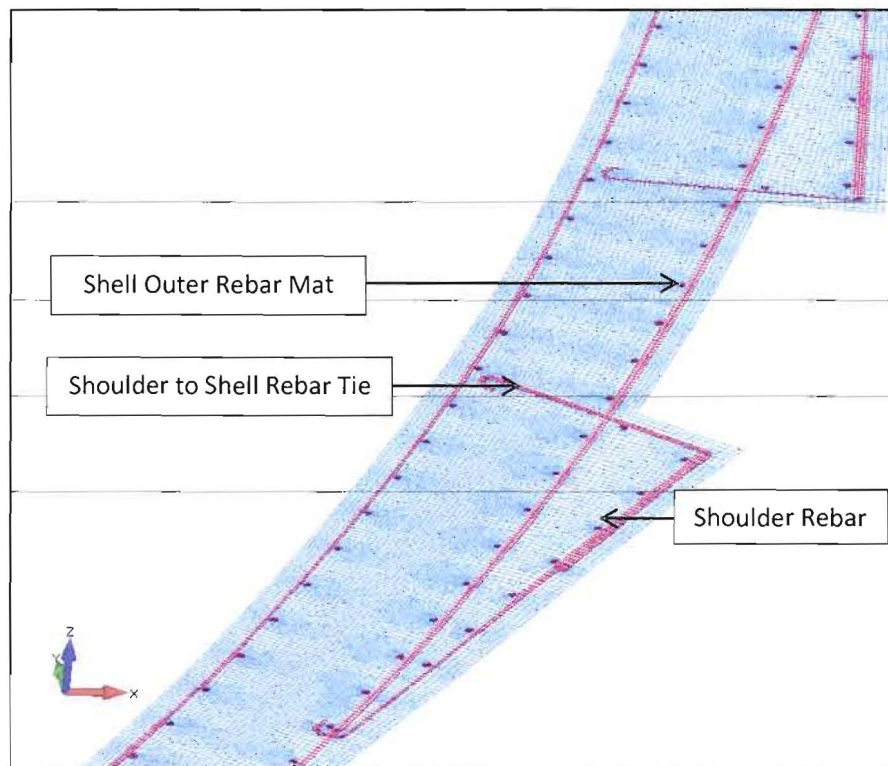
**Figure 2: Rebar Schematic of Shield Building Shell and Architectural-Panel Shoulder Interface**

The shoulders were not adequately considered in the structural analysis of the Shield Building for the unforeseen extreme set of unique environmental conditionals that ultimately caused the observed cracking; however, the building along with its architectural panels was properly designed and analyzed for all known load cases. As such, the reinforcing steel mat in the shoulder area is independent of the main outside reinforcing steel mat with the exception of the horizontal reinforcing steel anchored only at the ends of the shoulder area. This results in a discontinuity since the shoulder reinforcing steel mat is not sufficiently tied to the shell outside reinforcing steel mat. Any stress in the main outer reinforcing steel mat would tend to cause differential stress between the shoulder areas and the Shield Building shell area. The original design of the Shield Building did not consider this structural discontinuity and any affects it might have on the building's structural capacity.

The following figure illustrates the shoulder/shell interface showing the shell's outer rebar mat and the rebar in the architectural panel which ties the panel to the shell.

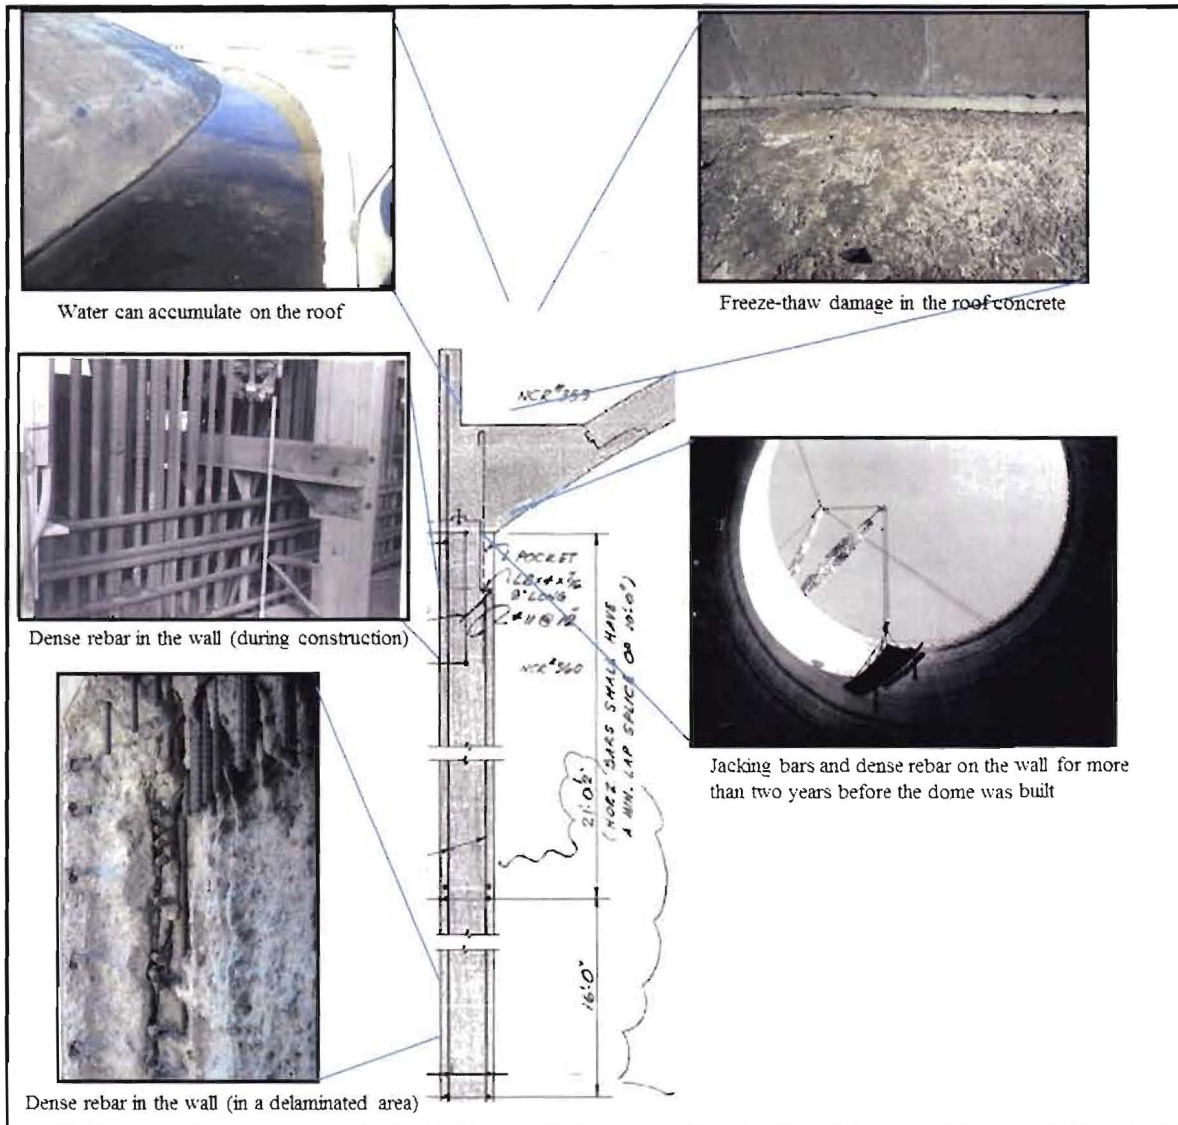
**Figure 4: Top-Down Moisture Transport Mechanism**

The second most likely scenario is that during the blizzard, water intruded from the cracks in the dome of the structure and trapped in small gaps between the rebar and concrete. Upon freezing, the volume expansion of ice produced significant radial stresses that resulted in the observed cracking. This mechanism was explained in Section 6.02 Failure Mode 2.7 on page 16 and by Fig. 4 on page 17.

The top-down moisture transport process assumes that the water comes from the top of the structure and slowly penetrates down within the concrete wall. During the construction of the Shield Building, the wall was built first and the dome was subsequently constructed two years and four months later. So, the jacking bars, dense rebar, and top of the concrete wall were all exposed to the environment. Moreover, initial defects may be generated by the jacking bars and dense rebar, together with the large aggregate used in the concrete. These factors resulted in the potential for high porosity concrete near the rebar and jacking bars allowing for water penetration. Due to the heterogeneous characteristics of concrete, the water comes down along random paths of least resistance which may tend to explain the sporadically distributed cracks in the wall. This moisture transport mechanism is illustrated in Figure 4.

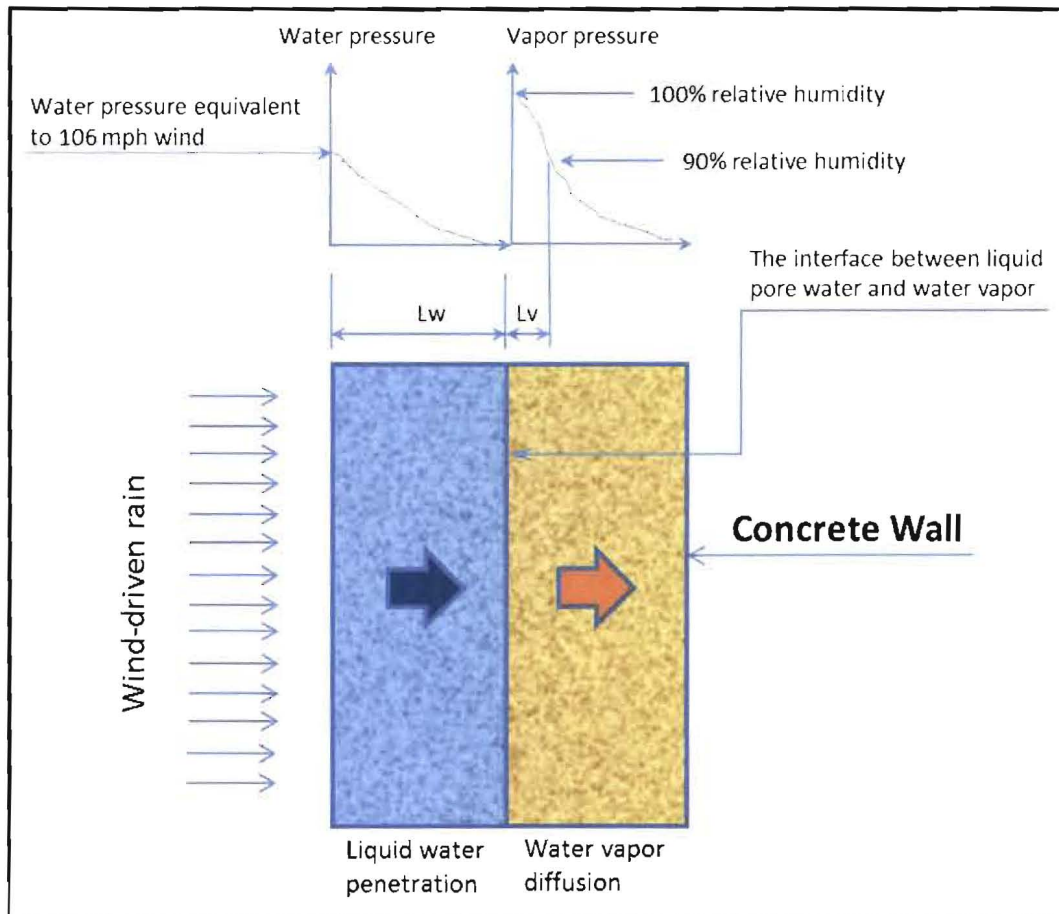
Figure 5: External-Internal Moisture Penetration

consider. On the outer surface of concrete wall, the rain water is pressed by the wind pressure and penetrates into concrete. The liquid water penetration is a dominant process which is driven by the wind pressure on the surface.

Figure 5 shows the two transport processes in a concrete wall during a blizzard. The blue region represents the outer layer of concrete in which pores are saturated by liquid water, which may be called water region, and the yellow region stands for the inner layer where vapor water is dominant, which may be called vapor region. The entire depth of the water region is shown in Figure 5 as  $L_w$  (on the left), which is important in the study conducted. The partial depth of the vapor region, say higher than 90% pore relative humidity is shown as  $L_v$  (on the right), which is also important for our study. The depth of the water region  $L_w$  is much higher than that of vapor

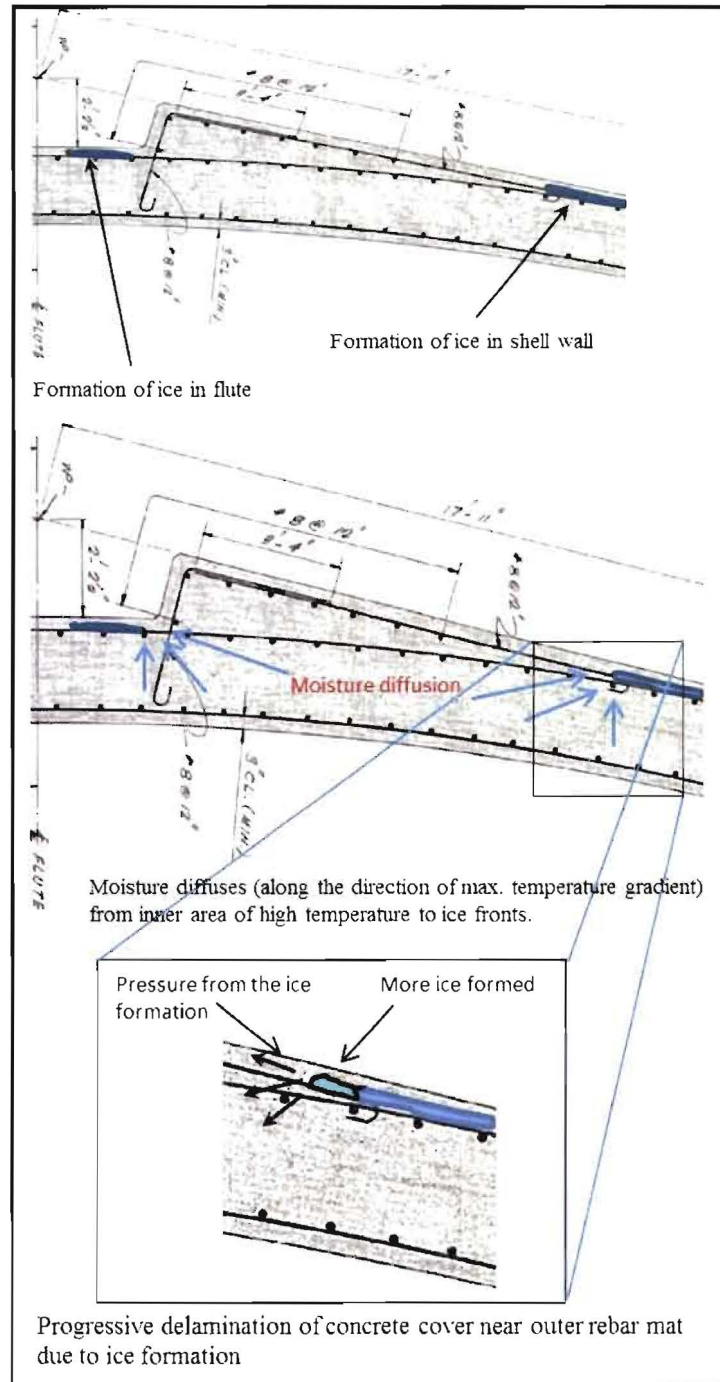
Figure 6: Freezing of Water near Outer Rebar Mat Sequence (FM 3.6, Sub-Mode 1)

2. As the blizzard continues, the temperature continues to drop well below the freezing point of water. At this point, the water trapped near the outer mat horizontal rebar between the two first-freezing areas starts to freeze, i.e., in the areas directly behind the thick shoulders from the surface. The moisture behind the shoulder diffuses towards the ice fronts, which are located near the surface of the flute and shell wall. The diffusion directions of moisture are shown in the middle figure of Figure 6. The moisture diffusion is driven by the maximum temperature gradient from the hottest area to the coldest area as well as by the maximum free energy gradient from the area with higher free energy (vapor and liquid) to the area with lower free energy (ice).

3. When the diffusing moisture reaches the ice fronts, it turns into ice. This is shown in the third figure (the enlarged area) in Figure 6. So, the ice fronts move from both sides (the flute and the shell wall) toward the middle of the shoulder. Due to the formation of ice at both ends of the shoulder which acts as a dam, high pressure is generated in the shoulder areas as the water continues to migrate to the ice fronts resulting in the crack initiation in the shoulder.

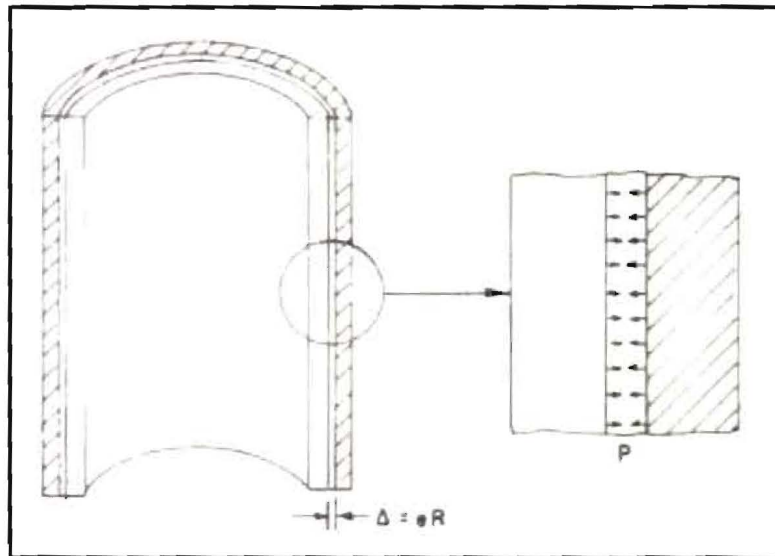
**Figure 7: Outer-Expansion-Inner-Contraction Schematic (FM 3.6, Sub-Mode 2)**

For illustration purposes, Figure 7 shows a general schematic of the outer-expansion-and-inner-contraction phenomenon. Due to the structural configuration of the DBSB, this phenomenon causes significant stresses in the shoulder areas, as will be demonstrated in subsequent sections of this report.

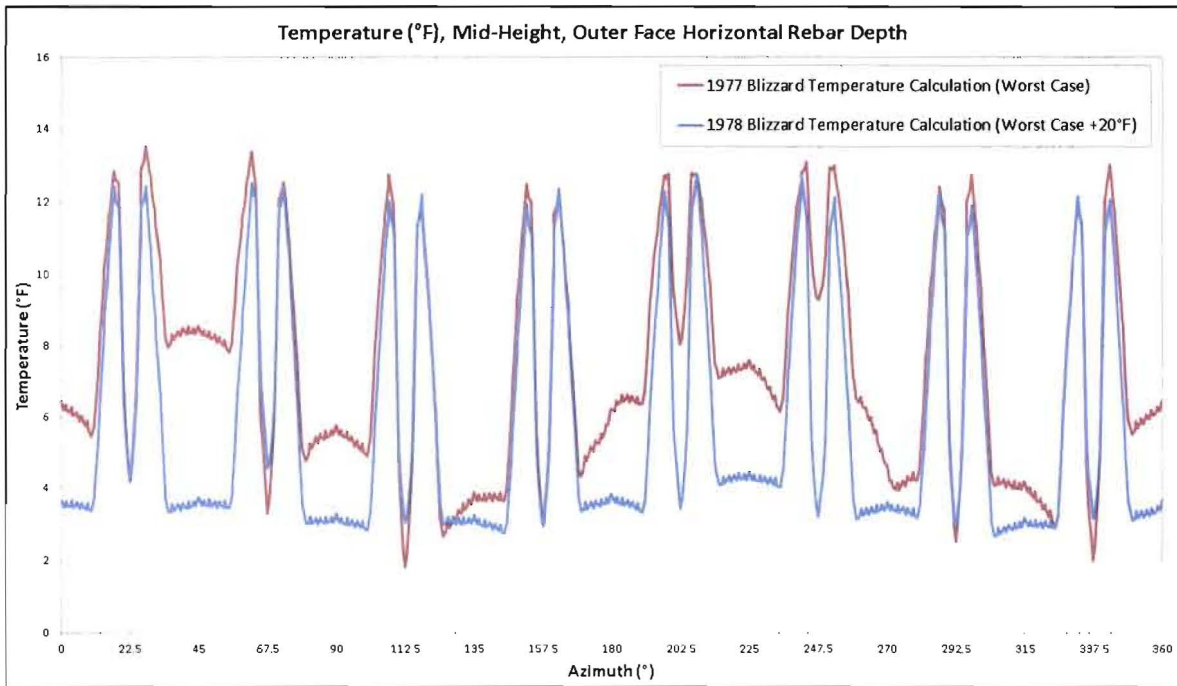
Figure 11: Circumferential Temperature Distribution at the O.F. Horizontal Rebar Depth

The figure shows 8 sets of double peaks for each temperature profile. The double peaks represent the warmer temperature under the shoulders. The temperature is warmer under the shoulders because there is a thicker layer of concrete at those locations which reduces the heat loss to the exterior during the blizzards.

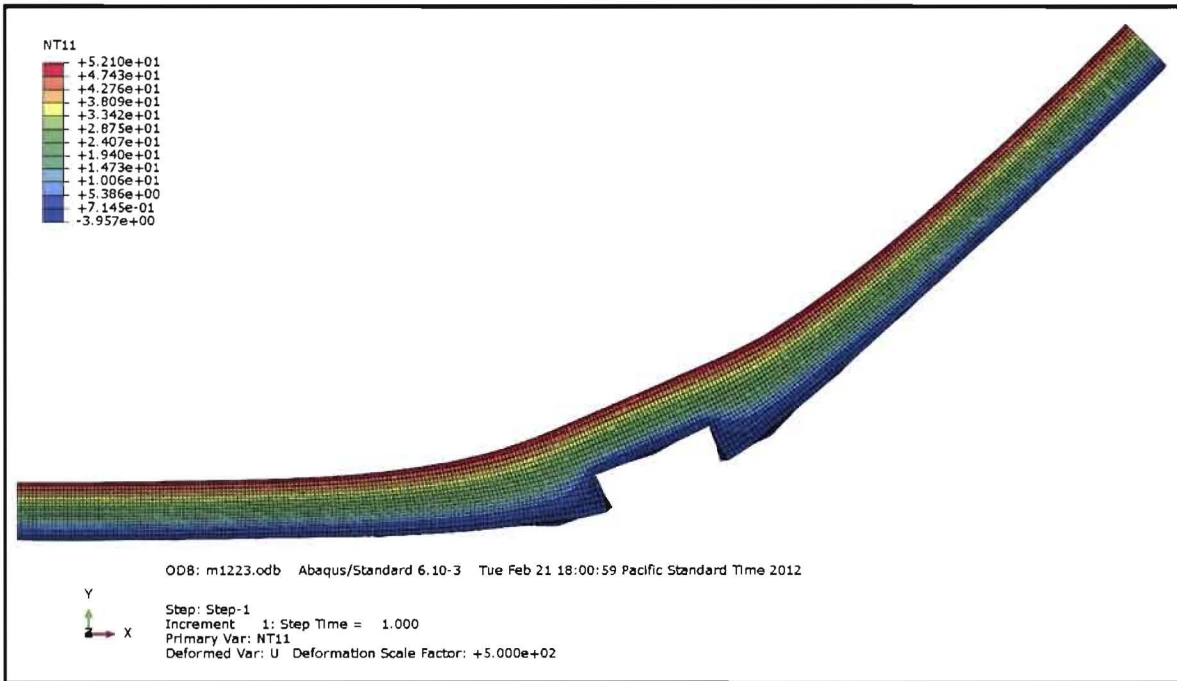
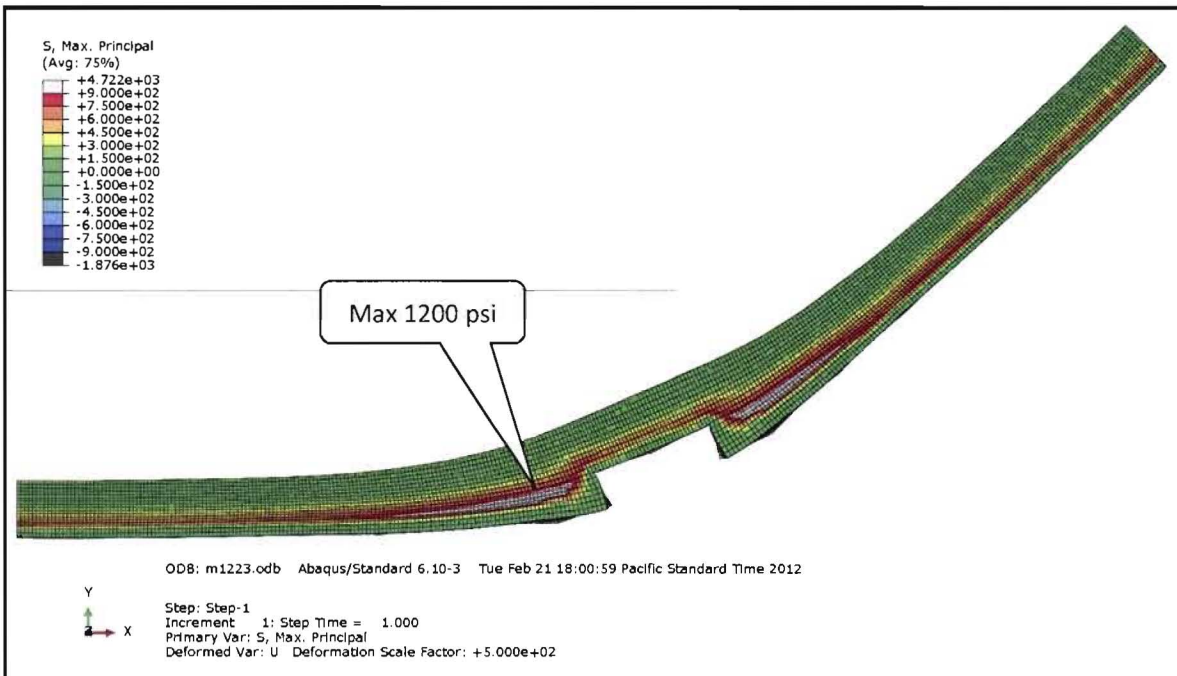
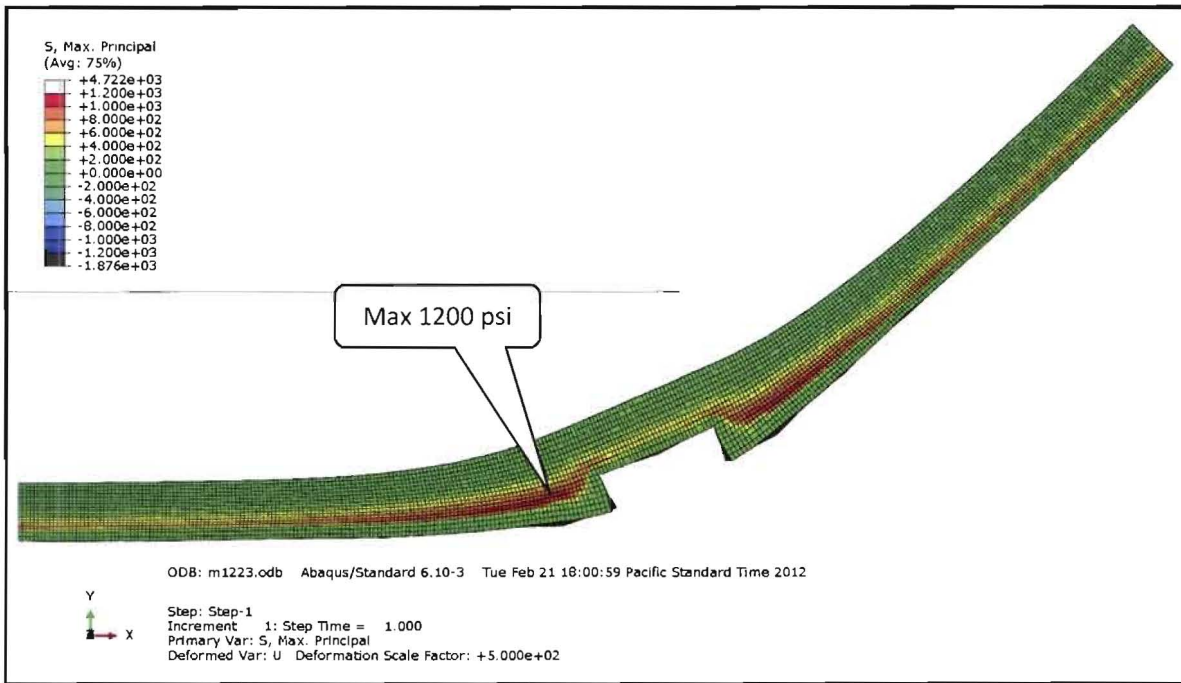
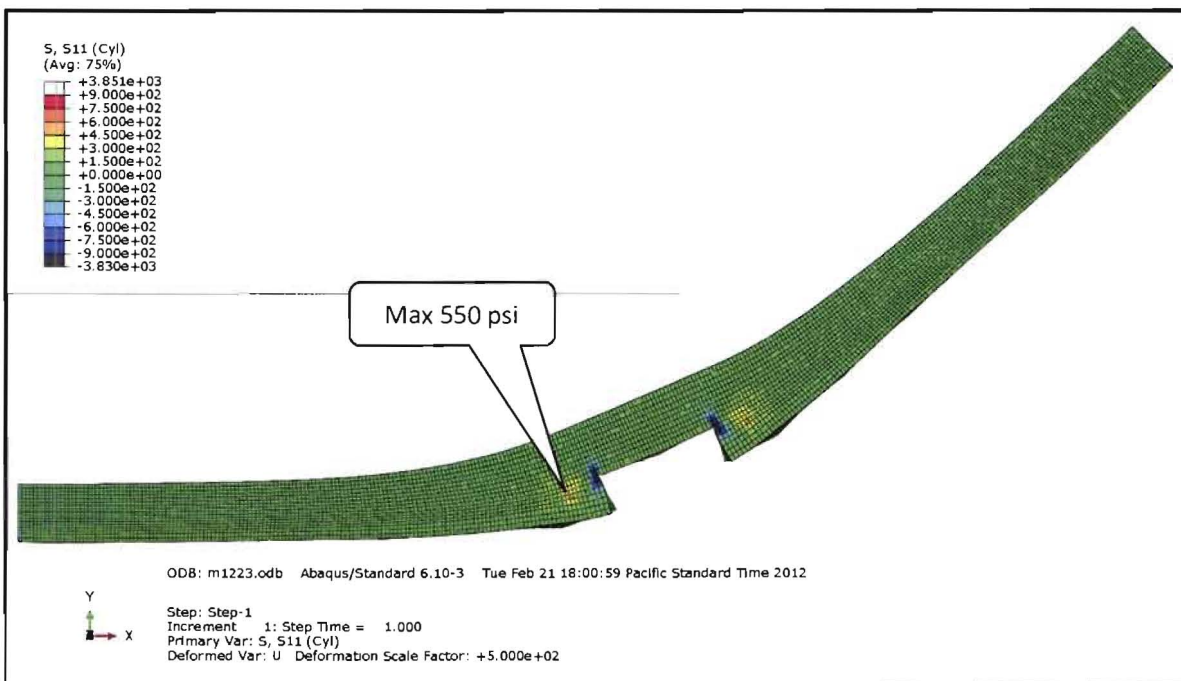
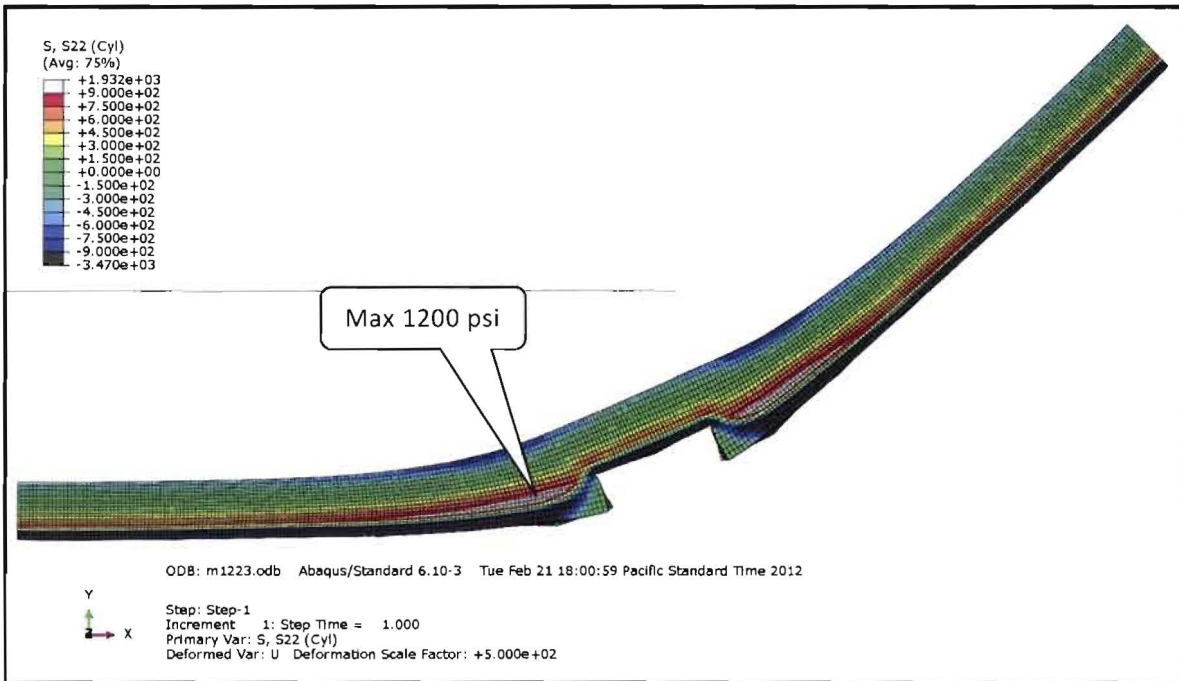
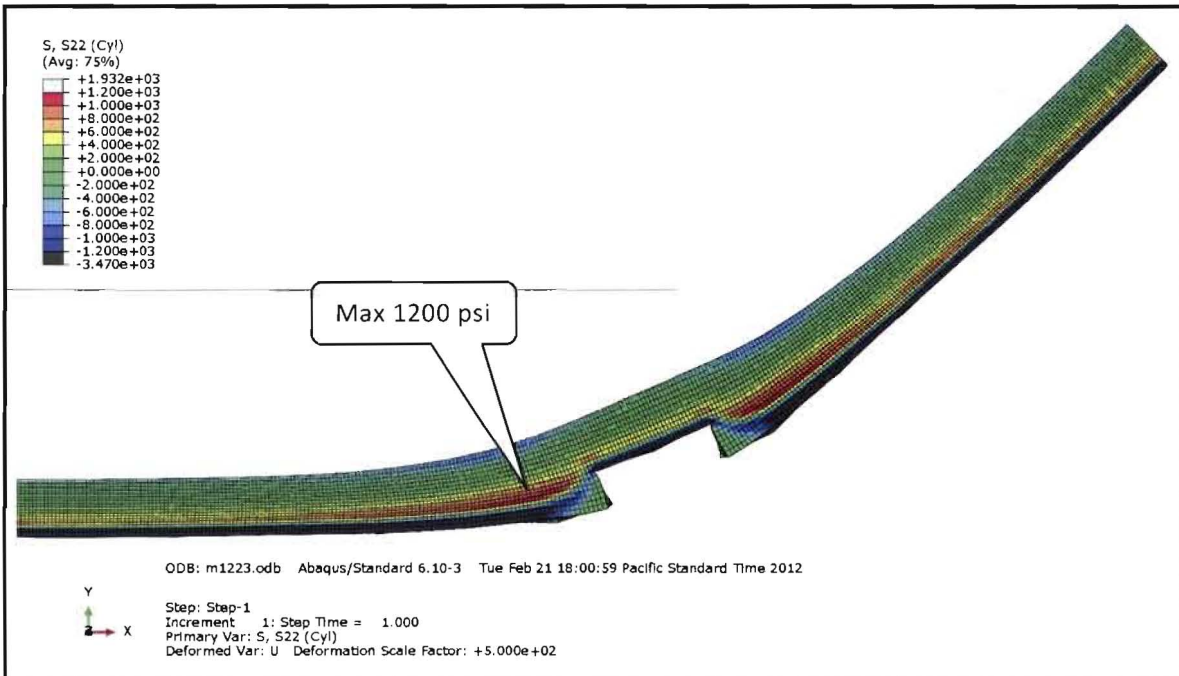
The result due to the 1978 blizzard is shown in Figure 15 through Figure 21. The temperature contours can be seen in Figure 15 and the stress results is shown in Figure 16 through Figure 21.

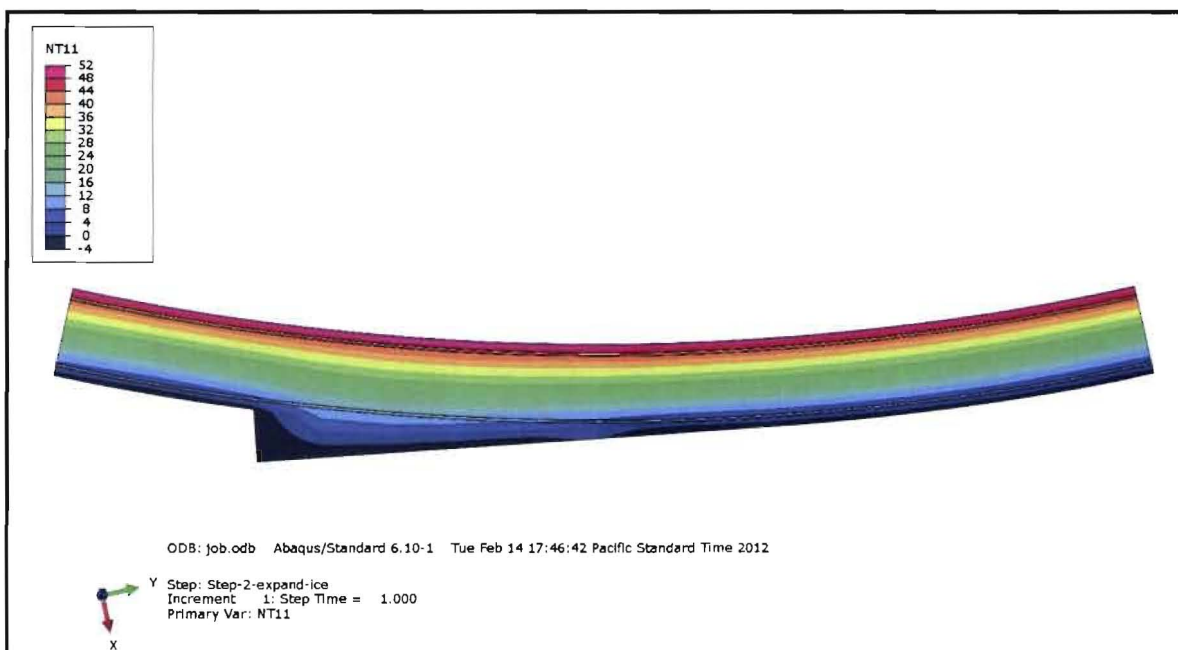
Figure 39: Temperature Contours (°F) in the Top 20' of the Wall

The results at the top 20' location, perturbed by the 1978 blizzard are shown in Figure 39 and Figure 40. The 20°F offset temperature contours can be seen in Figure 39 and the cracking results are shown in Figure 40.

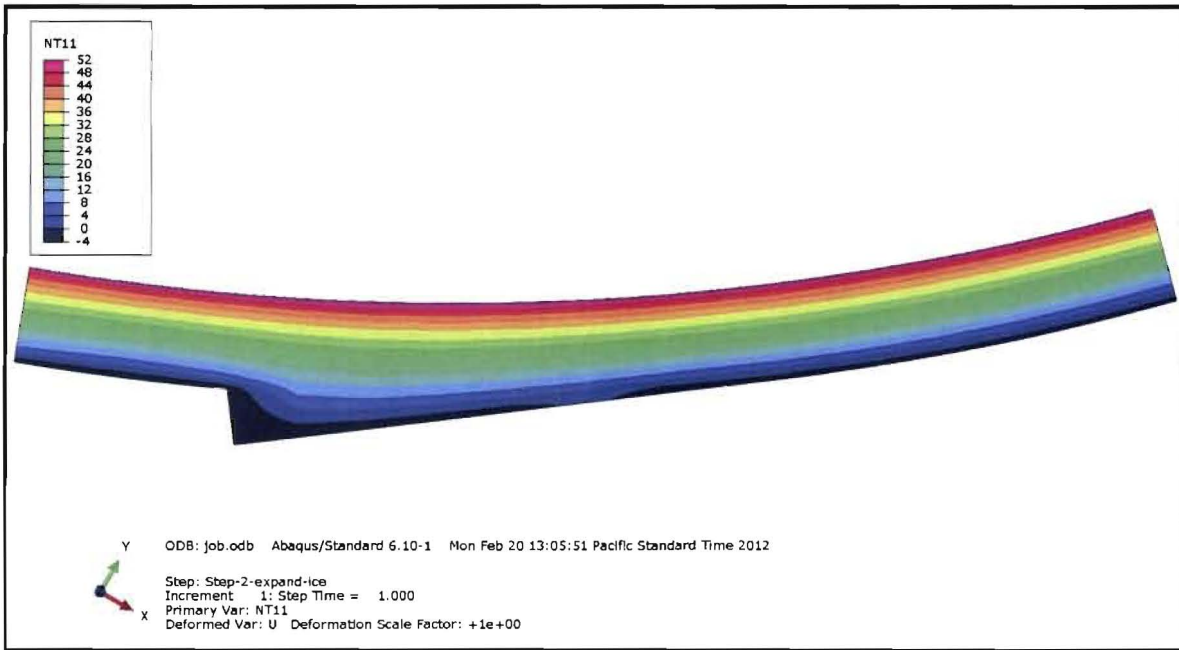
Figure 41: Temperature Contours (°F) at Steam Line

The results at the steam line location, perturbed by the 1978 blizzard are shown in Figure 41 and Figure 42. The 20°F offset temperature contours are in Figure 41 and the cracking results are shown in Figure 42.

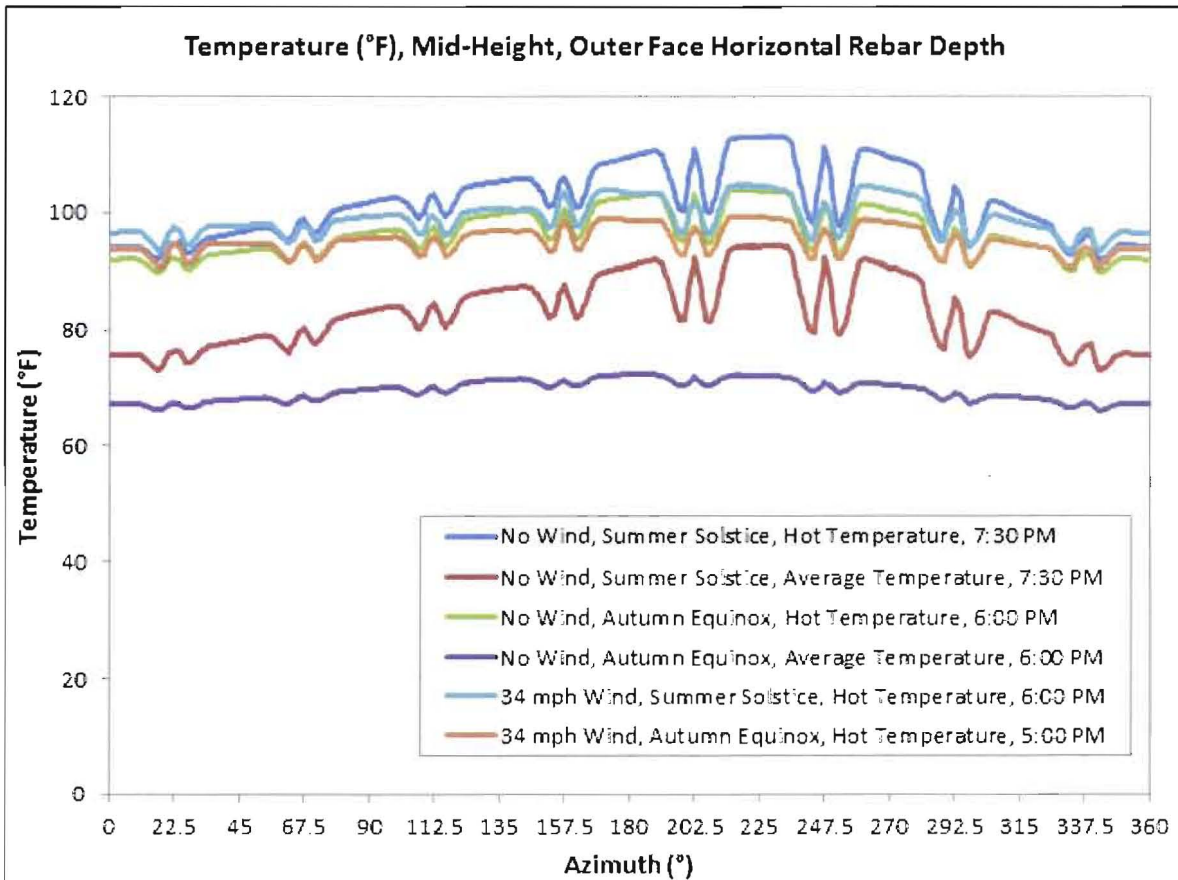
**Figure 43: Circumferential Temperature Distribution at O.F. Horizontal Rebar**

For each of the six temperature profiles shown in Figure 43 eight set of double valleys can be seen. The valleys represent the lower temperature under the thick sections of the shoulders. These areas are covered by thicker layer of concrete so it takes longer for them to heat up due to the hot exterior conditions. Figure 43 also shows that the azimuth 225° location corresponds to the hottest location around the structure. The condition resulting in the hottest temperature at the outer face horizontal rebar depth is labeled “No Wind, Summer Solstice, Hot Temperature, 7:30 PM.” This is the temperature condition studied in detail [REDACTED] following sections.

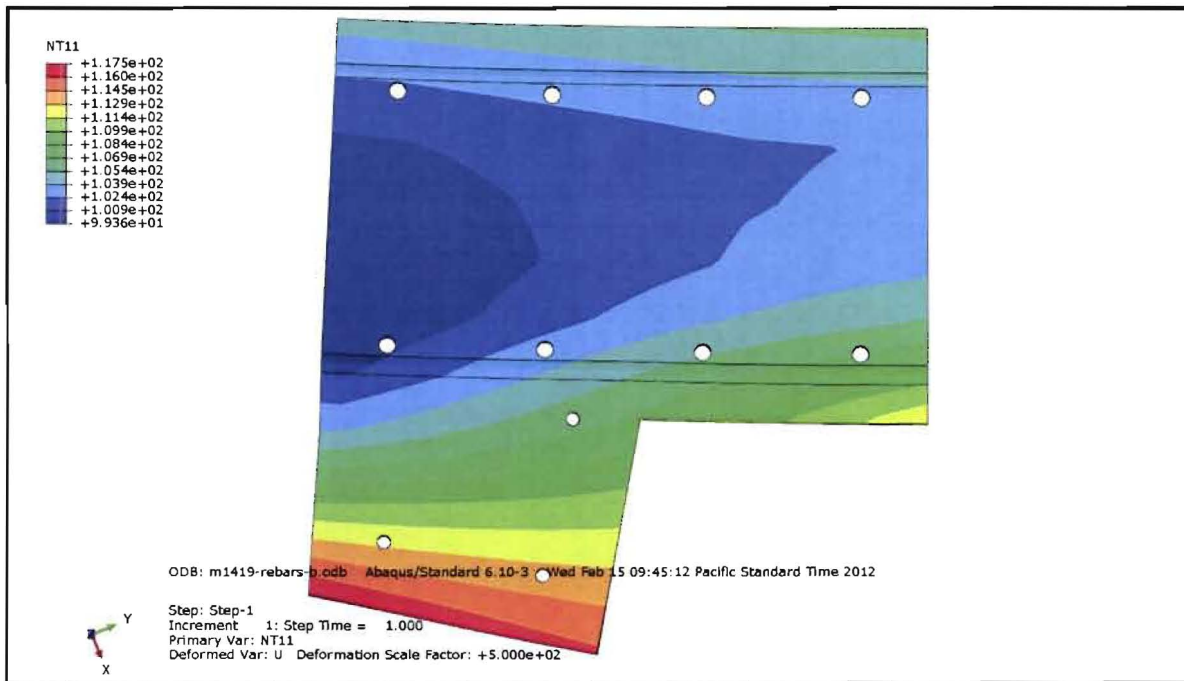
Figure 45: Temperature Distribution (°F) in Shoulder 10 Location

The temperature distribution, max principal stress, radial stress, hoop stress, and vertical stress in shoulder 10 are depicted in Figure 45 through Figure 49, respectively. Figure 45 shows that the shoulder surface is hotter than the flute surface. This is the result of more solar exposure on the shoulder surface compare to the flute valley. Also, there is more surface area at the corner of the shoulder resulting in higher temperature during the hot ambient condition.

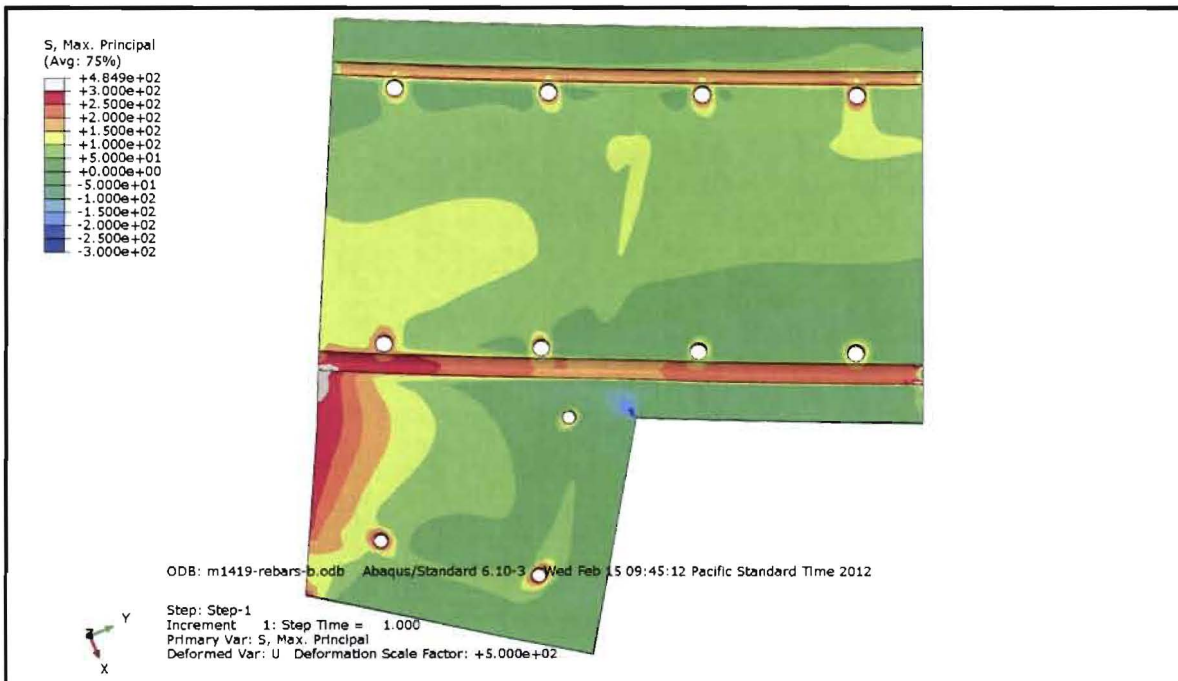
Figure 46: Max Principal Stress (psi) in the [redacted] laced in the Shoulder 10 Location

Figure 46 through Figure 49 depict the stress state using the max principal stress and the three stress components in a cylindrical coordinate system located at the containment structure center. The max principal and radial stresses are highest at the outer face horizontal rebar. The figures

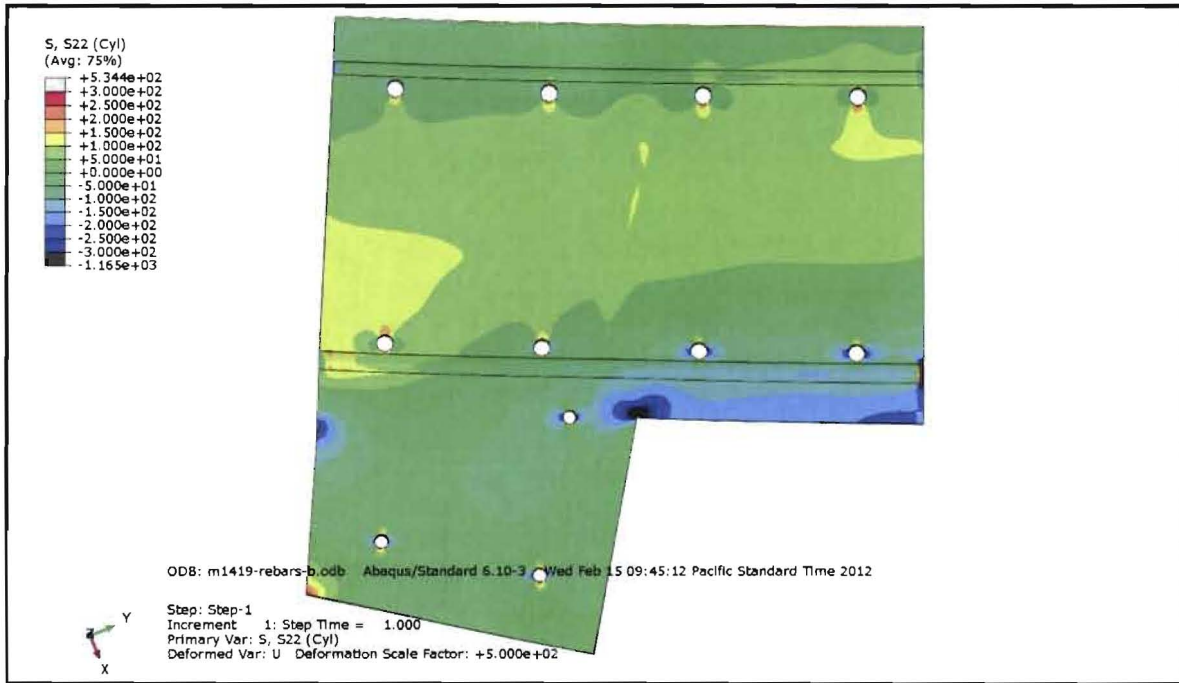
Figure 48: Hoop Stress (psi) in the [REDACTED] placed in the Shoulder 10 Location

Comparing the stress in the three radial, hoop, and vertical directions (Figure 47 through Figure 49 respectively) indicates that the radial component has the highest tensile stress. As shown in Figure 47, the radial tensile stress is below 300 psi which is less than the tensile strength of the concrete. It is concluded that the hot summer temperature condition is not capable of delaminating the structure in the flute/shoulder location.

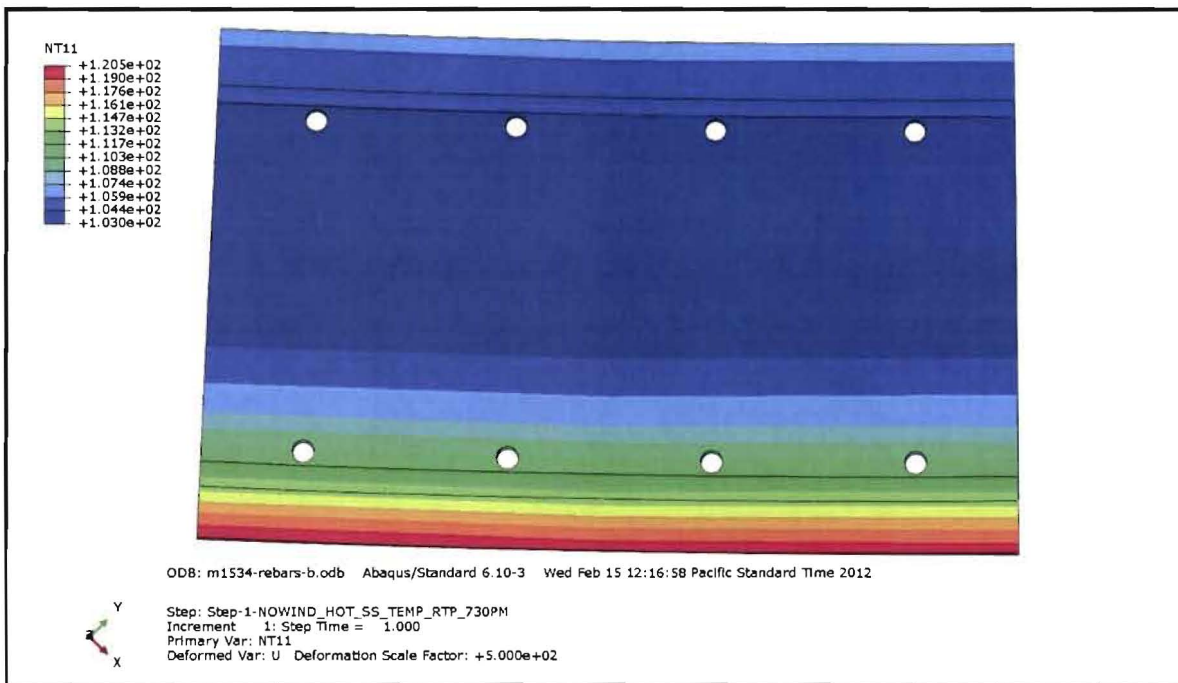
Figure 50: Temperature Distribution (°F) in the [redacted] placed at the Azimuth 225° Location

The temperature distribution, max principal stress, radial stress, hoop stress, and vertical stress in the shell area at azimuth 225° are shown in Figure 50 through Figure 54, respectively. Figure 50 shows that the exterior surface is hotter than the interior. This is the result of the hot ambient daytime condition and the colder nighttime condition.

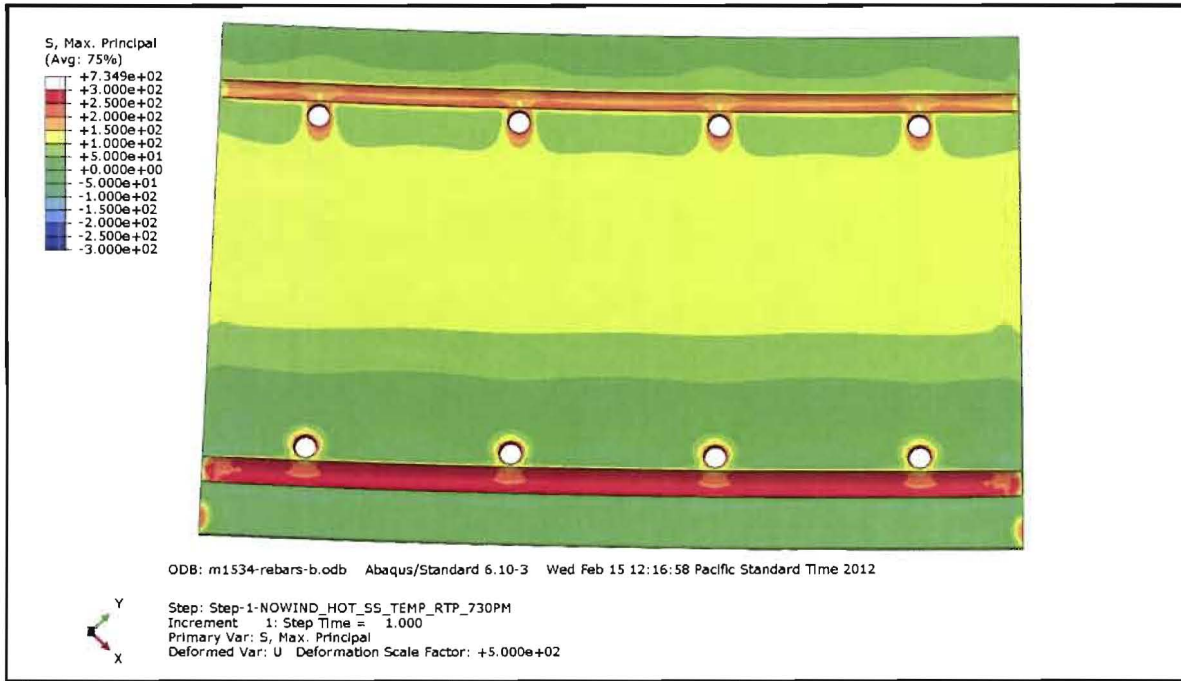
Figure 51: Max Principal Stress (psi) in the [redacted] placed at the Azimuth 225° Location

Figure 51 through Figure 54 depict the stress state using the max principal stress and the three stress components in a cylindrical coordinate system located at the containment structure center. The max principal and radial stresses are highest at the outer face horizontal rebar depth (see Figure 51 and Figure 52). Comparing the stress in the radial, hoop, and vertical directions (Figure 52 through Figure 54, respectively) indicates that the radial component has the highest tensile stress. As shown in Figure 52, the radial stress is below 300 psi which is less than the strength of the concrete. It is concluded that the hot summer temperature condition is not capable of delaminating the structure in the shell section location (middle of a panel). Furthermore, Figure 53 and Figure 54 show that the hotter exterior surface temperature results in compression stresses in both the hoop and vertical directions due to expansion of the outer layer.

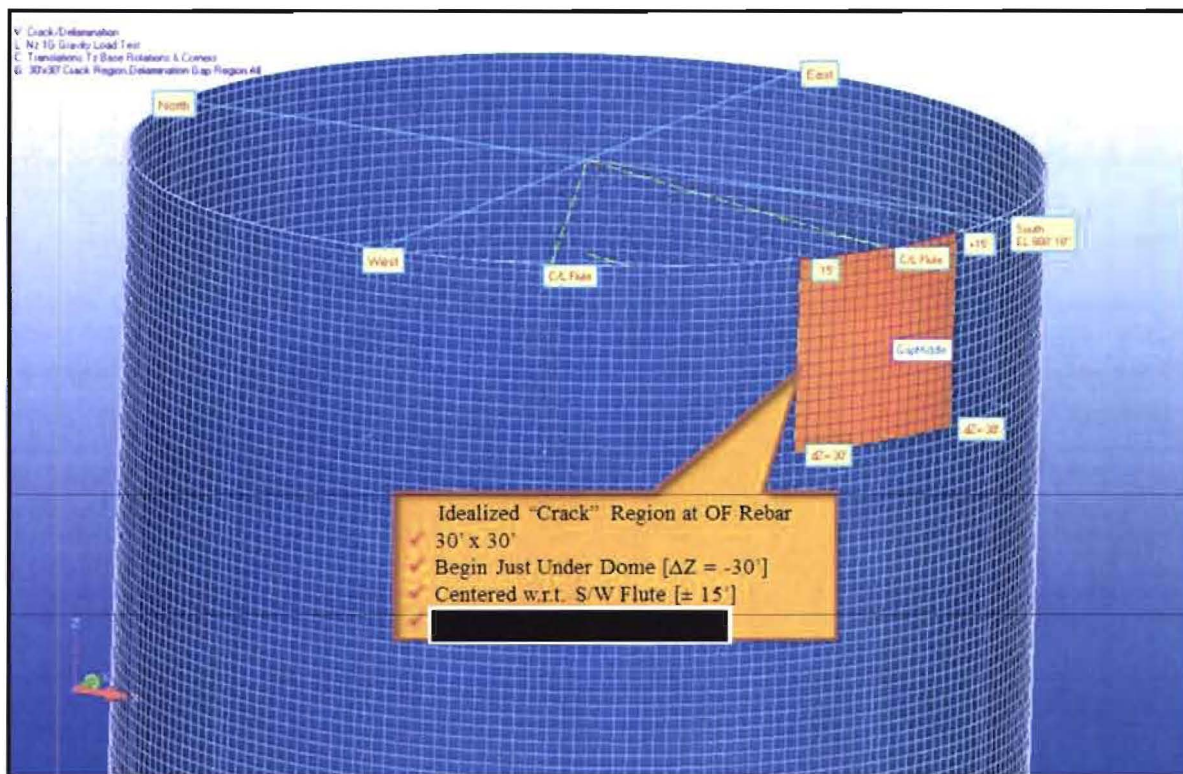
Figure 55: "Thin-Crack" region introduced as idealized the "Cracked" boundary at the OF Rebar

A Finite Element Analysis was performed using the NASTRAN 3D Model to investigate the potential for existing-crack propagation. The NASTRAN 3D Model idealized a 30 ft. by 30 ft. cracked section of the DBSB centered with respect to the southwest flute (Flute Number 6). Figure 55 shows an illustration of the NASTRAN idealization and Figure 56 shows a detailed region of the flute and shoulder highlighting the difference in stresses due to the existing crack.

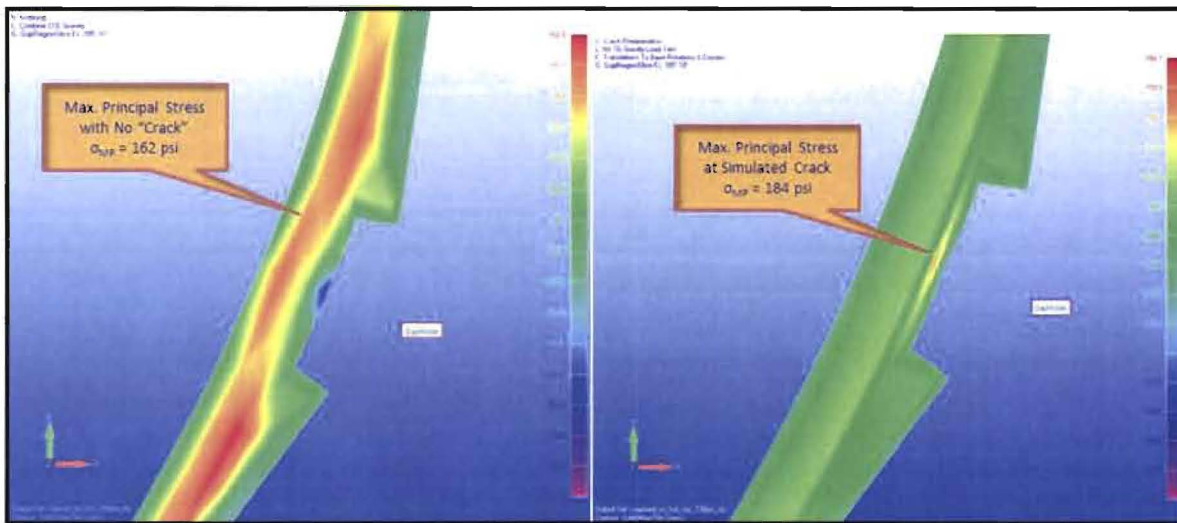
Figure 56: Summer Solstice Hot No Wind 7:30 pm, Constant Concrete CTE =  $5.20 \times 10^{-6}$  in/in/°F

As summarized in Table 6 the magnitude of maximum principal stresses increased a slight amount from  $\sigma_{MP} = 162$  psi (No crack) to  $\sigma_{MP} = 184$  psi (w/crack). There is only a marginal increase in the magnitude of radial stress, from  $\sigma_R = 76$  psi (No crack) to  $\sigma_R = 92$  psi (w/crack).

Therefore it is not believed that the increased magnitudes in either the radial or maximum principal stresses are sufficient to propagate cracks that may have formed under normal thermal and environmental conditions, such as winter and summer.

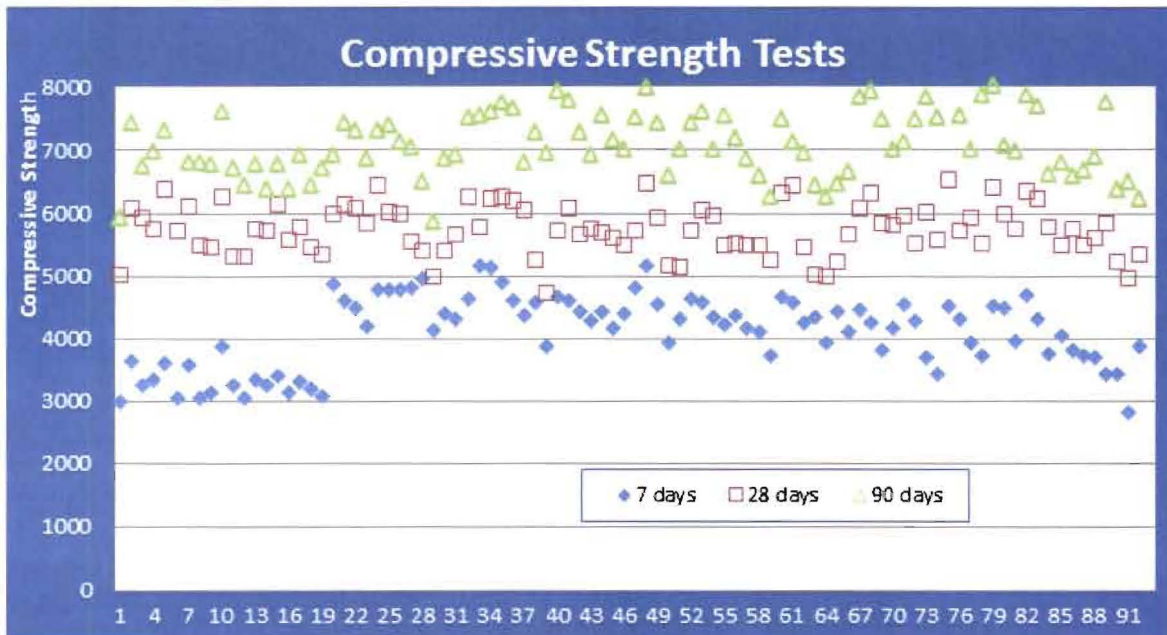
Figure 1 – Compressive Strength tests of concrete in containment wall below and above grade

A total of ninety-two (92) cylinder sets from original construction were analyzed. Eighteen sets were for concrete using the Type II cement (Exhibits 34-35) and seventy four (74) were for Type I cement (Exhibit 36). Figure 1 below summarizes the results. Note the first 19 tests and 3 of the last are for concrete with Type II cement – resulting in lower seven day strength but comparable later strength.

Average strength at 90 days reached 7075 psi with Standard Deviation (StD) of 505, maximum strength of 8100 psi, and minimum value of 5884 psi.
