Davis-Besse Nuclear Power Station, Unit 1  
Docket Number 50-346, License Number NPF-3  
Submittal of Contractor Root Cause Assessment Report

Root Cause Assessment

Davis-Besse Shield Building

Laminar Cracking

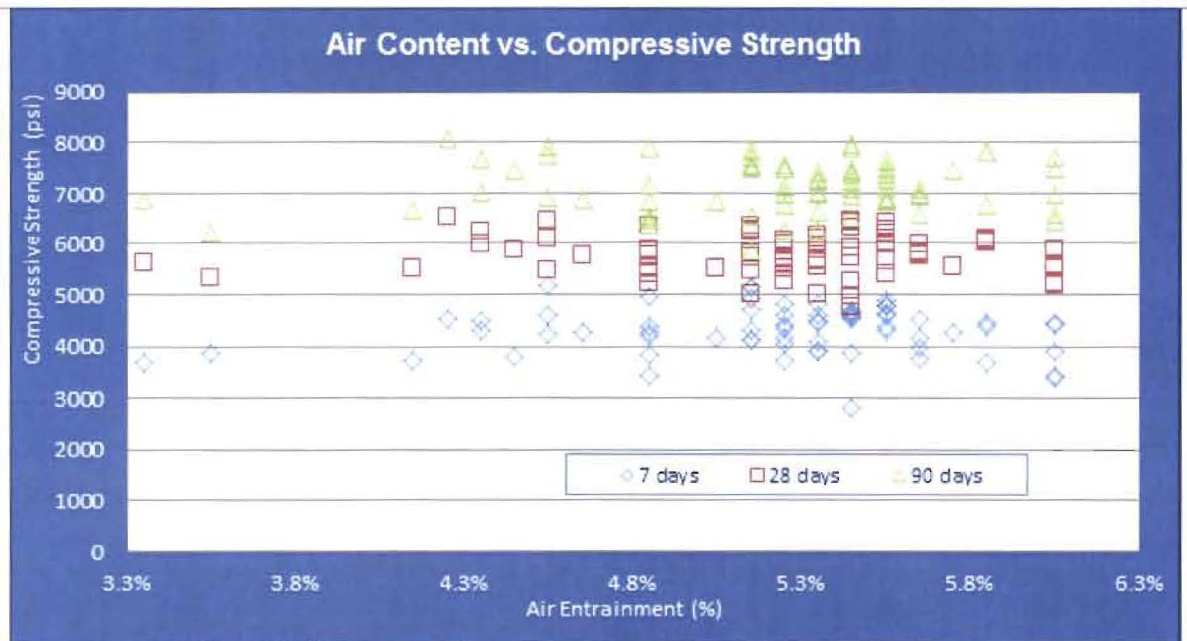
Figure 2 – Air content vs. Compressive Strength of concrete in containment wall

Analysis to measure effect of air on the compressive strength shows no significant effect of air content on the strength at 7, 28 and 90 days. (See Figure 2)

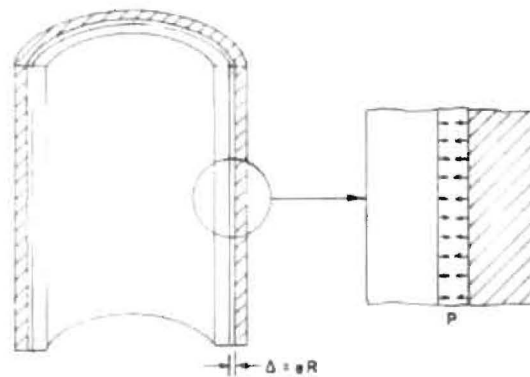
Concrete may expand instead of contract during a cooling period. This is possible because of ice formation in the concrete. During the blizzard, as shown in Fig. 2, the temperature in outer layer of the cylindrical wall is lower than that of inner layer. So, the ice may form in the concrete of outer layer of the wall resulting in an expansion, while the inner layer of the wall has contraction. This special outer-expansion-and-inner-contraction deformation pattern may generate a tensile stress in the radial direction of the wall. Delamination cracking may occur in the case of high radial tensile strength. This failure mode was used to analyze the damage of concrete walls of more than 50 water tanks in Ontario, Canada (Grieve et al. 1987).

Fig. 2 Expansion of outer layer and contraction of inner layer of a concrete wall generate tensile stress in the radial direction (Grieve et al. 1987)

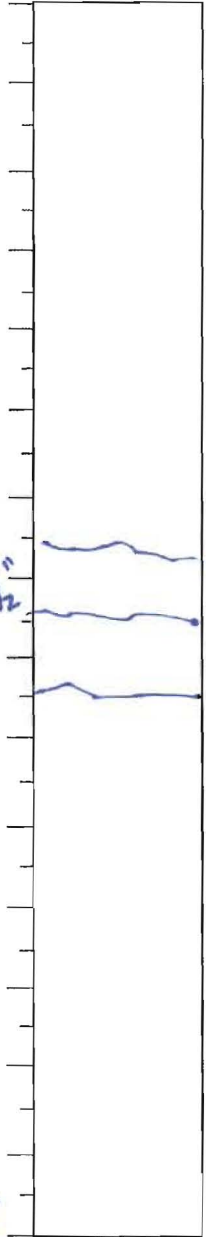
← LIKELY EXISTING CRACK LOCATIONS  
VERIFIED WITH BORESCOPE
