FUKUSHIMA DAI-ICHI INITIATING EVENT SIGNIFICANCE

FUKUSHIMA DAI-ICHI FLOODING DAMAGE

FUKUSHIMA DAI-ICHI HYDROGEN GENERATION

FUKUSHIMA DAI-ICHI RADIOLOGICAL RELEASE

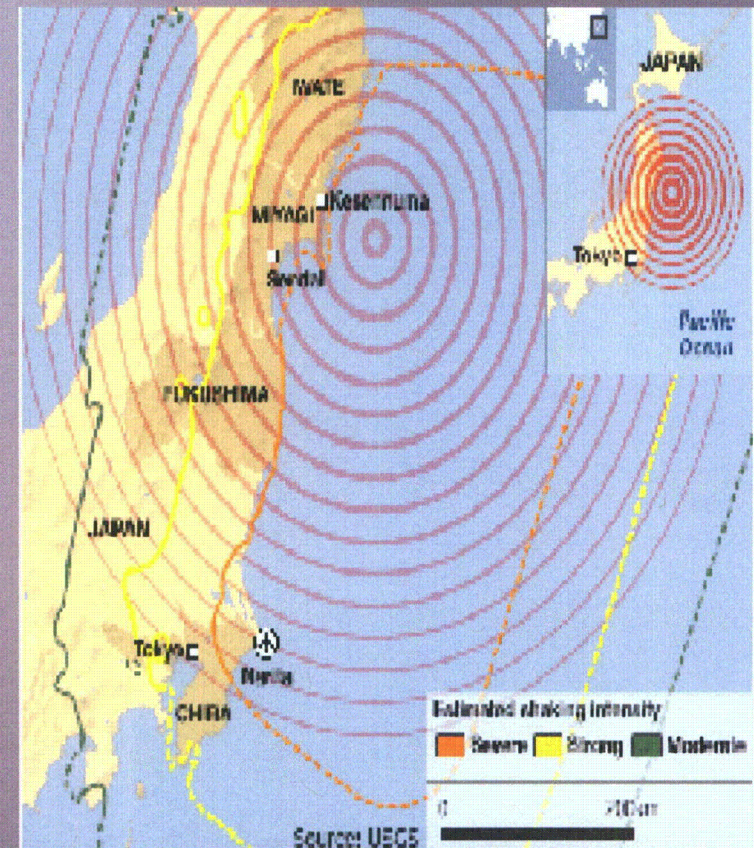
PLANT RESPONSE

- Automatic shutdown
- Loss of offsite power
- Emergency diesel generators powered safety busses
- Plant conditions stabilized and were controlled

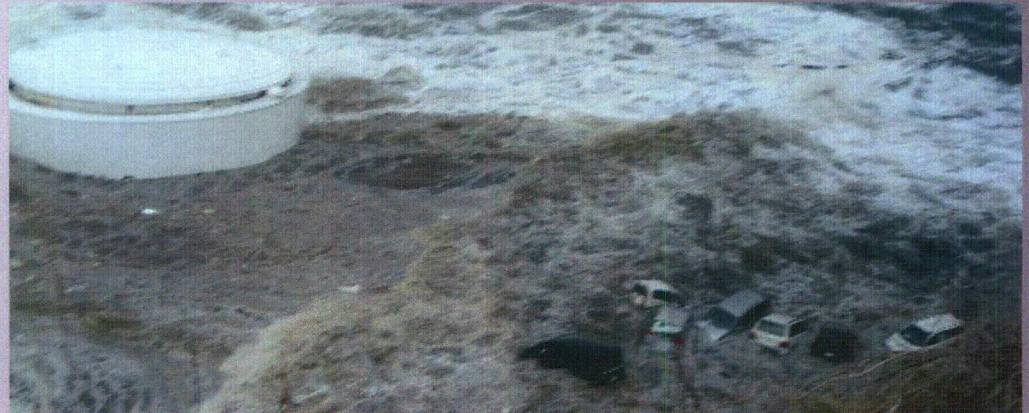
PLANT RESPONSE

- Station blackout
- Unit 1: Isolation condenser accommodating decay heat without shell makeup capability
- Units 2-3: RCIC accommodating vessel makeup and SRV's accommodating decay heat without suppression pool cooling
- Unit 4: Loss of spent fuel pool cooling
- Upon loss of RCIC/IC, the SRV's cycled on high pressure
- Suppression Pool reaches saturation temperature resulting in containment pressurization

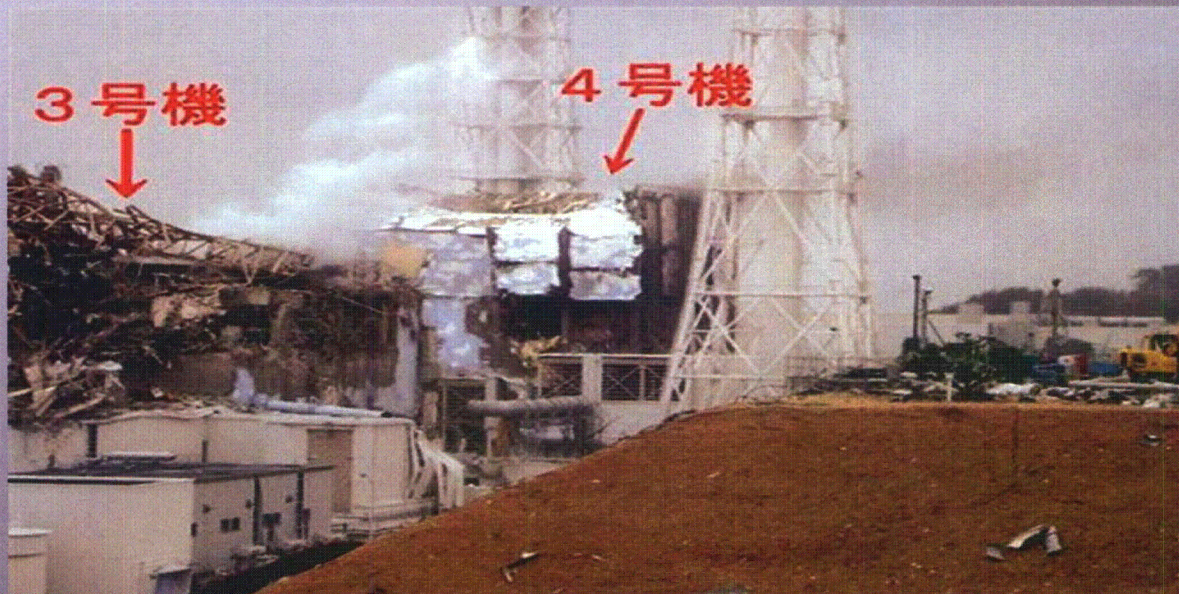
UNIT 3

FUKUSHIMA DAI-ICHI HYDROGEN EXPLOSIONS

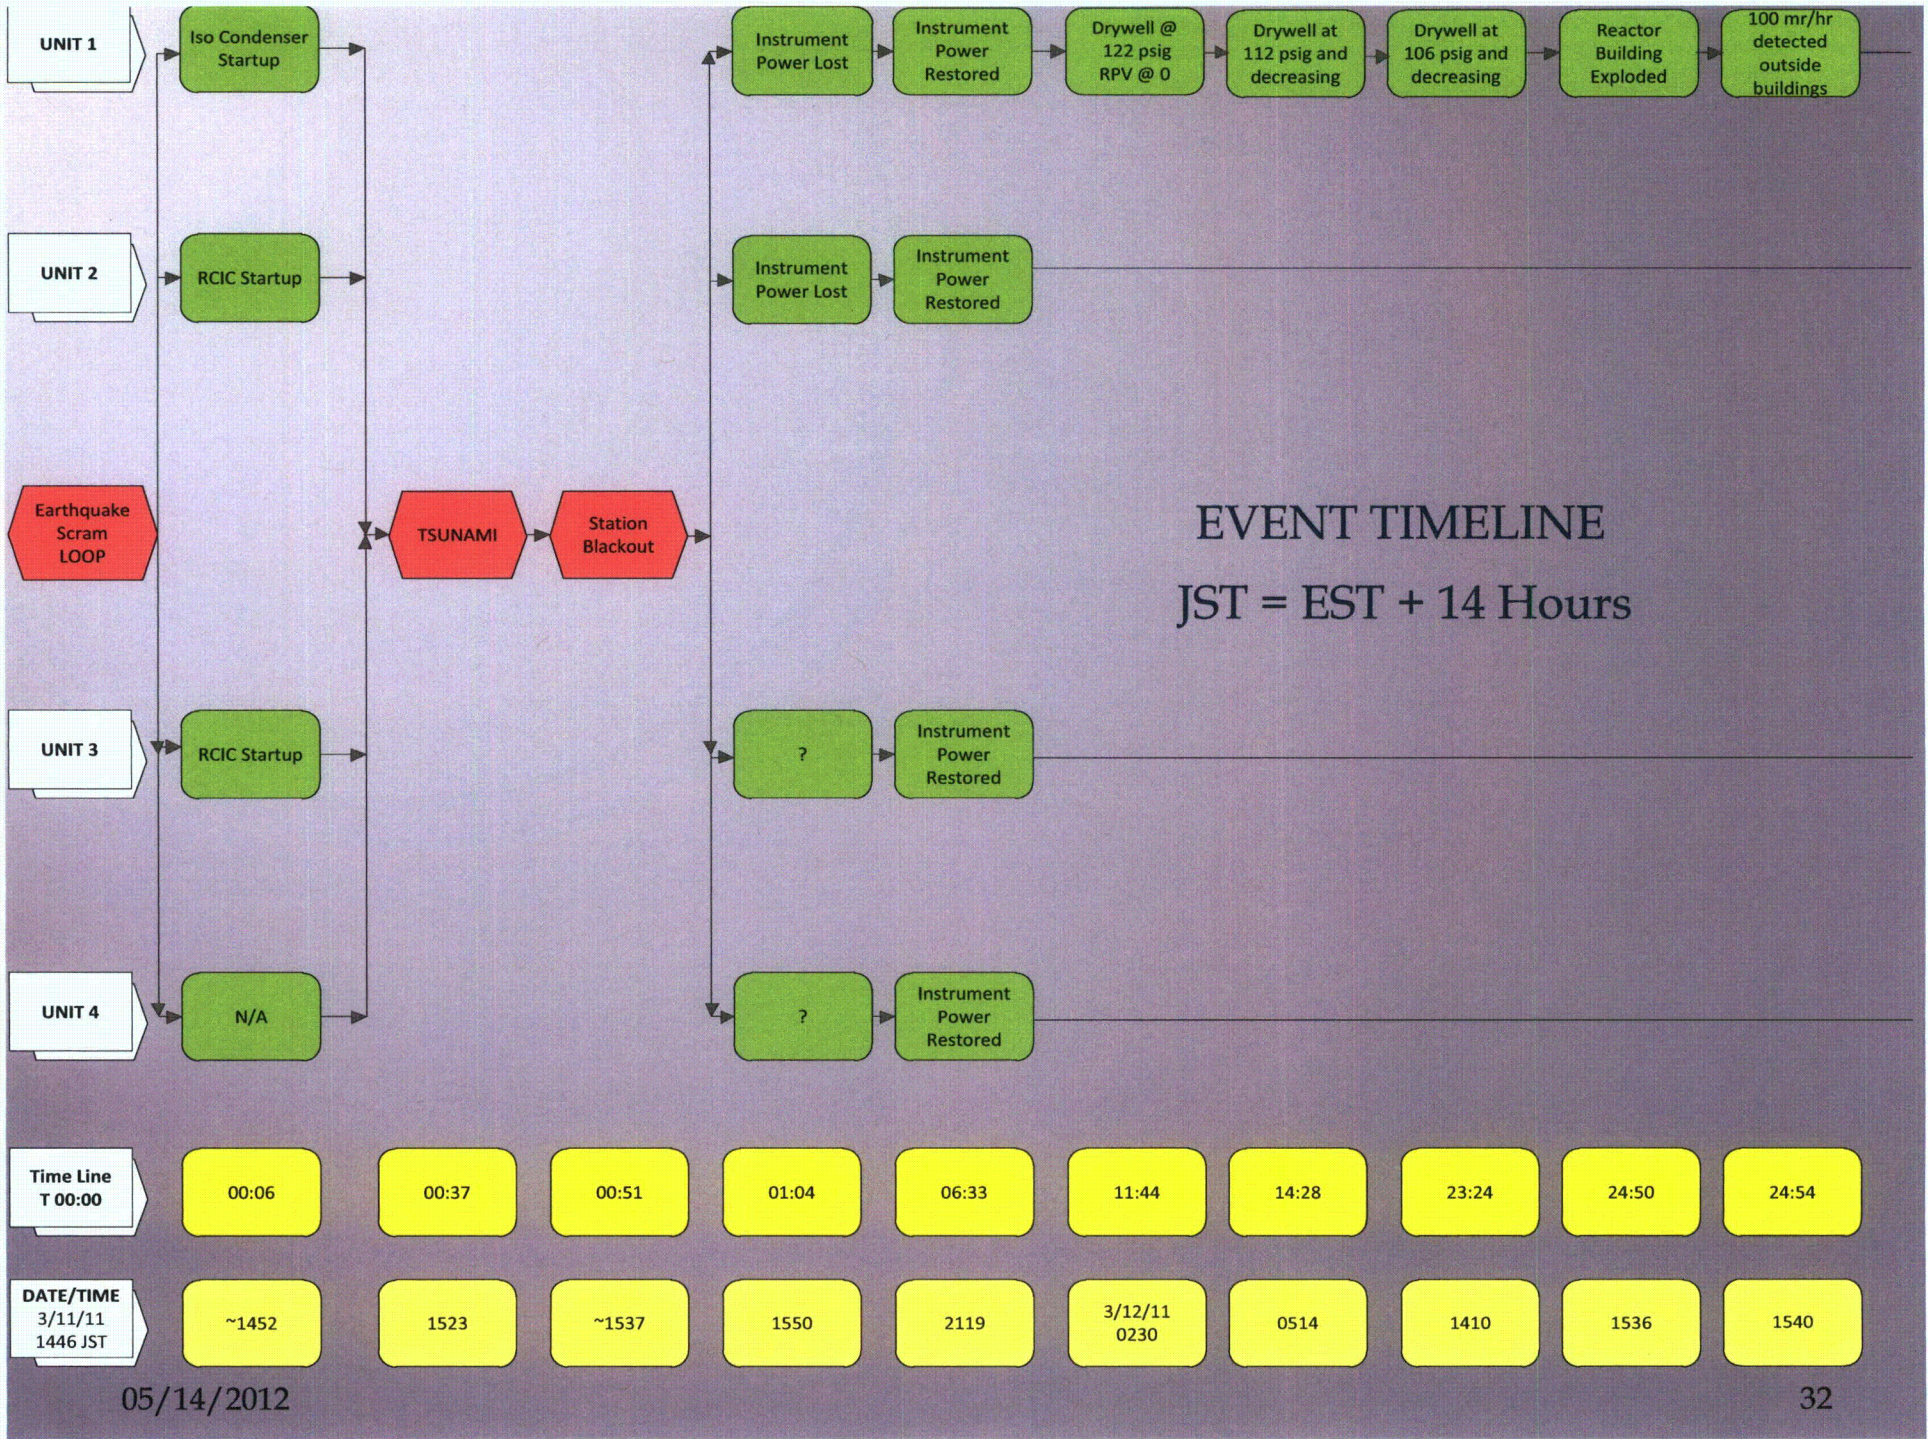
- SRV operation vents RPV internals to Suppression Pool
- Hydrogen accumulates in Suppression Chamber
- Hydrogen vents to Drywell atmosphere
- Containment failure or intentional venting passes hydrogen to the Reactor Building atmosphere
- 4-78% hydrogen in air is flammable/explosive

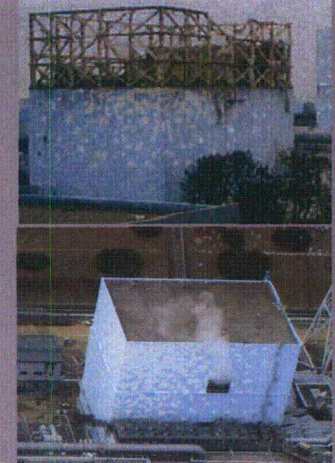
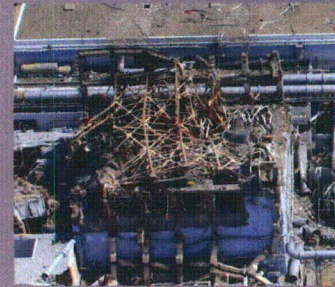
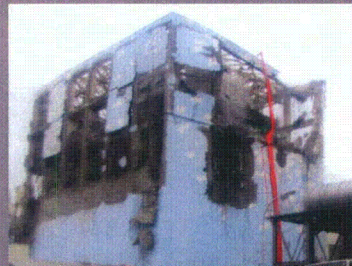
100 R/hr debris outside Unit 3 Reactor Building

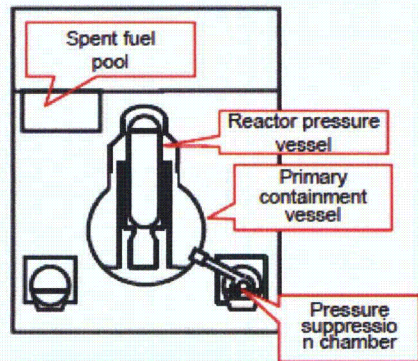
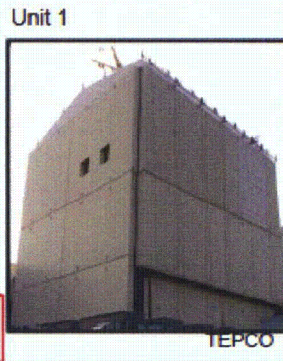
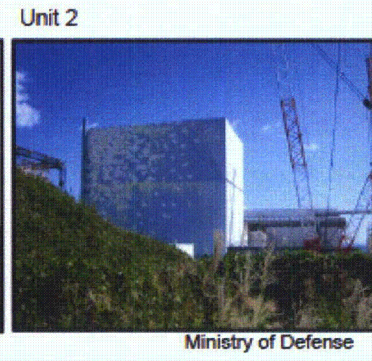
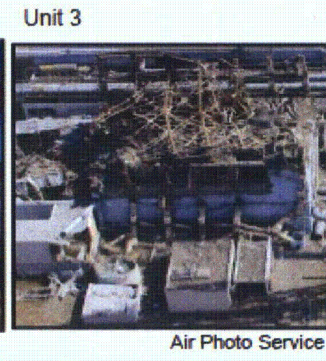
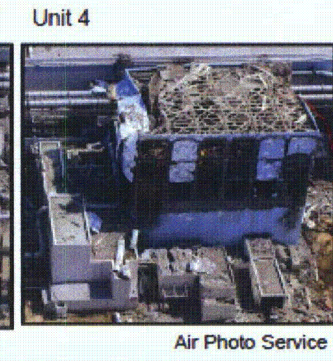
Current Status of Fukushima Dai-ichi NPP

Reactor Pressure vessel Temperature at reactor vessel bottom*	Circulating water injection cooling 24.3°C	Circulating water injection cooling 47.1°C	Circulating water injection cooling 51.4°C	No fuel
Primary Containment vessel Temperature of air in PCV*	Nitrogen injection 25.4°C	Nitrogen injection 54.3°C	Nitrogen injection 44.4°C	—
Fuel pool Temperature of pool water*	Circulation cooling 26.5°C	Circulation cooling 14.2°C	Circulation cooling 14.4°C	Circulation cooling 26°C
Highly-contaminated water in R/B and T/B**	14,100 m ³	22,000m ³	23,800 m ³	18,300 m ³

Effectively Cold Shutdown (100° C = 212° F)
