Assessment of NDE Methods on Inspection of HDPE Butt Fusion Piping Joints for Lack of Fusion

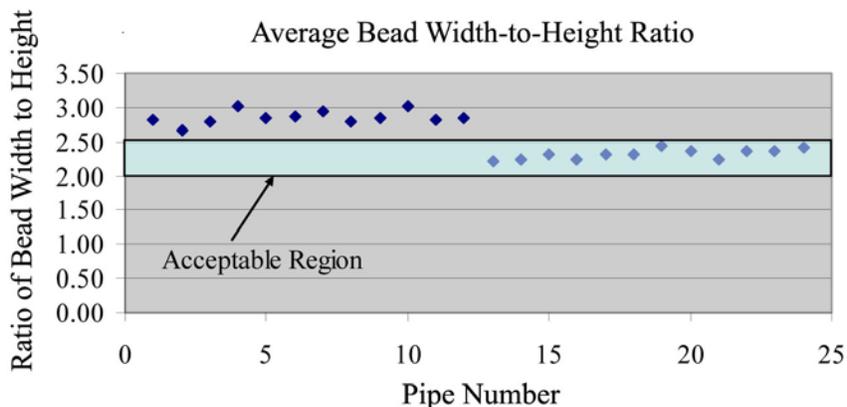
similar in all pipe joints. The average bead width-to-height ratio, which should be in the 2 to 2½ range, was also calculated. Figure 3.3 shows the results for this calculation for each of the 24 pipes. The single plotted value for each pipe joint represents an average of the eight measurements taken circumstantially around the pipe at approximately 45-degree increments. Joints fused with fusion pressure during the heat cycle, conditions 1-3, were out of bounds in the width-to-height ratio and the beads were smaller in these joints as already mentioned. With fusion pressure during the heat cycle, the weld bead width was approximately 15 percent smaller and the bead height was 32 percent smaller than a bead with a normal heat cycle.

Figure 3.3 Bead Width-to-Height Ratio Comparison for the 24 Fused Pipes

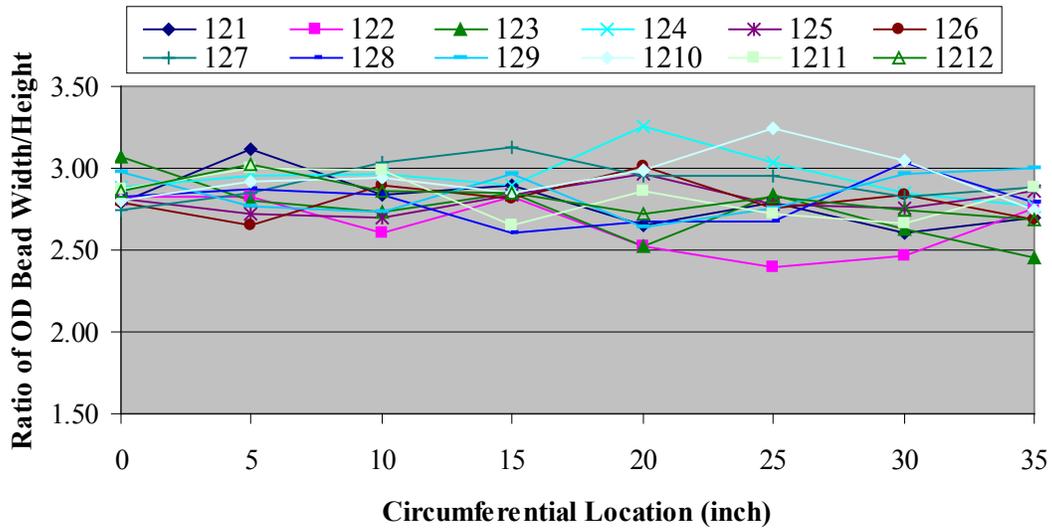
but three data points lie above the 2.5 bead width-to-height ratio line. This criterion would reject all but these three positions, if the VT method was used as one of the inspection techniques. The points that fall in the acceptable range are from pipe 122, two points, and pipe 123. Figure 3.5 represents pipes 1213–1224, which were not fused with fusion pressure applied during the heat cycle. Furthermore the last four pipe joints, 1221–1224, represent joints fused with the acceptable F2620 procedure. All of the data presented are above the 2.0 ratio line; however, pipes 1219 and 1222 each have a point above the acceptable 2.5 bead width-to-height ratio.

Figure 3.4 Pipes 121–1212: Fusion Pressure During the Heat Cycle

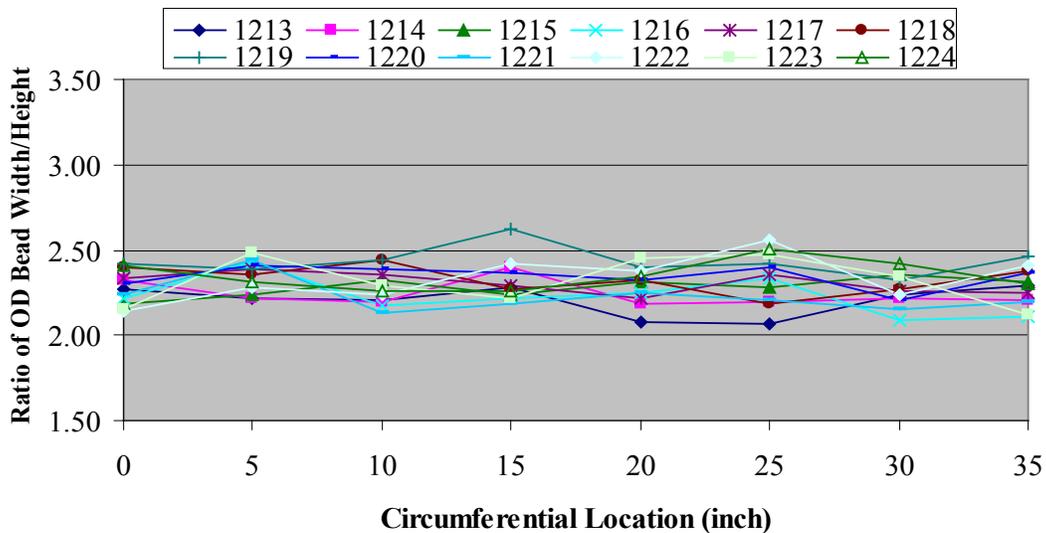
Figure 3.5 Pipes 1213–1224: No Fusion Pressure During the Heat Cycle

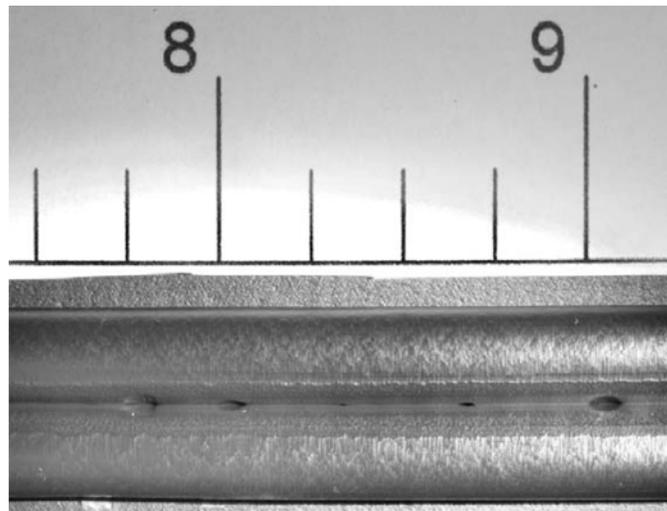
The weld bead fusion zone from the OD of each pipe was visually inspected and areas with anomalies were photographed. Typical anomalies were voids or dimples in the v-groove between the weld beads as shown in Figure 3.6. In general, there was little or no correlation between the VT results and the ultrasonic TOFD data from the Fluor/NDT Innovations, Inc. workshop, which is discussed later. As an example, one pipe contained many TOFD indications with 70 percent of the pipe fusion zone showing flaw signals. From the VT results, only four small defective areas were noted in the fusion joint from an OD inspection.

Figure 3.6 Fusion Zone Anomalies. The scale is in inches (1 in. = 2.54 cm).

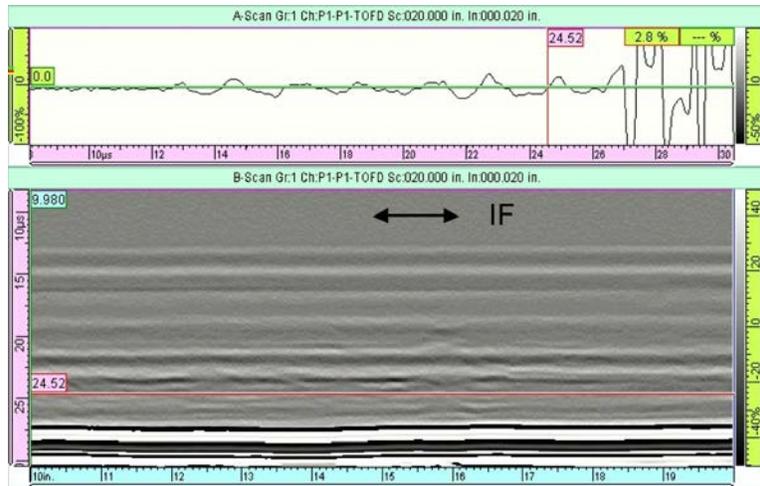
In general, the technique appeared to detect acoustical anomalies in many of the pipes. Figure 3.11 shows an area that was identified as having incomplete fusion. Figure 3.12 shows an area called flawed in one of the good pipes, fusion condition 6. Images of all the data are shown in Appendix B. These calls, as noted on the images, were made by NDT Innovations personnel during their two-day inspection of all 24 joints. Some of the calls are obvious, as in Figure 3.10, and others are less obvious, as in Figure 3.11. It should be noted that the original data was of high resolution and contrast, which unfortunately, is somewhat reduced in the figures of this report.

Figure 3.11 Area Identified as Incomplete Fusion

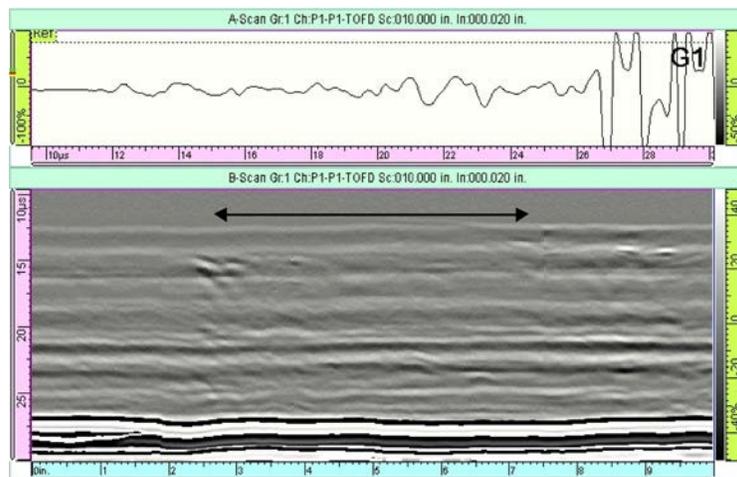
Figure 3.12 Possible Flaw Indications in One of the “Good” Pipes

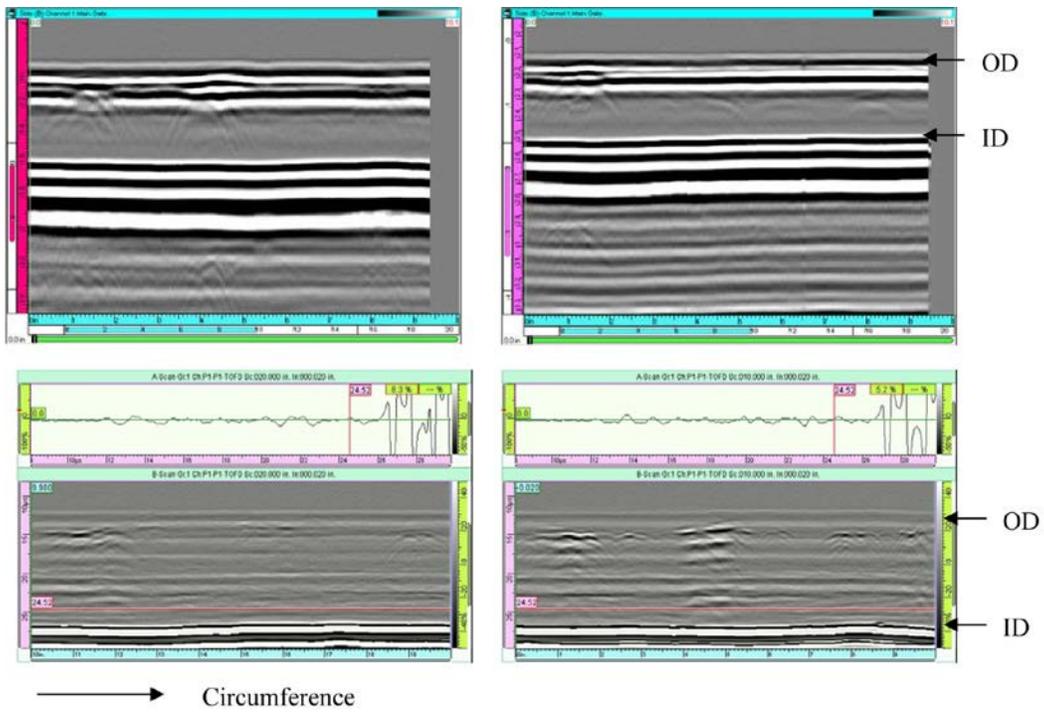
The worst-case condition for pipe fusion, out of the McElroy batch of 24 test assemblies, and the one most likely to produce LOF, was condition 2, with fusion pressure during the heat cycle and a 20-second open/close time. One of these pipes was examined with TOFD by PNNL showing results comparable to those presented by Fluor/NDT Innovations, Inc. The data are shown in Figure 3.15 and Figure 3.16 for the four pipe quadrants, with the PNNL data shown in the top of each figure and the Fluor/NDT Innovations, Inc. data at the bottom of each figure. Notice that the PNNL data show the mode-converted signals beyond the longitudinal-wave back wall (ID) echo. The time window was extended to include the slower mode-converted signals with the thought that this additional data would enhance the detection of defects. The Fluor/NDT Innovations, Inc. data images are cropped at the ID and additionally do not have the saturated OD lateral wave signal seen in most TOFD images and in the PNNL data. This set-up results in a cleaner looking image and should provide better near-surface sensitivity to flaws. Fluor/NDT Innovations, Inc. data is also much more sensitive, due most likely to their patented processing of the raw data. Regardless, in this data comparison, flaw indications are identified at similar locations by both PNNL and Fluor/NDT Innovations, Inc. Each quadrant represents approximately 10 in. (25.4 cm) of pipe circumference.

Figure 3.15 TOFD Data Acquired on Pipe 125, First and Second Quadrants (left and right), by PNNL in the Top and by Fluor/NDT Innovations, Inc. in the Bottom

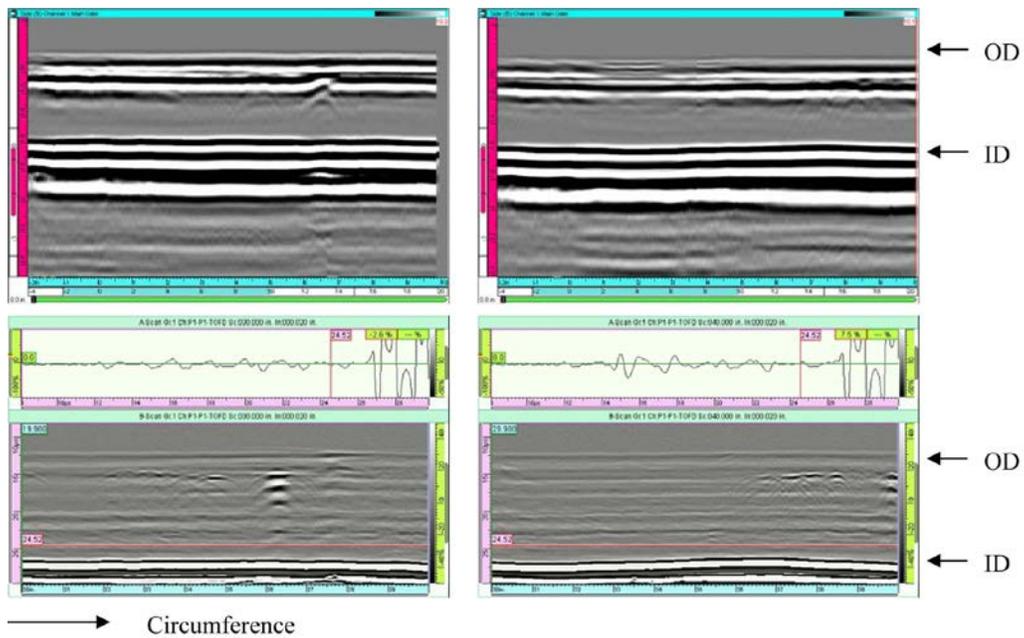
Figure 3.16 TOFD Data Acquired on Pipe 125, Third and Fourth Quadrants (left and right), by PNNL in the Top and by Fluor/NDT Innovations, Inc. in the Bottom

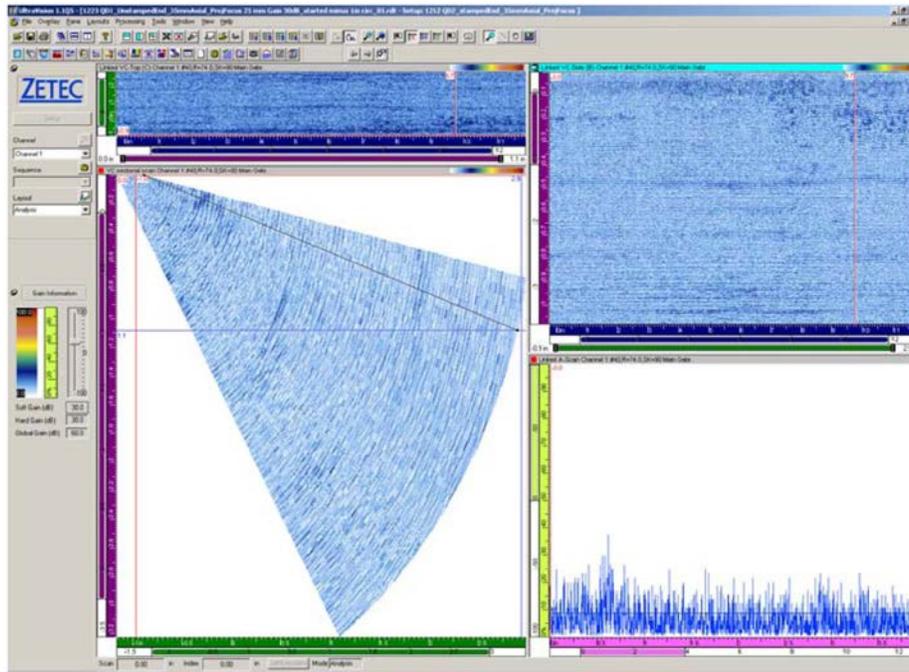
Figure 3.24 Pipe Joint 1223 Quadrant 1 from the Unstamped Side Showing No Flaw Indications in the Sample Made Using the Optimal Fabrication Procedure

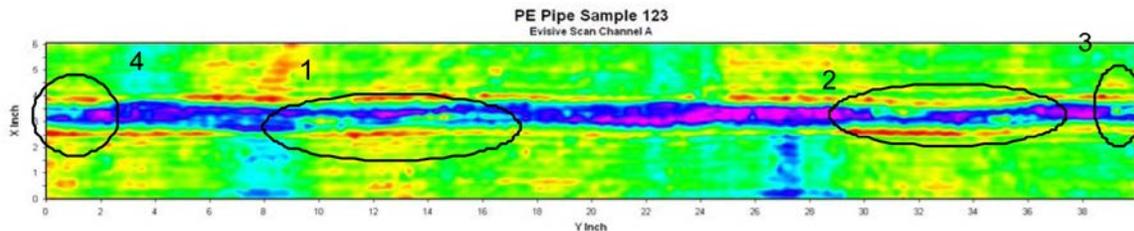
Figure 3.27 Microwave Results for Pipe Joint 123 Showing Possible LOF in Areas 1 and 2 with an Inclusion at 15 in. (38.1 cm). Areas 3 and 4 show a disruption in the center of the weld bead.

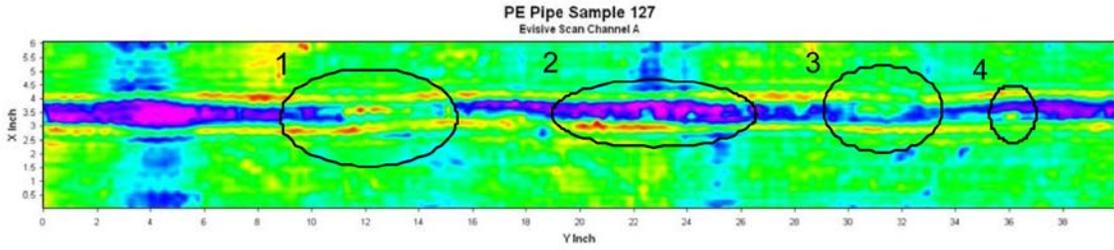
Figure 3.28 Microwave Results for Pipe Joint 127 Showing LOF in Area 1, Pinholes at 15, 21, 22.5, and 24.2 in. (38.1, 53.3, 57.2, and 61.5 cm), and a Possible Inclusion at 12 in. (30.5 cm) and Area 4. Area 3 shows weld zone disruption.

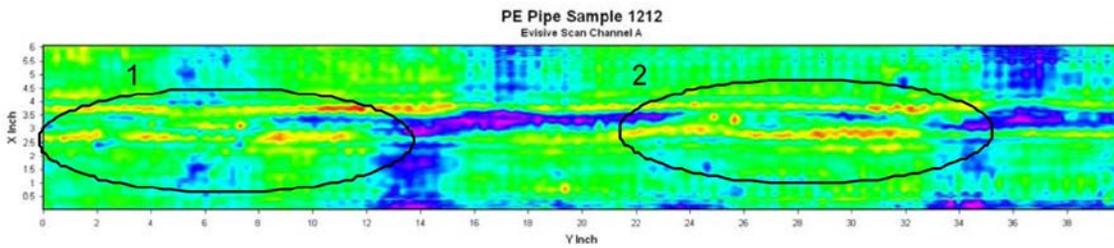
Figure 3.29 Microwave Results for Pipe Joint 1212 Showing Large Areas with LOF

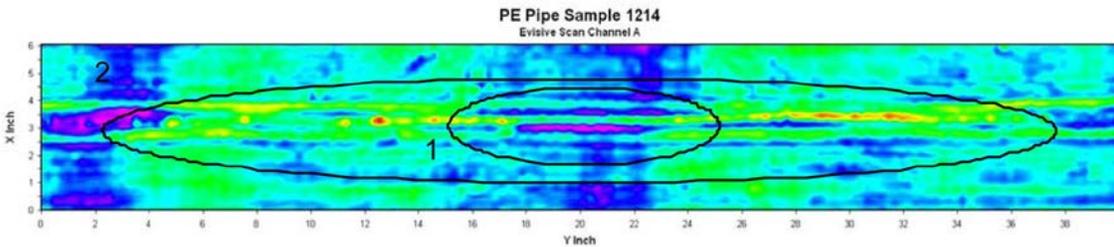
Figure 3.30 Microwave Results for Pipe Joint 1214 Showing Cold Fusion in Area 1 and LOF in Area 2. Possible inclusions at 7.5, 11.5, and 12.5 in. (19.1, 29.2, and 31.8 cm).

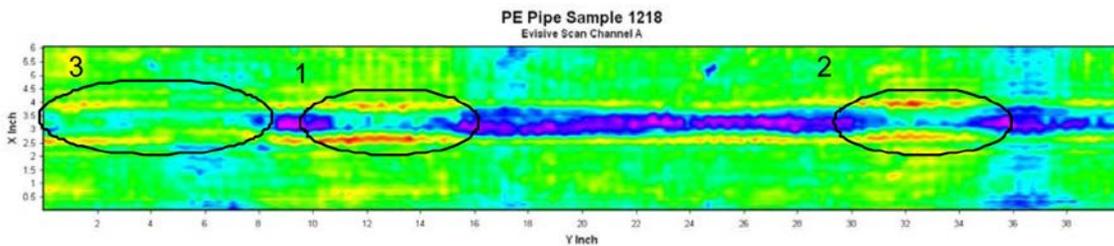
Figure 3.31 Microwave Results for Pipe Joint 1218 Showing LOF or Cold Fusion in Area 1 and 2 with General LOF in Area 3

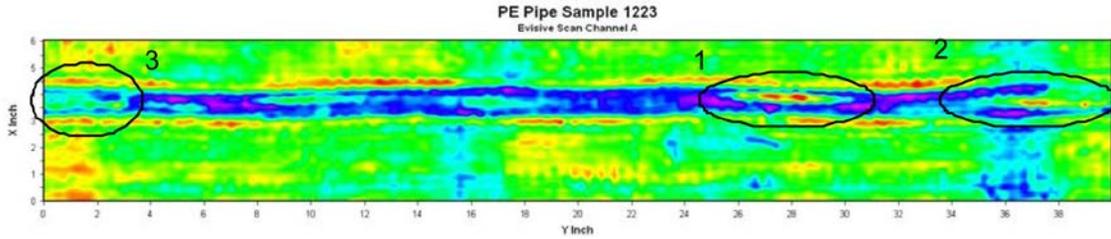
Figure 3.32 Microwave Results for Pipe Joint 1223 Showing Cold Fusion. Other problem areas are at 10 and 17 in. (25.4 and 43.2 cm).

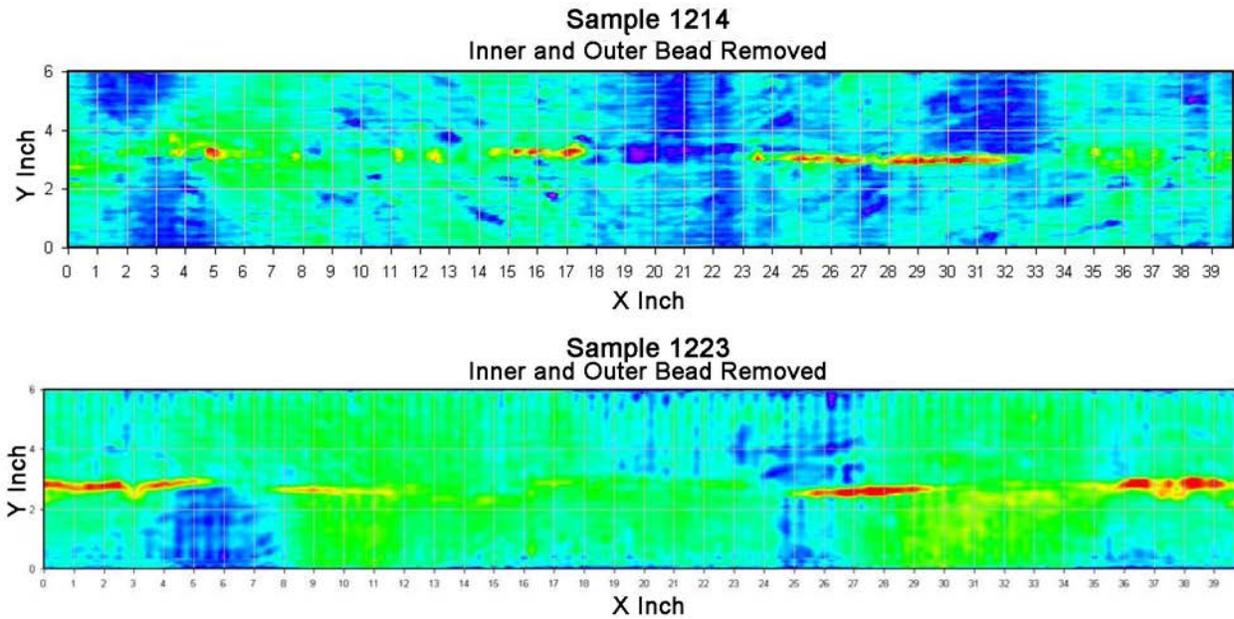
After discussing the initial results with Evisive, it was agreed to remove the inner weld bead from two pipes and rescan the joints. The images with both inner and outer bead removed from pipe 1214 and 1223 are displayed in Figure 3.33. Mr. Stakenborghs stated that the defective areas appear the same in both scans with and without the ID bead.

Figure 3.33 Evisive Microwave Results on Two Pipe Joints After ID Beam Removal

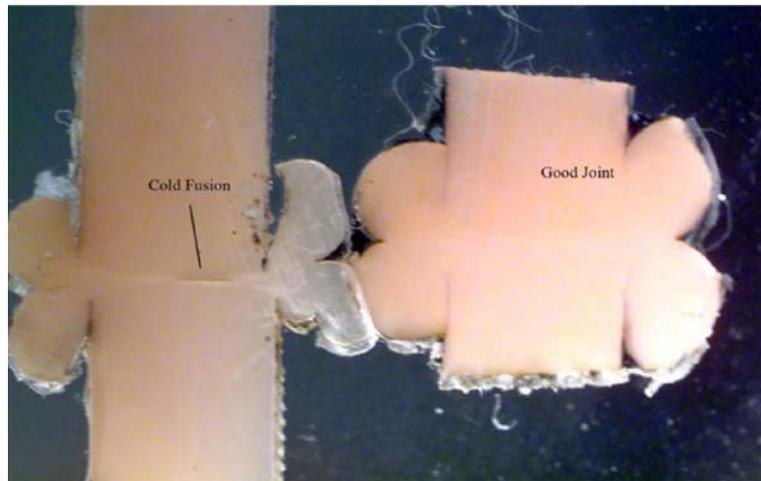
Figure 4.1 Cold Fusion and Good Joint in PE Material. Photo courtesy of Frank Schaaf.

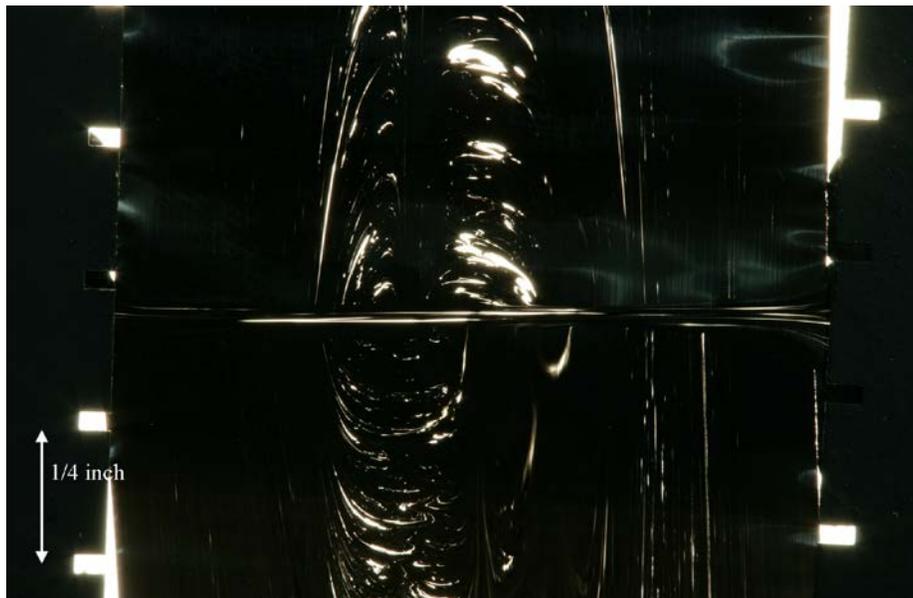
For comparison, a piece of a reportedly good fusion joint was also evaluated. TOFD and PA ultrasonic examinations showed no indications in quadrant 4 of pipe 1224 at 3 to 4 in. (7.6–10.2 cm). This area was cut out and sectioned. Figure 4.7 shows a slice from this fusion joint at approximately 3.4 in. (8.6 cm). As in pipe 125, streaks of light material due to uneven mixing with the dark carbon black pipe material are evident and make a lack-of-fusion detection from the slice difficult or impossible. The pipe surface after slicing appears to be a better indicator of the fusion joint condition. Figure 4.8 shows the cut surface with no evidence of LOF in the fusion zone. Figure 4.9 shows the ultrasonic results with no flaw indications in the area that was sliced.

Figure 4.7 Slice from HDPE Pipe 1224, Quadrant 4 at Approximately 3.4 Inches (8.6 cm)

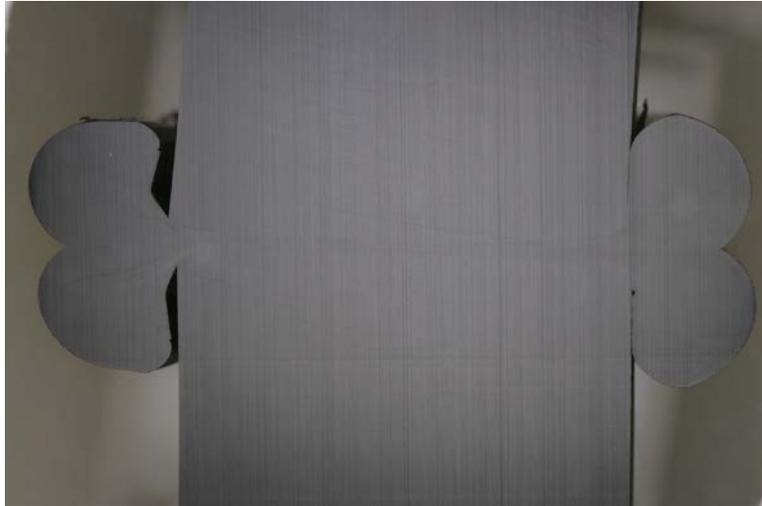
Figure 4.8 Surface of HDPE Pipe 1224, Quadrant 4 at Approximately 3.4 Inches (8.6 cm). No lack of fusion is seen.

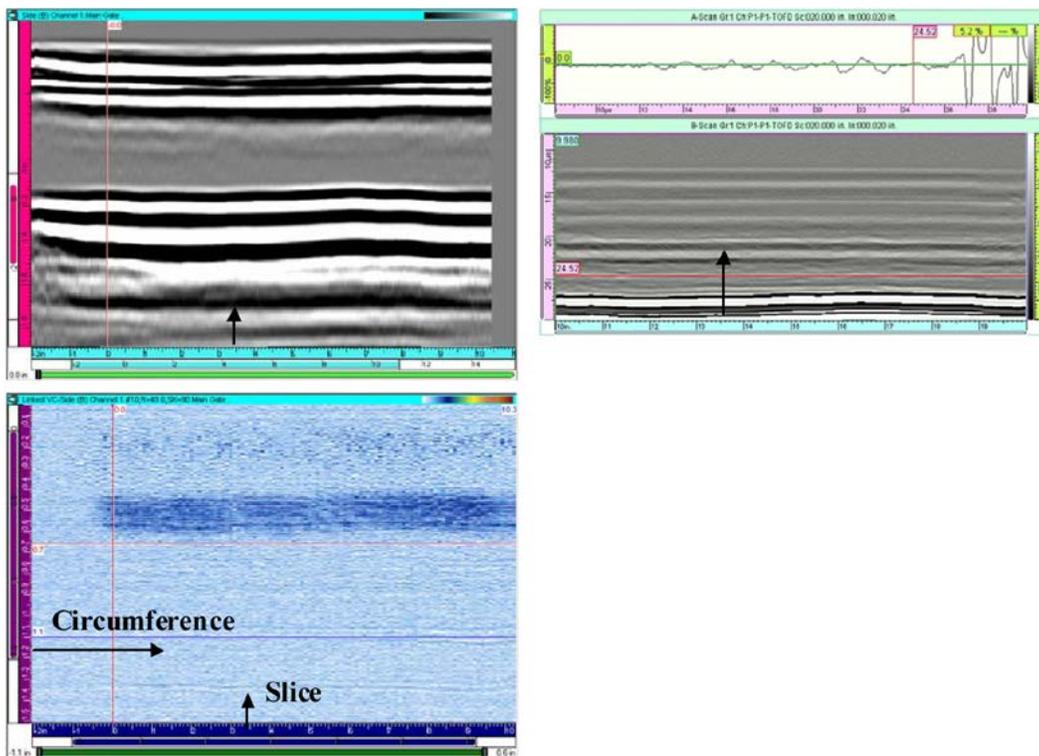
Figure 4.9 Ultrasonic Responses from Quadrant 4 of Pipe 1224 Show No Flaw Indications. The PNNL TOFD data is in the upper left, Fluor TOFD data in the upper right, and PNNL PA data in the lower left. The vertical arrows show the approximate location of the slice of material at 3.4 inch (8.6 cm), see Figure 4.8.

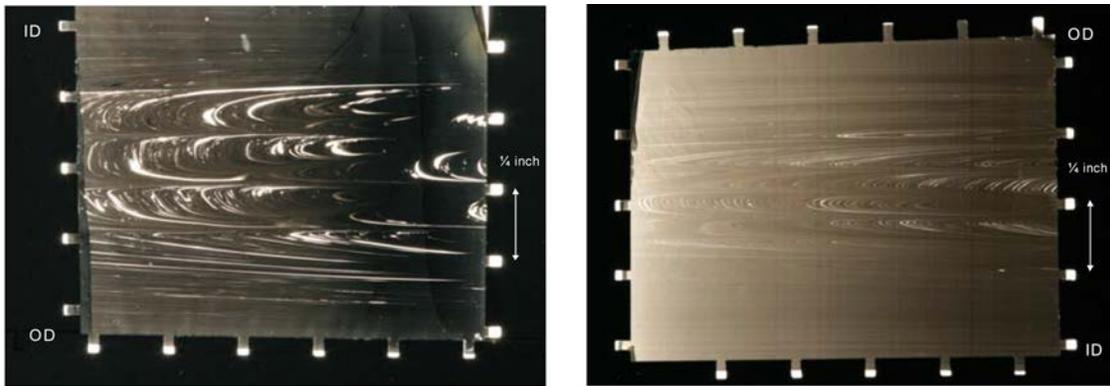
A preliminary evaluation of base material showed no ultrasonic indications in one 3408 pipe and one 4710 pipe. Slices from the 3408 and 4710 base material are shown in Figure 4.10, left and right, respectively. The spacing between fiducial notch marks on the edge of each image is 0.25 in. (0.64 cm). It is obvious that the 3408 material is less uniformly mixed, with the 4710 material showing some lack of uniformity, but to a lesser extent. However, even with this reduced amount of swirling, it would likely remain difficult to detect LOF when examining a thin slice of material removed through a 4710 fusion joint. No porosity was found in the few slices that were collected through base material. In fact, only one or two areas were found with a single pin hole or porosity in or near a fusion joint in the numerous fusion joint slices evaluated. This would represent an approximate 1 percent or less rate of porosity detected in this material.

Figure 4.10 Base Material Slices from 3408 on the Left and 4710 on the Right Show Swirls from Non-uniform Mixing. The spacing between edge notches is 0.25 in. (0.64 cm).

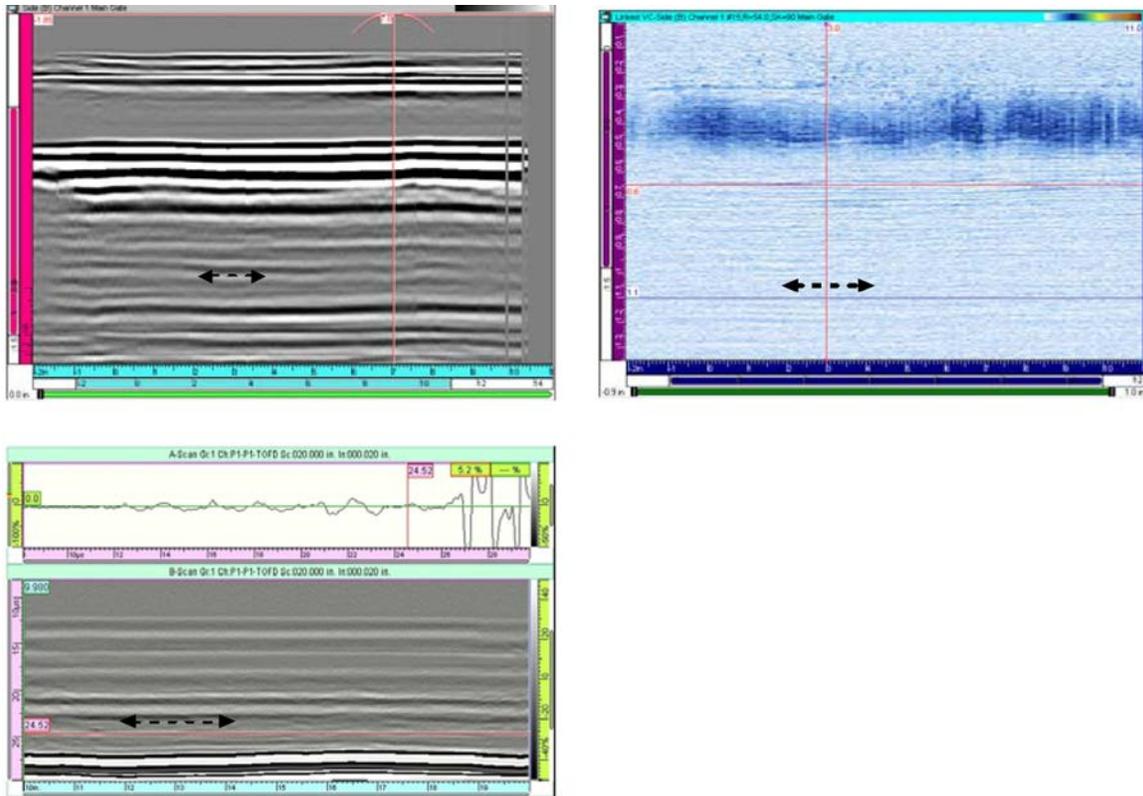
One area from pipe 1224, fused as a good pipe, was also selected and is shown in Figure 4.13. In addition to these five joint specimens, the base material was also tested. These tests were performed in April 2008.

Figure 4.13 Area Marked for Tensile Testing as Shown by the Lower Arrows in the NDE Images for Pipe 1224, Quadrant 2. This was fused as a “good” joint. Results are for PNNL TOFD, upper left, PNNL PA, upper right, and for Fluor TOFD, lower left.

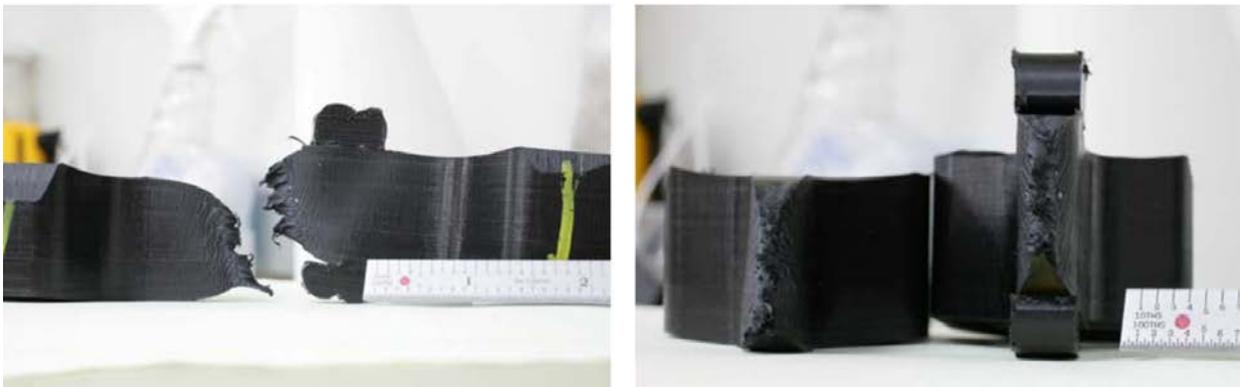
Figure 4.14 Coupon 1 from Pipe 1215 Quadrant 4 with a Long Open/Close Time of 20 sec Showing a Ductile Failure Outside of the Joint. Both PNNL and Fluor called this area good.

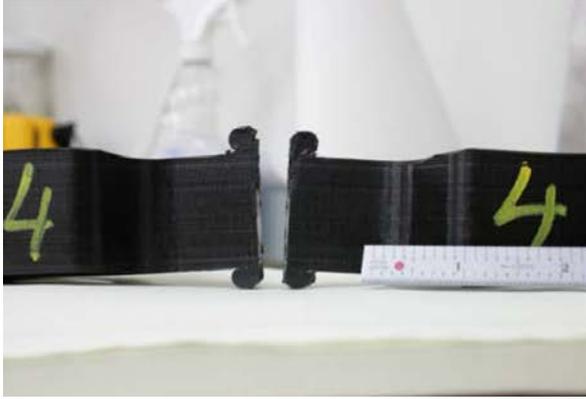
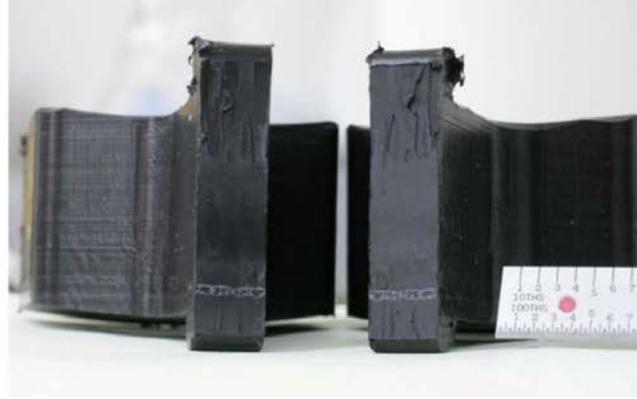
Figure 4.17 Coupon 4 from Pipe 126 Quadrant 4, Fused with Fusion Pressure During the Heat Cycle and a 20-sec Open/Close Time. The failure mode is brittle but shows some tearing at the top (ID) in the right figure. PNNL called this area good and the Fluor call was on the edge of a good-to-bad region.

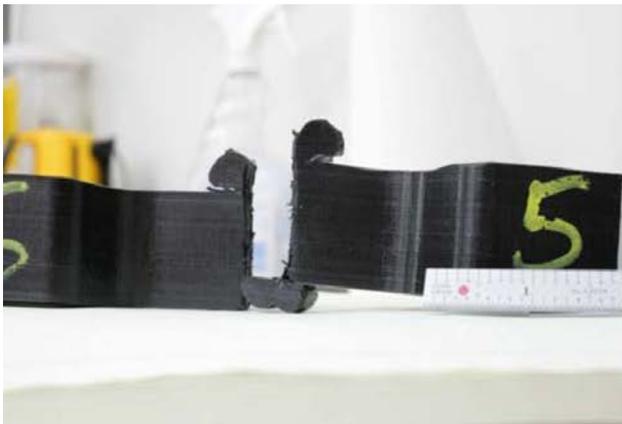
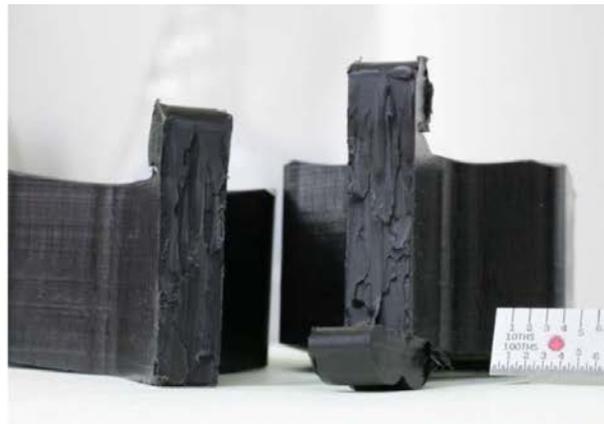
Coupon 5 in Figure 4.18 failed at the joint in the brittle mode but showed some signs of tearing. This coupon 5 sample was removed from pipe 1224, which was fused to be a “good” joint. Lastly, Figure 4.19 shows one of the base material coupons with necking and failure in the ductile (good) mode.

Figure 4.18 Coupon 5 from Pipe 1224 Quadrant 2, Fused with Procedure F2620 and Expected to be Good. The failure mode was brittle at the joint but shows some ductility. Both PNNL and Fluor called this area good.

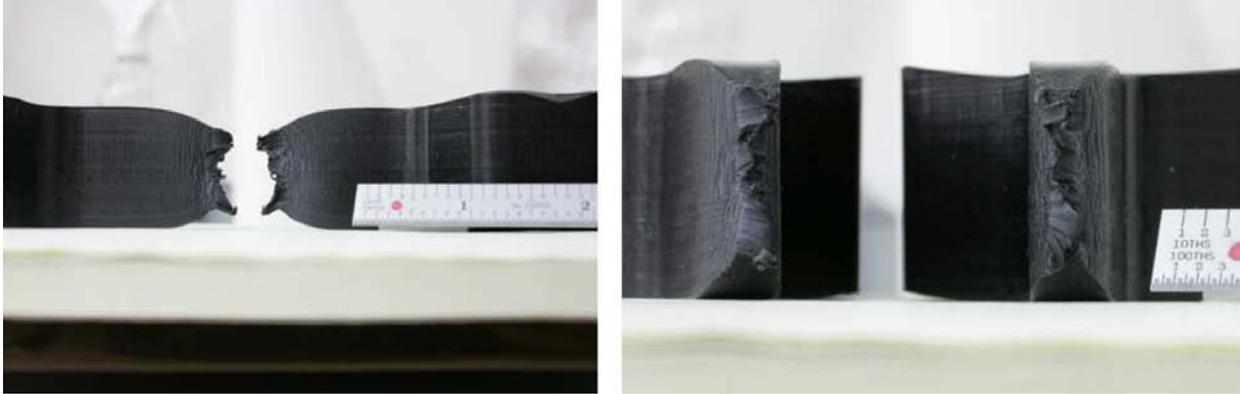
Figure 4.19 Coupon 6 Base Material Shows a Ductile Failure

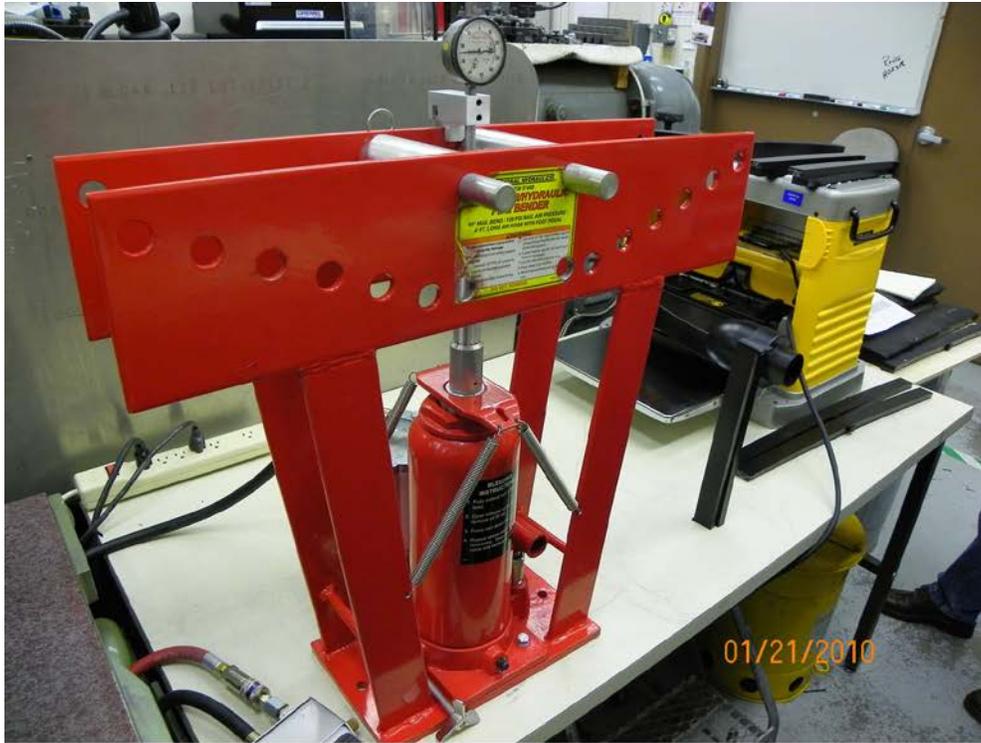
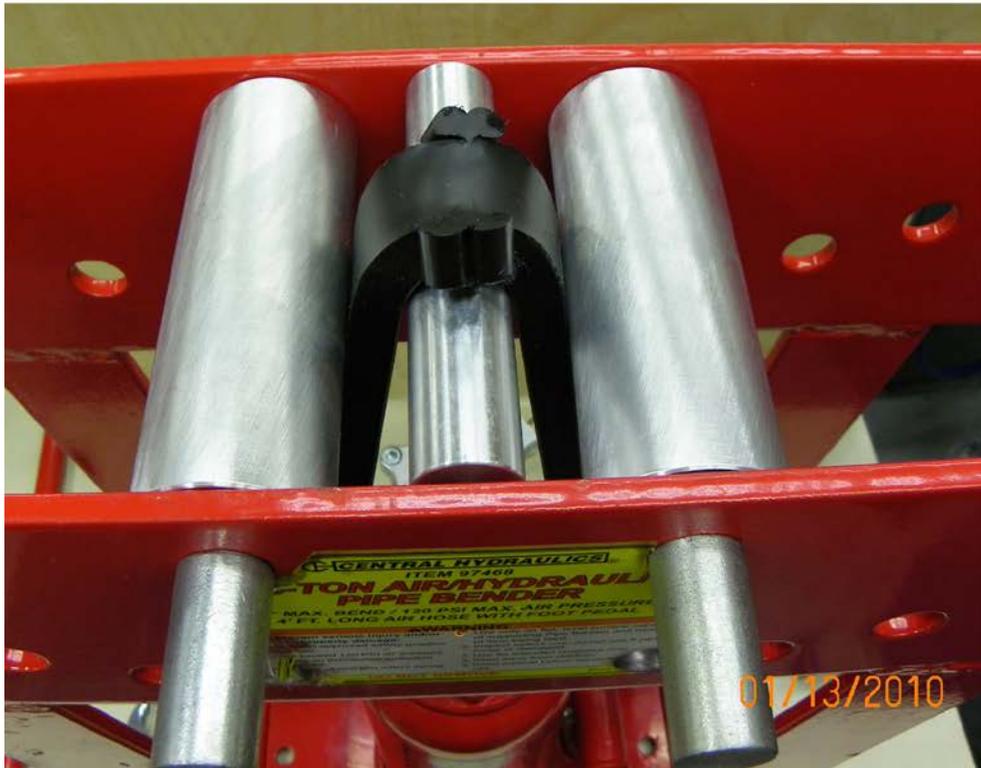
Figure 4.21 Side-Bend Test Apparatus (top) with an HDPE Test Specimen from Pipe 1224 Undergoing Testing (bottom) – Example of a Dark Green SBT Result

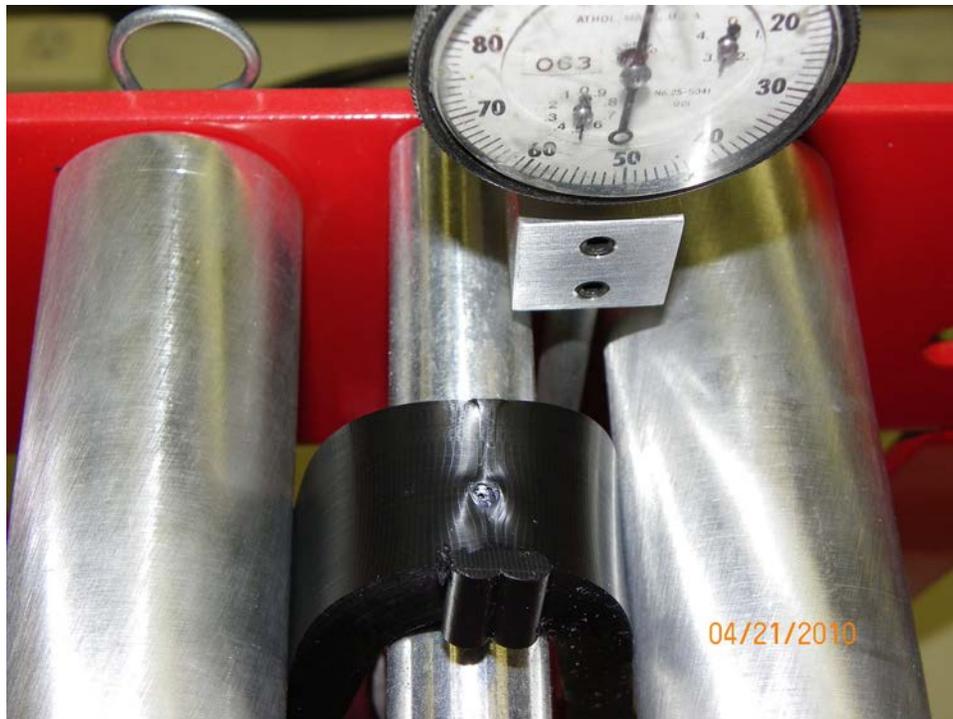
Figure 4.22 Another HDPE Specimen Undergoing Side-Bend Testing Showing the Dial Indicator Used to Track Travel of the Ram Which, in This Case, is Showing the Maximum Travel of 2.5 Inches (63.5 mm) as Shown by the Upper Right and Lower Left Dials. This is an example of a light green SBT result.

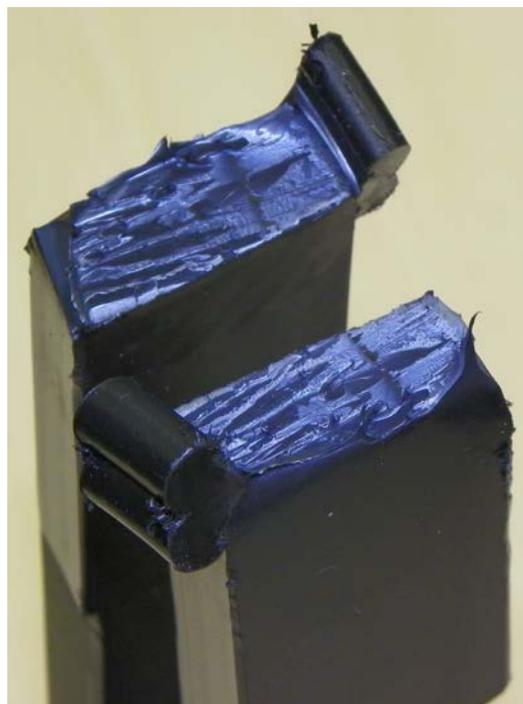
Figure 4.24 The Specimen from Pipe 126 at the End of the SBT – Example of a Red SBT Result

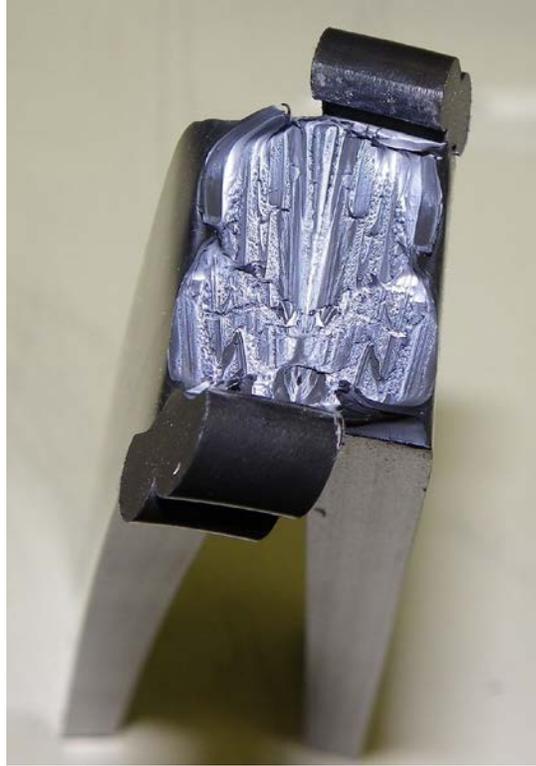
Figure 4.25 Sample from Pipe 1224 Failed the SBT and Was Removed Adjacent to the Specimen Shown in Figure 4.21, Which Did Not Fail – Example of a Red SBT Result

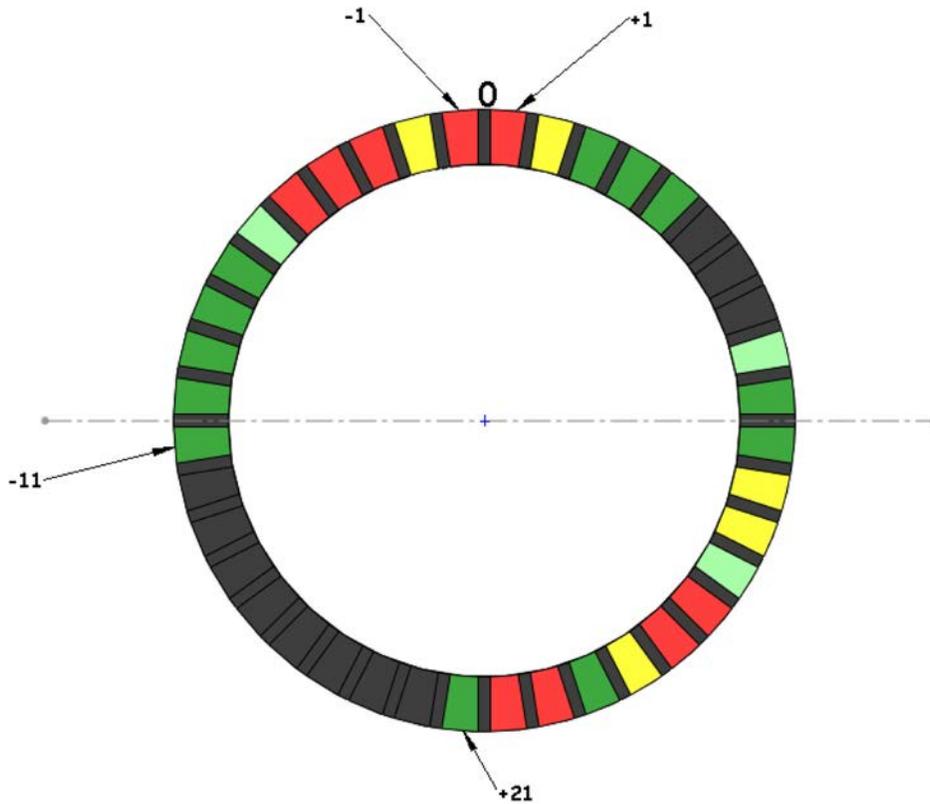
Figure 4.27 SBT Results for Pipe 1224

This color scheme was then applied to the results of each of the SBT specimens. Figure 4.27 shows the SBT results for pipe 1224. The blank zone located at the 2 o'clock (2:00) position was an area that had been removed in order to conduct some slicing of the fusion joint to assess its integrity; this process was described in Section 4.1. For this region, the slicing did not reveal any flaws and could be colored green. The area from about 6:30 to 9:00 was a piece cut out and subjected to the high-speed tensile testing that was described in Section 4.2. In this region, the high-speed tensile test produced a brittle failure and this region could be colored red.

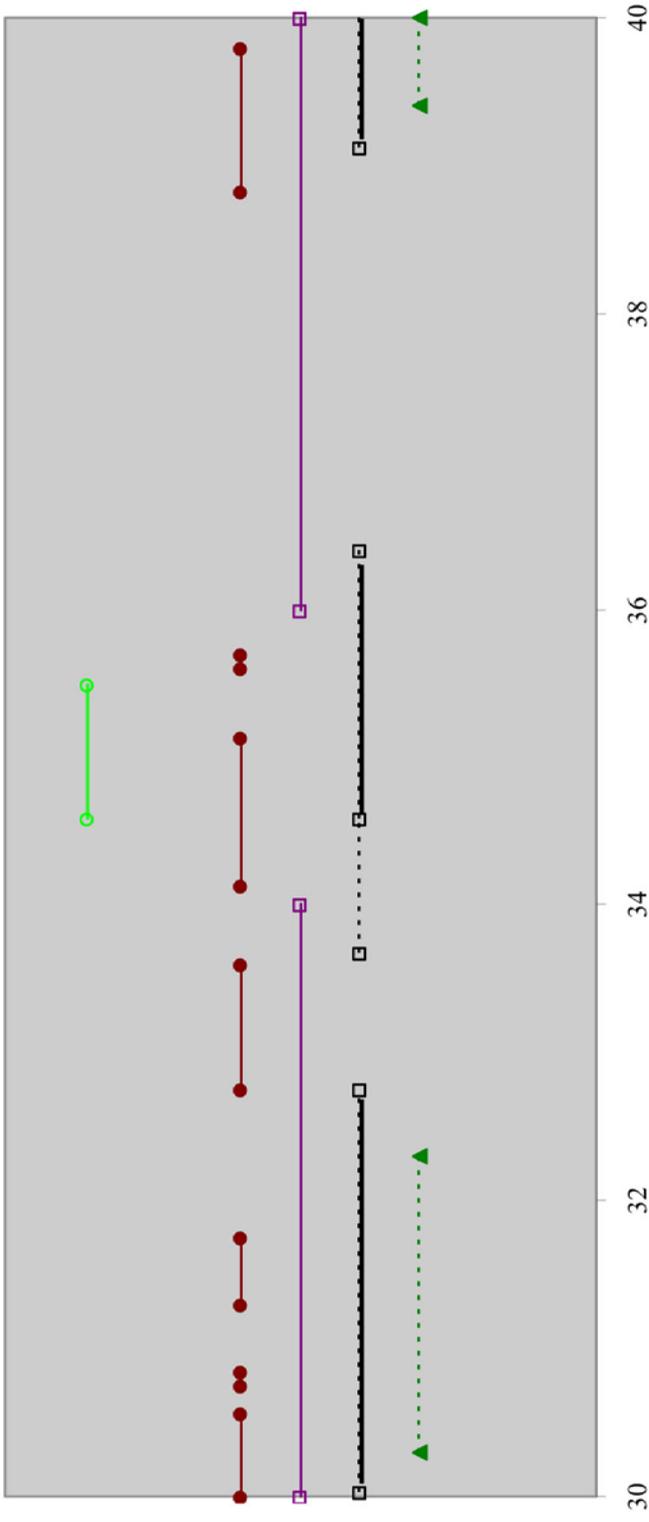
123 Q4: Circumferential Location (inch)

Figure 5.3 SBT Yellow Region was Detected with the NDE PA-SI, PA-PNNL, TOFD-PNNL, and TOFD-Fluor. The SBT Red region was not detected by any of the NDE techniques. Note that only a select few regions from pipe 127 were subjected to the SBT and they all failed in the Yellow or Red mode. It was assumed that the entire pipe joint was bad so these plotted summary results should be used only for a correlation of the plotted SBT results and the NDE results and not as an indicator of false calls.

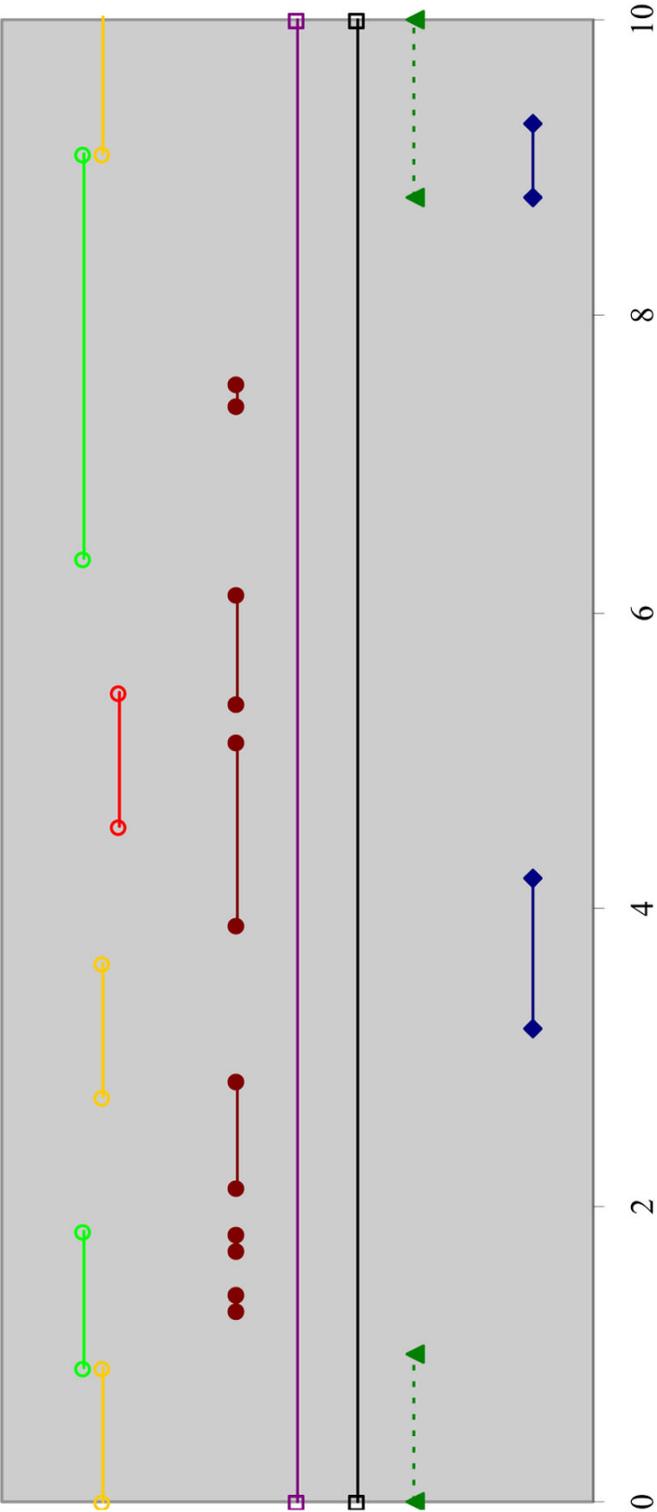
1212 Q1: Circumferential Location (inch)

Figure 5.7 Most of This Specimen Showed Some Type of Failure in the SBT. Evisive NDE detected flaws over the entire quadrant and TOFD Fluor detected two flawed regions.

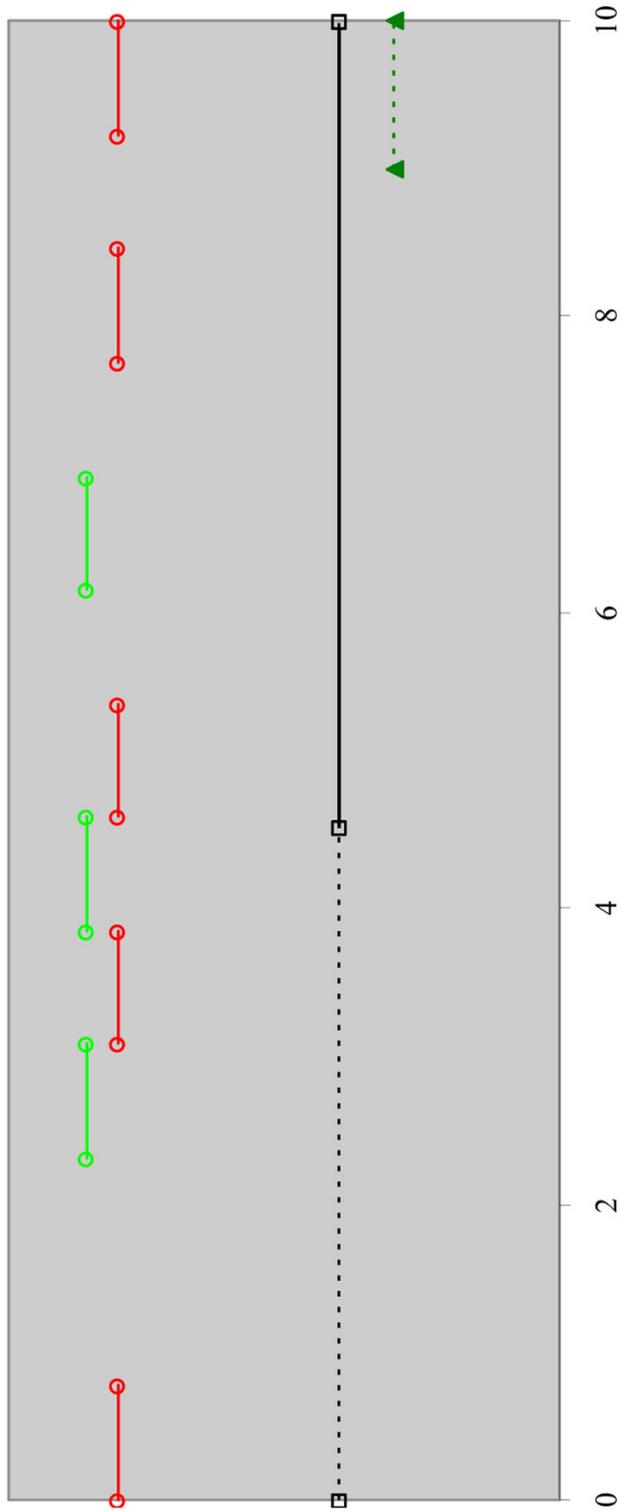
1214 Q1: Circumferential Location (inch)

Figure 5.9 SBT Failure Regions Covered Most of This Quadrant and were Partially Detected with Evisive NDE
