Assessment of NDE Methods on Inspection of HDPE Butt Fusion Piping Joints for Lack of Fusion

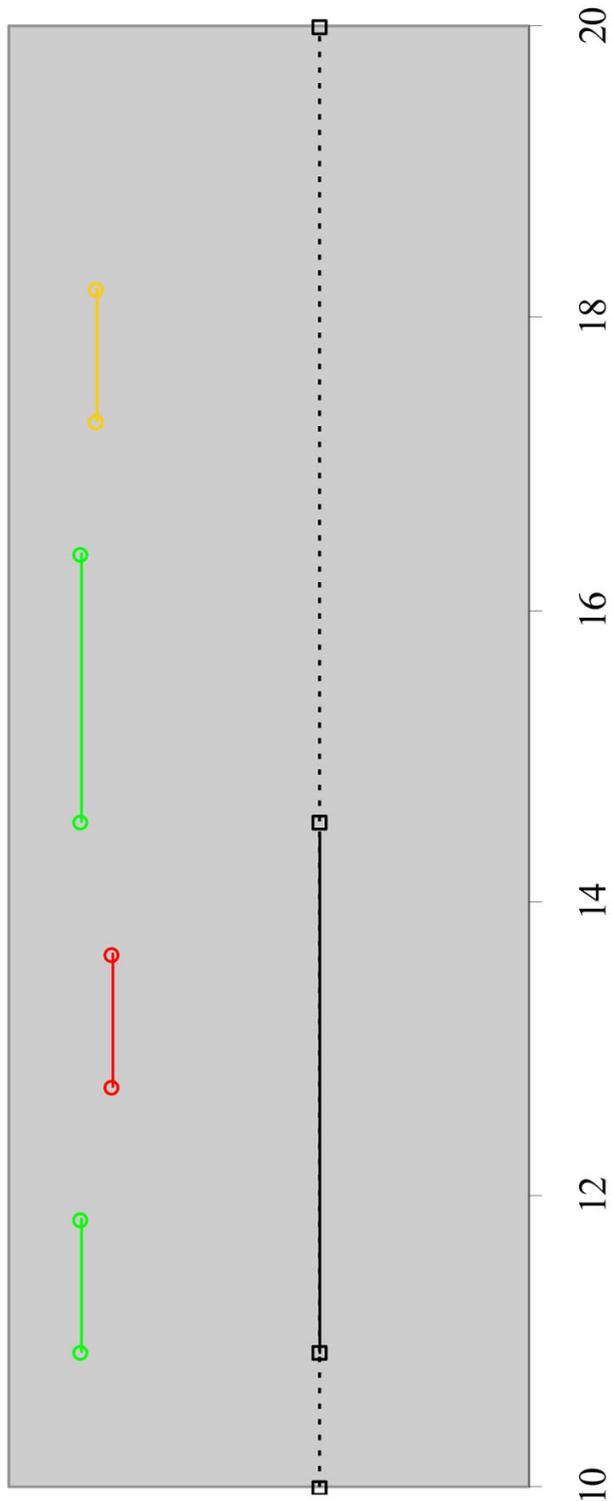
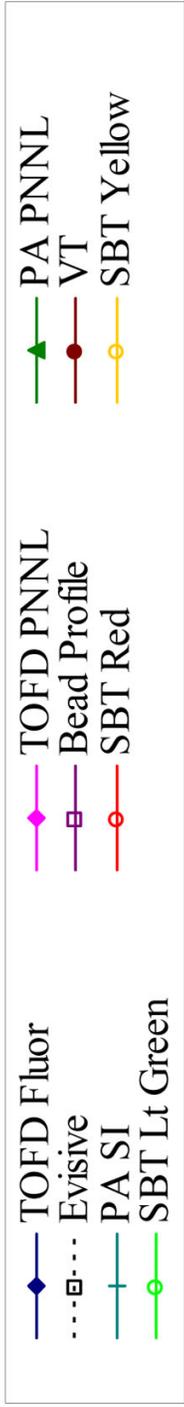
1218 Q2: Circumferential Location (inch)

Figure 5.12 Majority of This Quadrant Failed in the SBT to Some Extent. Only the Evisive NDE technique called any flaws. There were false call areas as well.

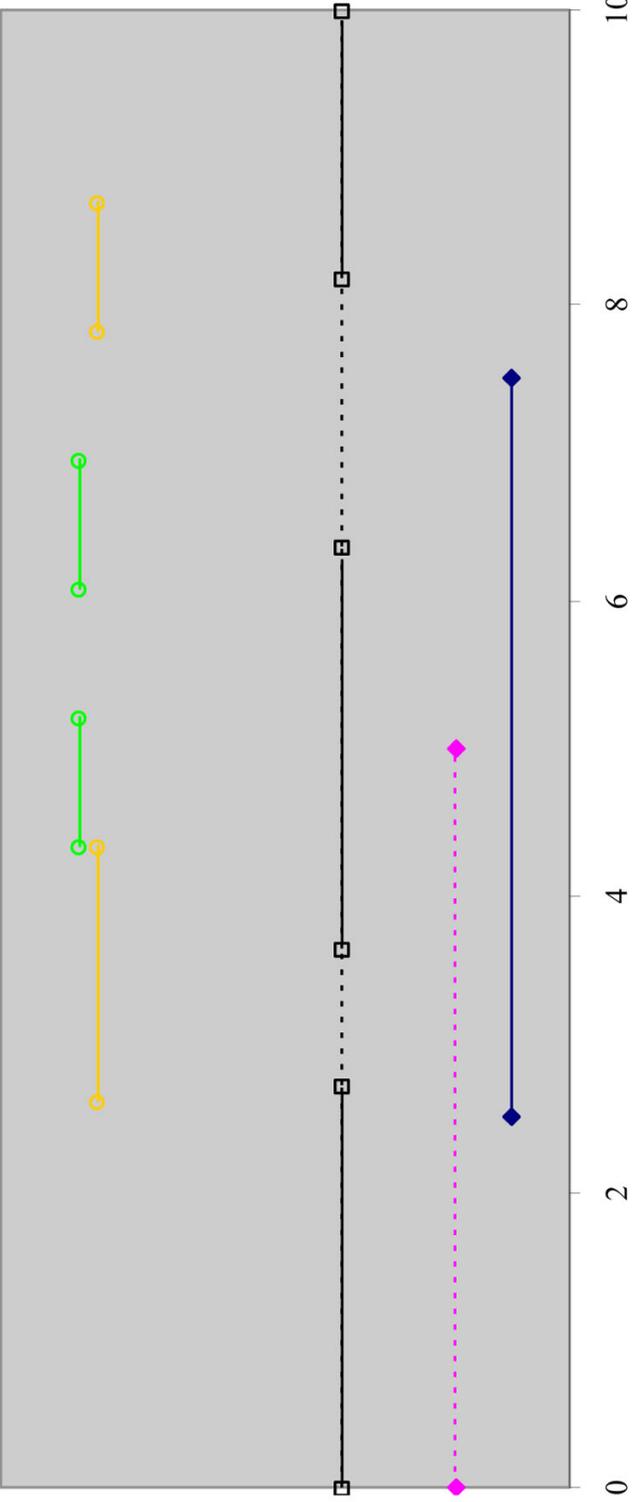
1223 Q1: Circumferential Location (inch)

Figure 5.13 Approximately Half of the Quadrant Showed Signs of Failure in the SBT in the Yellow or Light Green Range. Evisive and TOFD Fluor NDE detected these regions; however, Evisive had false calls.

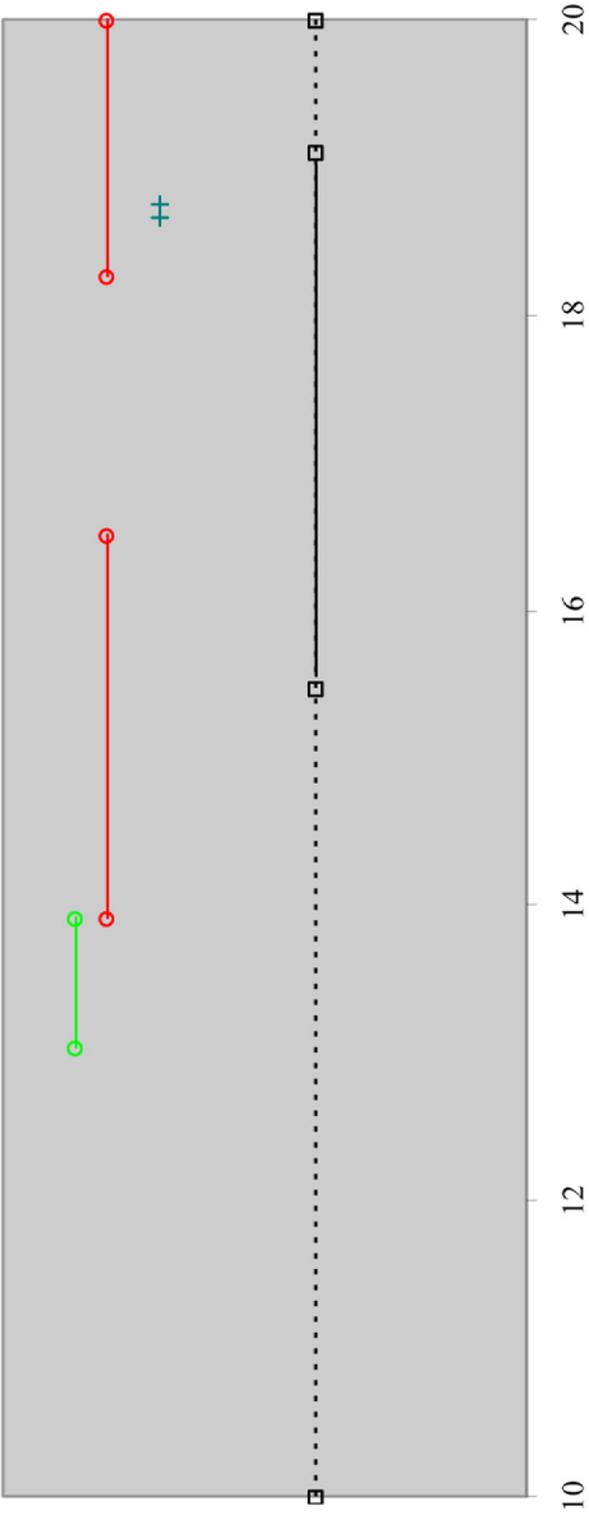
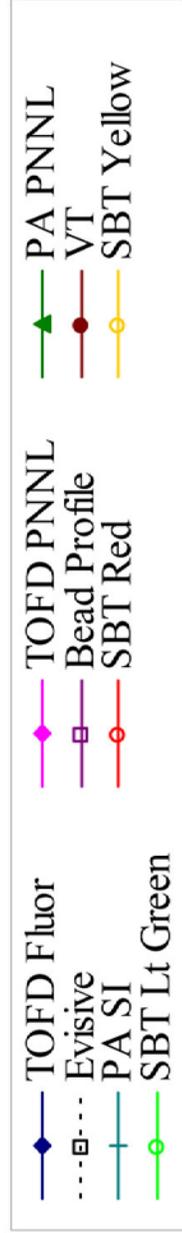
1223 Q2: Circumferential Location (inch)

Figure 5.14 SBT Red Failure Regions were Partially Detected with Evisive NDE and a Very Small Region with PA SI NDE. Evisive NDE had a false call region.

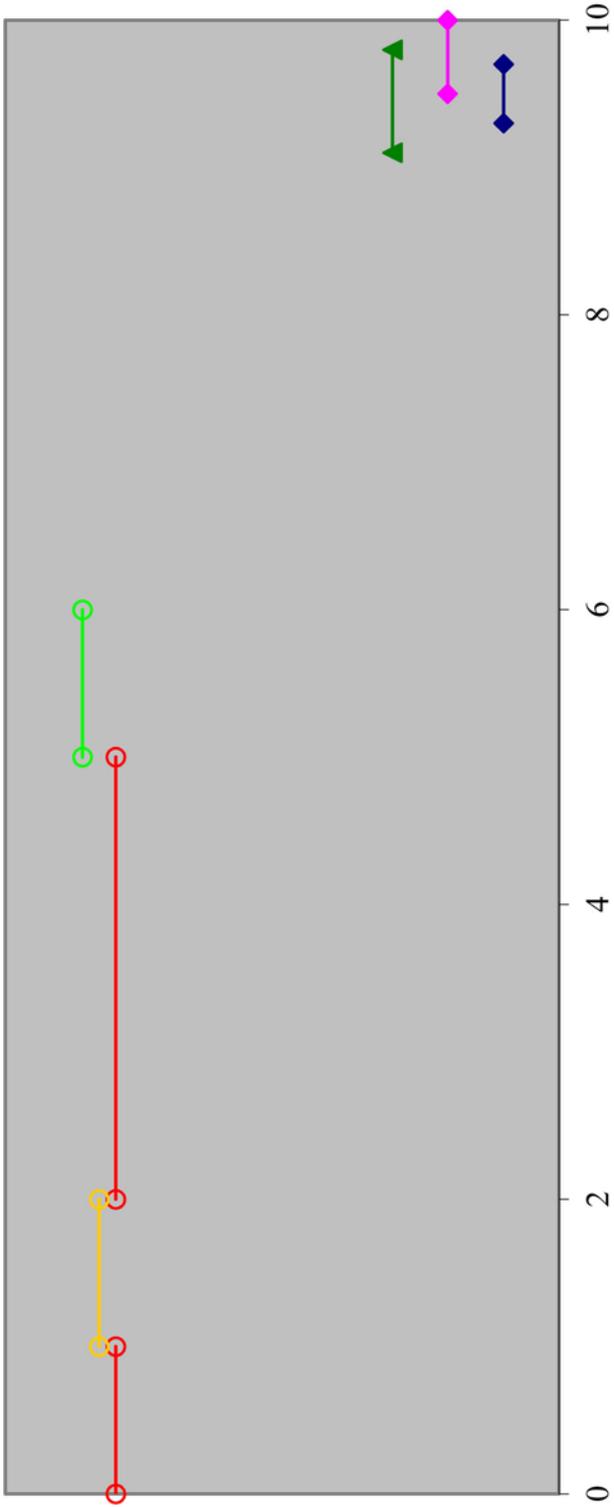
1224 Q1: Circumferential Location (inch)

Figure 5.15 SBT Failure Regions were Not Detected by Any of the NDE Techniques. PA PNNL, TOFD PNNL, and TOFD Fluor had small false call regions.

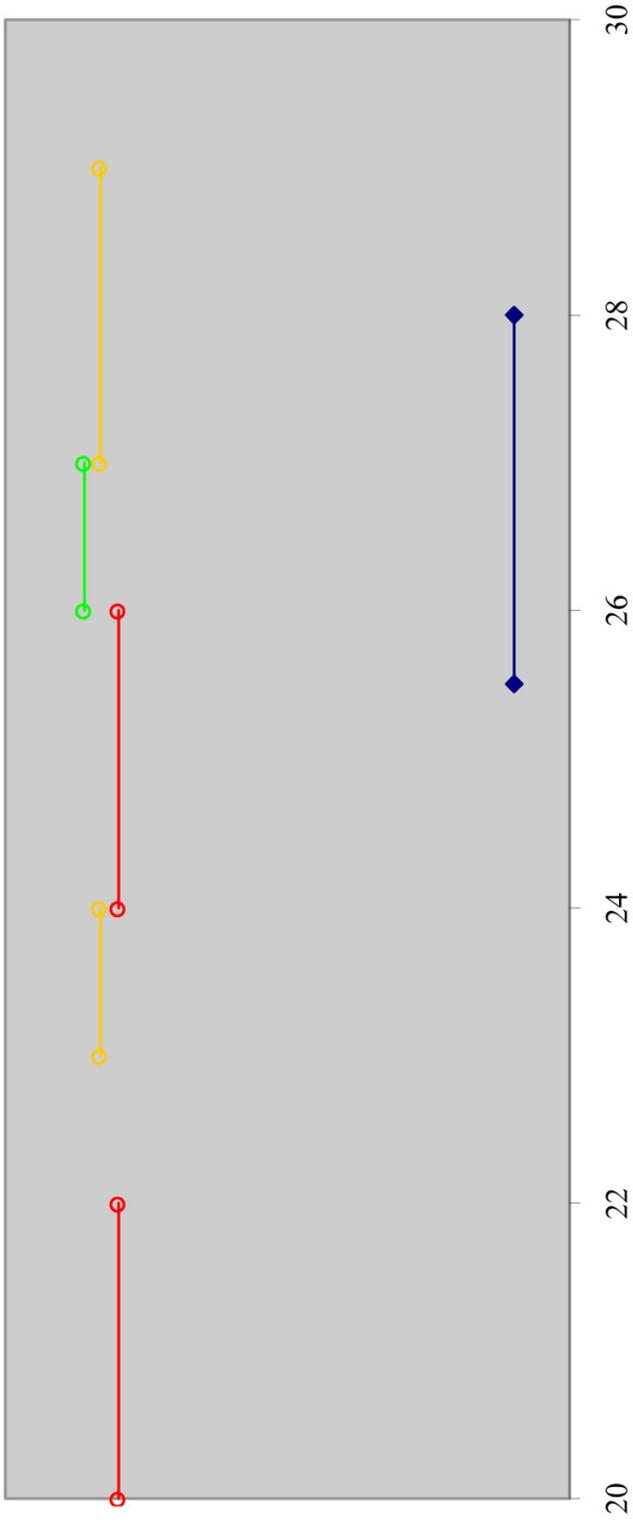
1224 Q3: Circumferential Location (inch)

Figure 5.16 Quadrant Showed SBT Failures Over Most of the Quadrant. TOFD Fluor NDE detected part of the SBT Red region, the SBT Light Green region, and part of a SBT Yellow region. No other NDE techniques detected flaws.

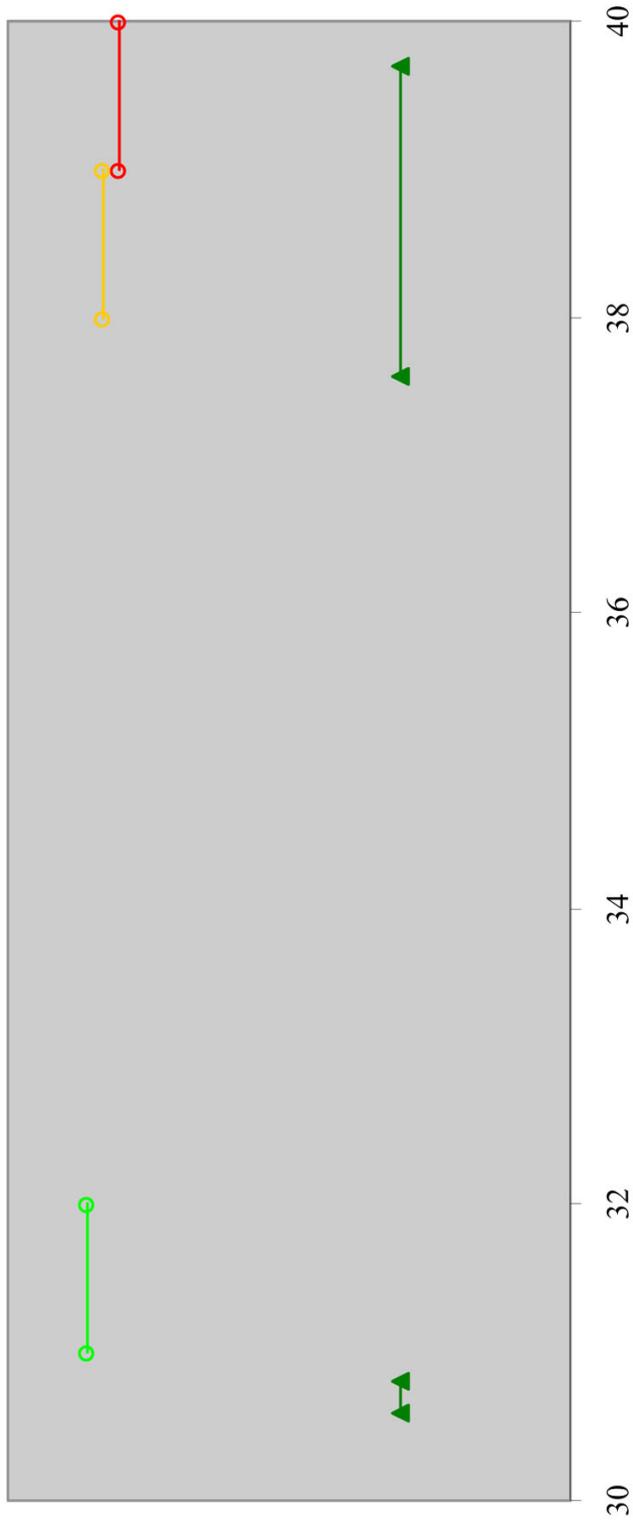
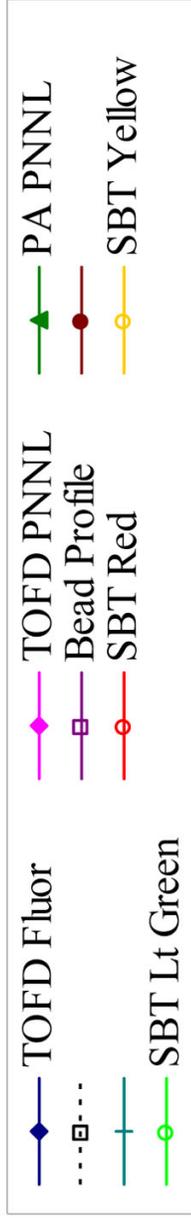
1224 Q4: Circumferential Location (inch)

Figure 5.17 Several Flawed Regions were Noted with the SBT DE Results. PA PNNL detected two of the regions and possibly part of the third region with a positional error.

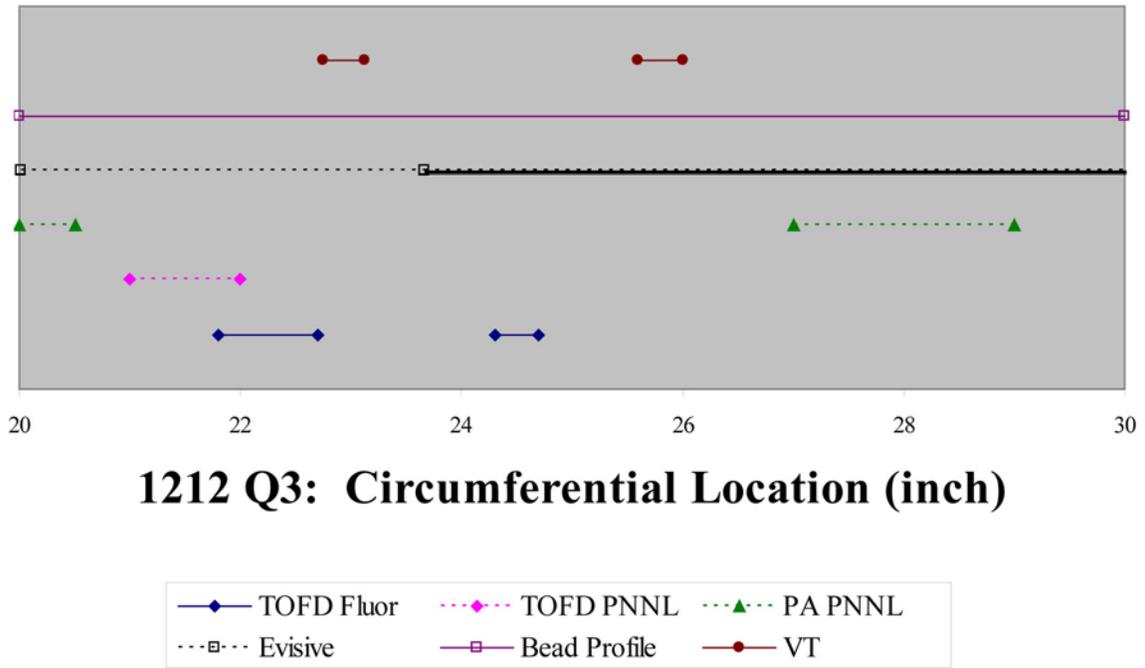
Figure E.3 Evisive called approximately 60% of this quadrant flawed and TOFD Fluor showed two flawed areas, one of which overlapped with the Evisive call.

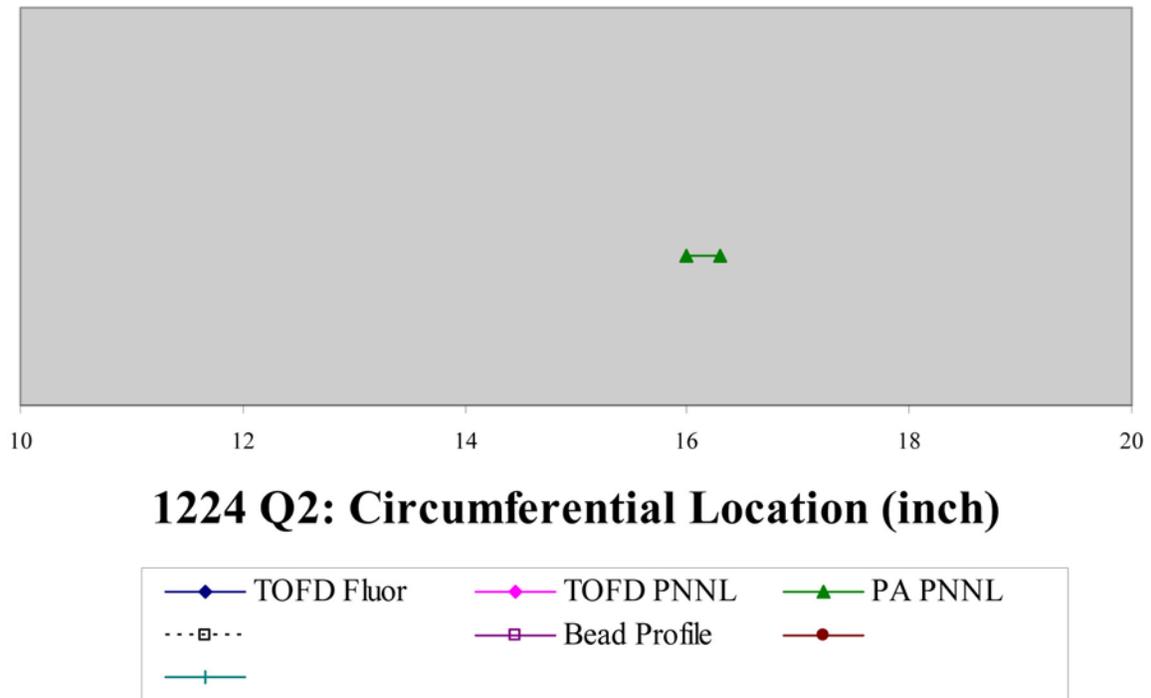
Figure E.11 This quadrant only had one small flaw call by PA PNNL.
