POEF-2086
ORNL/TM-11988

**Investigation of Breached Depleted
UF₆ Cylinders**

Date Published: September 1991

Prepared by the
OAK RIDGE NATIONAL LABORATORY
and
URANIUM ENRICHMENT
Oak Ridge, Tennessee 37831-6285
managed by
MARTIN MARIETTA ENERGY SYSTEMS, INC.
for the
U.S. DEPARTMENT OF ENERGY
under contract DE-AC05-84OR21400 and
DE-AC05-76OR00001

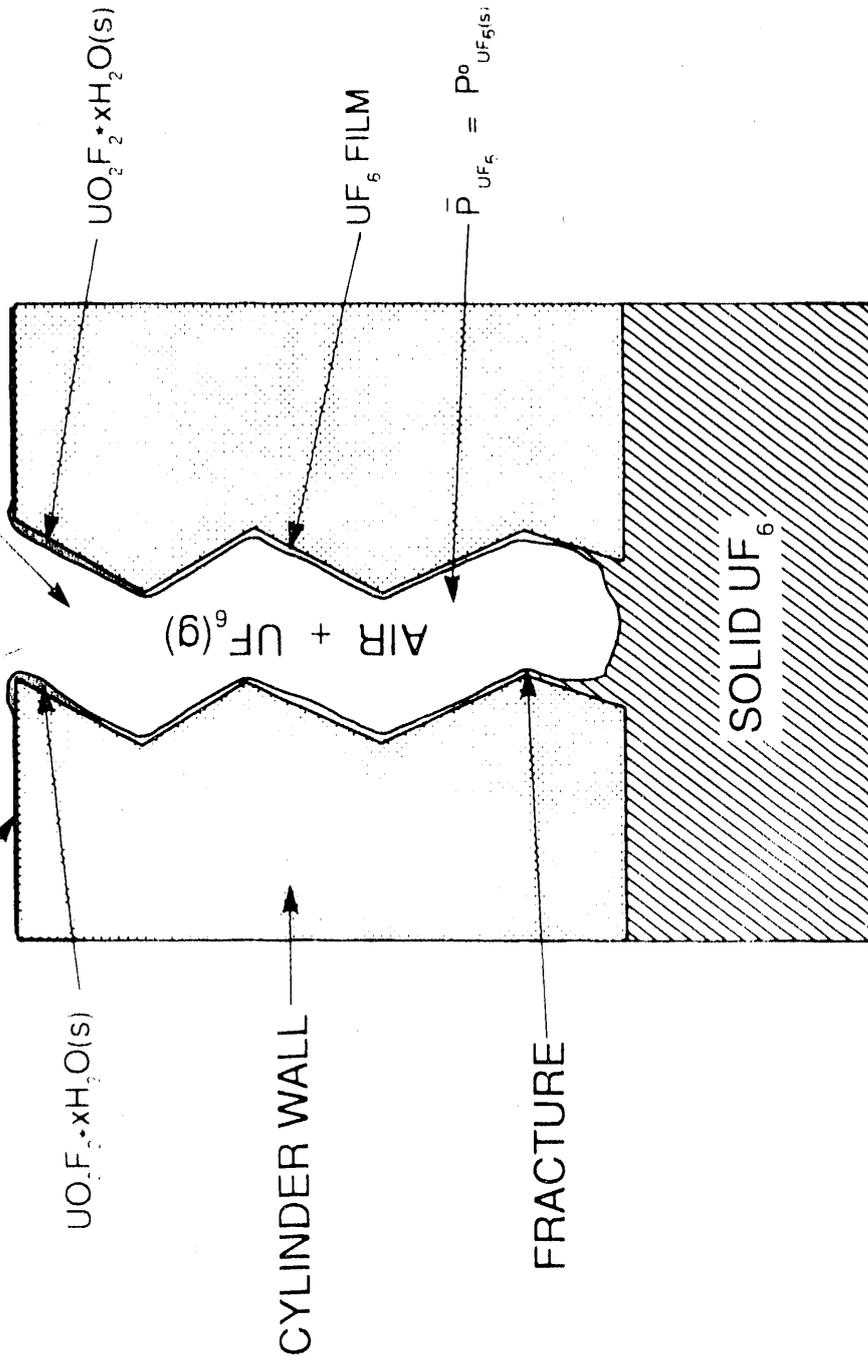
Very Early Stage, $\bar{P}_{UF_6} > 4 \bar{P}_{H_2O}$

Fig. B3.5. Schematic cross section of fracture shortly after impact showing results of reaction initiation in phase 2.

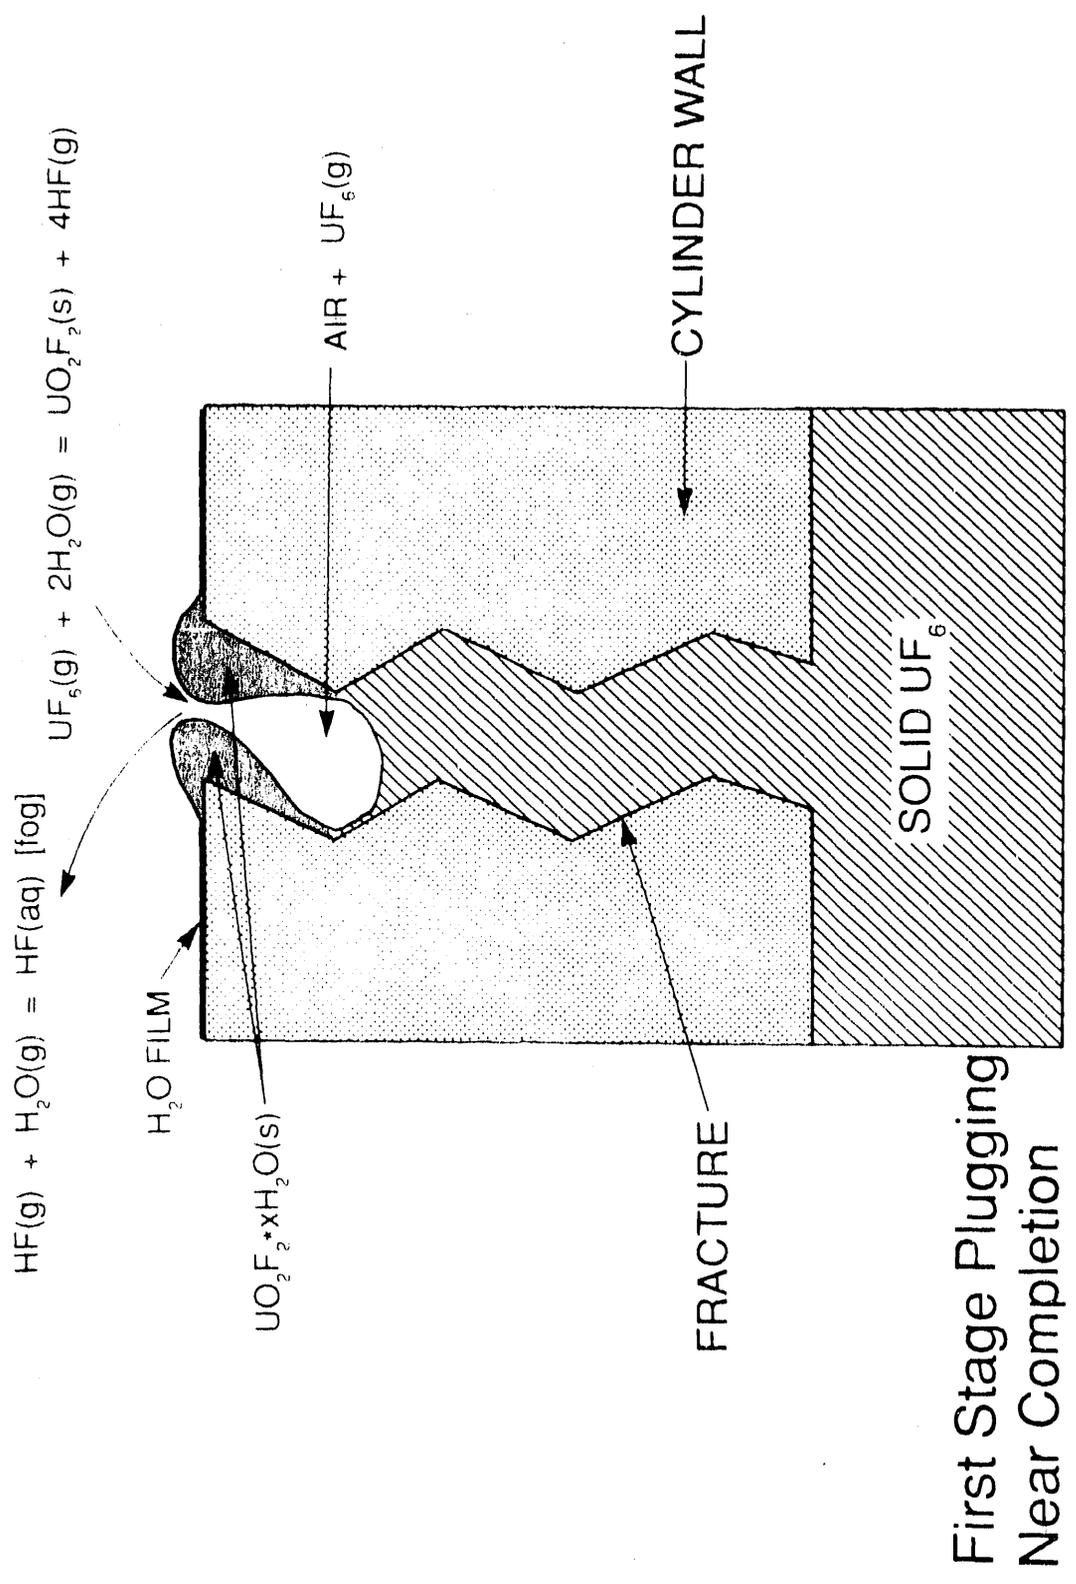
First Stage Plugging Near Completion

Fig. B3.6. Schematic cross section of fracture showing development of initial plug nearing completion.

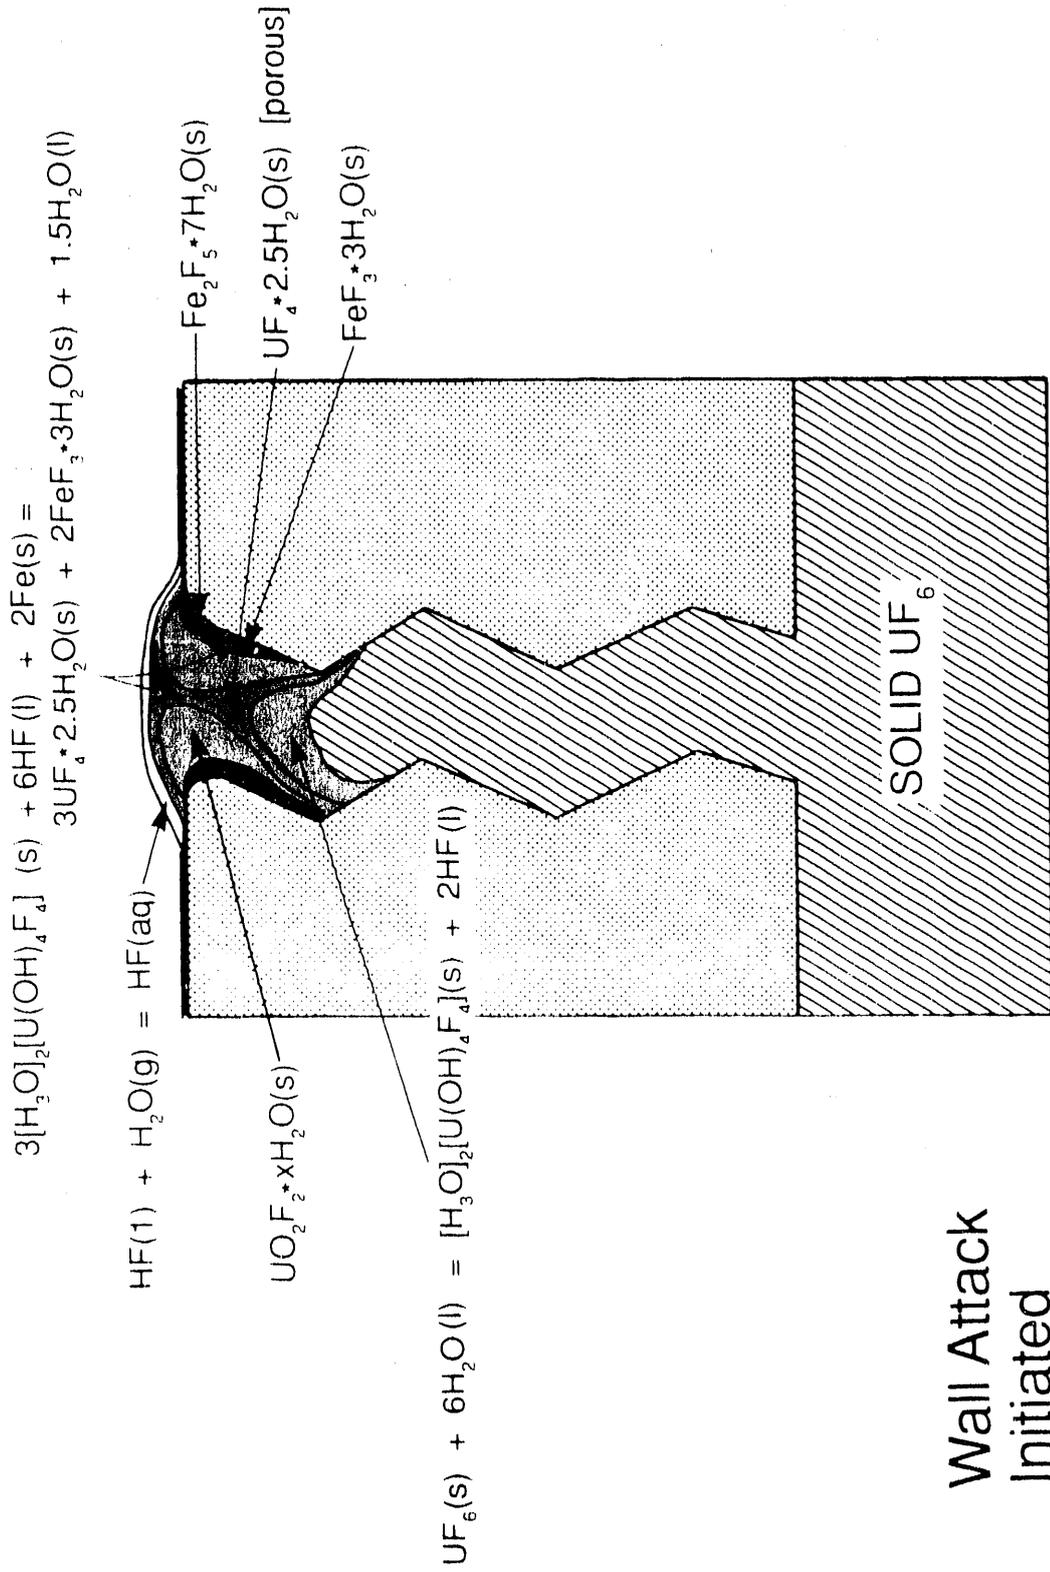
Wall Attack Initiated

Fig. B3.7. Schematic cross section of fracture showing initiation of reduction and interior hydrolysis reactions in phase 3.

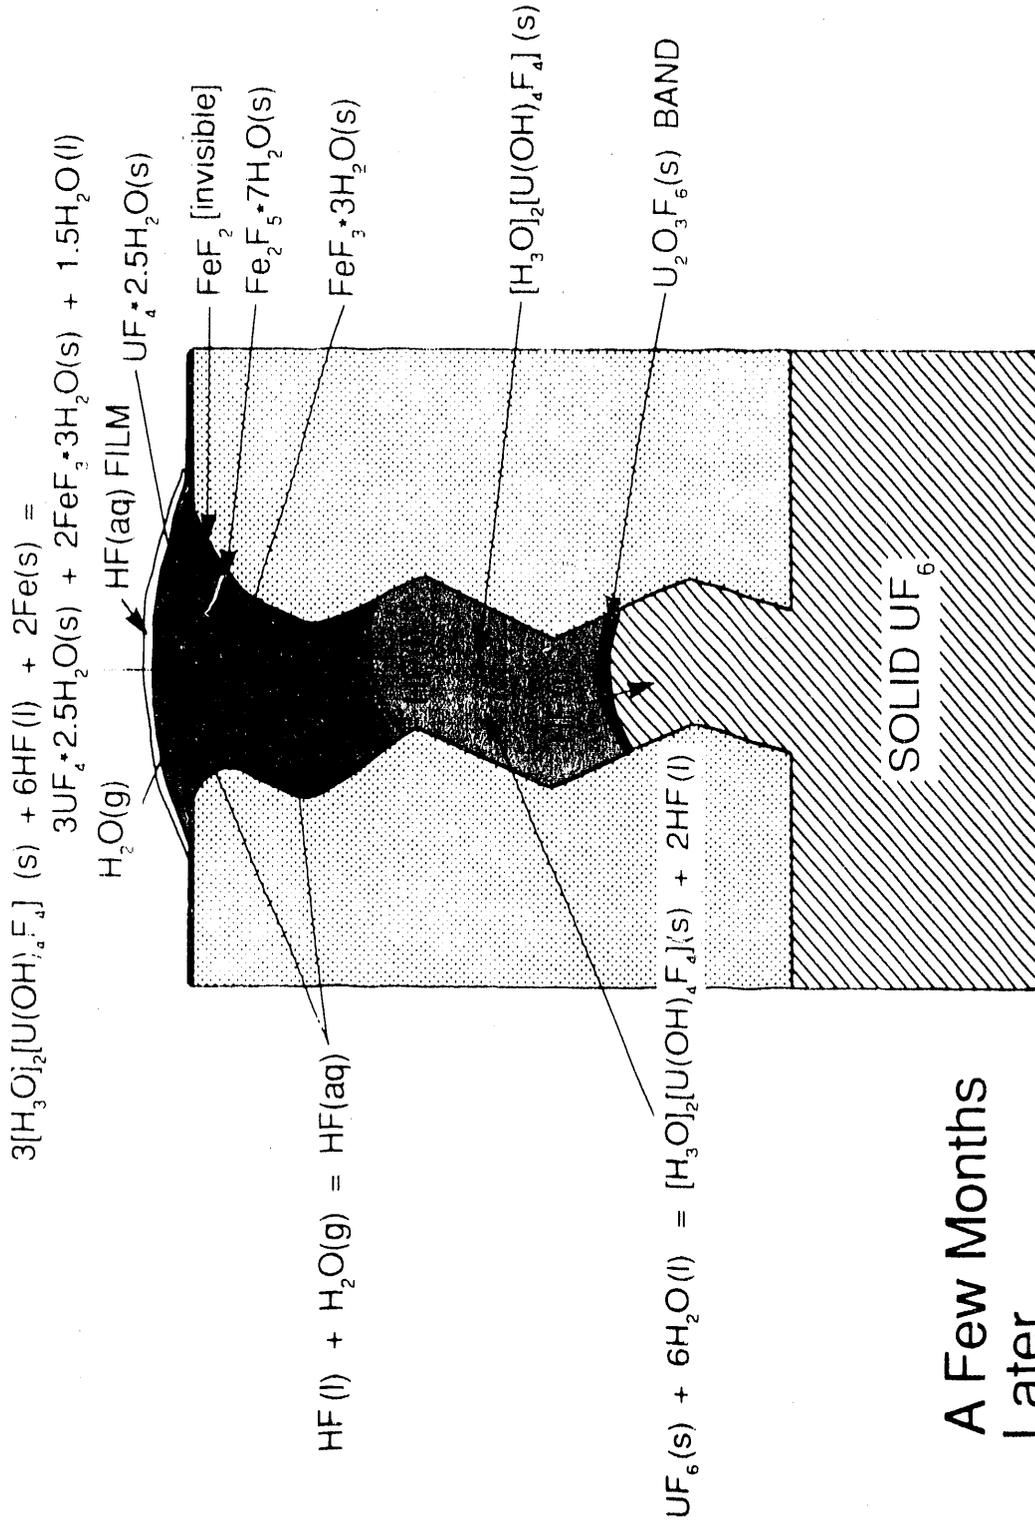
Fig. B3.8. Wall attack at fracture continues. Outer layer of UO_2F_2 hydrate replaced by UF_6 hydrate. Internal hydrolysis reaction continues down fracture.

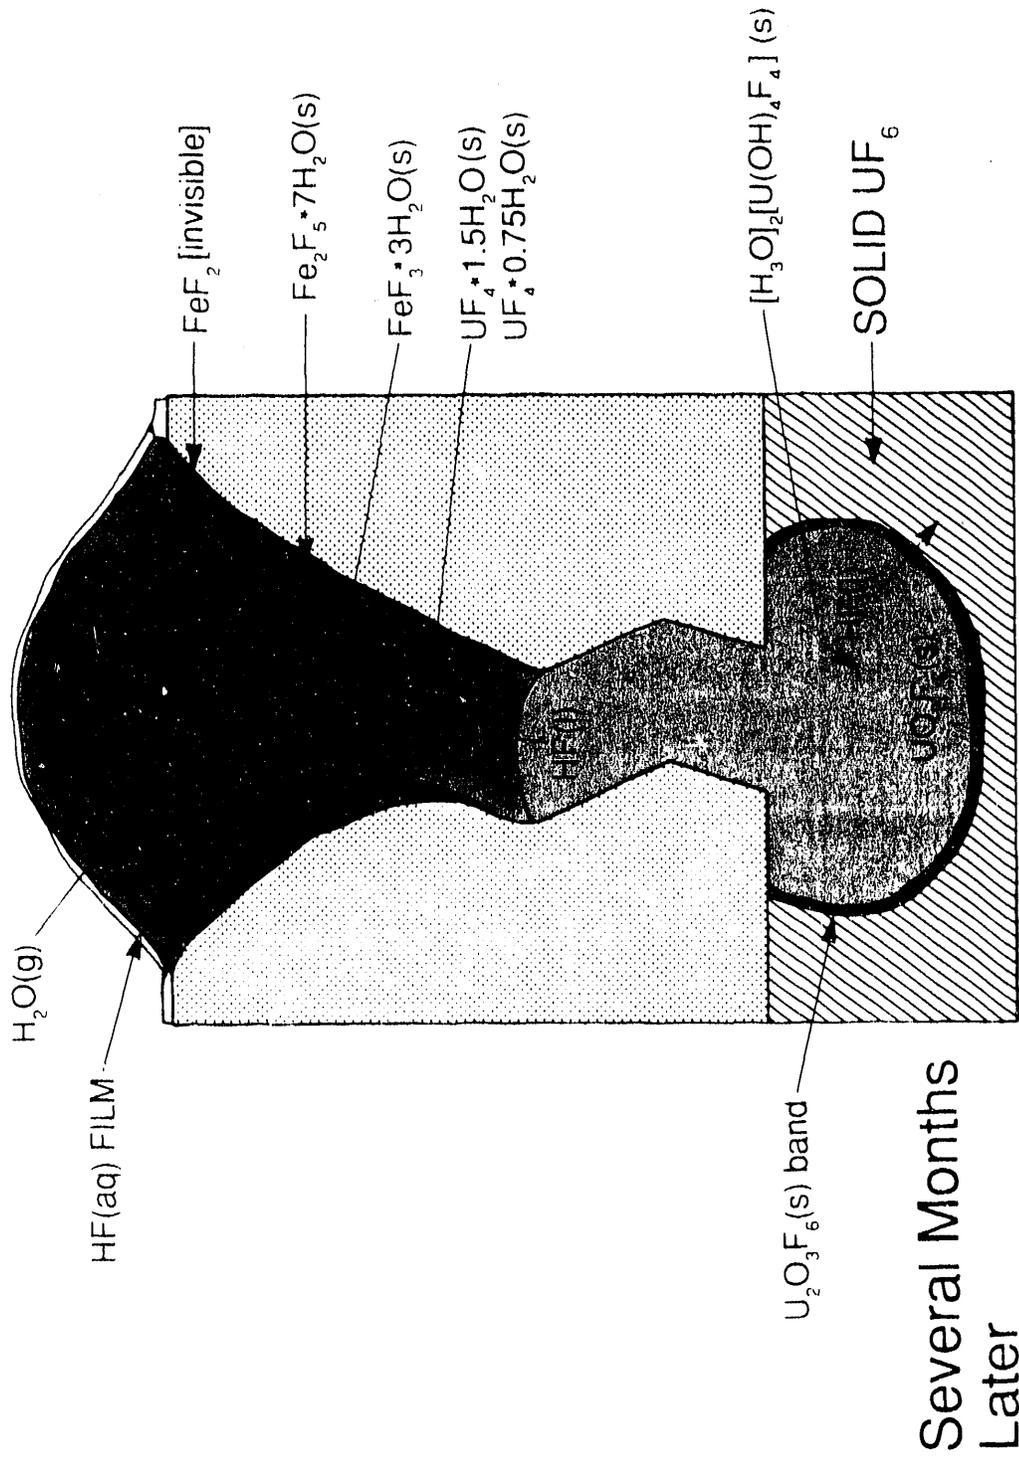
Fig. B3.9. Wall attack at fracture continues. Hydrolysis reaction enters into cylinder UF_6 . Fracture is being enlarged from outside in.

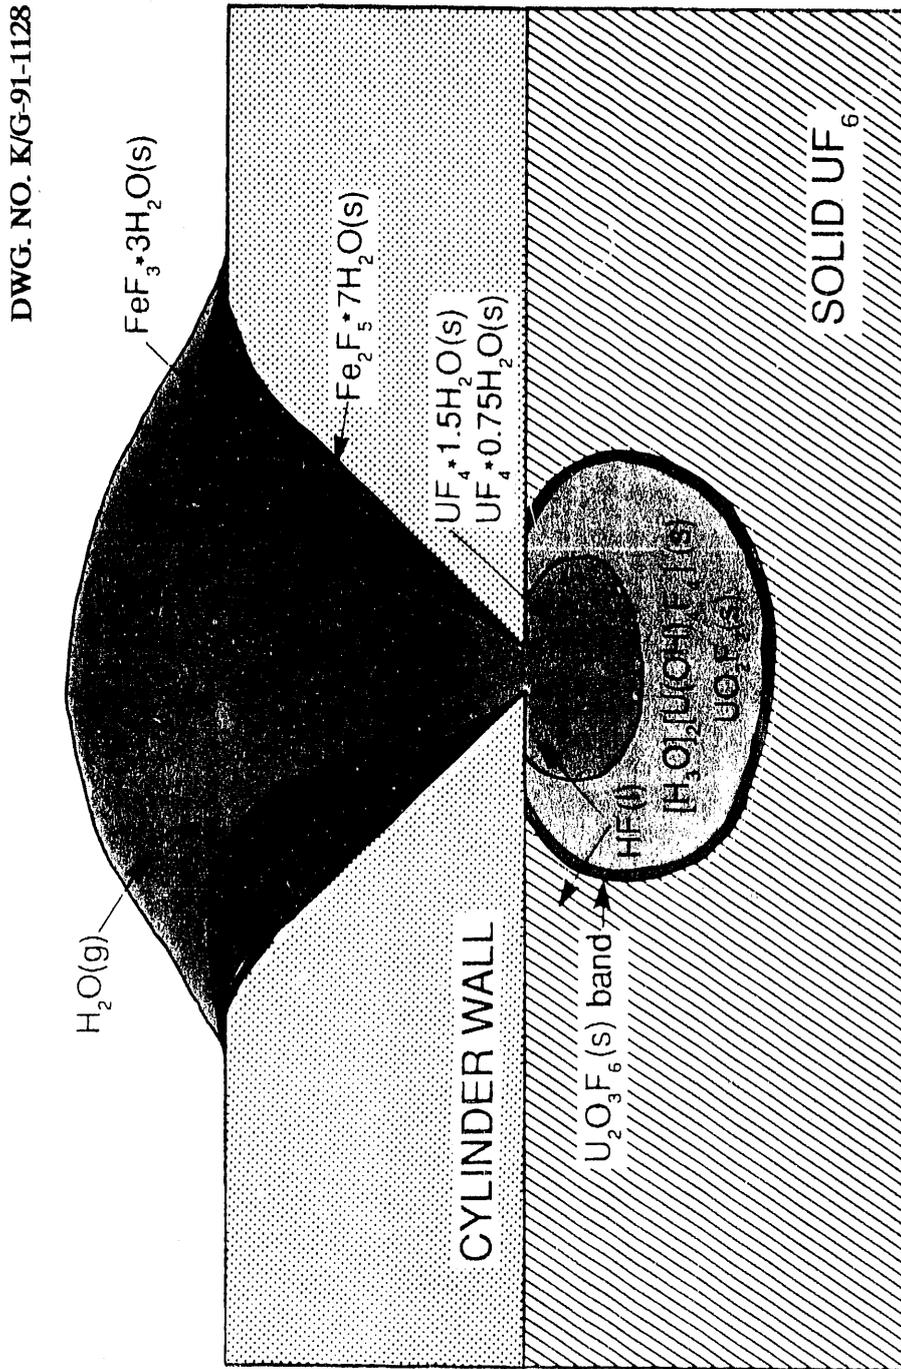
Ten to Fourteen Months Later

Fig. B3.10. Phase 3 is completed as fracture is enlarged along full depth. UF_4 hydrate is now forming inside cylinder. Hydrolysis of UF_6 reactions surrounds the UF_4 inside the cylinder.

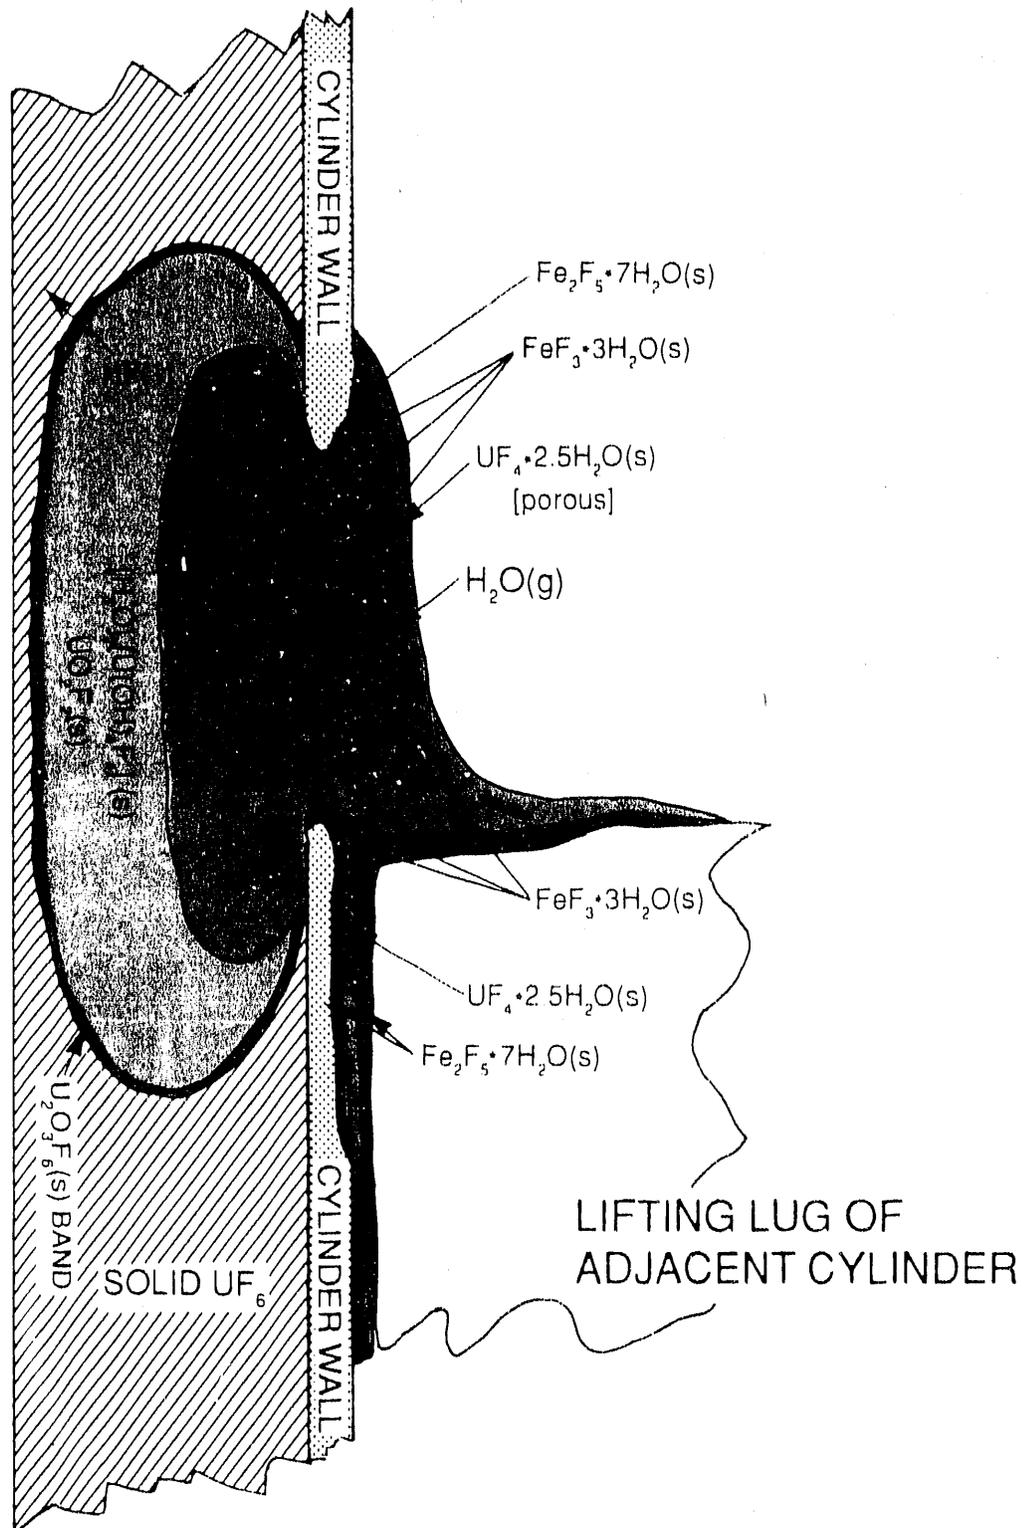
Four Years Later

Figure B3.11 is a schematic, cross-sectional drawing illustrating the distribution of reaction products in the hole in cylinder 4G127985 and on the lifting lug of the adjacent cylinder 4G127902 after a 4-year exposure. The layered isolation of products is seen, except that directly over the hole where no iron remains, the different layers are mixed on a macroscopic basis with retention of identity. The pattern of the attack of the cylinder wall below the hole and on the top and sides of the lifting lug toward the cylinder and the stiffening ring provides evidence of the acidic, hexavalent uranium-bearing solution, which has oozed from the hydrolysis products

Fig. B3.11. The main reactions continue to be hydrolysis of UF₆ inside and reduction to UF₄ inside and outside the cylinder. The fracture has become a small hole after 4 years.

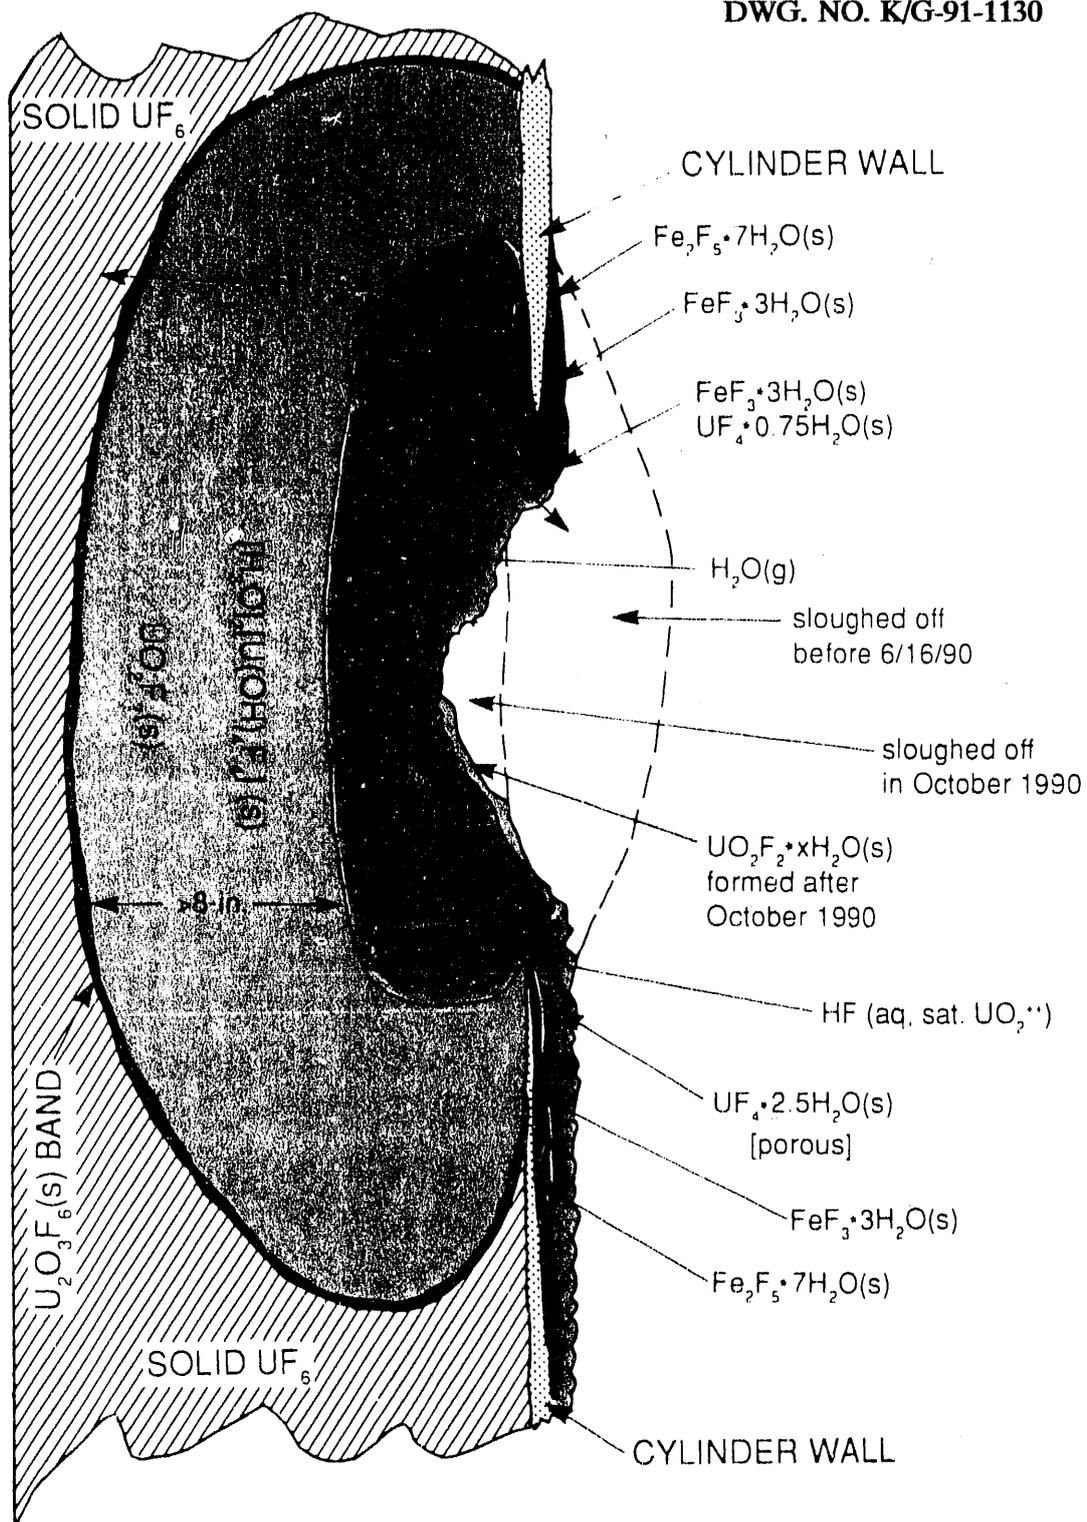
Thirteen Years Later

Fig. B3.12. The hydrolysis and reduction reactions continue. Deposits outside the cylinder slough off. The HF escapes both as vapor and liquid solution. A small amount of hexavalent uranium in solution not reduced to UF_4 hydrate escapes as UO_2^{++} from the vicinity of the cylinder. Condition shown is for 13 years after initial impact. The hole is now large, greater than 8 in.
