# A Review of Criticality Accidents

2000 Revision

LA-13638 Issued: May 2000

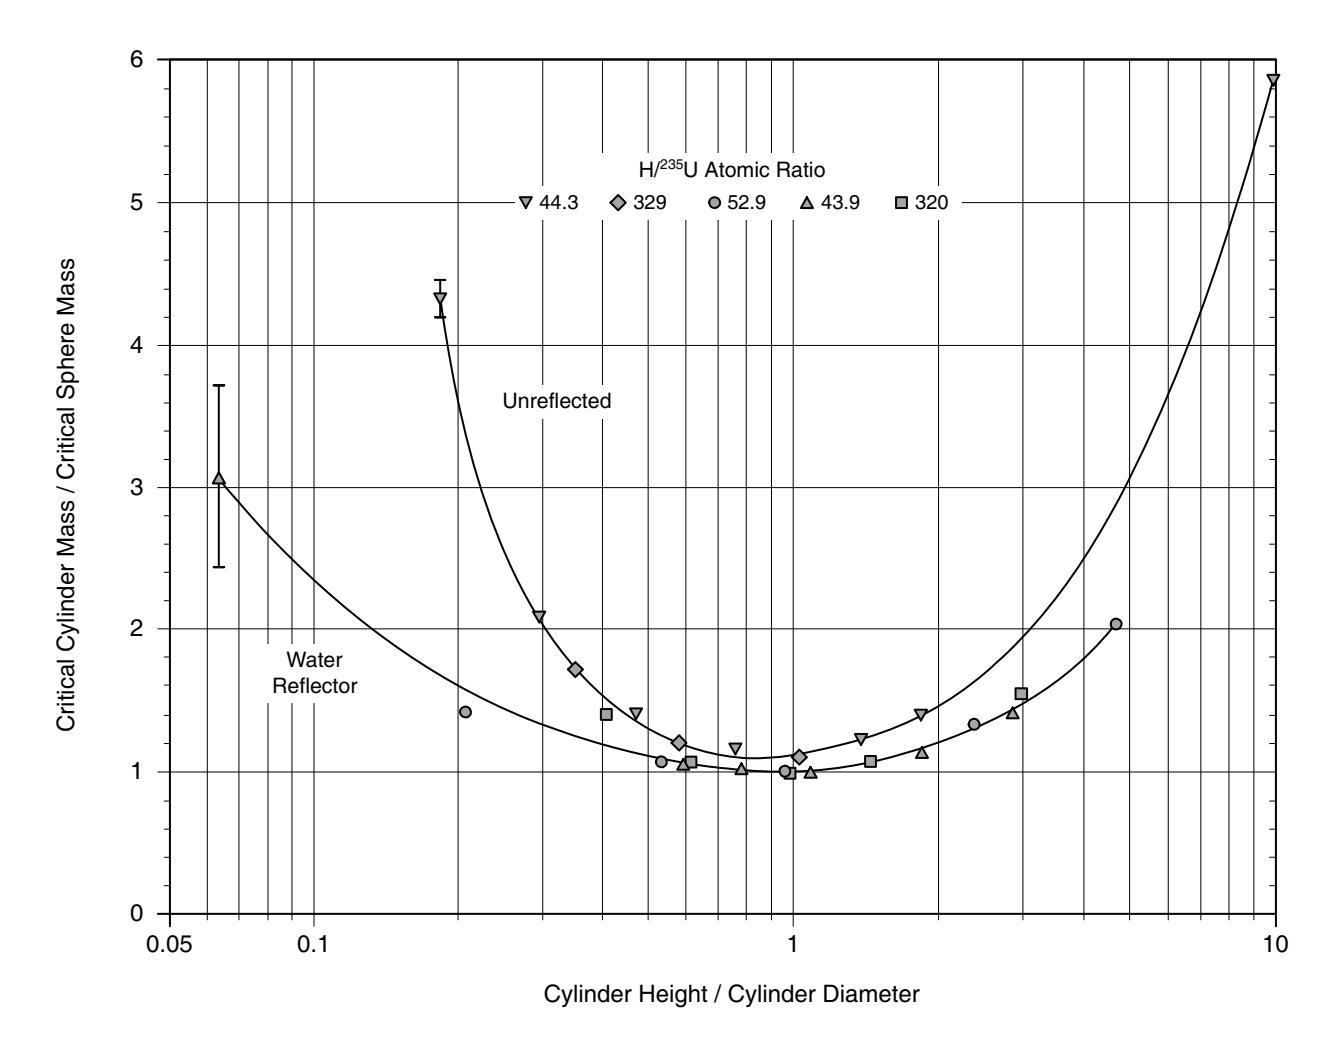
For the 18 accidents where h/D is specified, the unreflected curve in Figure  $36^{34}$  was used to determine the shape factor. The curve in Figure 36 is based directly on experimental results minimizing dependence on calculations. For the remaining 3 accidents (numbers 2, 6, and 20), buckling or other mathematically simple approximations were used to estimate the shape factor.

Figure 36. The ratio of cylindrical to spherical critical masses of  $U(93)O_2F_2$  solutions, unreflected and with water reflector, as a function of cylinder height to cylinder diameter ratio.

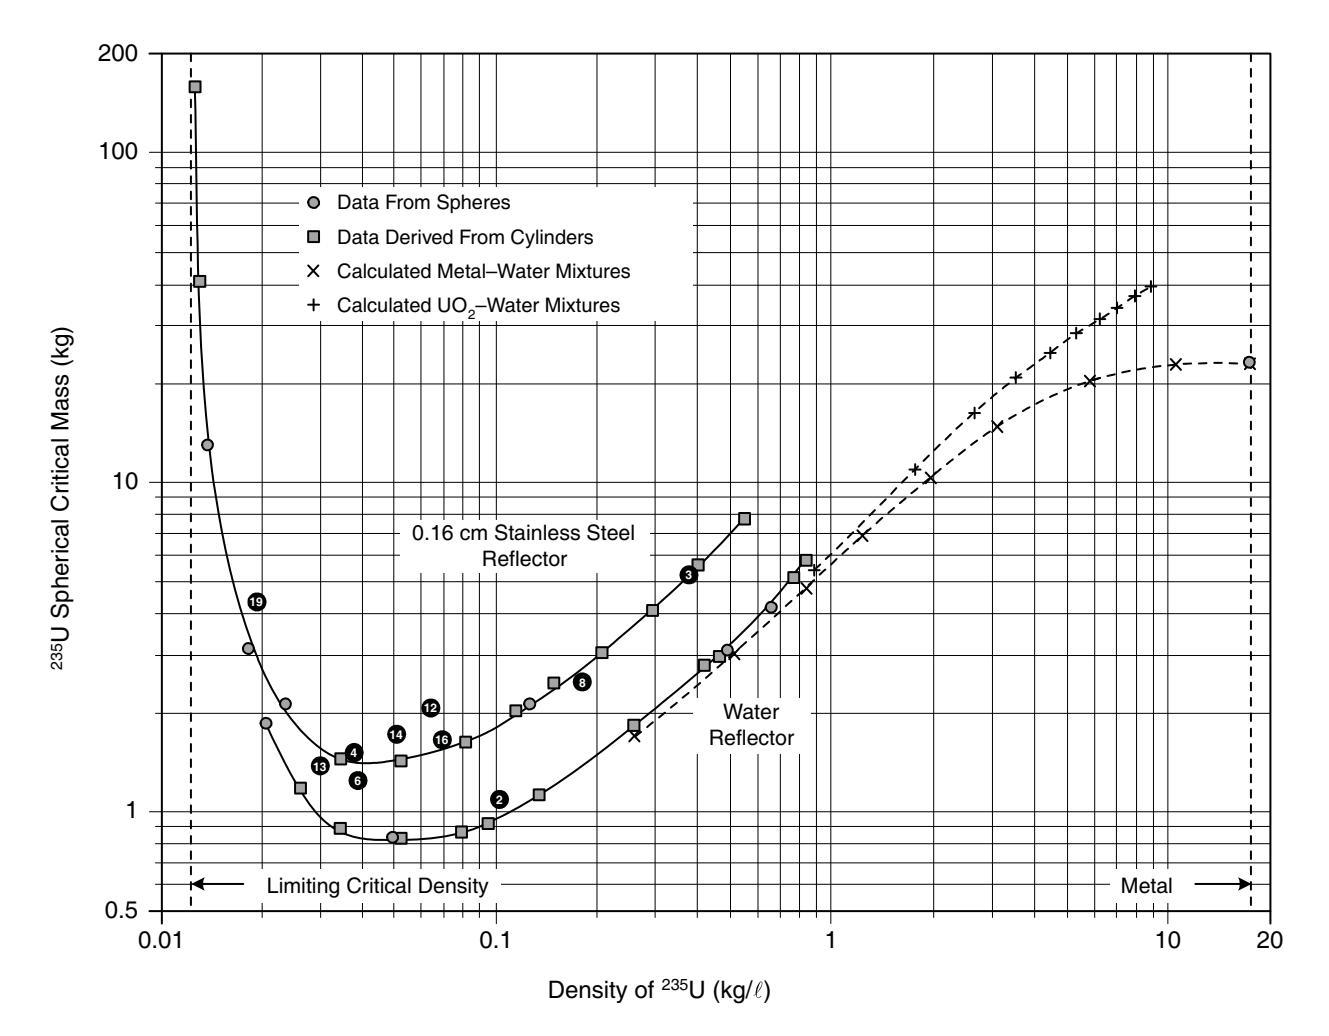
Considering the effects of partial reflection and inherent uncertainties in the estimates, it is judged that the position of 18 of the 21 points plotted in Figures 37, 38, and 39 are sufficient for establishing credible agreement between the reported accident conditions and known conditions for criticality. The estimates for accidents 1, 7, and 9 appear to be somewhat questionable in that more mass than reported in the accident would be required for criticality under the hypothesized unreflected accident conditions. However, accidents 1 and 7, would be in reasonable agreement if the partial reflection present during the accident were taken into account. It should be noted that for these two cases, the "missing" mass is no greater in magnitude than other accident reconstructions (notably, accidents 12, 14, and 17) in which the reported mass exceeds the known conditions for criticality. The discrepancy surrounding accident 9 is also consistent with the large reported uncertainty in the amount of mass present. No systematic features are distinguishable that differentiate the R.F., U.S., U.K., and Japanese accidents.

Figure 37. Critical masses of homogeneous water moderated U(93.2) spheres. Solution data appear unless indicated otherwise. The accidents are shown by numbered circles.

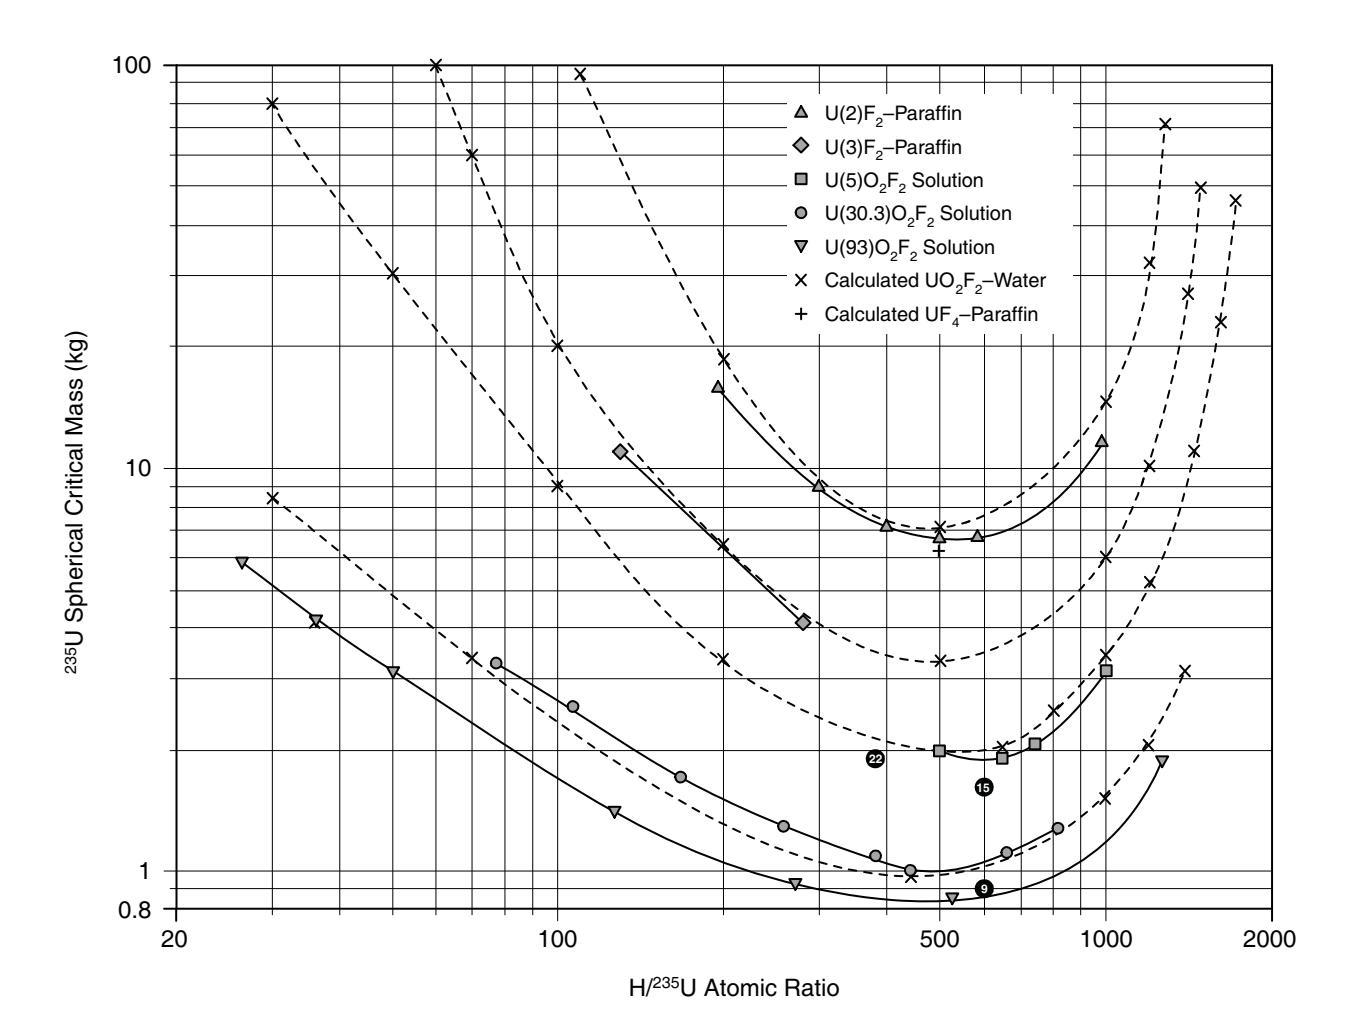
to 2.0, 3.0, 5.0, 30.3, and 93.0. Accidents 9, 15, and 22 are superimposed on this figure. Since the curves in Figure 38 are for water reflected systems, these points have been adjusted downward since the actual accidents were relatively unreflected.

Figure 38. Critical masses of water-reflected spheres of hydrogen-moderated U(93), U(30.3), U(5.00), U(3.00), and U(2.00). The accidents are shown by numbered circles.

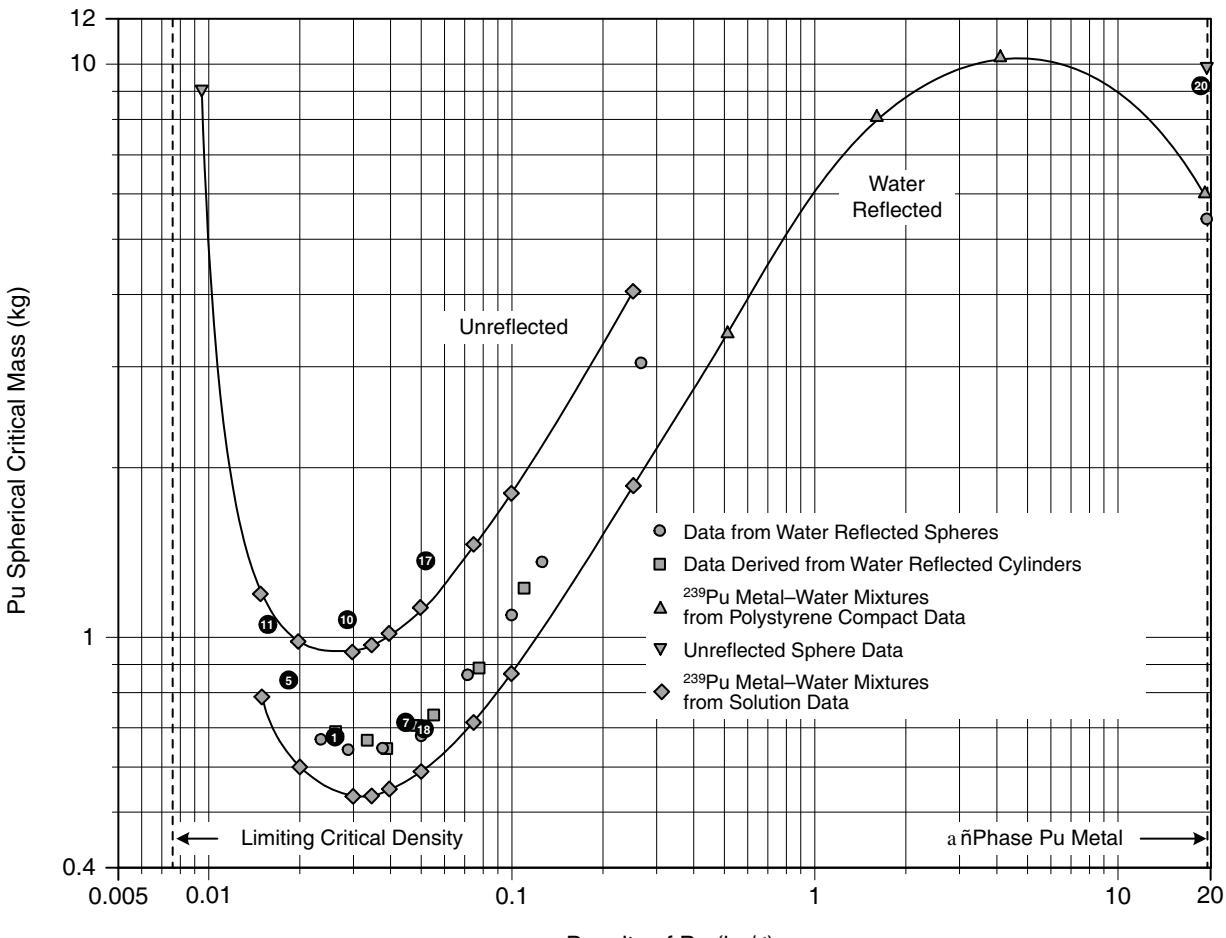
Figure 39. Critcial masses of homogeneous water moderated plutonium spheres. The points suggesting an intermediate curve apply to water reflected  $Pu(No_3)_4$  solution with 1 N HNO<sub>3</sub> and 3.1% <sup>240</sup>Pu content. The accidents are shown by numbered circles.

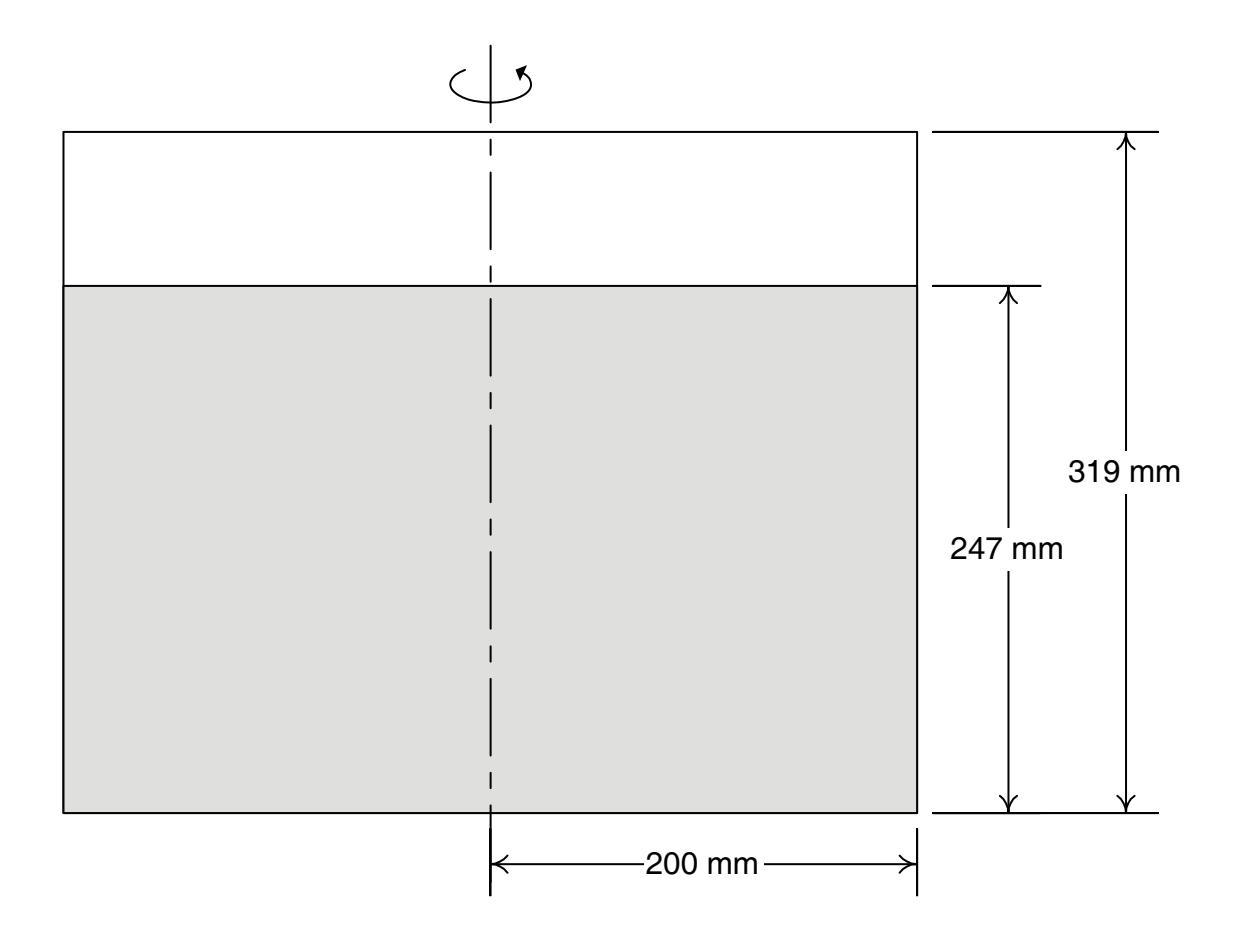
## 1. Mayak Production Association, 15 March 1953

Plutonium nitrate solution in an interim storage vessel; single excursion; one serious exposure, one significant exposure.

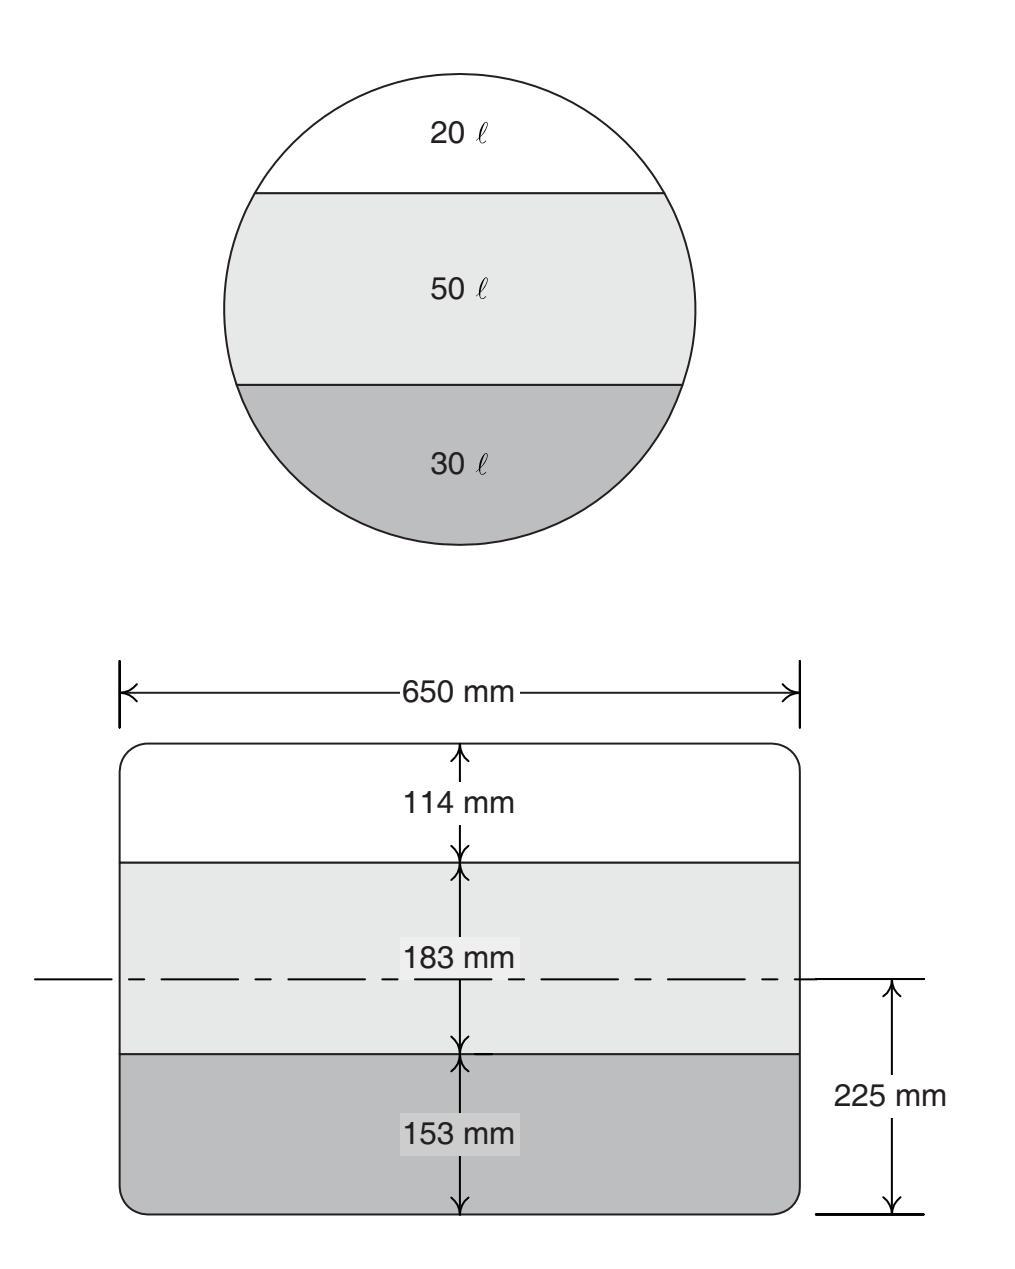
### 2. Mayak Production Association, 21 April 1957

*Uranium precipitate, U(90), buildup in a filtrate receiving vessel; excursion history unknown; one fatality; five other significant exposures.*

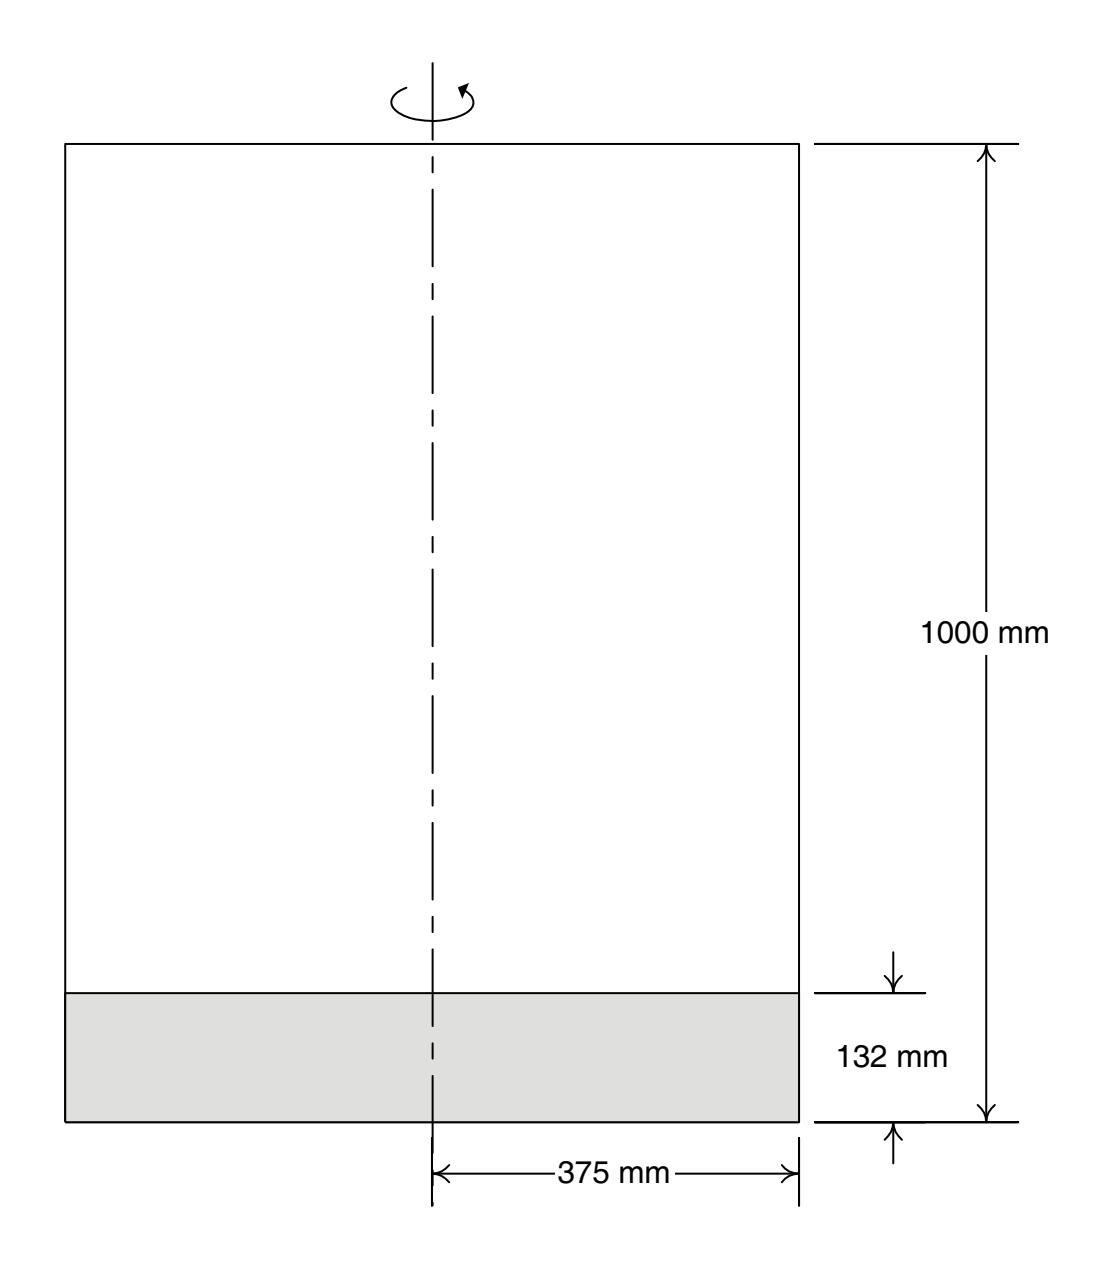
## 3. Mayak Production Association, 2 January 1958

Uranyl nitrate solution, U(90), in an experiment vessel; one prompt critical burst; three fatalities; one serious exposure.

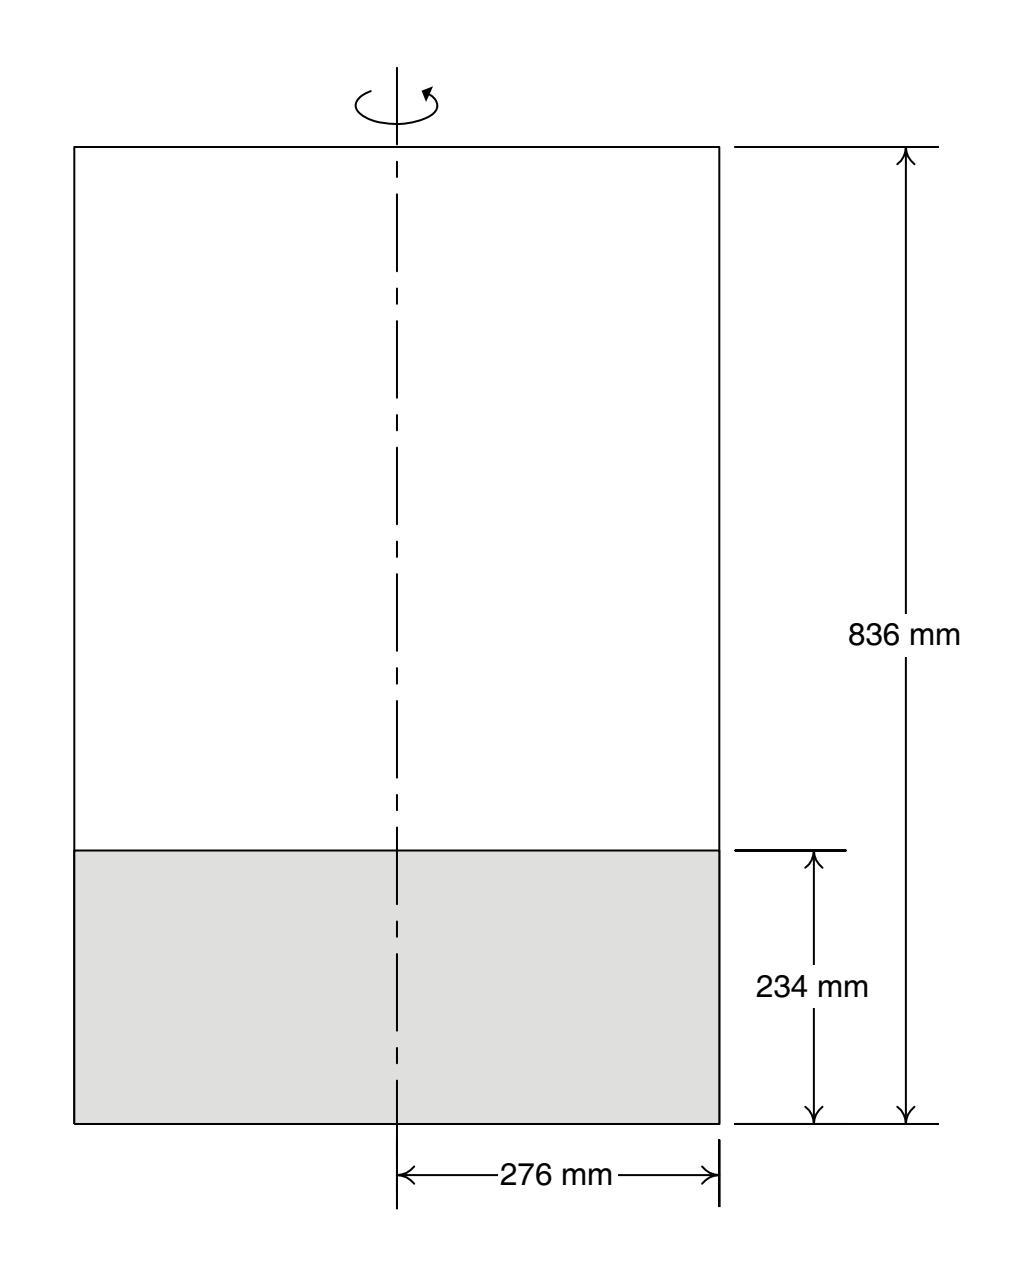
## 4. Oak Ridge Y-12 Plant, 16 June 1958

Uranyl nitrate solution, U(93), in a water collection drum; multiple excursions; seven significant exposures.

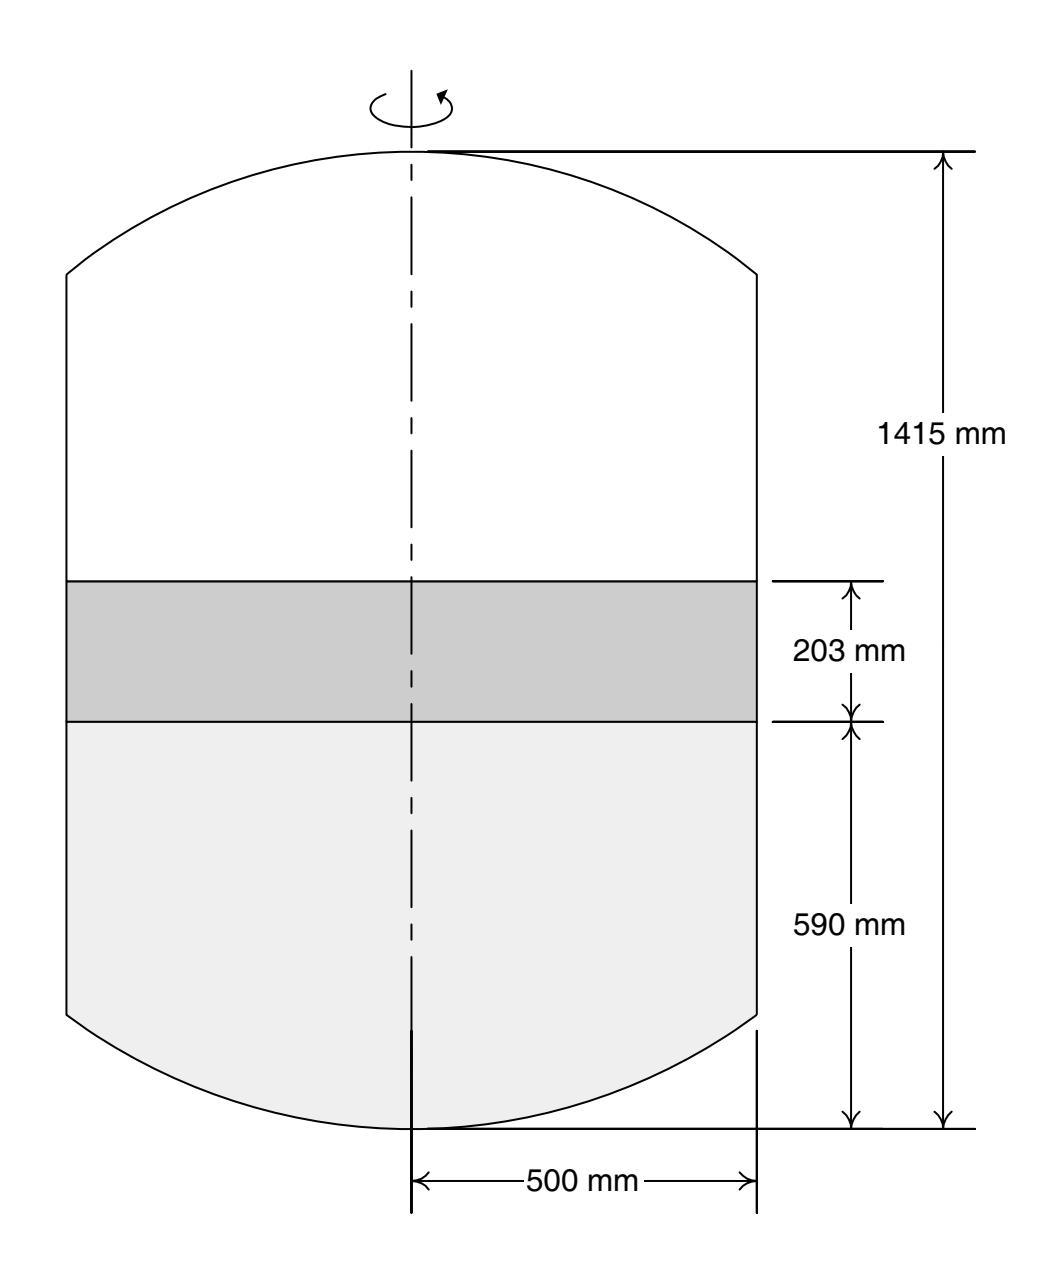
# 5. Los Alamos Scientific Laboratory, 30 December 1958

*Plutonium organic solution in an organic treatment tank; single excursion; one fatality, two significant exposures.*

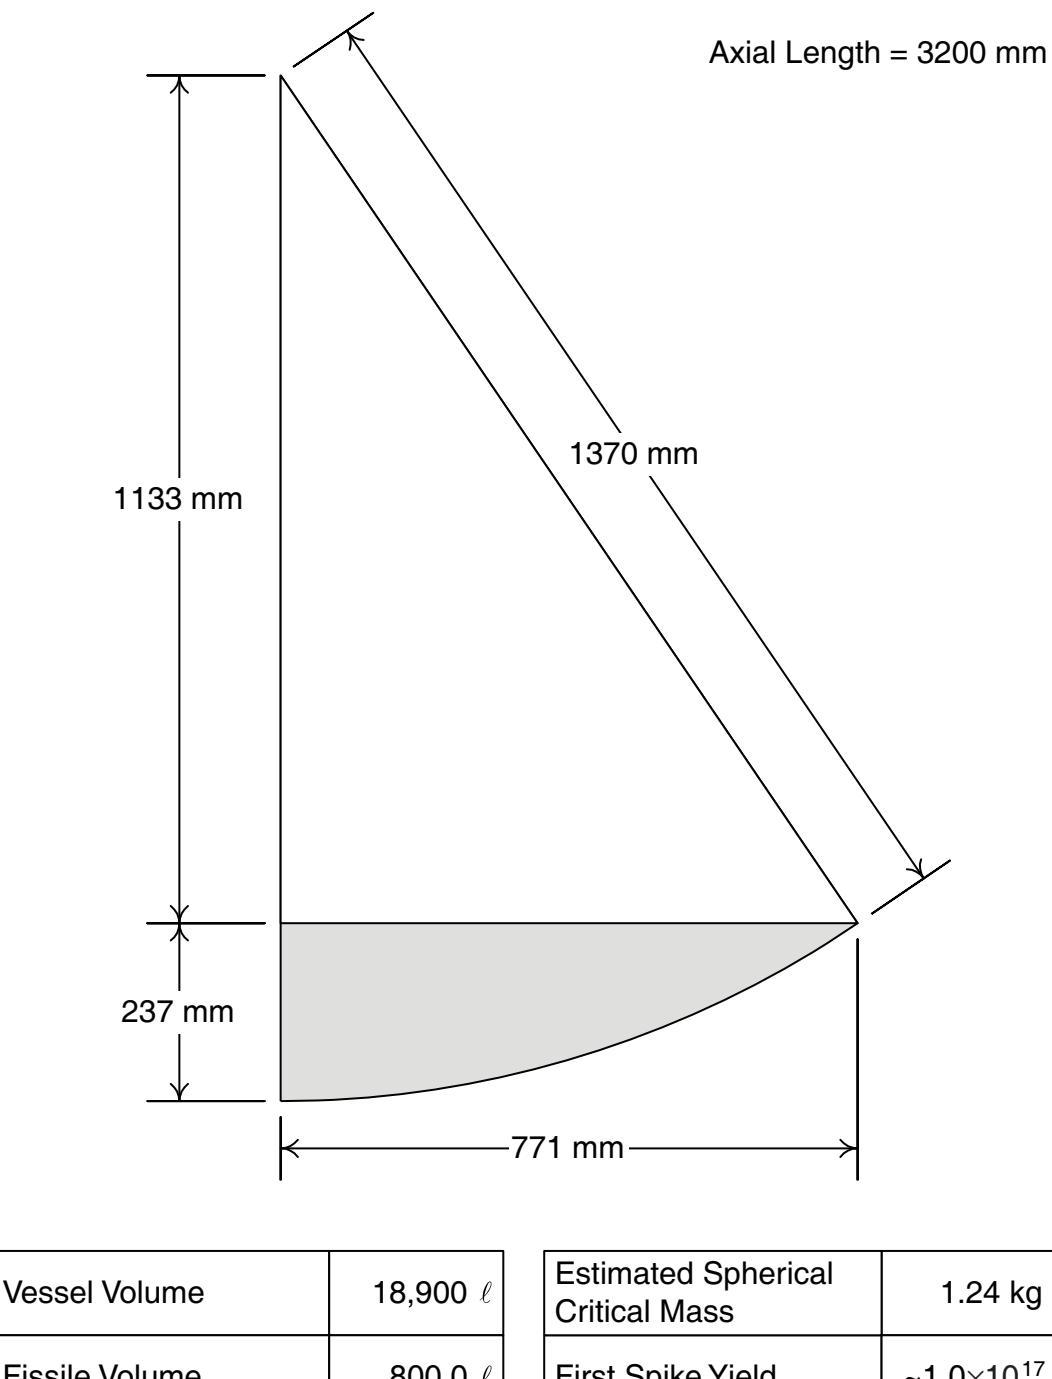
### 6. Idaho Chemical Processing Plant, 16 October 1959

*Uranyl nitrate solution, U(91), in a waste receiving tank; multiple excursions; two significant exposures.*

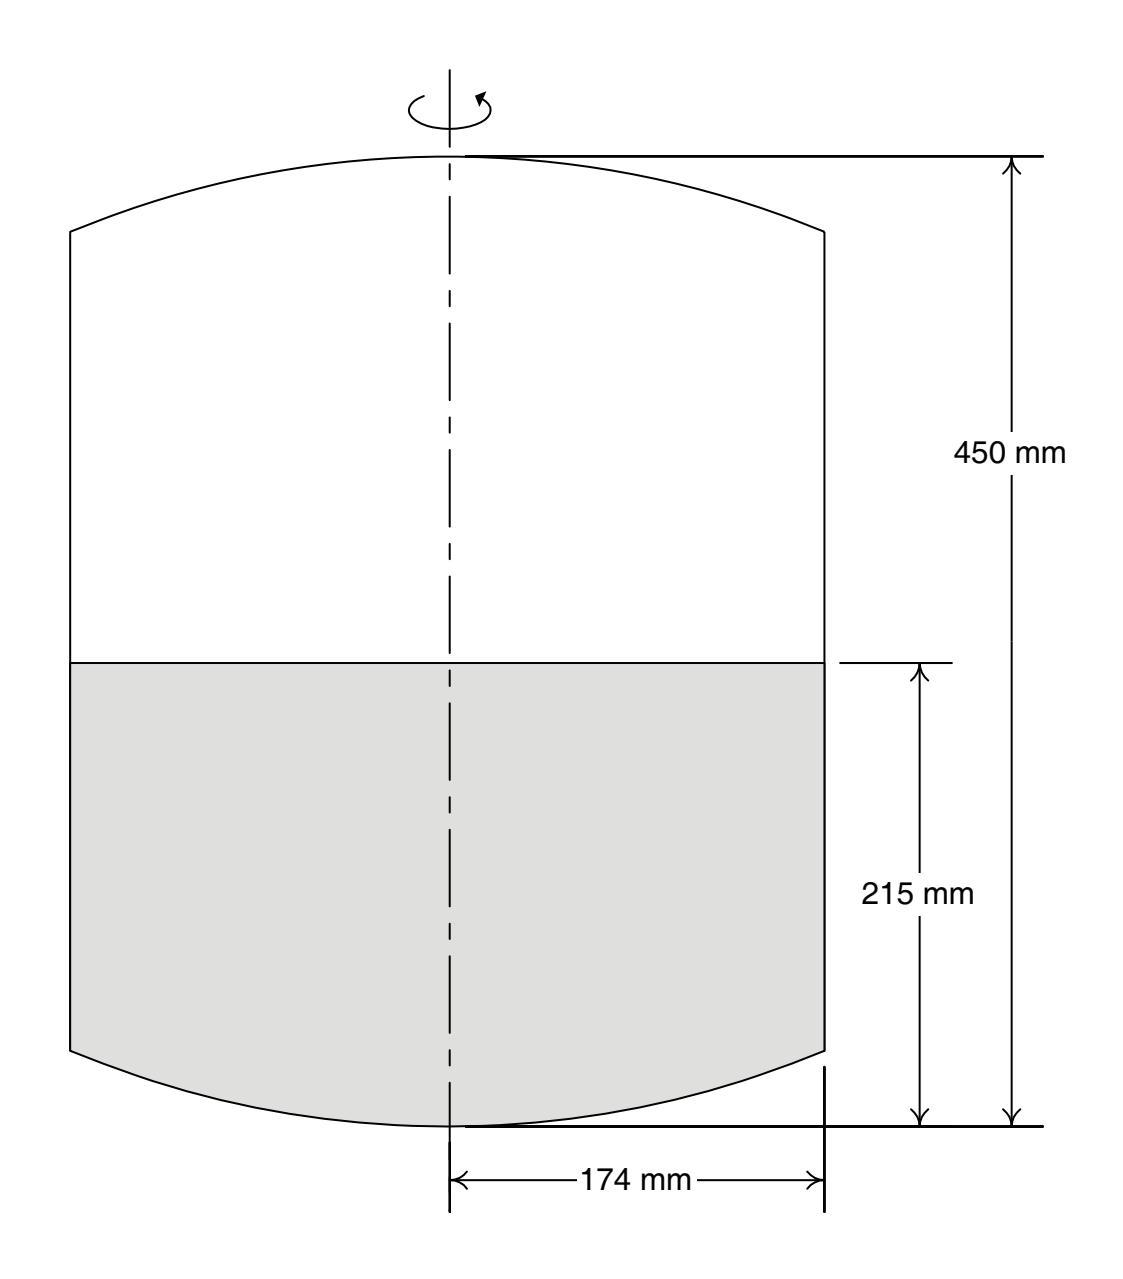
# 7. Mayak Production Association, 5 December 1960

Plutonium carbonate solution in a holding vessel; multiple excursions; insignificant exposures.

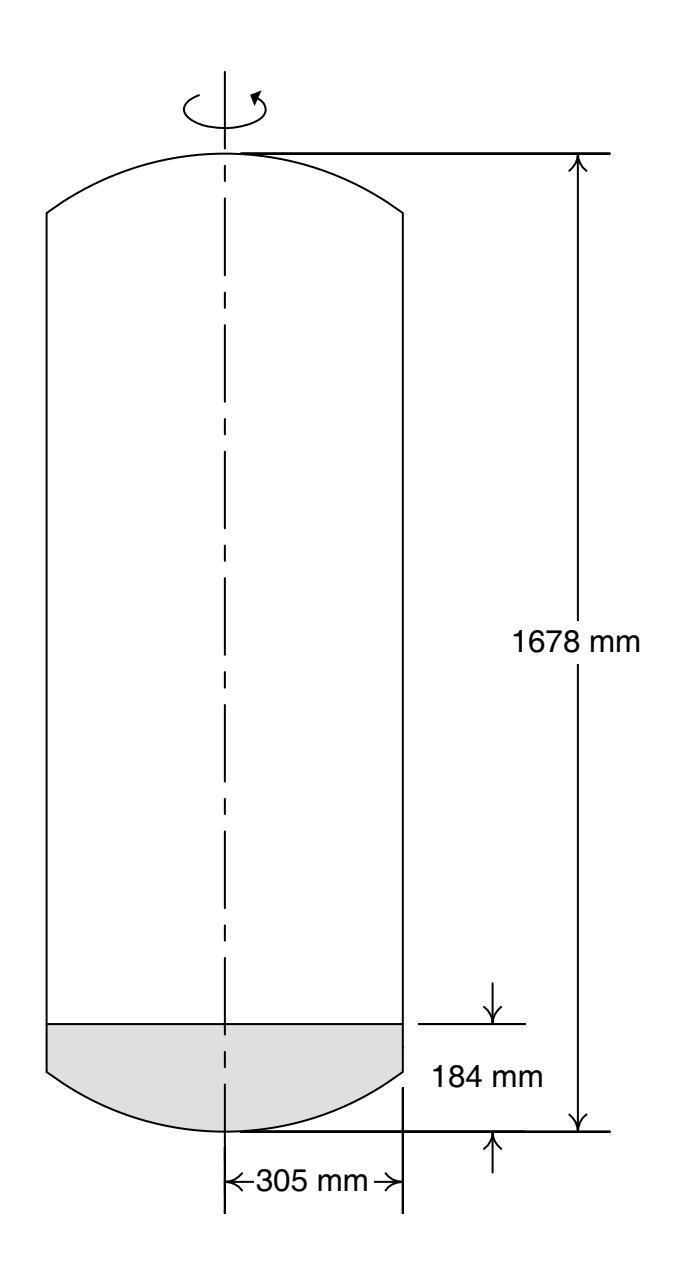
## 8. Idaho Chemical Processing Plant, 25 January 1961

Uranyl nitrate solution, U(90), in a vapor disengagement vessel; multiple excursions; insignificant exposures.

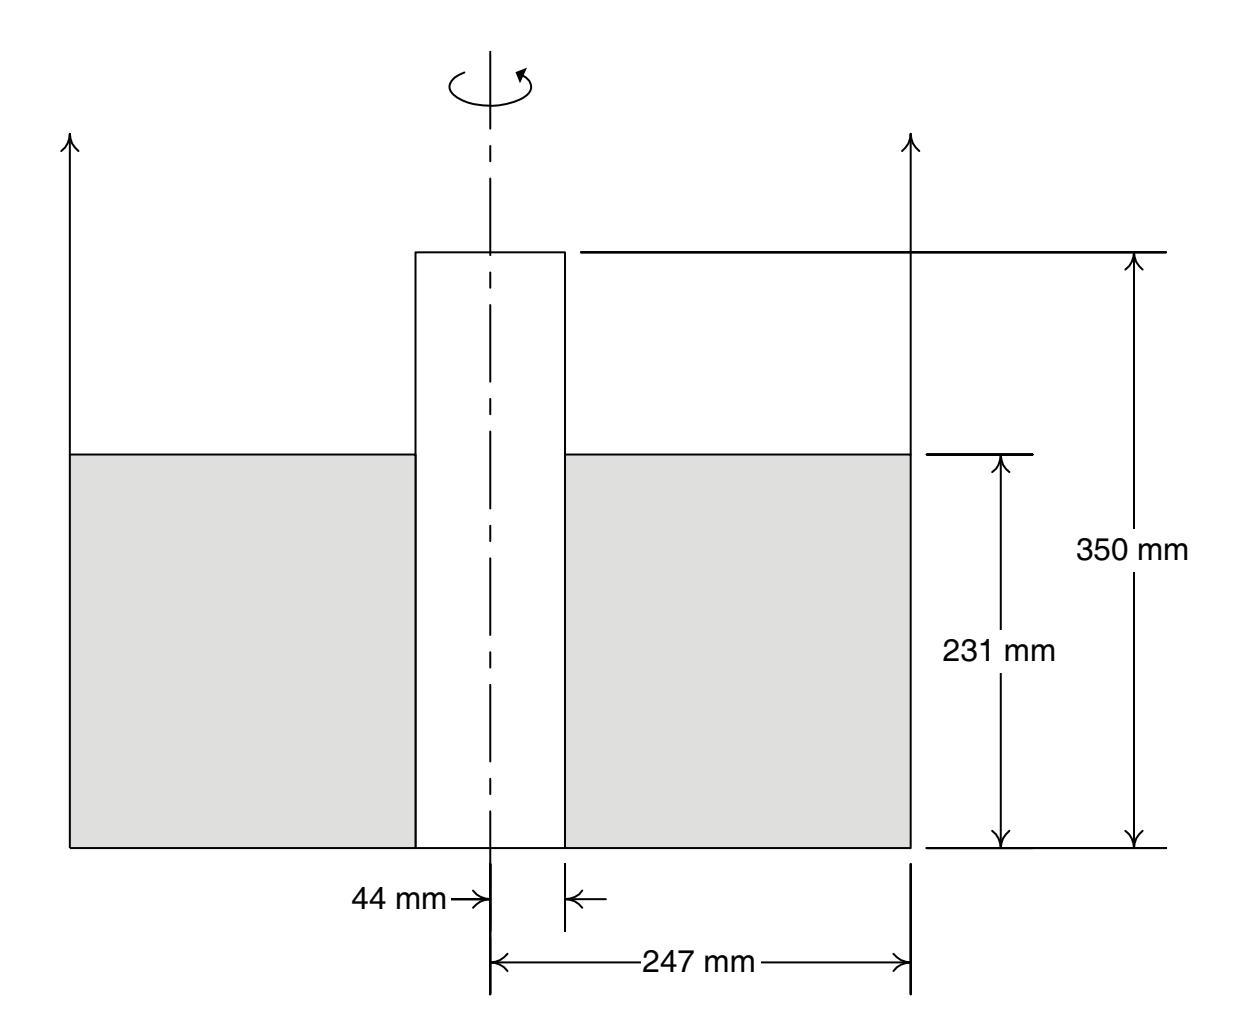
## 9. Siberian Chemical Combine (Tomsk), 14 July 1961

Uranium hexafluoride, U(22.6), accumulation in a vacuum pump oil reservoir; two excursions; one significant exposure.

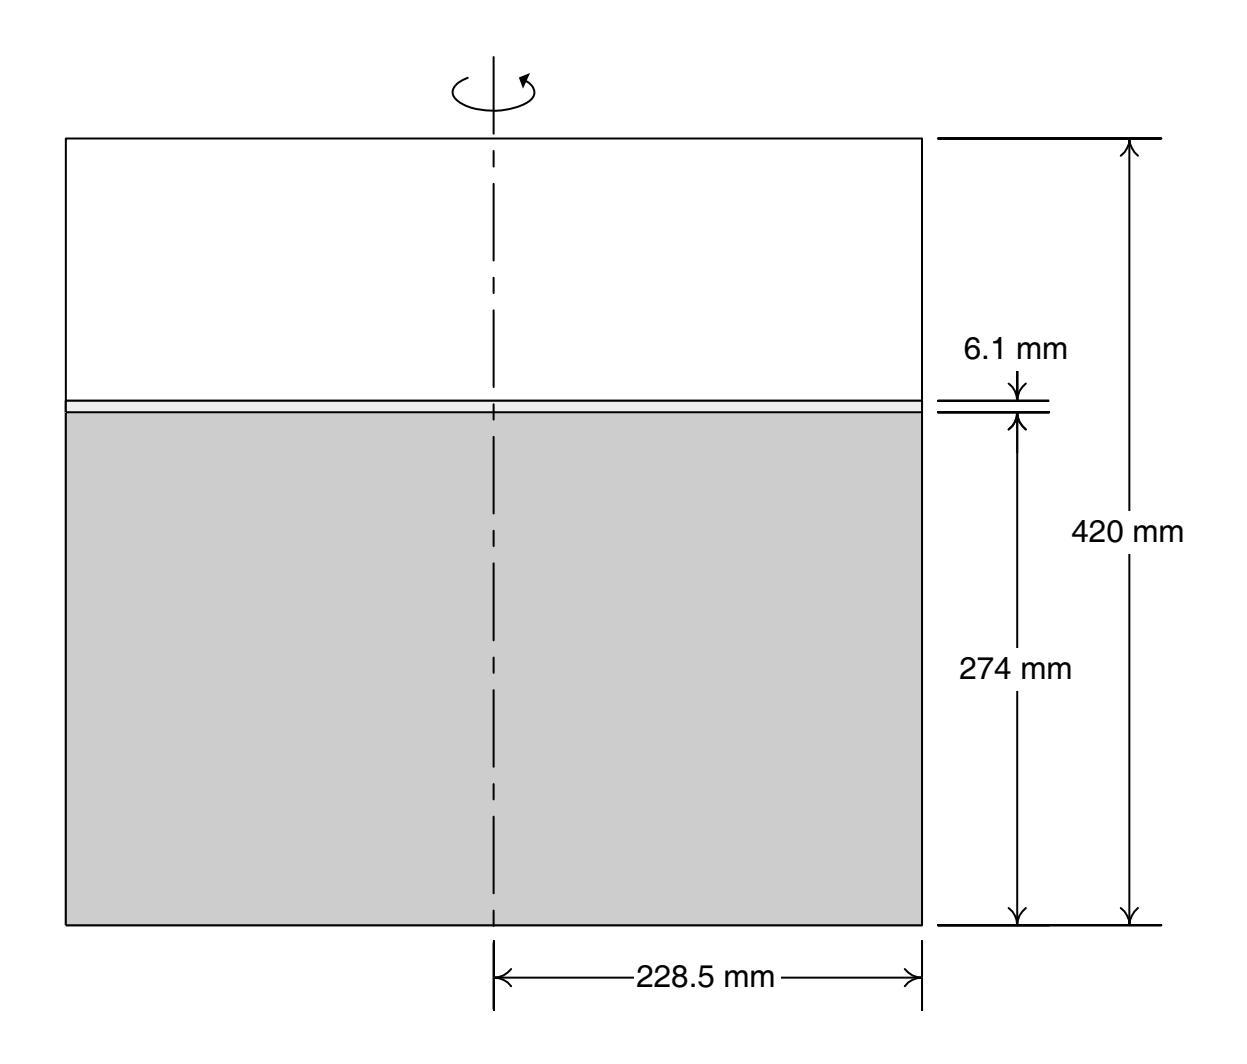
# 10. Hanford Works, 7 April 1962

*Plutonium solution in a transfer vessel; multiple excursions; three significant exposures.*

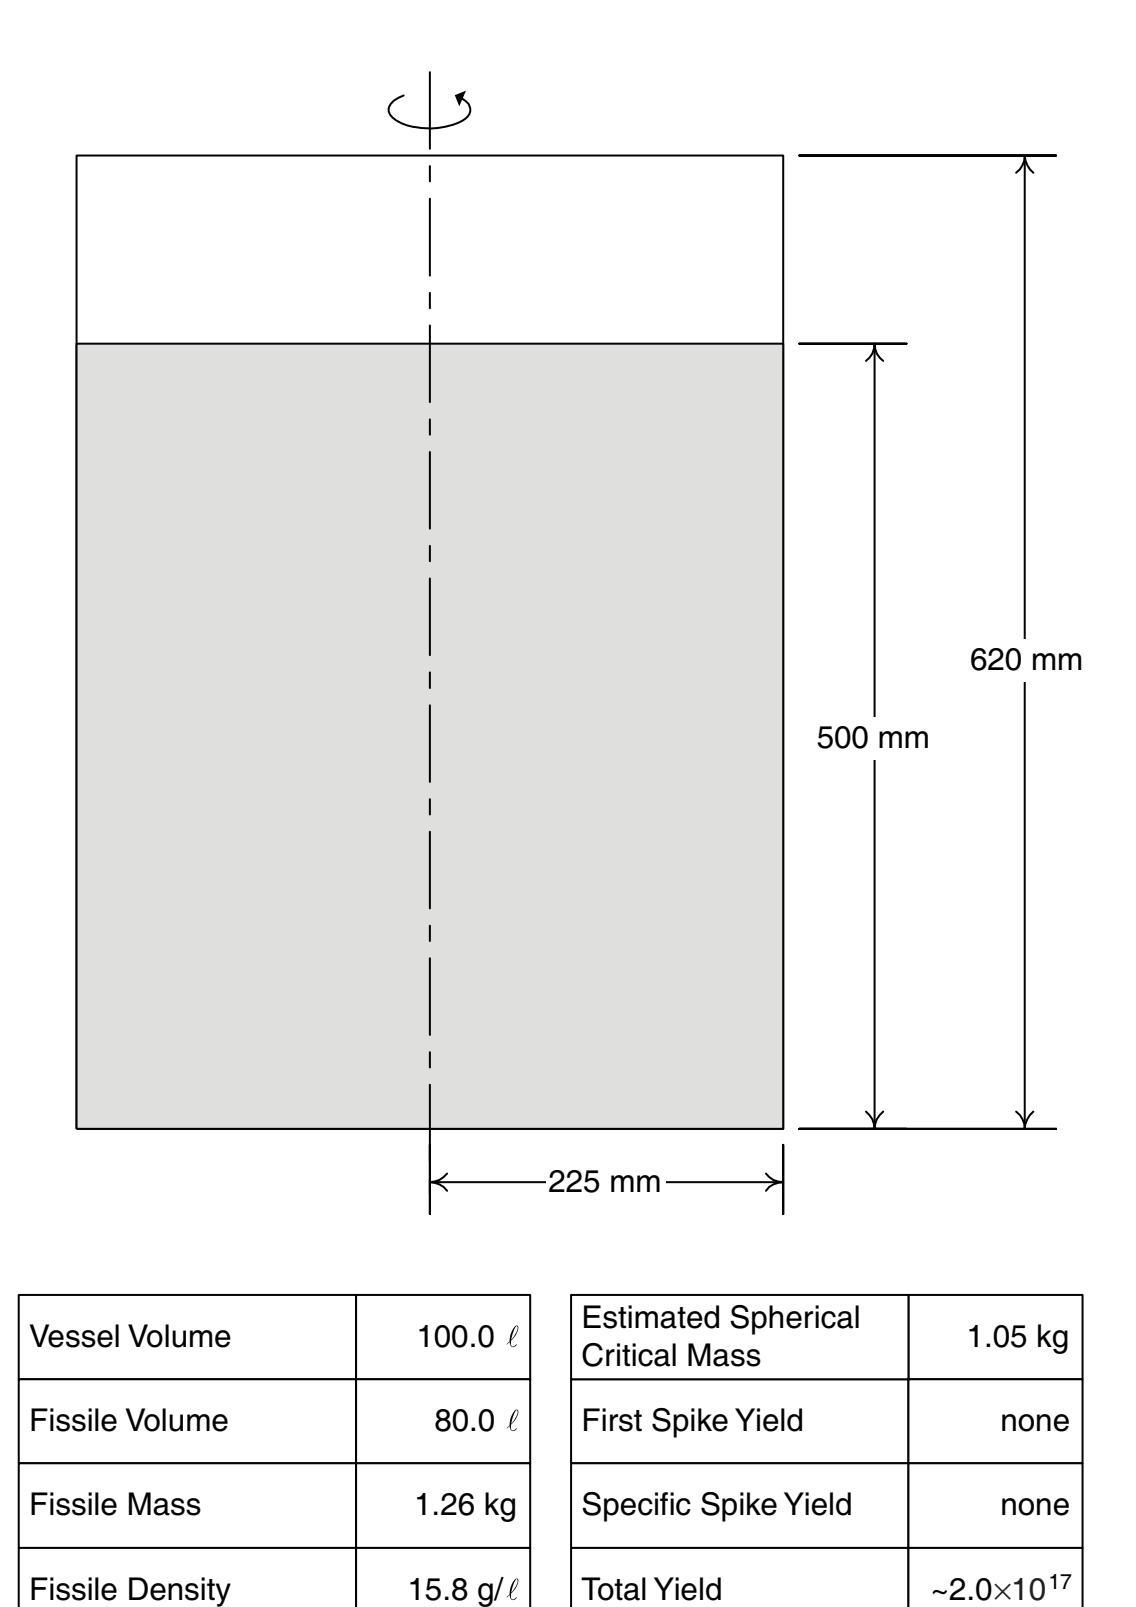
### 11. Mayak Production Association, 7 September 1962

Plutonium nitrate in a dissolution vessel; three excursions; insignificant exposures.

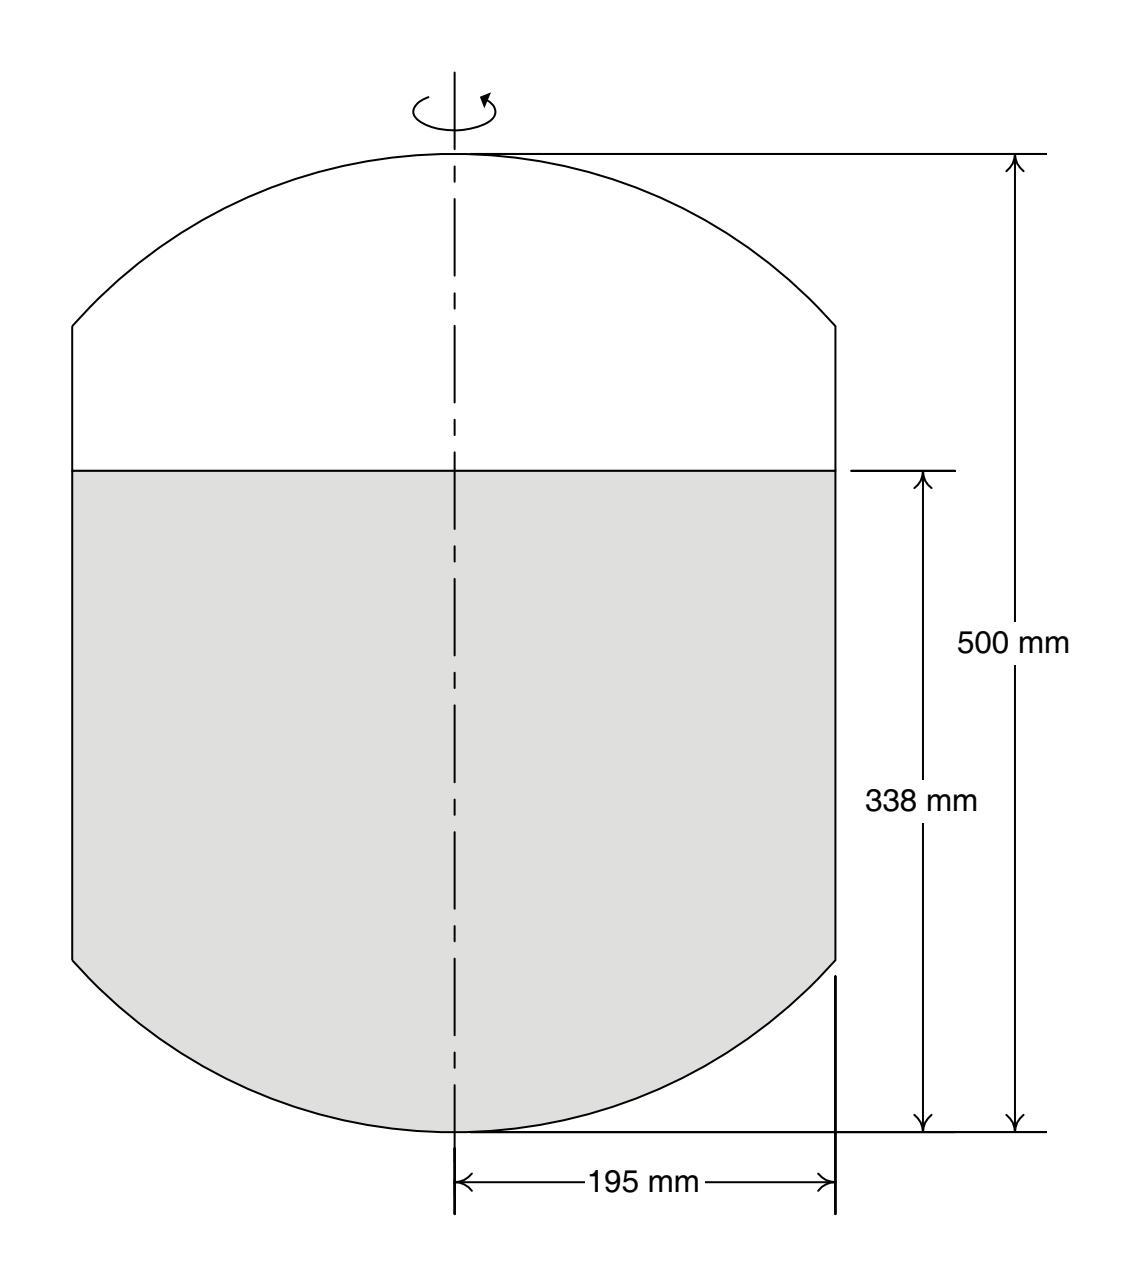
### 12. Siberian Chemical Combine (Tomsk), 30 January 1963

*Uranyl nitrate solution, U(90), in a collection vessel; multiple excursions; insignificant exposures.*
