# A Review of Criticality Accidents

2000 Revision

LA-13638 Issued: May 2000

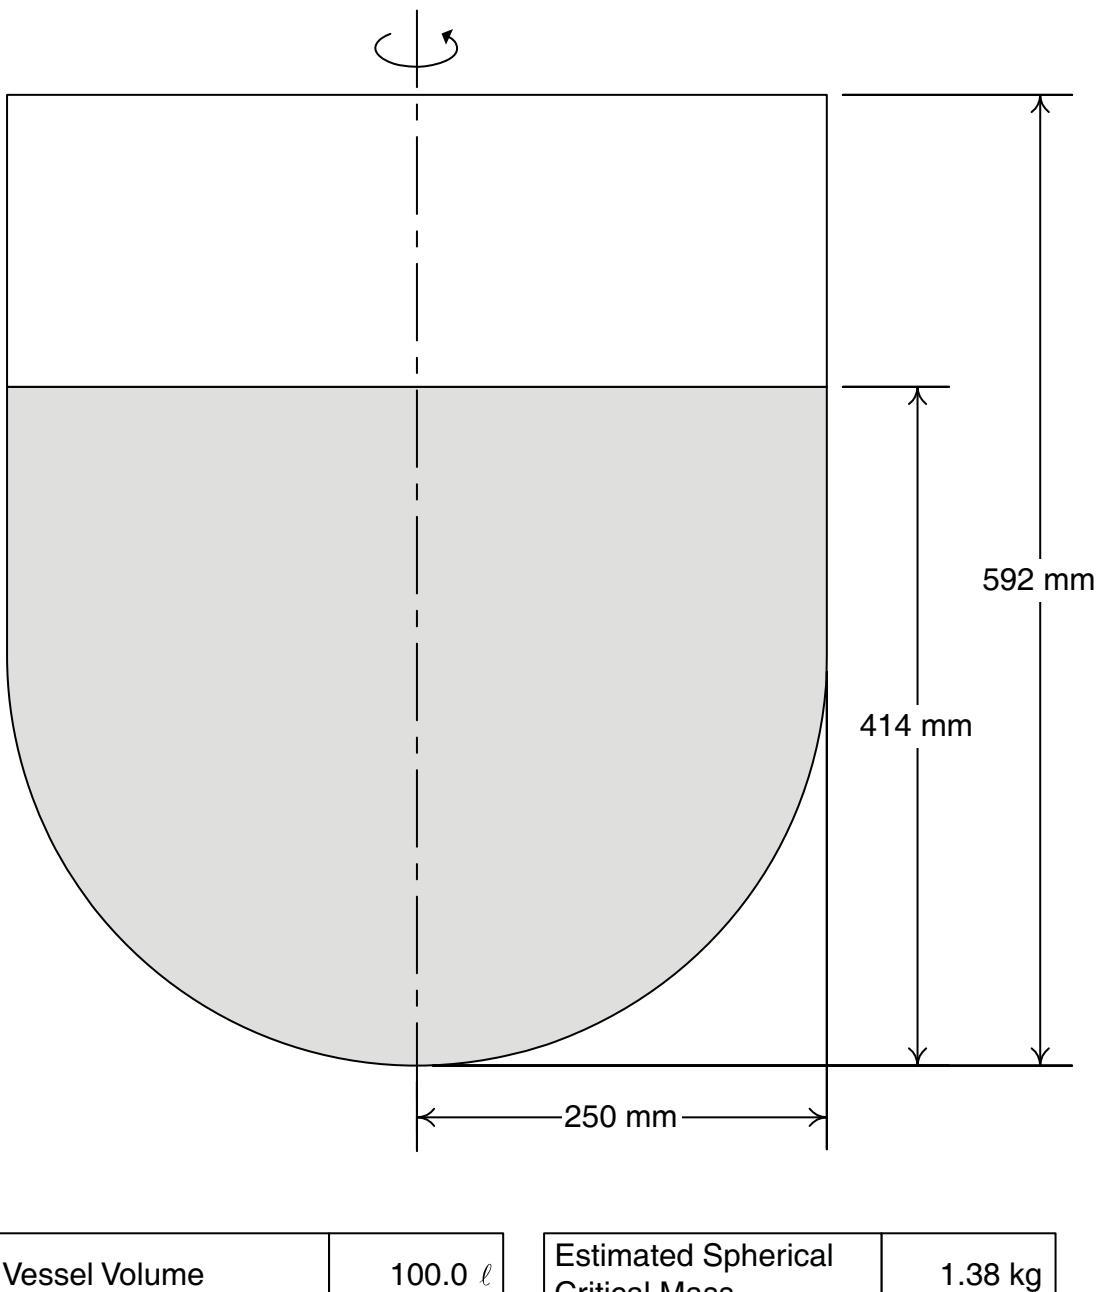
## 13. Siberian Chemical Combine, 2 December 1963

Uranium organic solution, U(90), in a vacuum system holding vessel; multiple excursions; insignificant exposures.

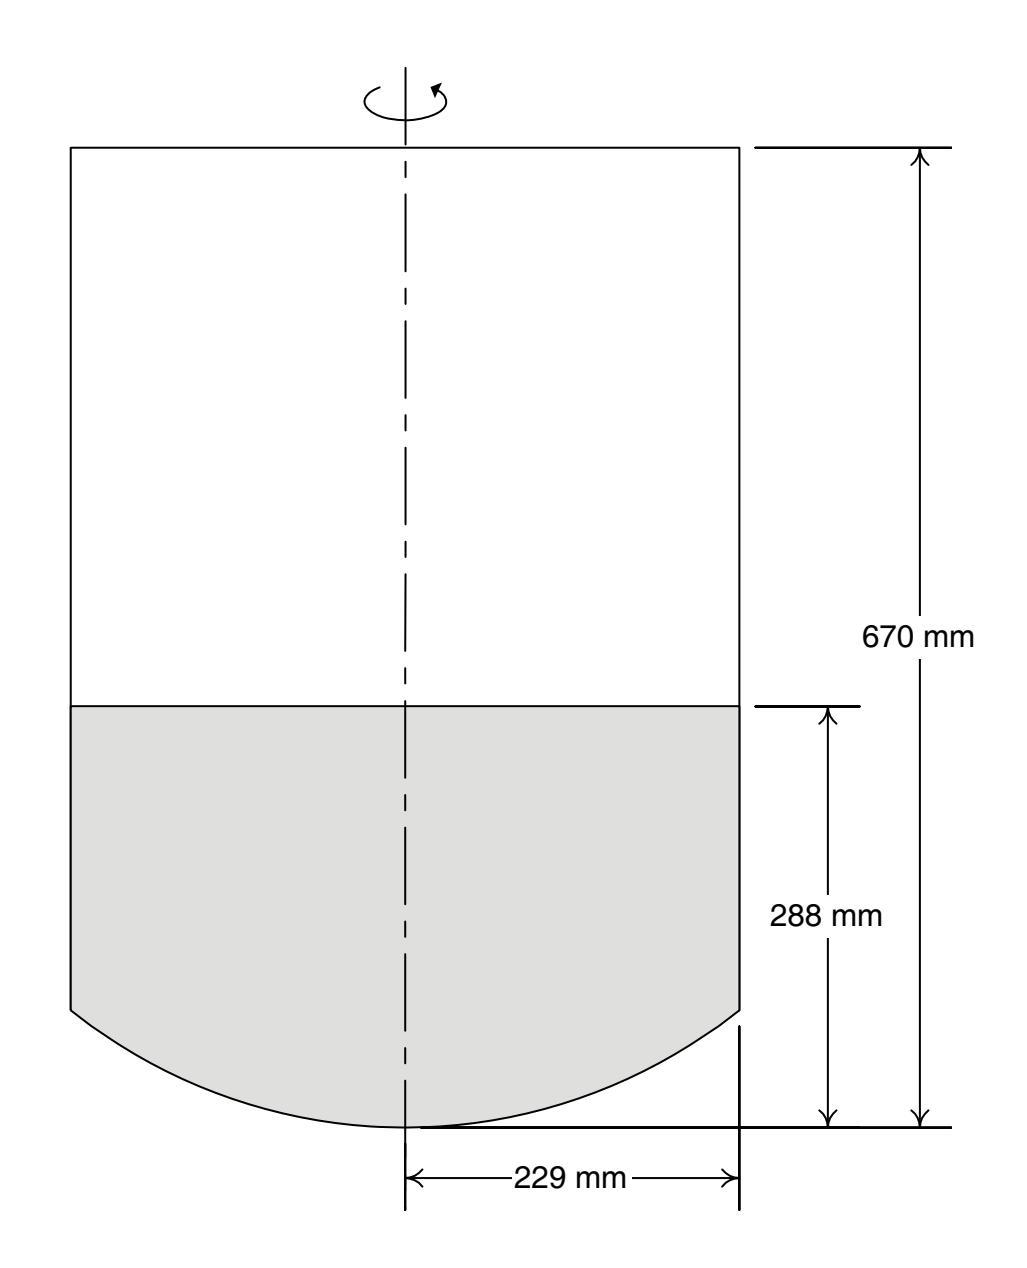
## 14. United Nuclear Fuels Recovery Plant, 24 July 1964

*Uranyl nitrate solution, U(93), in a carbonate reagent makeup vessel; two excursions; one fatality, two significant exposures.*

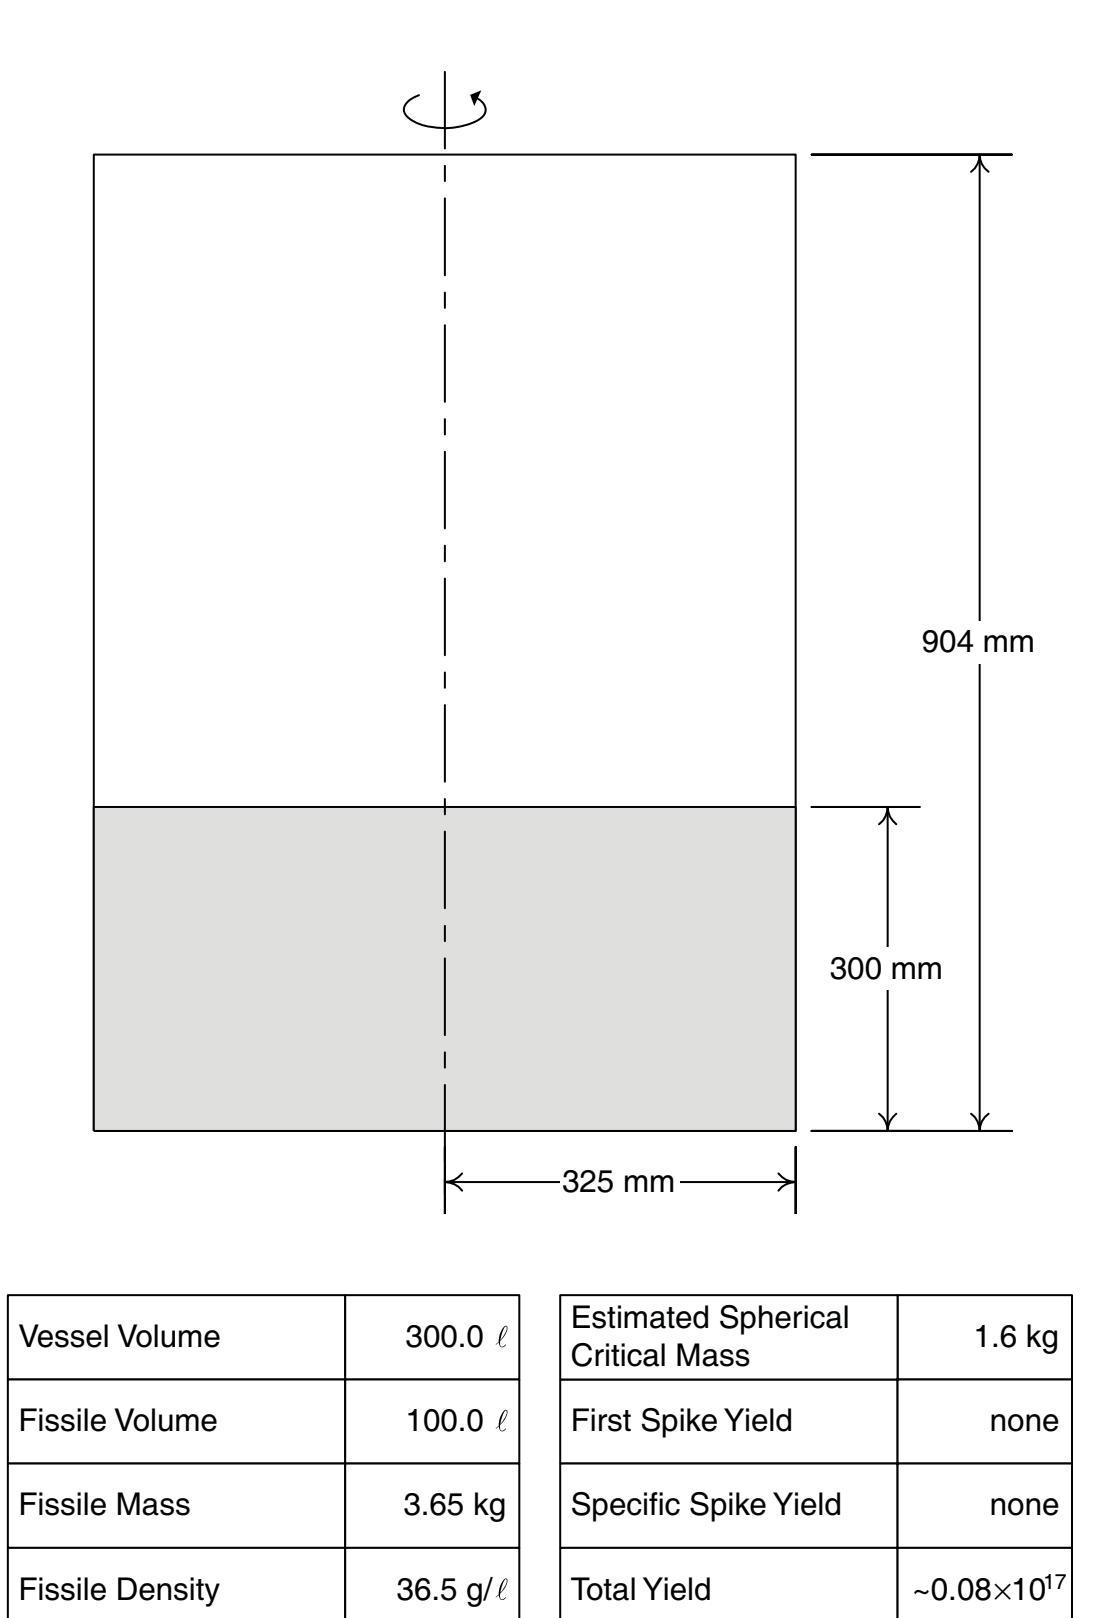
## 15. Electrostal Machine Building Plant, 3 November 1965

Uranium oxide slurry, U(6.5), in a vacuum system vessel; single excursion; insignificant exposures.

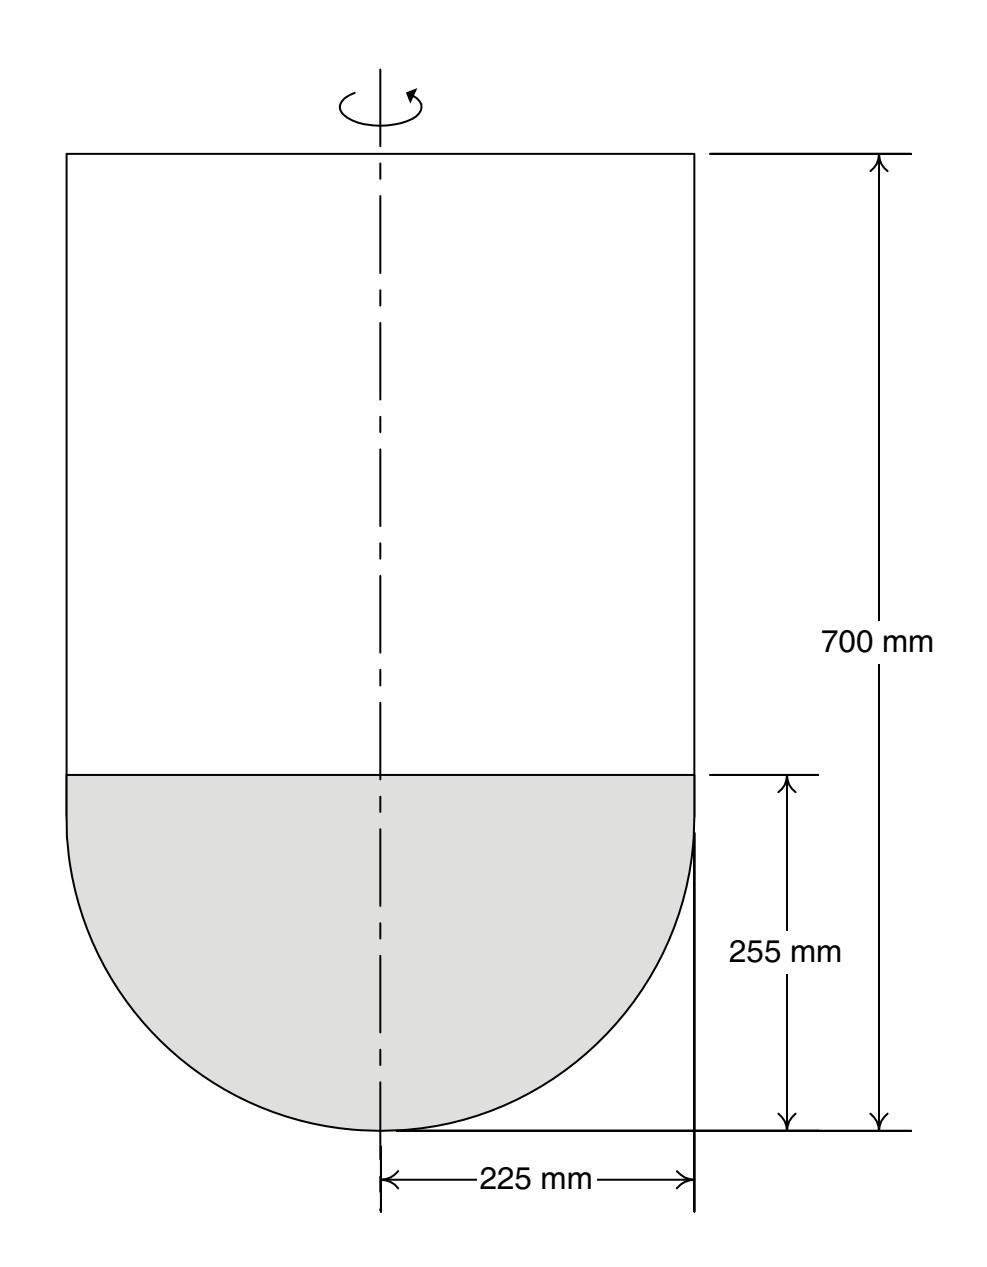
## 16. Mayak Production Association, 16 December 1965

*Uranyl nitrate solution, U(90), in a dissolution vessel; multiple excursions; insignificant exposures.*

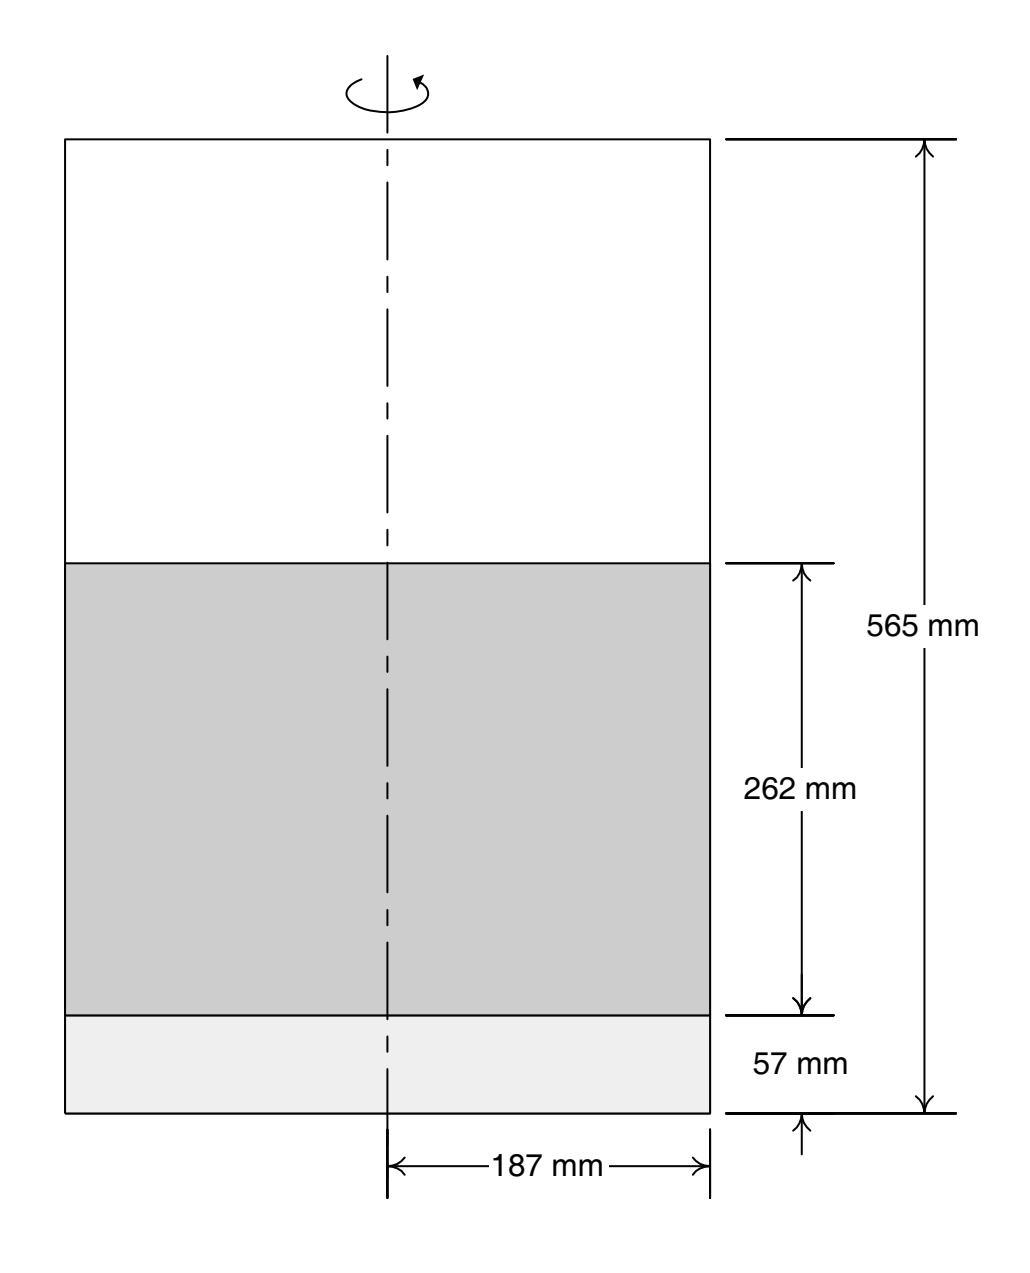
## 17. Mayak Production Association, 10 December 1968

Plutonium solutions (aqueous and organic) in a 60 liter vessel; three excursions; one fatality, one serious exposure.

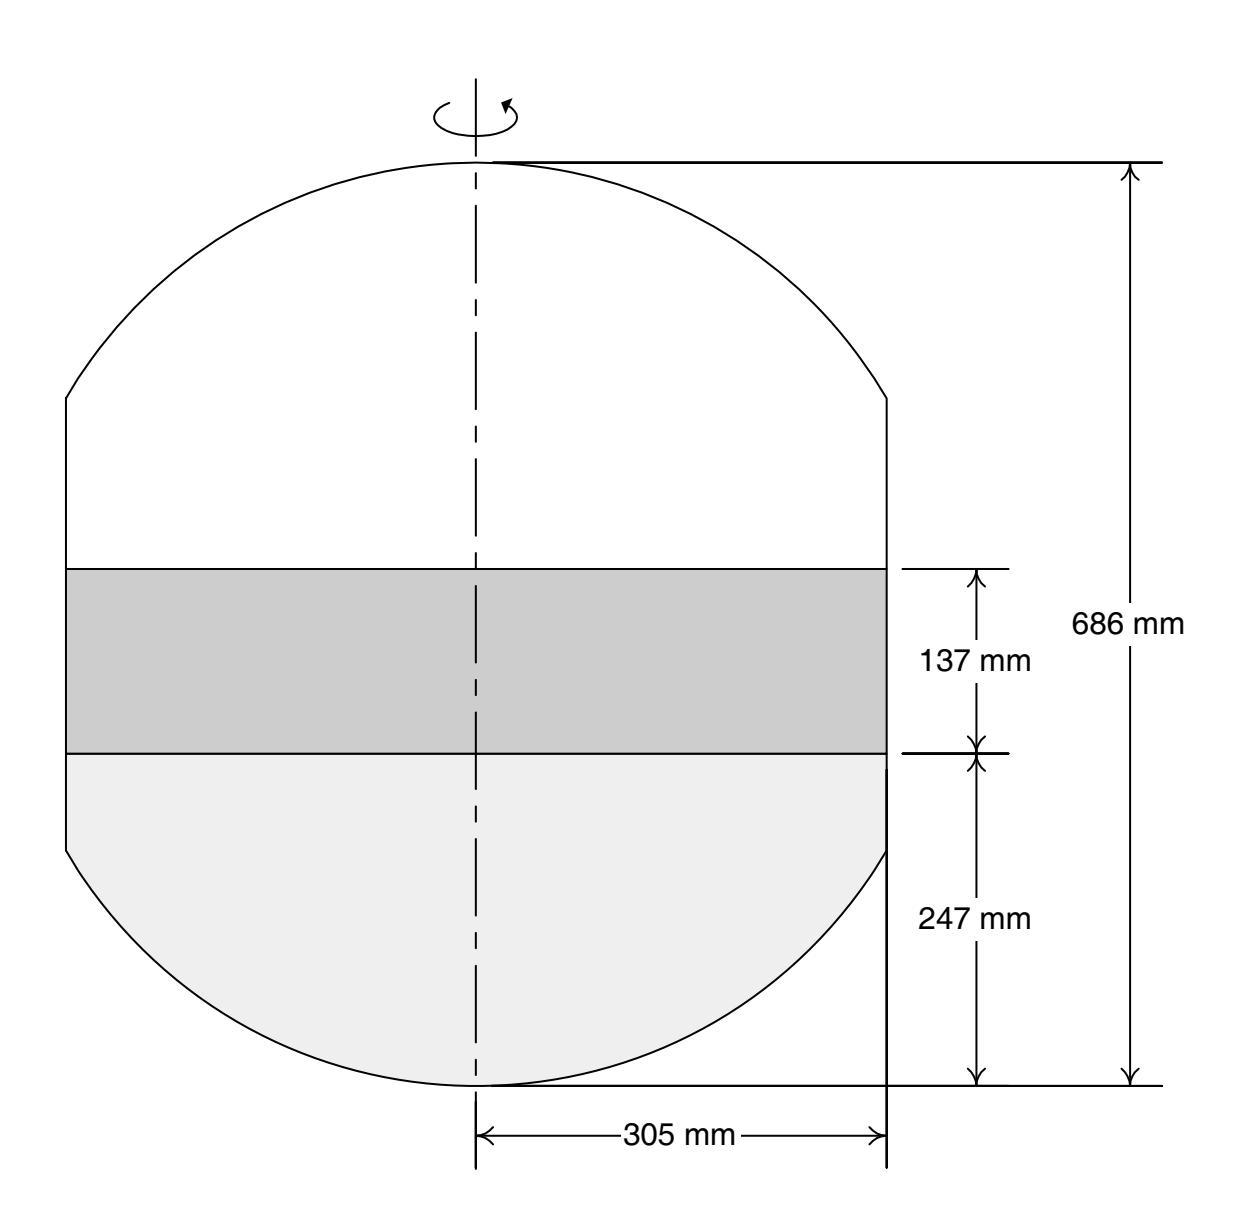
## 18. Windscale Works, 24 August 1970

Plutonium organic solution in a transfer vessel; one excursion; insignificant exposures.

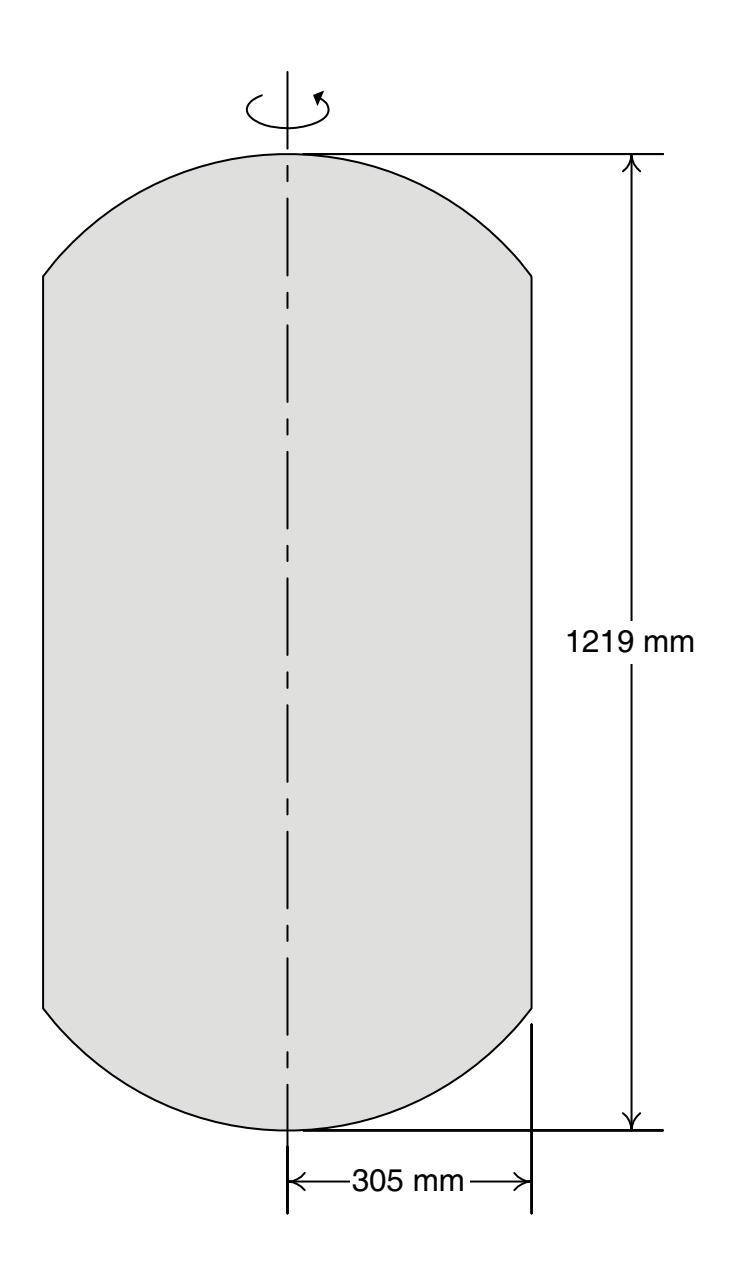
## 19. Idaho Chemical Processing Plant, 17 October 1978

Uranyl nitrate solution, U(82), in a lower disengagement section of a scrubbing column; excursion history unknown; insignificant exposures.

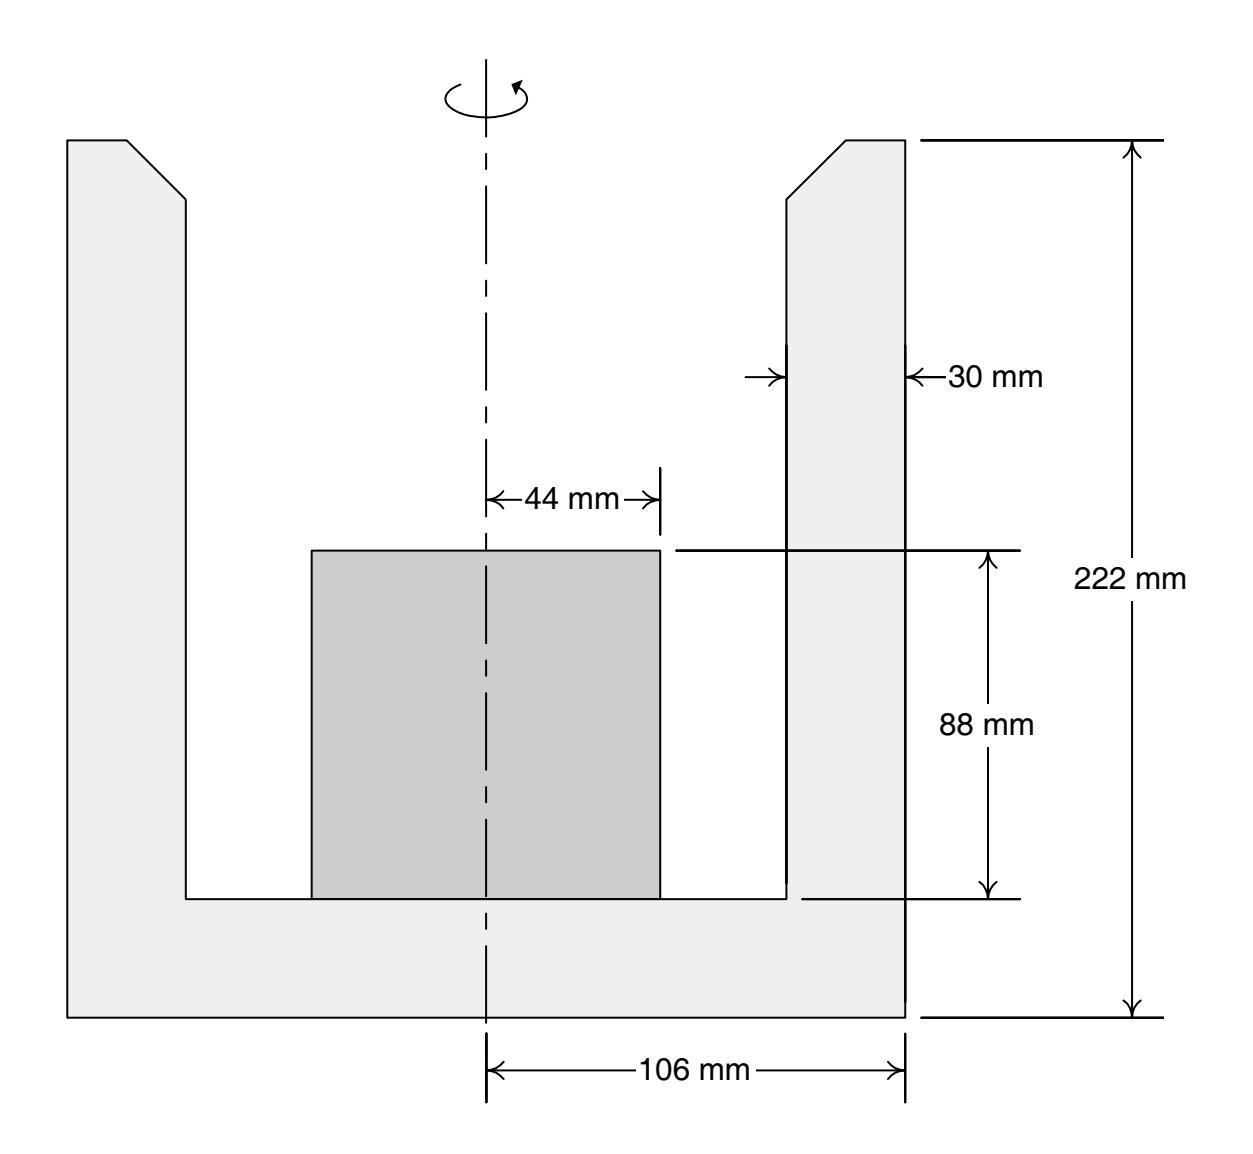
## 20. Siberian Chemical Combine (Tomsk), 13 December 1978

Plutonium metal ingots in a storage container; single excursion; one serious exposure, seven significant exposures.

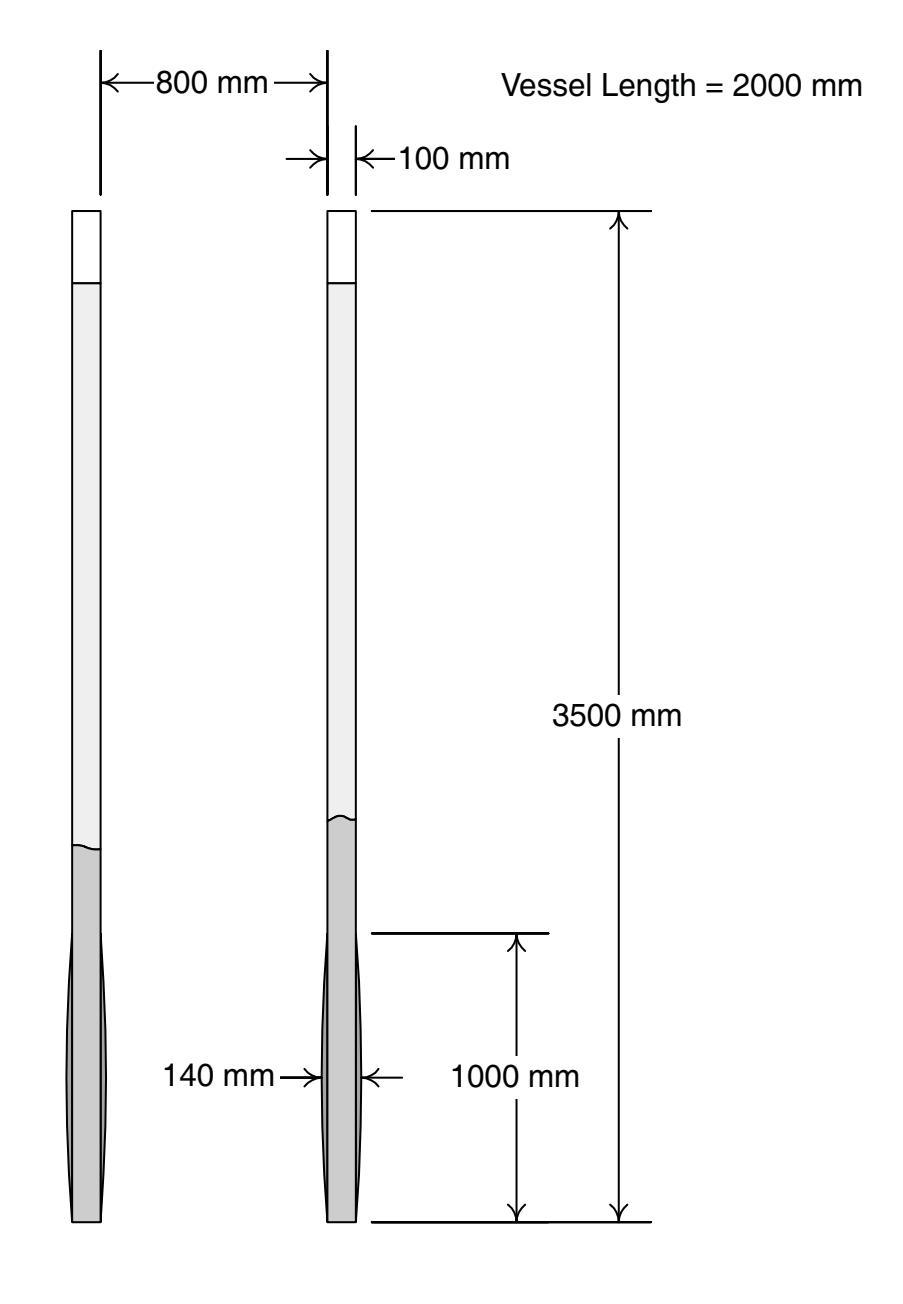
## 21. Novosibirsk Chemical Concentration Plant, 15 May 1997

Uranium oxide slurry and crust, U(70), in the lower regions of two parallel vessels; multiple excursions; insignificant exposures.

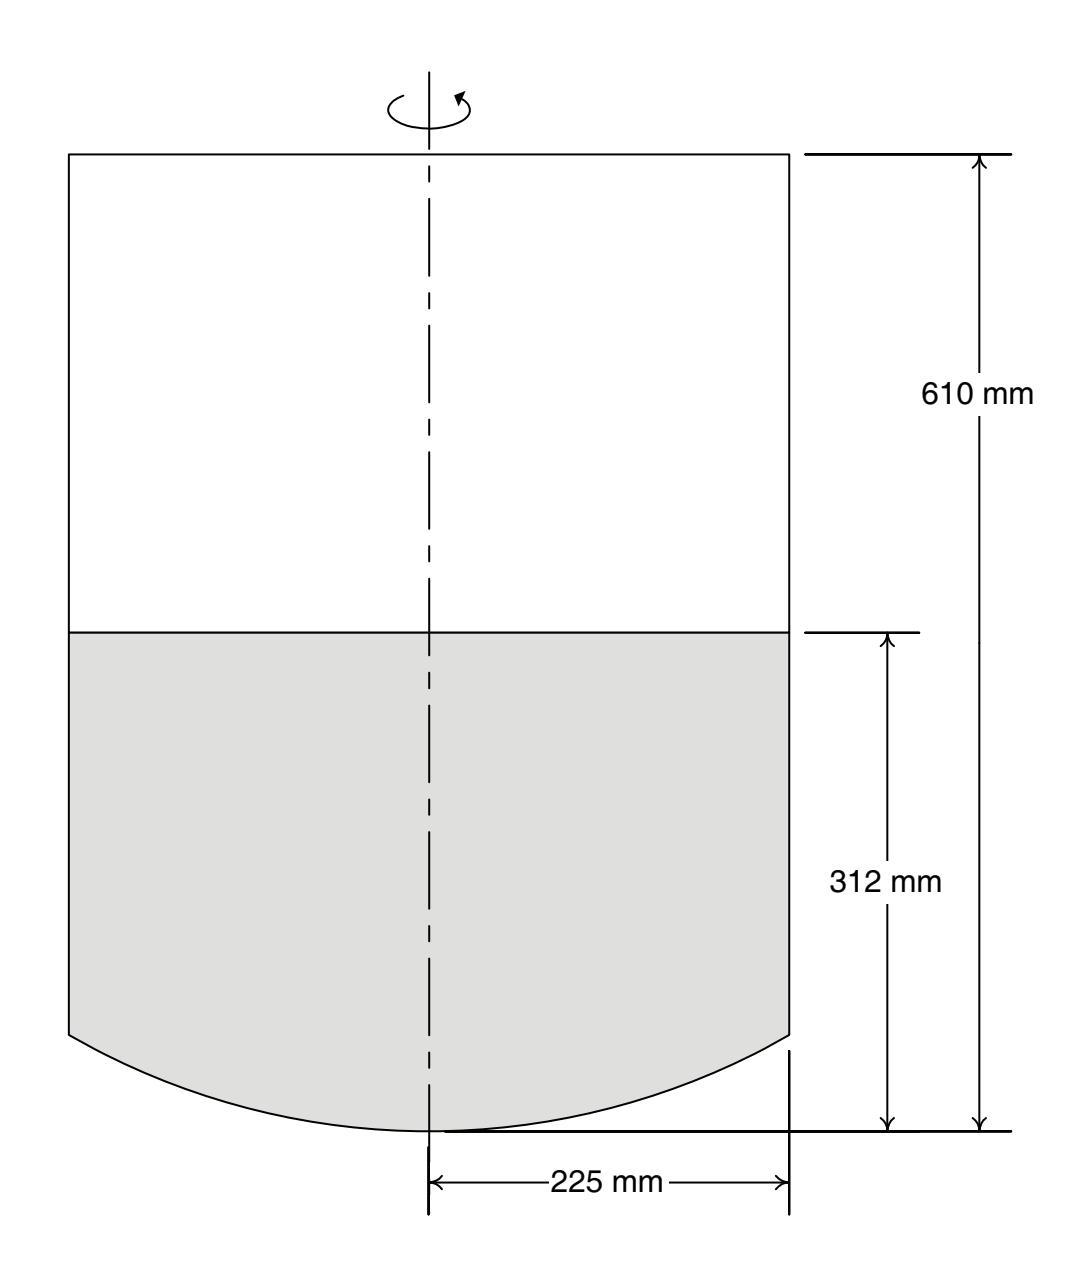
## 22. JCO Fuel Fabrication Plant, 30 September 1999

*Uranyl nitrate solution, U(18.8), in a precipitation vessel; multiple excursions; two fatalities, one significant exposure.*
