Rupture of Model 48Y UF₆ Cylinder and Release of Uranium Hexafluoride

Sequoyah Fuels Facility
Gore, Oklahoma
January 4, 1986

**U.S. Nuclear Regulatory
Commission**

Augmented Investigation Team

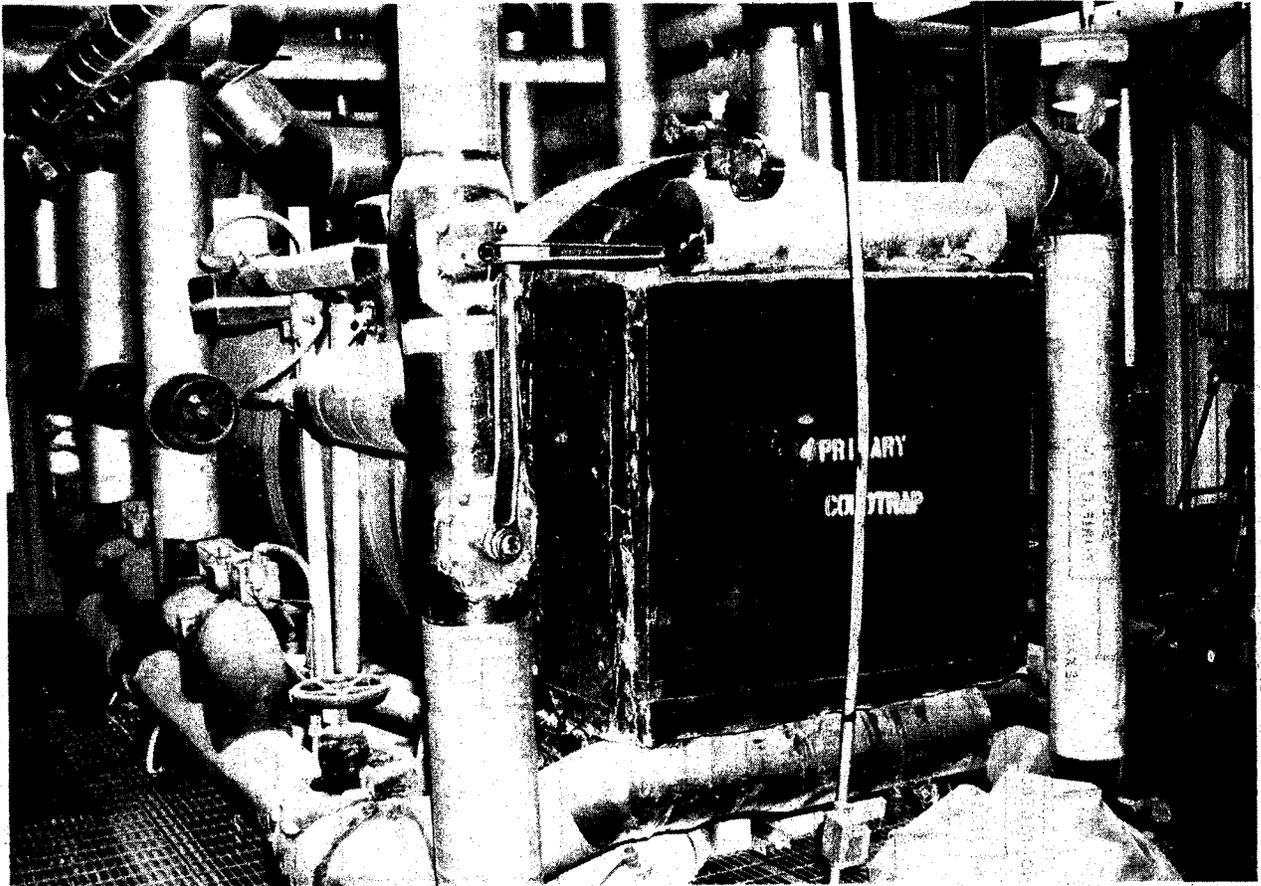
Figure 3.3 UF_6 cold traps

The cold traps that collect the solid UF_6 product are located on the second floor of the process building. One of these traps is shown in Figure 3.3. There are four primary traps, three secondary traps, and two cleanup reactor traps. While certain traps are valved into the process line to collect the product, others are isolated from the process line and can be heated to enable gravity feed of UF_6 liquid to the cylinders. Still other traps, having been drained of their contents, are evacuated and remain at ambient temperature. The suction available from these traps may be used to draw off UF_6 from cylinders.

Cold traps receive gaseous UF_6 and condense the material to a solid form. When loaded, traps are heated to liquefy the UF_6 for draining to cylinders, two floors below.

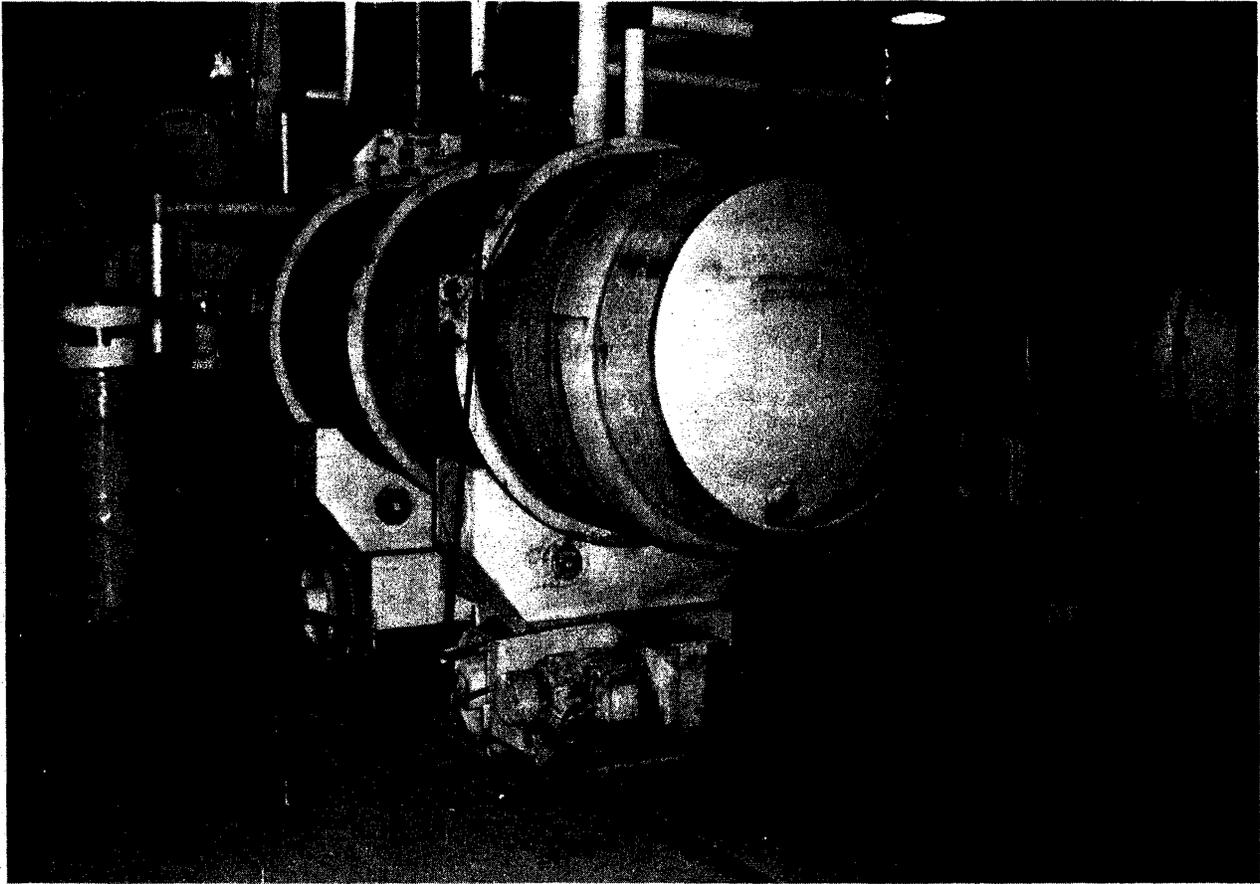
Figure 3.4 Cylinder-loading stations

An empty cylinder to be filled is placed on a four-wheeled cart, which is propelled on rails by an electric motor. This is shown in Figure 3.4. The cart with its attendant cylinder is moved to one of two drain bays each of which is equipped with scales. The general layout of the drain stations, final weigh stations, and steam chests is shown in Figure 3.5. The cart is moved onto the scales and a scale counterweight (tare poise) is adjusted to cancel the weight of the empty cylinder and the cart, as shown in Figure 3.6. The scales are set to indicate only the net weight of the product as the cylinder is filled, as shown in Figure 3.7. The time required to fill a cylinder may vary from one to several 8-hour work shifts depending on the production rate and the size of the cylinder. The maximum fill capacity for each type of cylinder is posted on a large sign located in the fill bay. There are no warning signs against heating overfilled cylinders, either in drain area or steam chest areas. The operator manually terminates the flow into the cylinder when the targeted fill weight is reached. There is no interconnection between the scales and the fill valve to allow for automatic termination of flow.

Two 14-ton cylinders are positioned on scale platforms to receive liquid UF_6 from heated cold traps overhead. Weight is observed on a large dial indicator in the background.

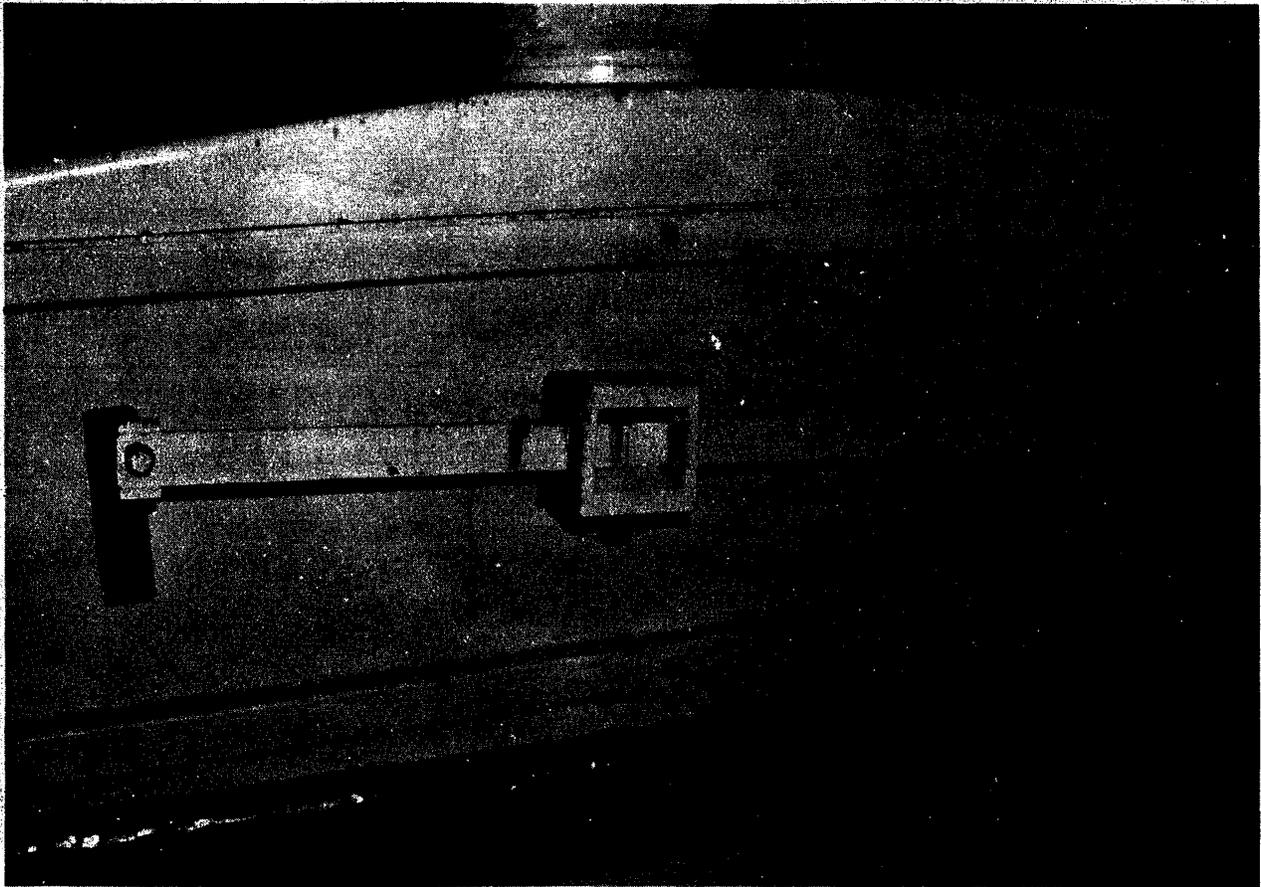
Figure 3.6 Tare-compensating weight

The tare weight of an empty cylinder and the cart is eliminated from the observed weight by moving the poise on the beam until the dial indicator reads zero.

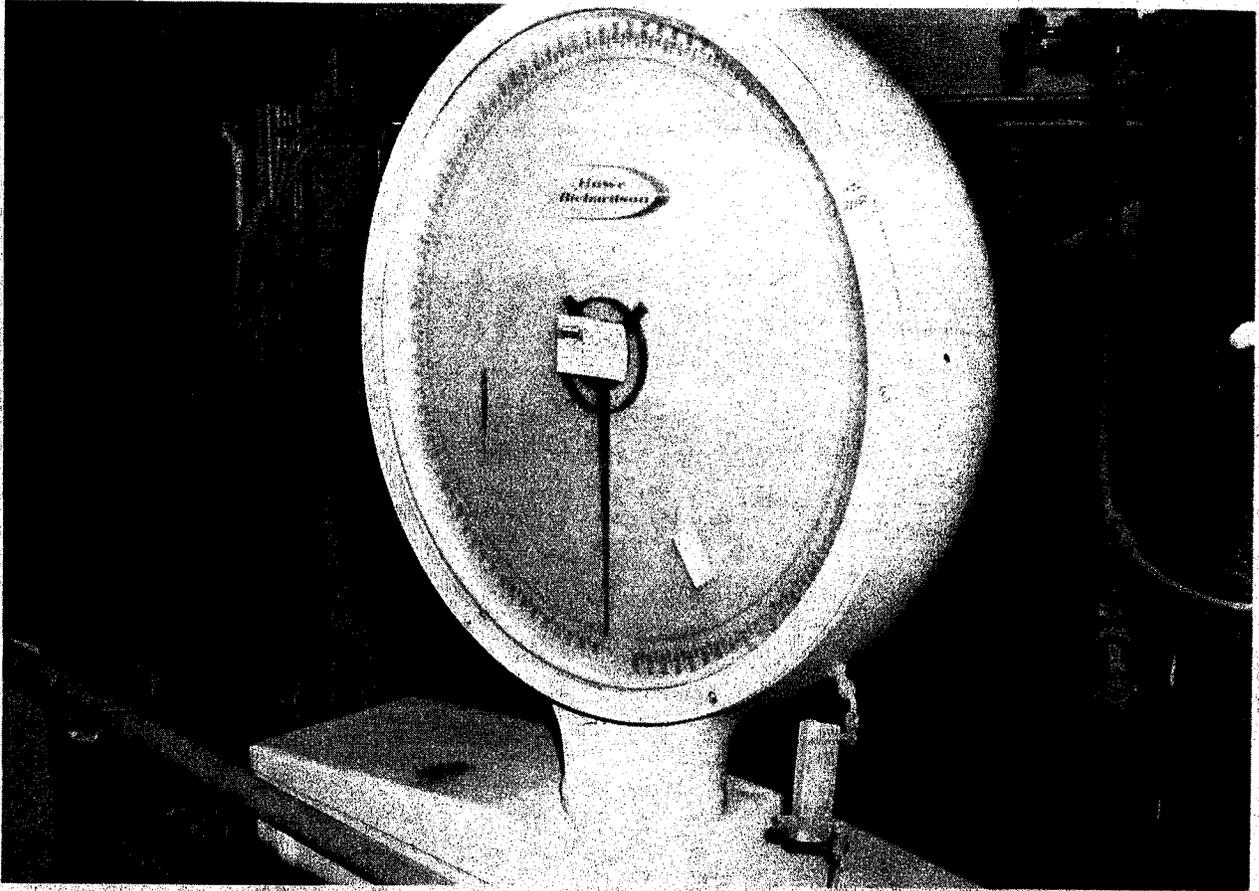
Figure 3.7 Scale dial indicator

With an empty cylinder on its cart and the tare-compensating mechanism adjusted to zero, the dial indicator records the net weight of the cylinder contents.

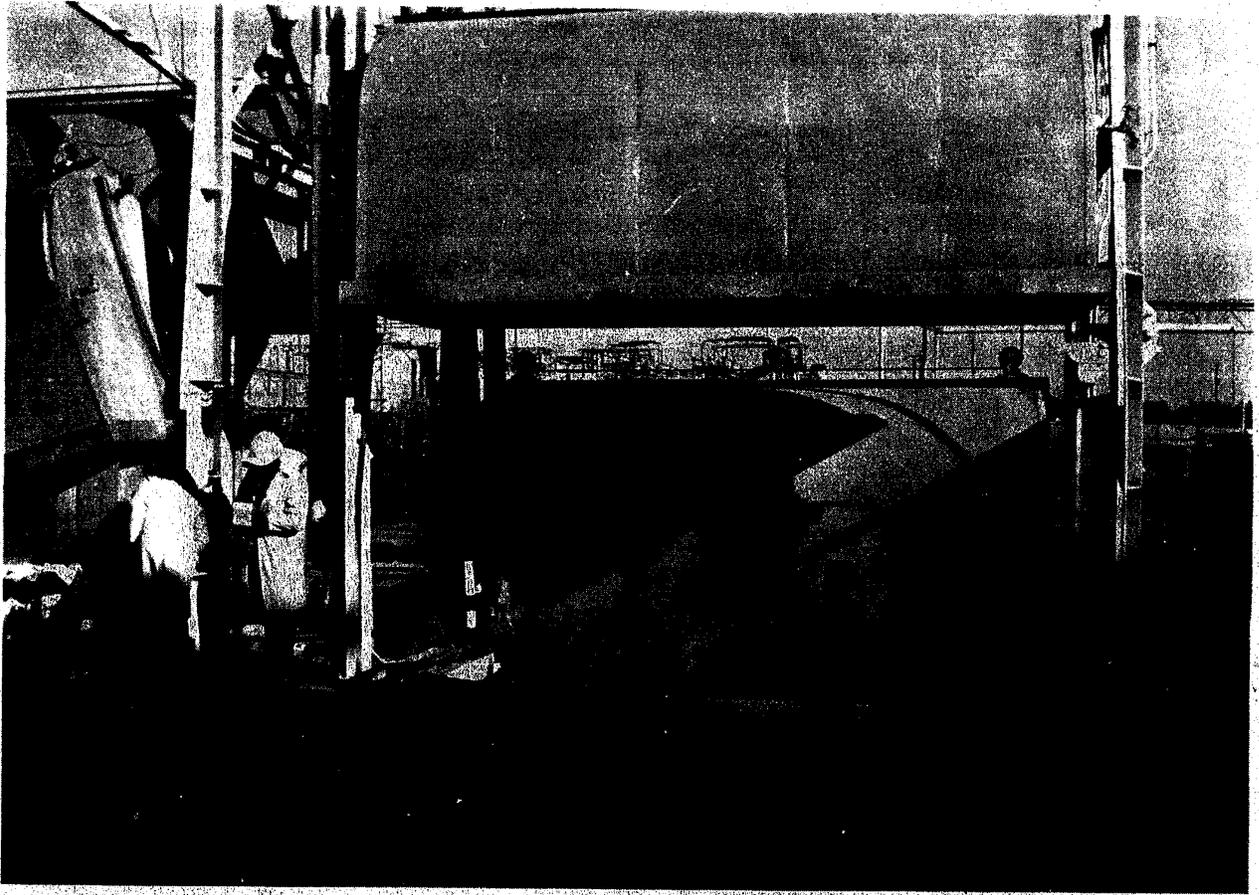
Figure 3.9 Steam chests

Two of the undamaged steam chests are shown. The nearer chest cover has been raised, showing the cradle on which the UF_6 cylinder is placed and the steam manifold through which steam is introduced. In the background, the cover has been lowered for heating.

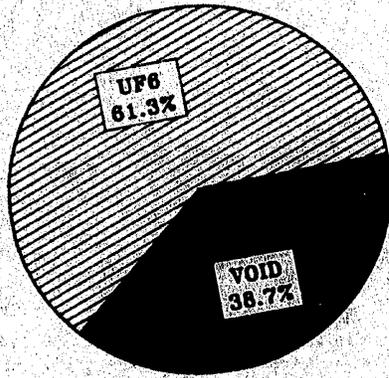
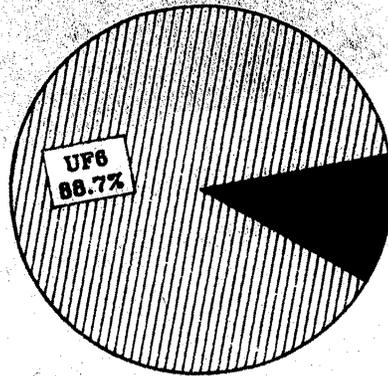
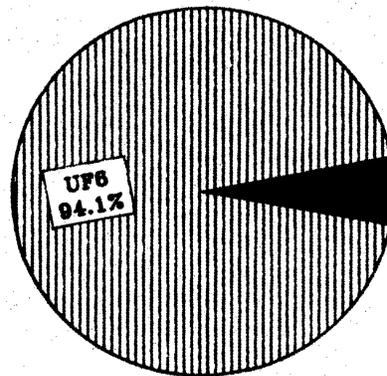
Figure 3.17
Uranium Hexafluoride Cylinder
Model 48Y Normally Filled
Contents Weight: 27,560 pounds

Figure 3.17 graphically depicts the relative volumes occupied by UF_6 in a normally filled cylinder when the UF_6 is in the solid phase at 100°F and the liquid phase at 200°F and 250°F. The UF_6 undergoes an increase in volume of about 36% when it changes from solid to liquid form at 147°F. Large internal pressures can be produced hydraulically when liquid contents expand to a volume greater than the volume of the vessel in which they are contained.
