Shield Building Crack Investigation and Root Cause Presentation

Davis-Besse Nuclear Power Station

August 9, 2012

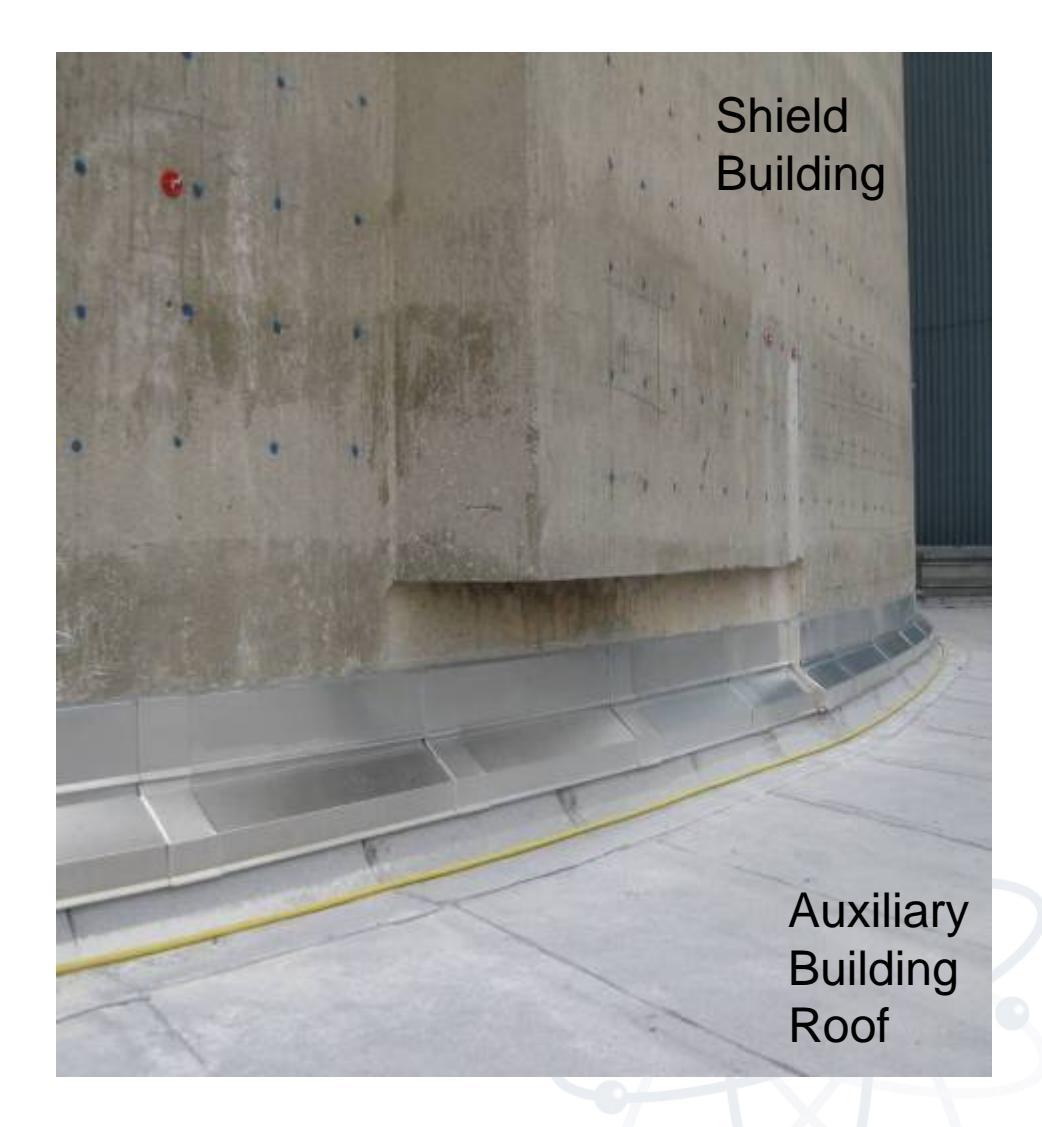
- The flute shoulders are a part of the Shield Building; concrete for shoulders and building shell was placed concurrently
- Evaluation of structural capacity of Shield Building does not credit flute shoulders
- Evaluated as a dead load in structural analysis

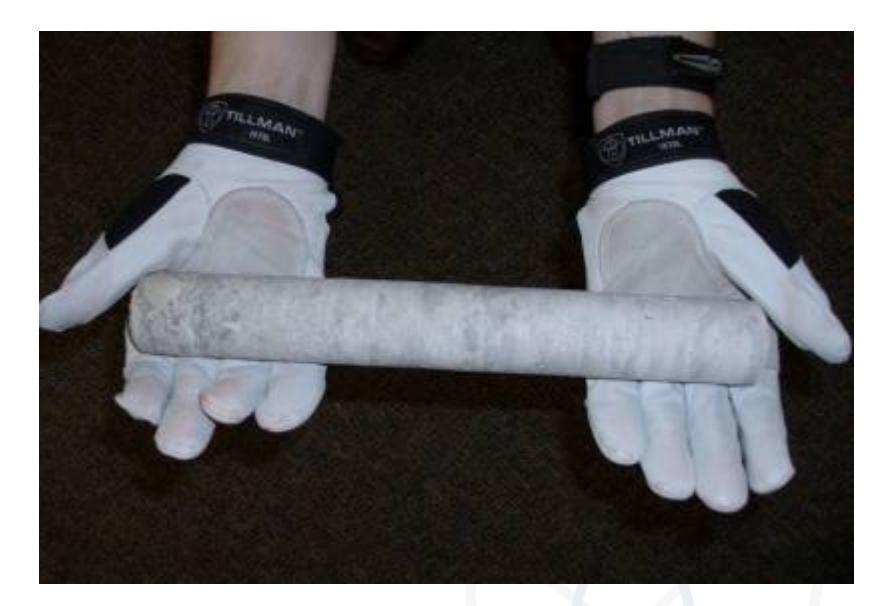
- Typical concrete sample showing the laminar crack sheared the coarse aggregate
- Therefore, laminar crack occurred after the concrete achieved it strength

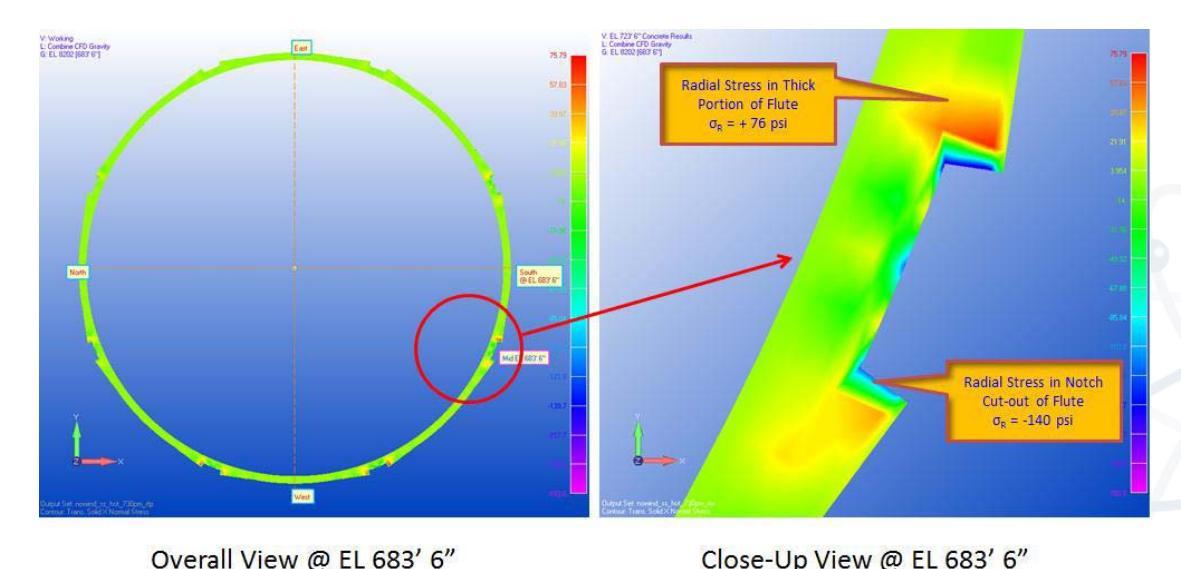
- Numerous computer analyses were performed for normal design conditions
 - Self weight, wind loads
 - Thermal analyses (summer hot and winter cold conditions)
 - Fujita Category 2 tornado
- Stresses were significantly below the normal tensile capacity of the concrete

- Design stresses can not initiate the laminar crack
- Significant stresses beyond what is normally analyzed would be required to crack the concrete

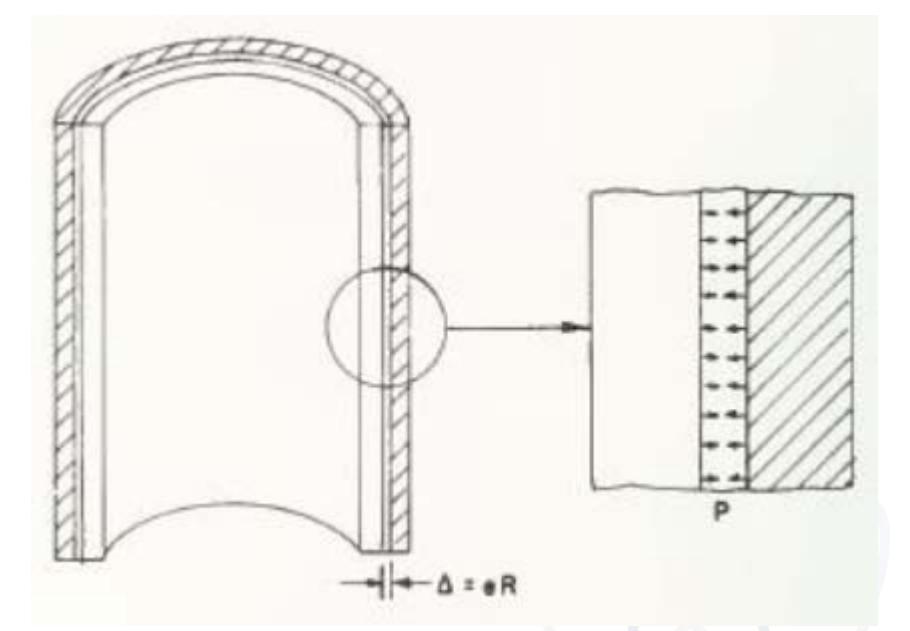
- Ontario Ministry of the Environment study on 50 above ground water tanks in Ontario
- Water migrated into the concrete from the inside
 - Inner layer of the wall freezes and expands
 - Outer layer of wall contracts
 - Creates high radial stress
 - Results in laminar cracking

Conclusion: Laminar cracking as a result of water freezing is a real potential

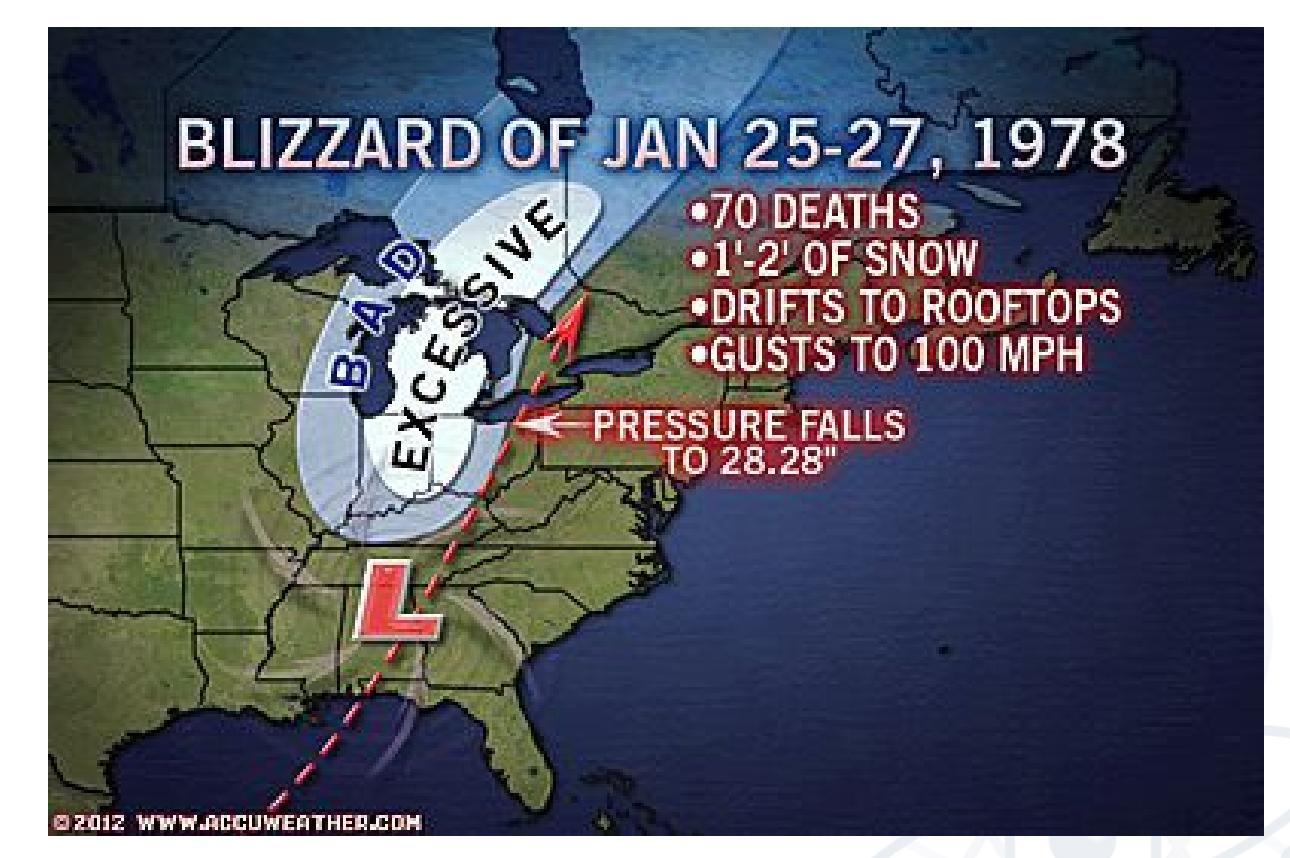
- January 25-27, 1978, was the worst in terms of:
 - Moisture
 - Winds
 - Temperature
 - Duration
 - Pressure

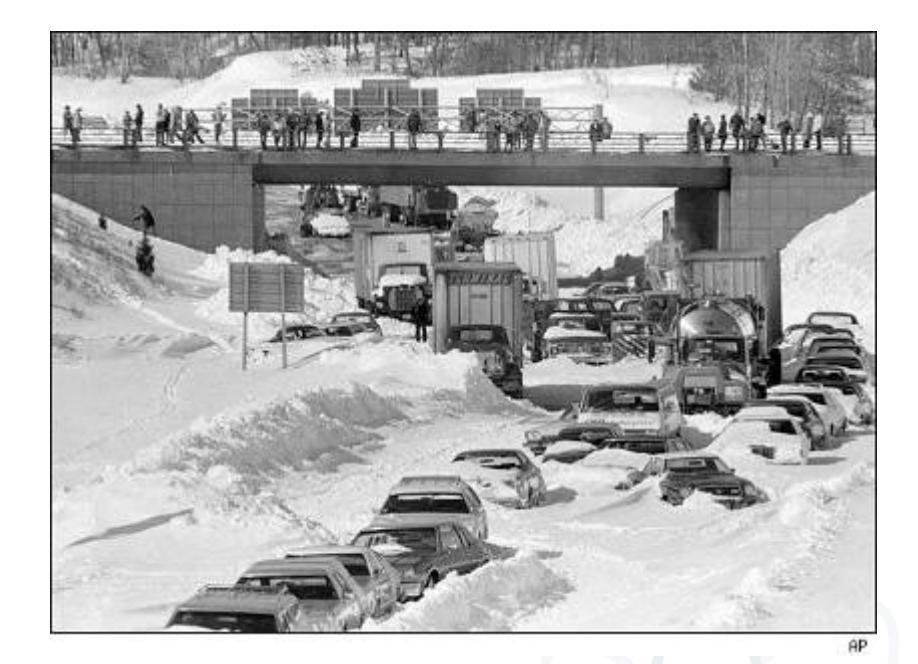
- Scenario:
 - Temperature near zero
 - Sustained strong winds
 - Moisture penetrated the Shield Building
 - Moisture trapped in the outer layer of concrete crystallized
 - Concrete expansion exceeded the tensile capacity of the concrete and propagated the crack
